Understanding and controlling crevice corrosion in stainless steel

A troublesome problem with marine gear and equipment

SG 78 / May 1984

OREGON STATE UNIVERSITY EXTENSION SERVICE

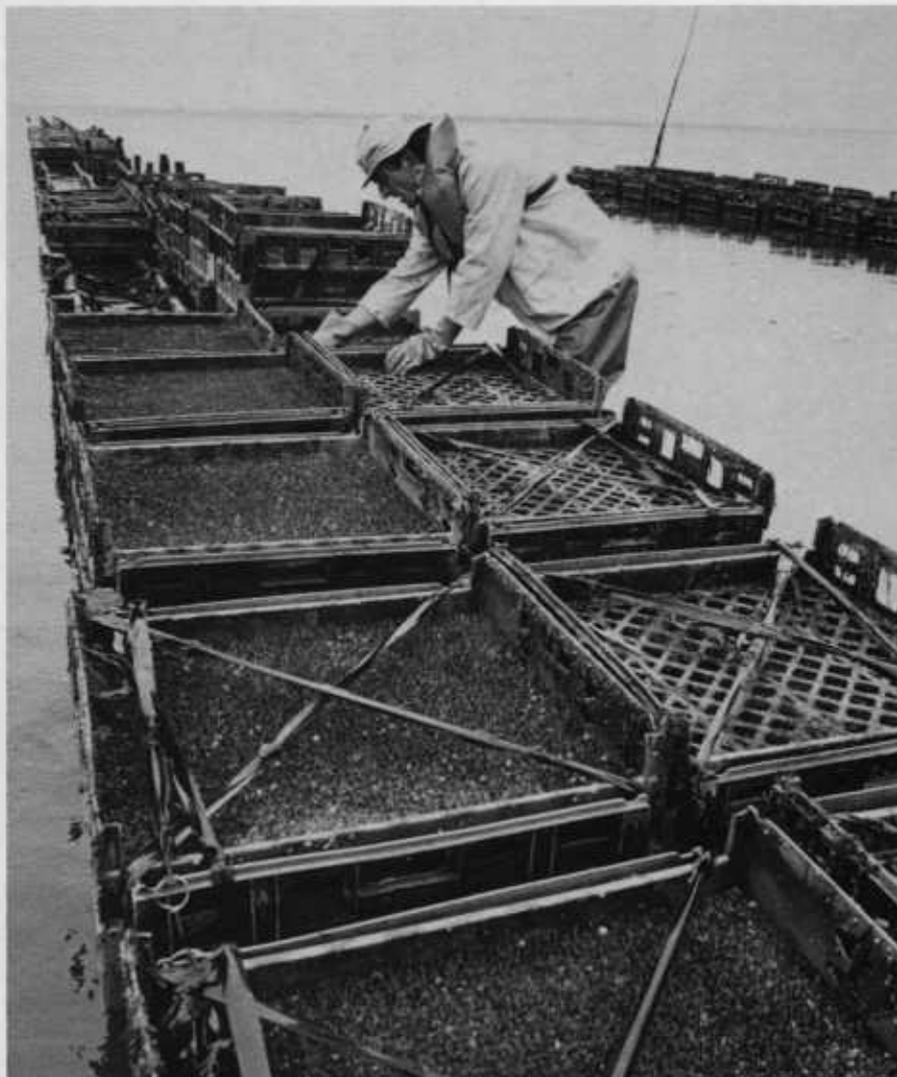
Plastic and wood are the main construction materials for this Oregon oyster grower—but it was the stainless steel hooks that failed first (see the third example in the column on the right).

- An oyster grower uses rubber thongs fastened to stainless wire hooks, to secure plastic shellfish trays to an intertidal wood frame (photo at left and figure 4a). After 6 months, the hooks begin to fail; the metal under each rubber band is corroded (figure 4b).

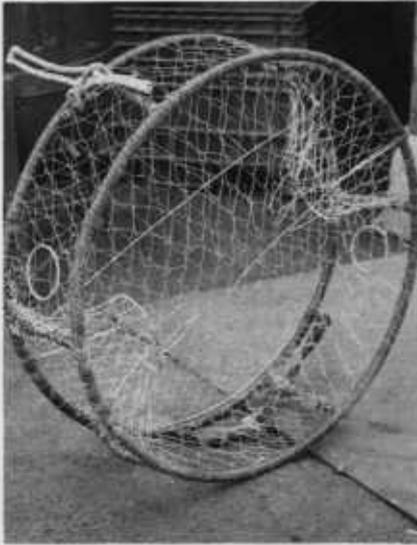
Figure 1a.—This Dungeness crab pot has no bare iron bars—needed for cathodic protection.

- A lightweight Dungeness crab pot is constructed without the customary exposed iron ballast weights (figure 1a). Stainless steel 316 wire mesh covers the frame, made up of steel reinforcing rod tightly wrapped with rubber. After only a few months in the ocean, the stainless wire is corroded and broken at all those places where it was tightly fastened to the rubber-wrapped frame (figure 1b).

The crab pot shown in figure 1a did not have the exposed iron ballast bars that are standard on the more traditional pots shown in figure 6. These bars also act as sacrificial anodes and will prevent onset of the crevice corrosion seen in figure 1b.

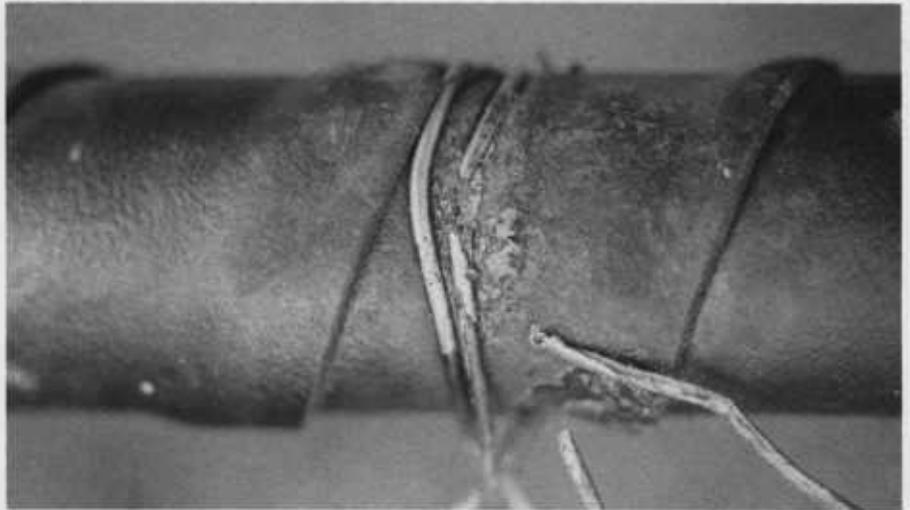
Figure 1b.—Stainless wire has corroded away, where it was imbedded in rubber on this Dungeness crab pot.

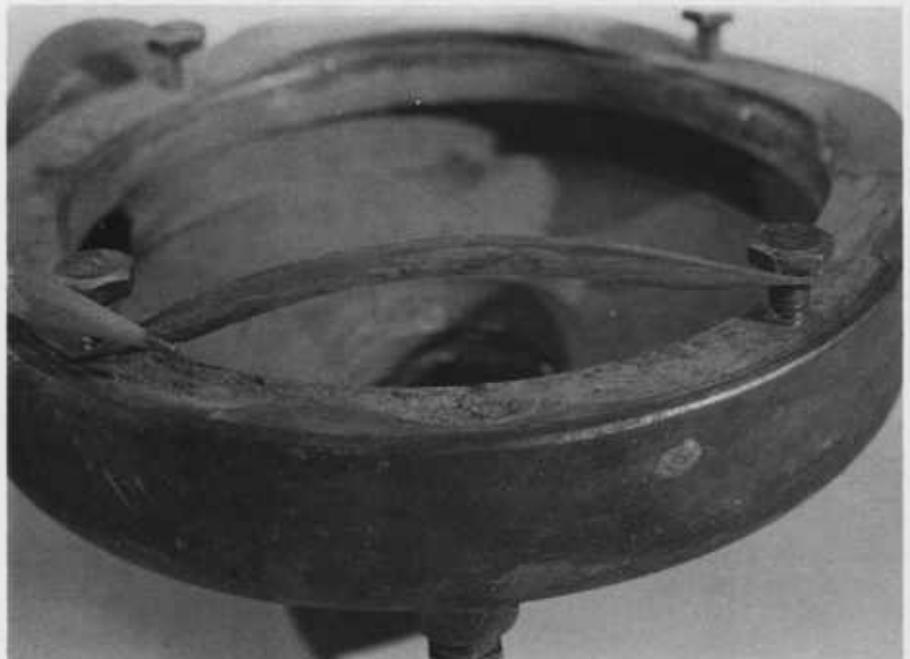
Figure 2.—Pitting has appeared under the gasket on this 316 stainless pump housing.

- A stainless steel pump has PVC plastic pipe threaded into its intake and discharge. After pumping seawater for about a year and a half, the housing under the gasket is badly corroded (figure 2). In addition, the pipe threads are virtually destroyed (figure 3).

Use of a heavy sealant (petroleum-based grease is not good enough) on these threads or around the housing gasket (figure 2) might have given a longer life to this 1-inch pump, which has a replacement cost approaching \$700.

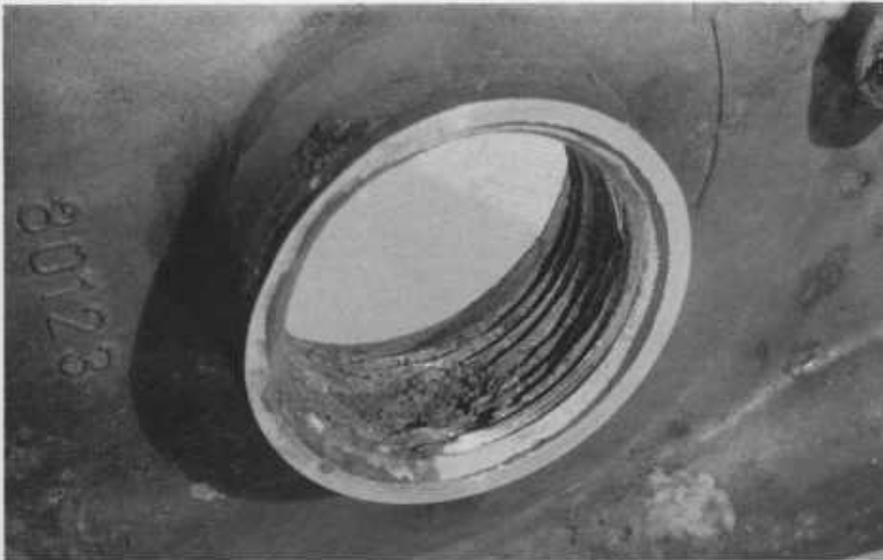
Figure 3.—The 1/4-inch stainless threads of this pump housing are badly corroded where a crevice was left between the housing and the threaded PVC pipe.

Using sealants. If there is no crevice, there won't be a problem. Technicians attempted to seal the threads in the pump housing (figure 3) with teflon tape.

There was apparently enough tape to keep water from leaking out, but not enough to completely fill all the voids. Some water seeped into the threads, and corrosion was on its way.

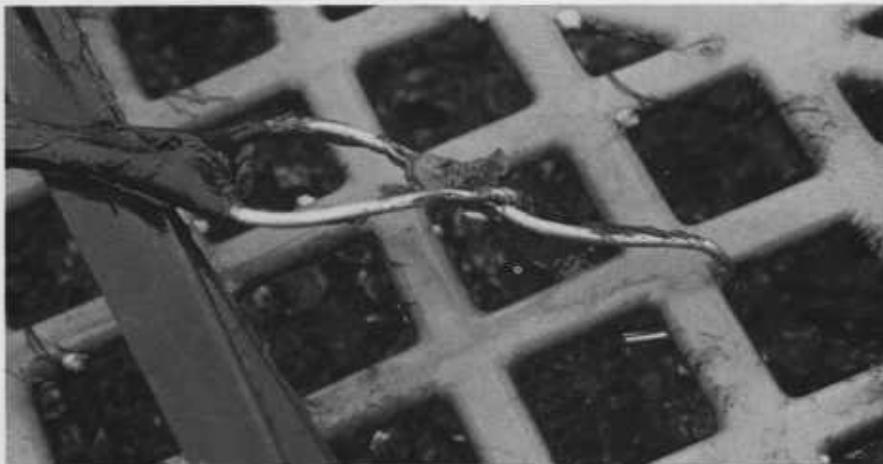
Figure 4a.—Hooks attached to a rubber thong hold down oyster trays in an intertidal area.

The rubber band hooks shown in figure 4a would have lasted longer if they'd been made from plastic. Using galvanized low-carbon steel might also have provided a feasible design option, given a suitable replacement schedule.

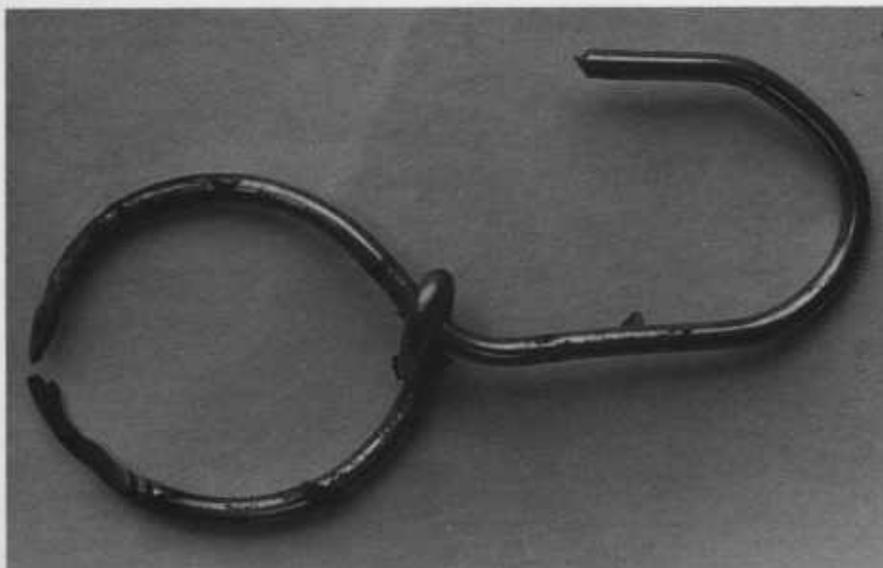
Figure 4b.—Stainless hooks covered with a rubber thong were destroyed in 6 months.

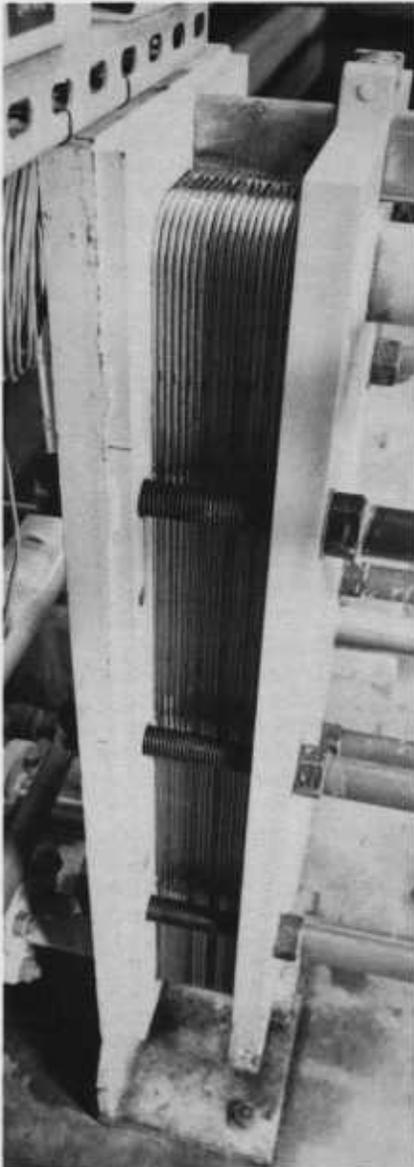
Figure 5a.—A plate heat exchanger is made from several corrugated plates pressed together.

- A marine lab supporting biological research controls seawater temperature by pumping it through a plate heat exchanger. Warm water or cool glycol flows in the other passages of the heat exchanger, which is made up of a stack of corrugated 316 stainless plates

Gaskets around the heat exchanger plates shown in figure 5b are sealed by squeezing the plates between two heavy end plates (figure 5a).

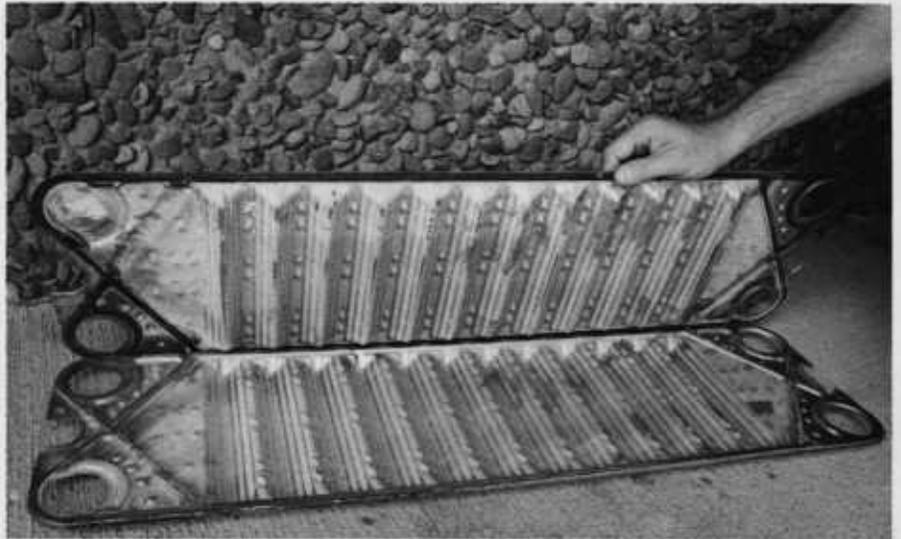
Figure 5b.—A neoprene gasket seals the edges of these heat exchanger plates.

pressed together (figure 5a). They are sealed along the edges by a neoprene gasket (figure 5b). After 3 years of intermittent use, holes in the plates appear under the gasket in several areas (figure 5c). They must be completely replaced.

In this case, perhaps more pressure might have prevented the formation of small crevices under a few stretches of the gasket where the corrosion started. Replacement cost for each of these 316 stainless plates is around \$100.

The heat exchanger plates shown in figure 5b would have lasted longer had they been made of titanium. Cost would have been about double, but a greatly extended lifetime could have made such an increase worth considering.

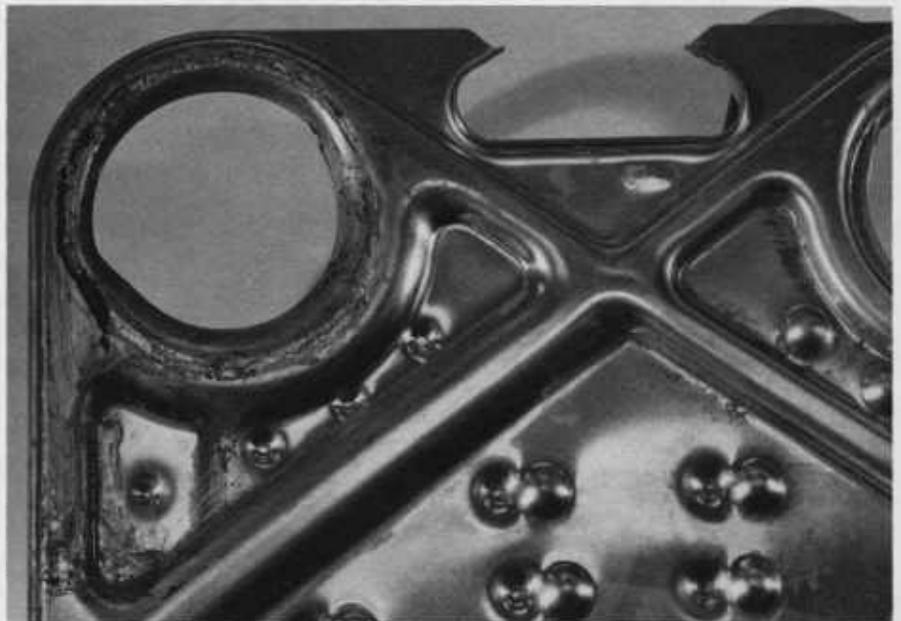
Figure 5c.—Crevice corrosion in several areas under the gasket of these 316 stainless heat exchanger plates has penetrated the thickness.

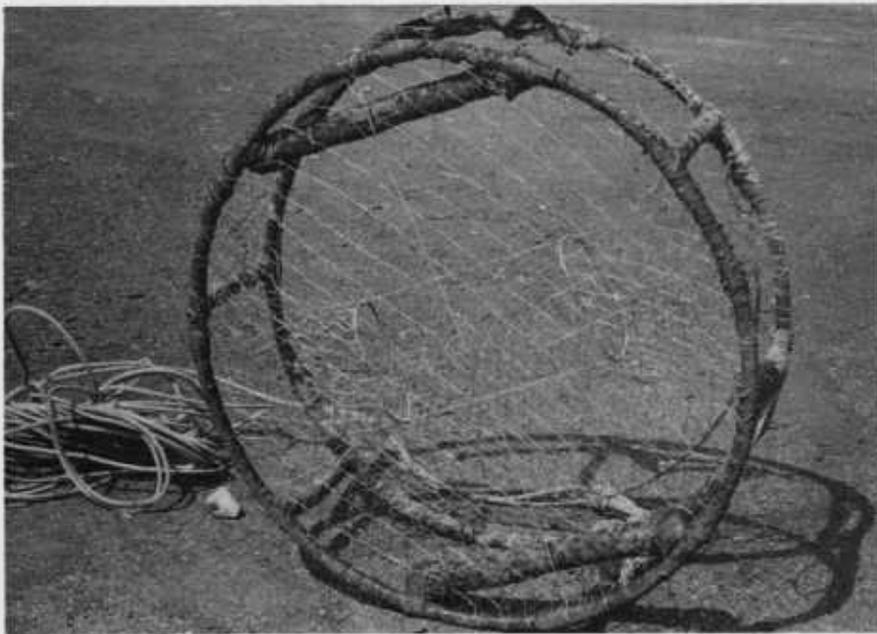
Figure 6.—Traditional Dungeness crab pots have iron bars crossing the floor—for ballast and for cathodic protection of the stainless wire mesh. Compare this one with the pot without iron bars shown in figure 1a.
