Title: Serviceability of Douglas-fir Marine Piles and Control of
Their Deterioration

Serviceability of Douglas-fir Marine Piles
and Control of Their Deterioration

A THESIS

Oregon State University

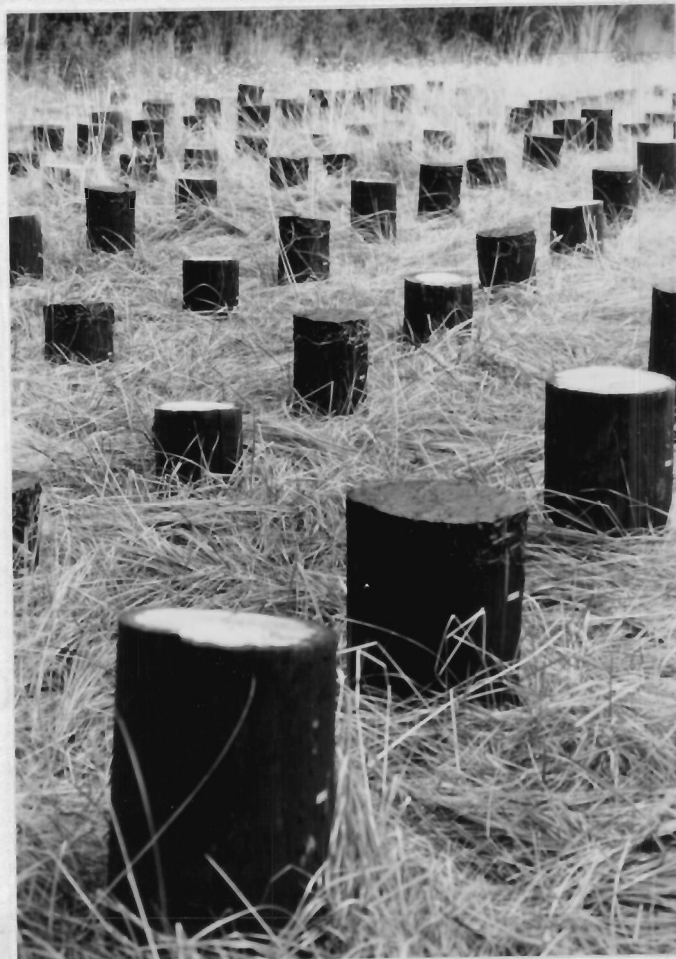
A test plot containing simulated piles was established at the Northwest Forest Genetics Nursery near Corvallis, Oregon, in 1976 to evaluate promising chemicals for protection of cutoff pile tops (Figure 12). Ninety-nine 5 to 6 foot-long piles about 12 to 14 inches in diameter were pressure-treated with penta in heavy petroleum by a commercial treating plant. Three 6-inch long cores equally spaced around each pile at midlength were removed and cultured for fungi, then the piles were cut in half through the plane of the core holes. The sections were placed with the treated ends down 1.0 foot deep in the soil and 22 different chemical treatments were applied to the cutoff pile tops (nine tops per treatment) (Figure 13). For most treatments, end-matched specimens received the same preservative treatment, but one was capped with a 1/2-inch thick coat of coal-tar cement with fiberglass cloth embedded.

Figure 12. Simulated cutoff Douglas-fir pile top plot established near Corvallis, Oregon, to evaluate promising chemicals for preventing top decay.

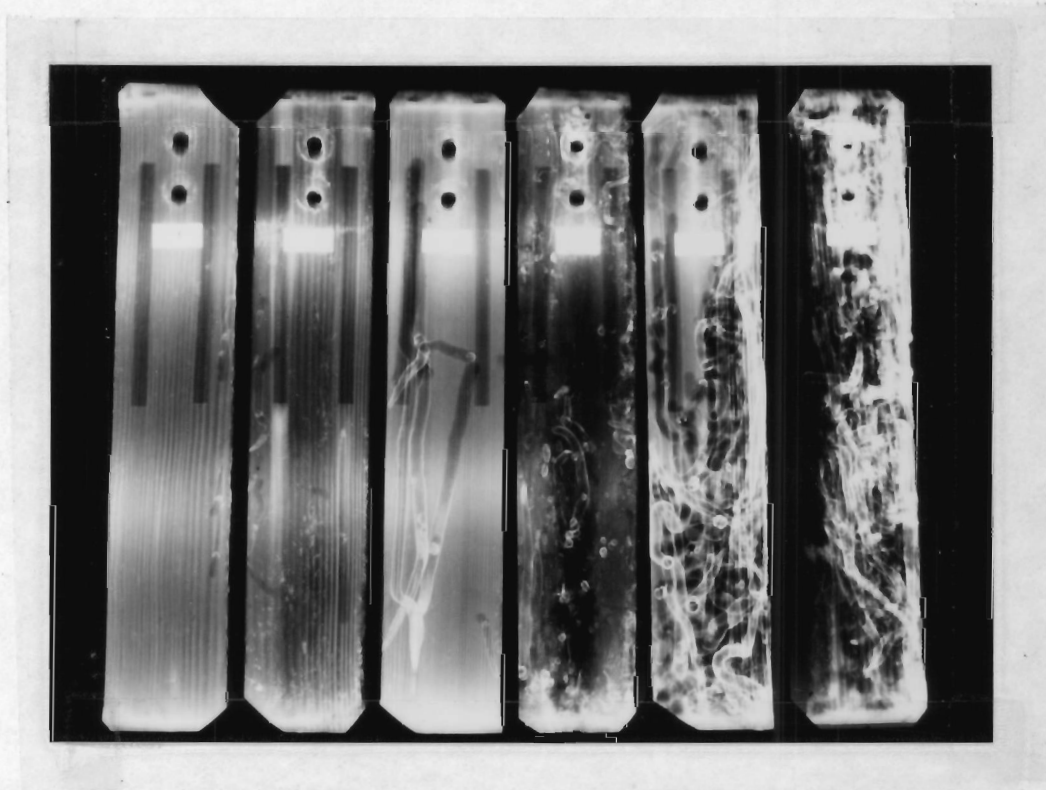
Figure 16. Shipworm attack ratings of 0 to 5 from left to right.

X-ray prints were made of all panels to expose internal shipworm attack (Figure 16). Hardware cloth with 0.63 cm squares was laid over the prints and the number of squares with shipworm damage recorded.
