STUDIES OF COMPRESSION FAILURES AND THEIR DETECTION IN LADDER RAILS

February 1949

No. D1733

By MAXON Y. PILLOW, Wood Technologist

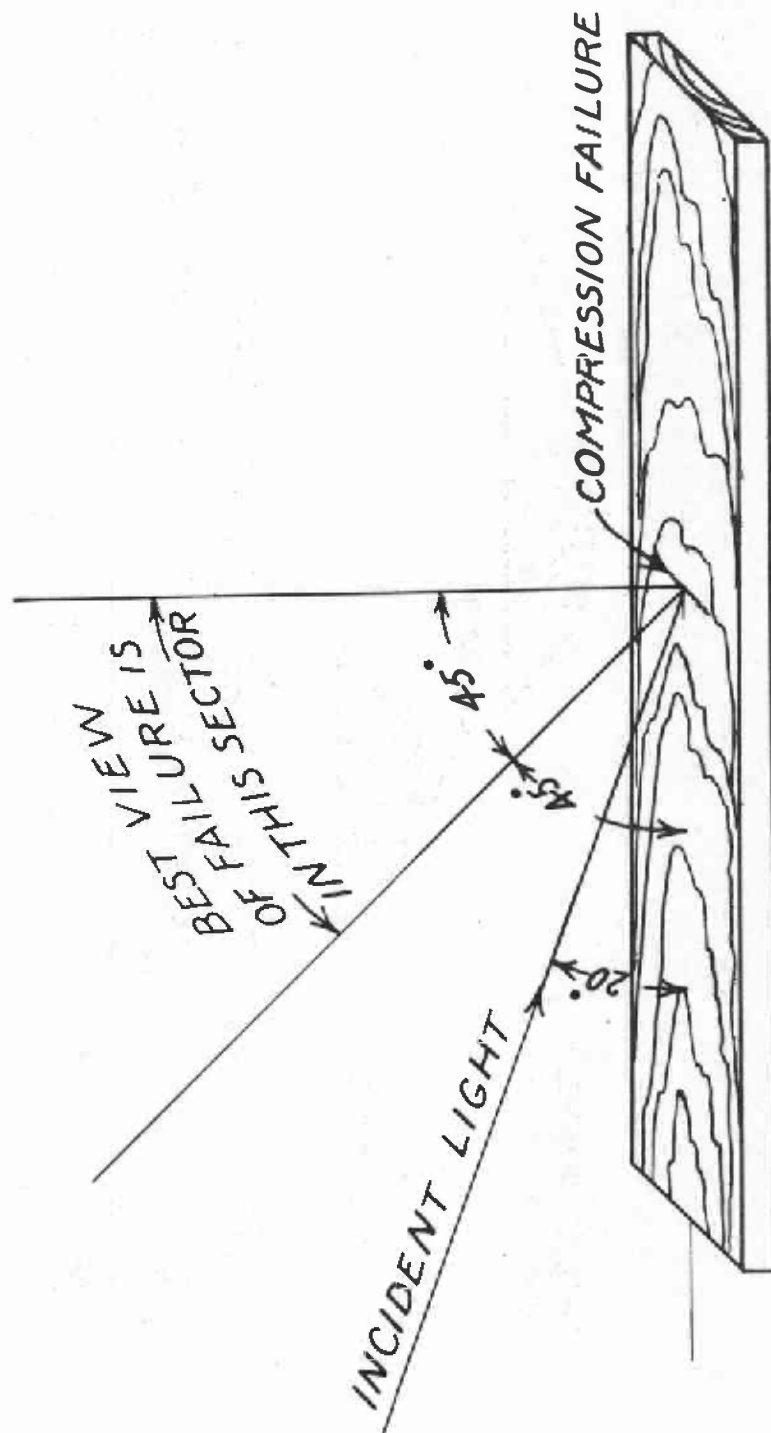
Figure 8.--Most effective angle of view and angle between wood surface and incident light when searching for compression failures.

Careful inspection of sides and edges of ladder rails after they have been lacquered or varnished, is considered a practical means of detecting visible compression failures that may have resulted from localized endwise compression stresses that resulted in forming compression failures only in narrow zones across the width of the rails. Incident light from a reflector spot bulb, for example, focused at an angle of about 20° to the surface being examined, has been found to facilitate identification of visible compression failures. These are most readily seen when viewed from a position between 45° and 90° with respect to the surface and from the same side from the vertical as the source of light (fig. 8).

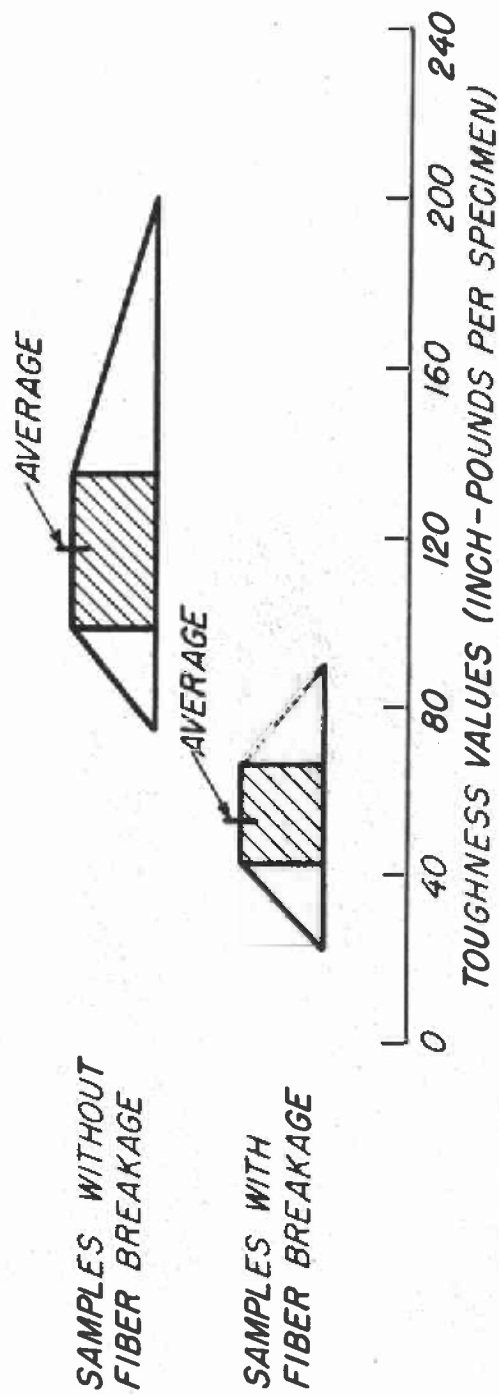
Z N 80319 P

Toughness.--Toughness-test values were determined for three specimens from each of the samples obtained from the ladder rails available for this study. The average value for all of the specimens from samples having fiber breakage was less than one-half of that of specimens from the samples without this characteristic, namely, 53.7 and 117.4 inch-pounds per specimen, respectively (table 1). The ranges of these values overlapped slightly; but, nevertheless, they differed significantly (fig. 9). This overlapping of the ranges resulted because the low specific gravity of three specimens from one sample without fiber breakage caused moderately low toughness values and several specimens with relatively high specific gravity caused about the same toughness values, even though fiber breakage and compression failures were present in the samples. The average toughness value of three specimens from each sample having fiber breakage was considerably lower in relation to average specific gravity of the specimens than that of the other specimens

Figure 9.--Total range, range of the middle two-thirds of the specimens (cross-hatched), and average of toughness-test values of specimens obtained from samples of ladder rails, some that showed fiber breakage on end-grain surfaces and, also, other samples without this characteristic.

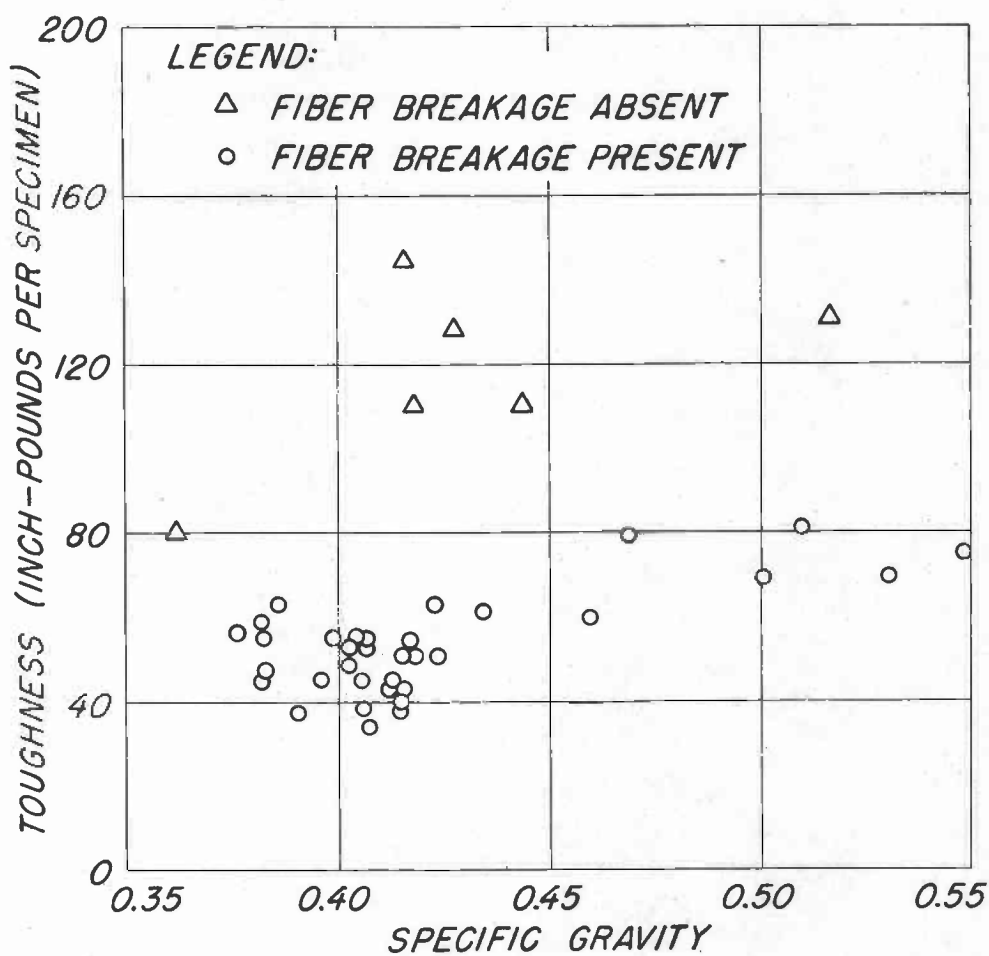
Z.M. 80320 F

from samples without fiber breakage (fig. 10). Thus, for wood of the same density, fiber breakage on end-grain surfaces is identified with seriously lower toughness-test values than is wood without this characteristic, which is caused by the presence of compression failures.

Figure 10.--Relation of average toughness-test values to specific gravity of three specimens from each sample with fiber breakage in comparison to similar values of specimens from samples without fiber breakage.

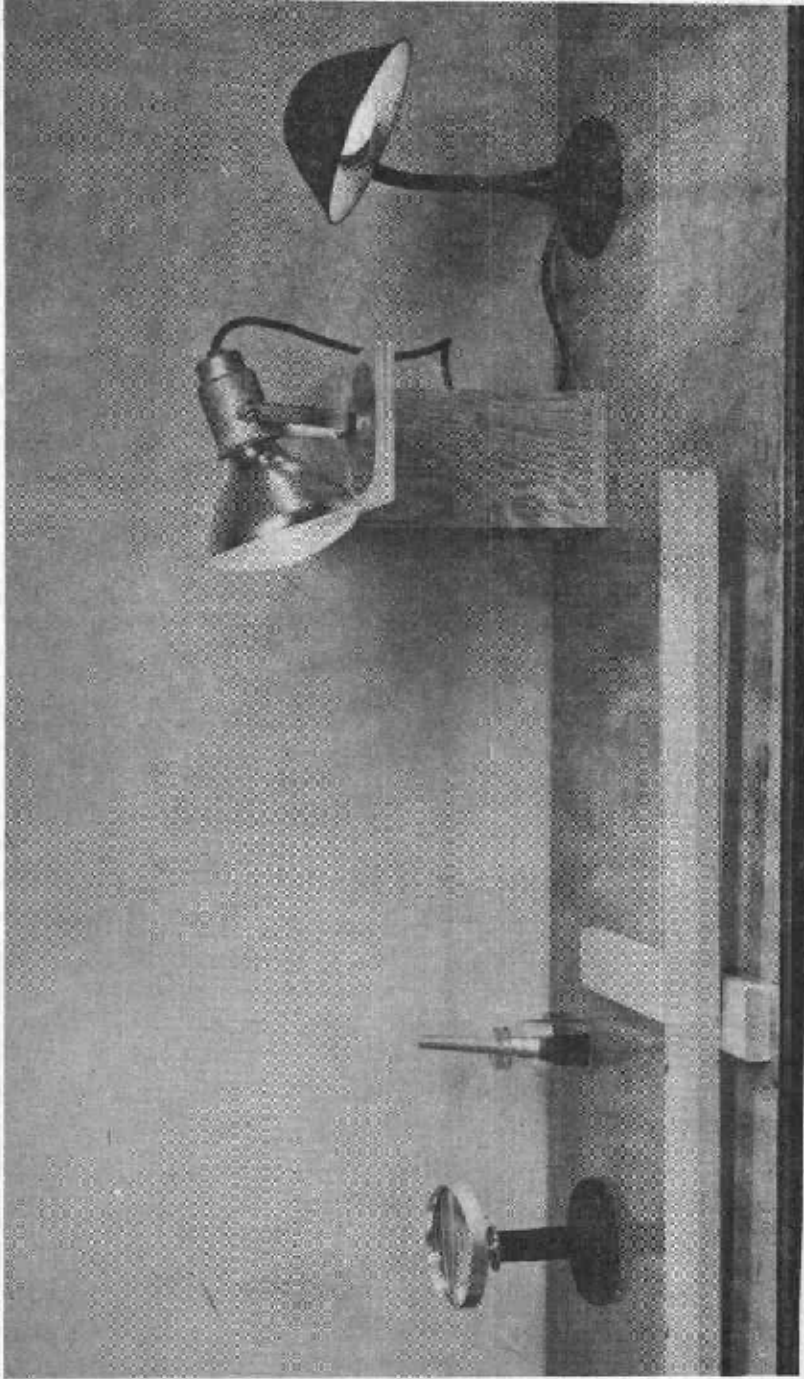
Z M 80325 F

Figure 16.--A convenient arrangement of a reflector spotlight and an ordinary incandescent-bulb desk lamp placed on a work table for examination of ladder rails to detect visible compression failures and fiber breakage on the side- and end-grain surfaces.

Figure 16 shows a convenient arrangement of lighting from a reflector spotlight for identifying visible compression failures on the side grain and from a conventional incandescent 60-watt bulb in a desk lamp for examining end-grain surfaces for fiber breakage. The latter bulb should be shielded so that the light does not shine directly in the inspector's eyes. Studies of these methods to identify visible compression failures and fiber breakage
