SPECIAL REPORT No. 1

EFFECT OF UNUSUALLY LOW DISCHARGE FROM PELTON
REGULATING RESERVOIR, DESCHUTES RIVER, ON
FISH AND OTHER AQUATIC ORGANISMS

By
Robert W. Phillips
Fishery Biologist

Portland, Oregon
May 1969

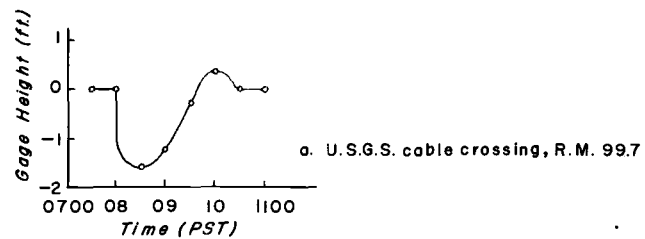
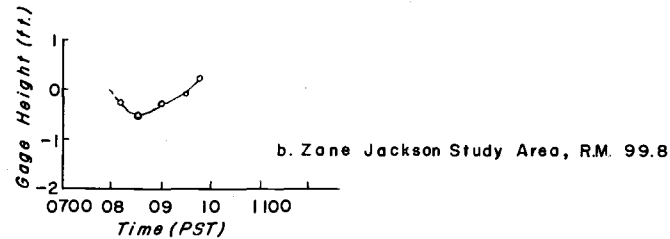
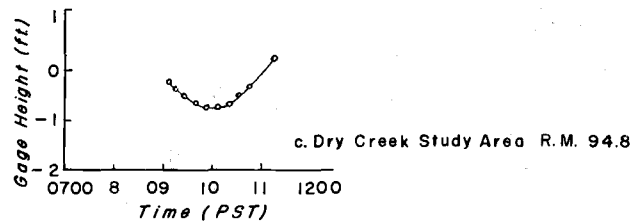
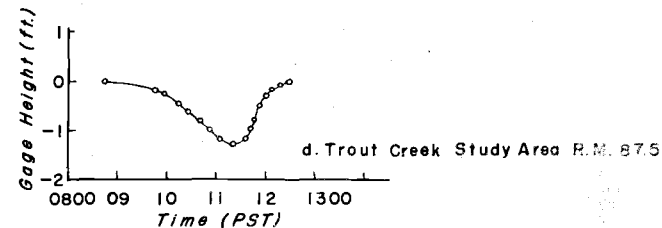
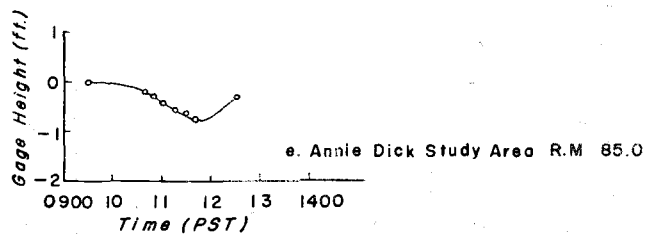
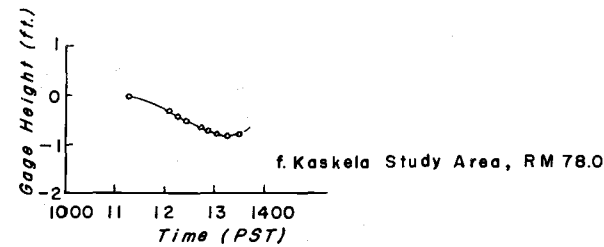
Figure 2. Characteristics of the flow reduction in the Deschutes River, April 2-3, 1968
Locations are designated by River Mile (RM)

After closure of the gates, water level below the dam dropped 1.55 feet almost immediately, as measured at the USGS cable crossing some 0.3 mile below the dam. (Fig. 2a) Brief examination of a few feet of exposed shoreline revealed that several sculpins and stonefly nymphs were stranded among the rubble (Fig. 5). No salmonids were seen. Loss of salmon and trout from stranding in the area was probably negligible because the exposed stream banks were relatively steep and there were no gravel bars.

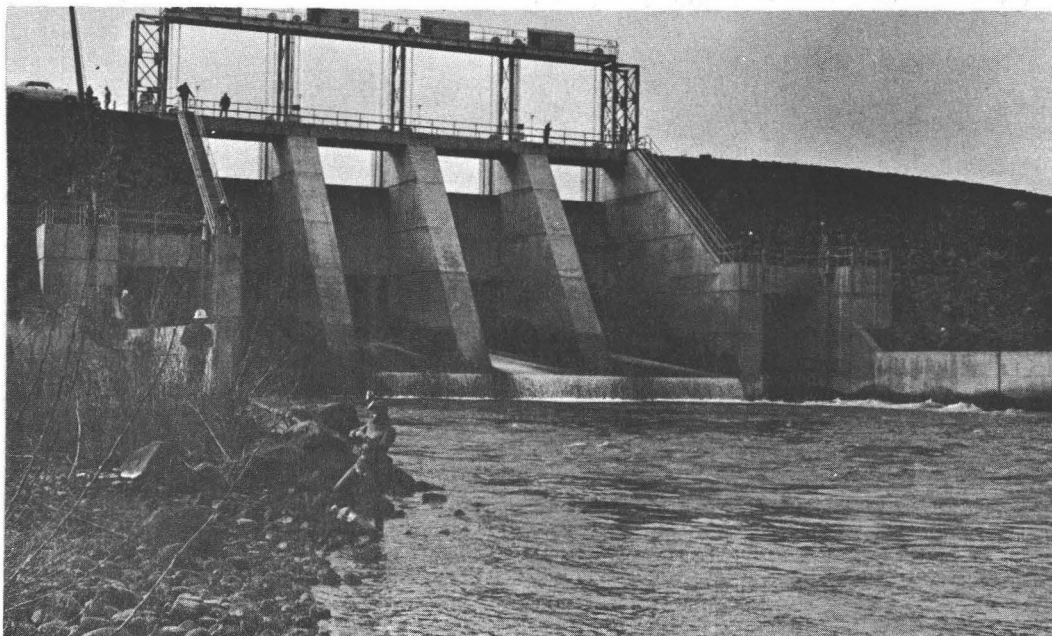
Divers went into the water to inspect the stilling basin immediately after the flow was reduced (Fig. 3 and 4). A Company report concludes, "A large portion of the basin could not be inspected because of the presence of well-graded boulders and gravel; however, the damage which could be observed was of the extent that no immediate repairs are warranted." (Portland General Electric Company, 1968). The inspection was completed at 0845 and the gates cracked open to begin a gradual increase in flow.

Fig. 3. SCUBA diver prepares to enter water to inspect stilling basin at Pelton regulating dam. (Photo by Phillips)

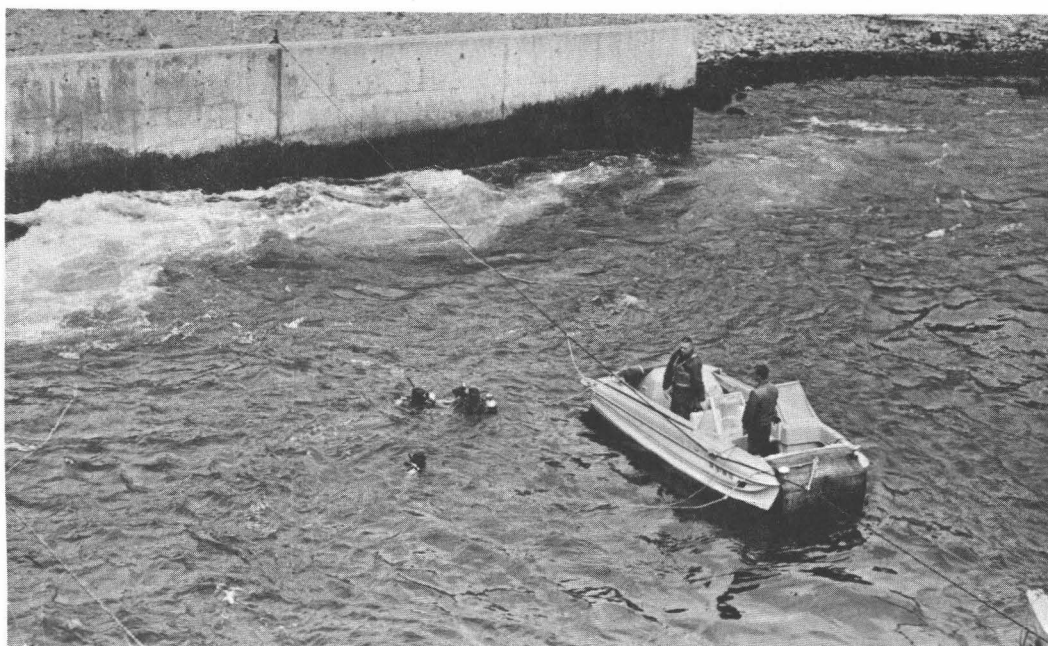
Fig. 4. Divers surface briefly during inspection of stilling basin. (Photo by Phillips)

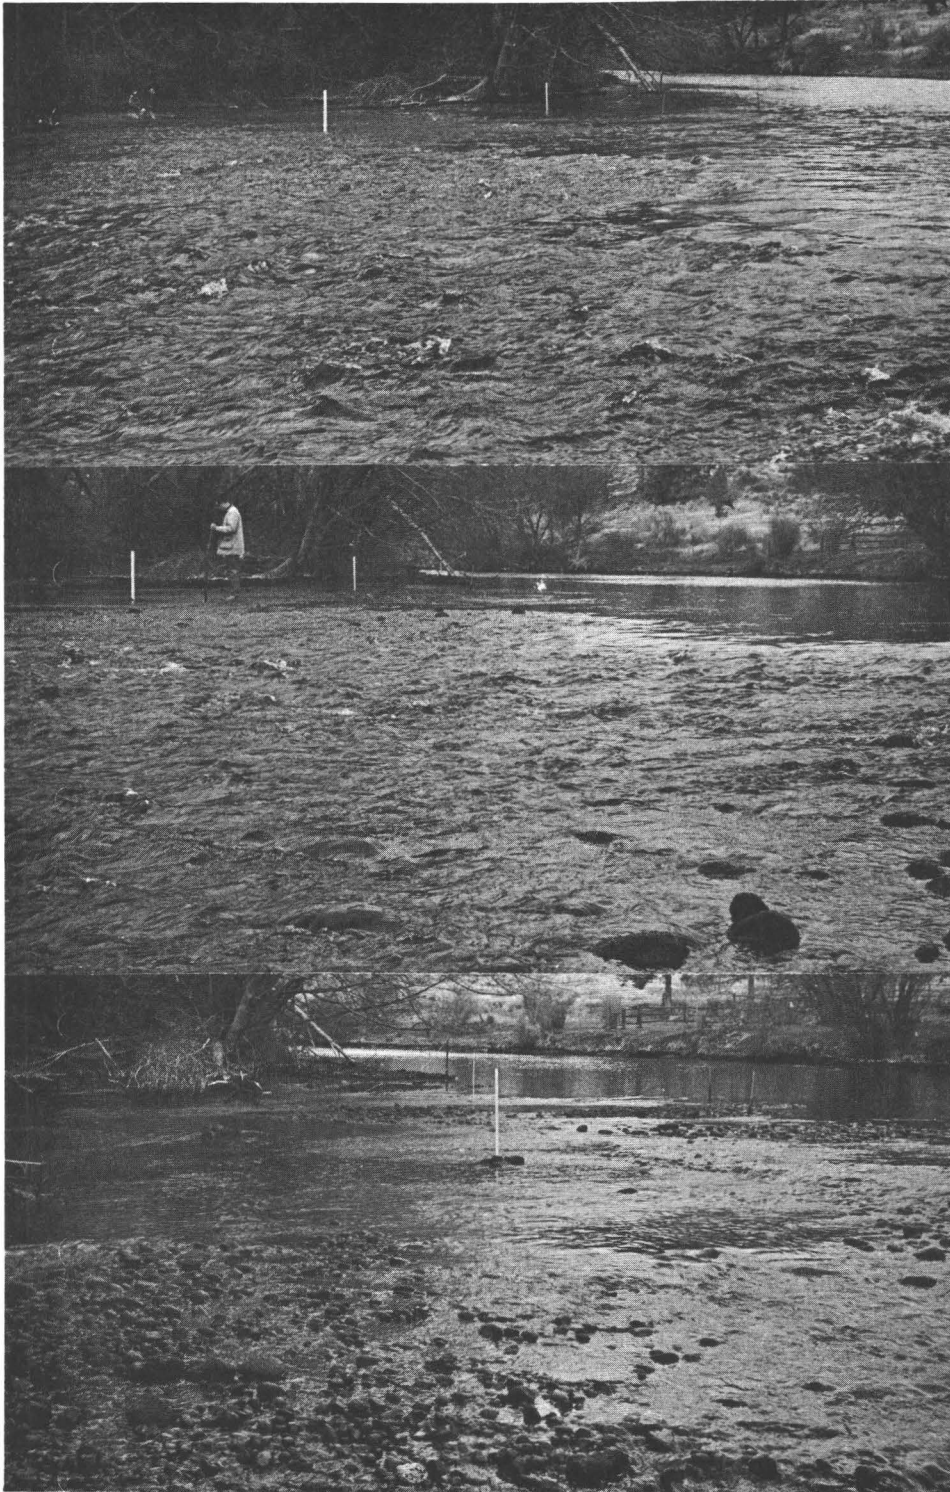
The decrease in flow below the regulating dam was insufficient to dewater the channel on the west side of the island, where the study area at Zane Jackson is located (Fig. 6). Loss of fish by stranding was therefore small.

Fig. 6. Zane Jackson study area showing water at normal, intermediate, and low levels. (Photos by Herrig)

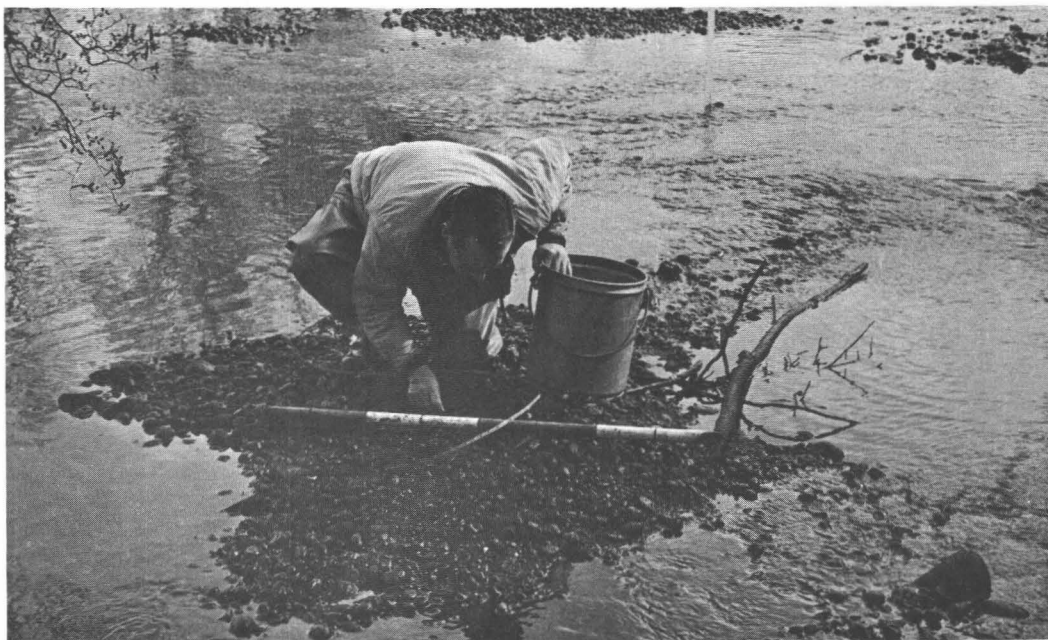
One area along the island drained (Fig. 7), stranding two rainbow trout 6 to 8 inches long, and about 30 chinook fry 2 inches long. The fish would have died had they not been removed and placed in deeper water. Numerous sculpins and aquatic insects were also stranded (Fig. 8). Loss of these organisms was minimal because of the short duration of the flow reduction and the cool weather.

Fig. 8. Zane Jackson study area: collecting stranded aquatic insects. (Photo by Herrig)

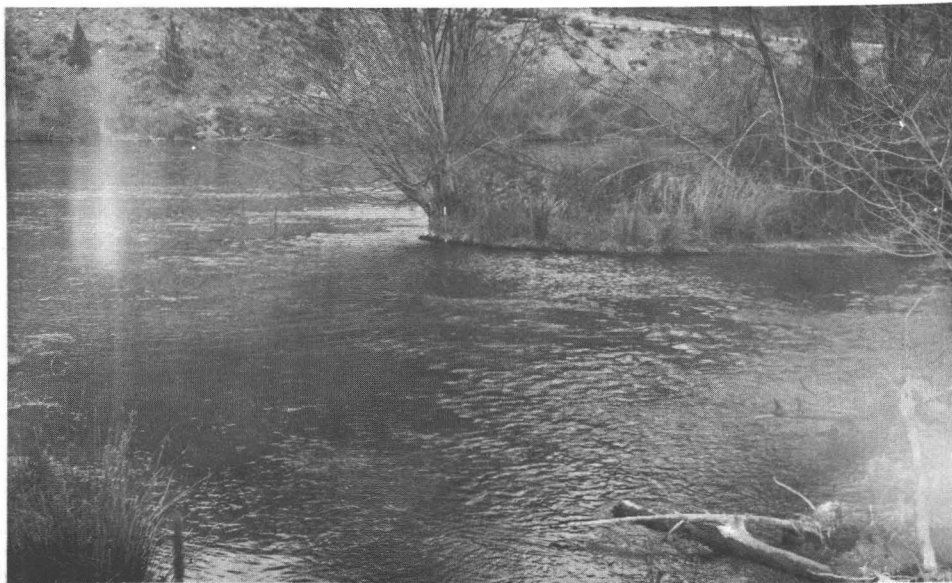
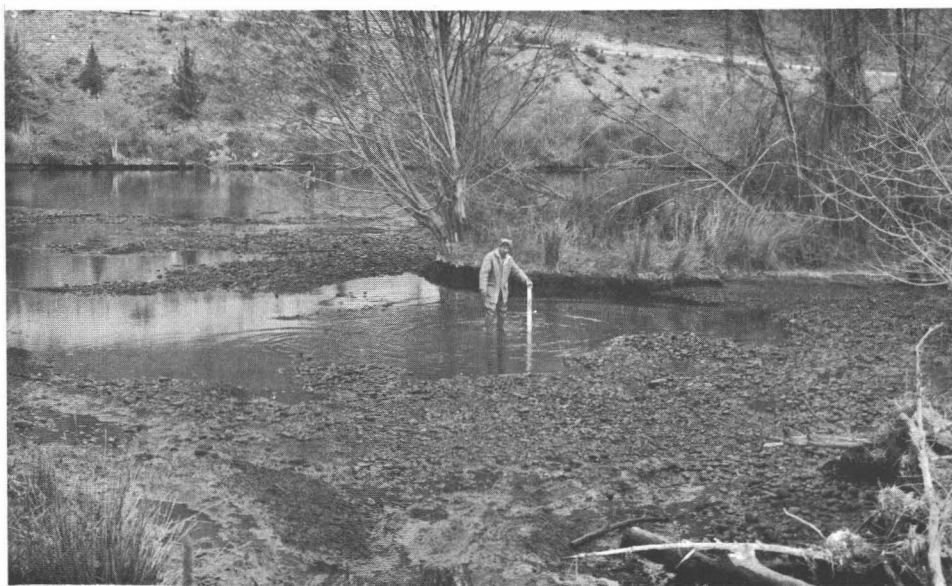
The water had already started dropping when we arrived at East Disney. Two gages were placed to record the changes in water level, one 32 feet from shore (Fig. 9) and the second 195 feet into the stream bed (Fig. 10). Photos were taken of the exposed area (Fig. 11) as well as some of stranded fish (Fig. 12).

Fig. 9. East Disney study area showing water level beginning to fall (top) and at low point (bottom). (Photos by Ebert)

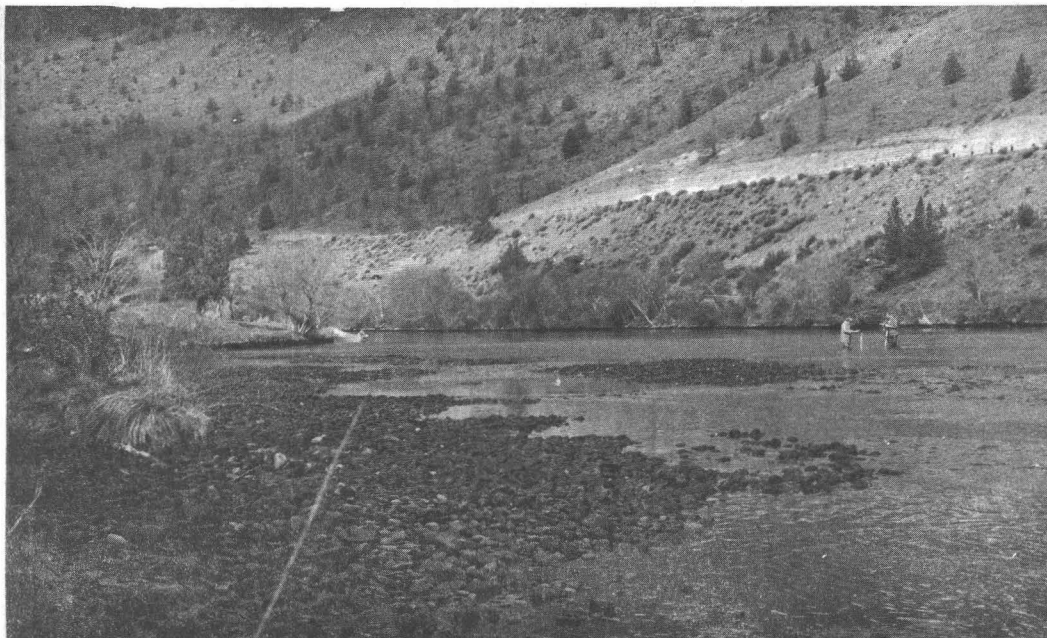
Fig. 10. East Disney study area at low flow, looking upstream.
(Photo by Ebert)

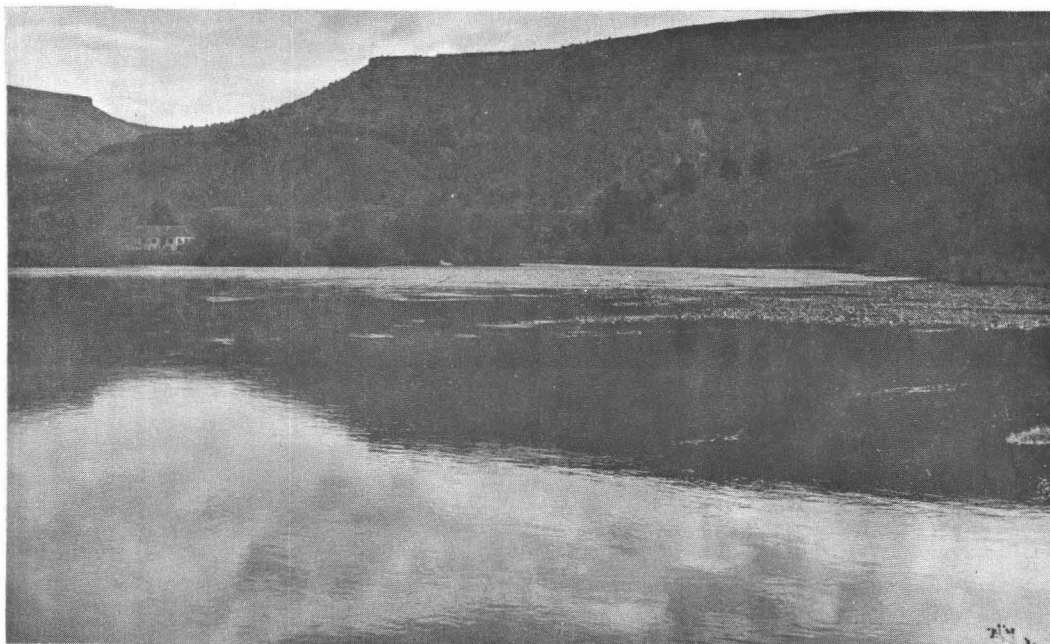
Most of the time was spent making observations of stranded fish. There were large numbers of 1-3 inch chinook and some trout to 7 inches. The West Disney area was also surveyed for stranded fish; many 1-3 inch chinook and a few small trout were observed, as well as three exposed steelhead redds. We estimated the loss of fish in the East Disney and West Disney areas to number several thousand.

Fig. 11. East Disney study area at low flow, looking downstream.
(Photo by Ebert)

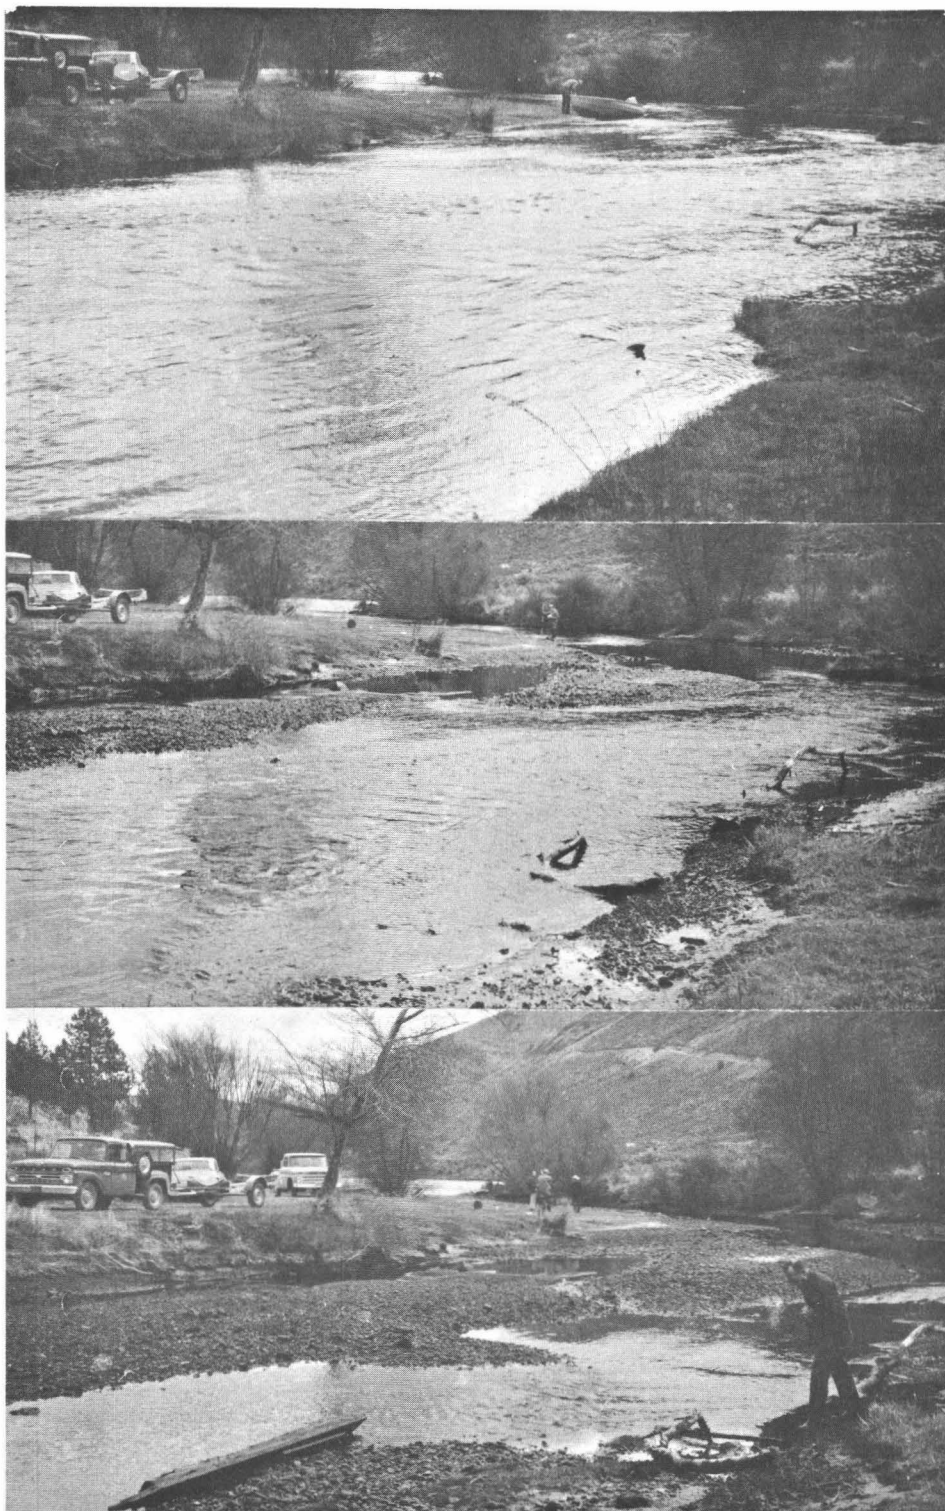
Fig. 13. Dry Creek study area showing water at normal (top), intermediate (middle), and low (bottom) levels. (Photos by Scherzinger)

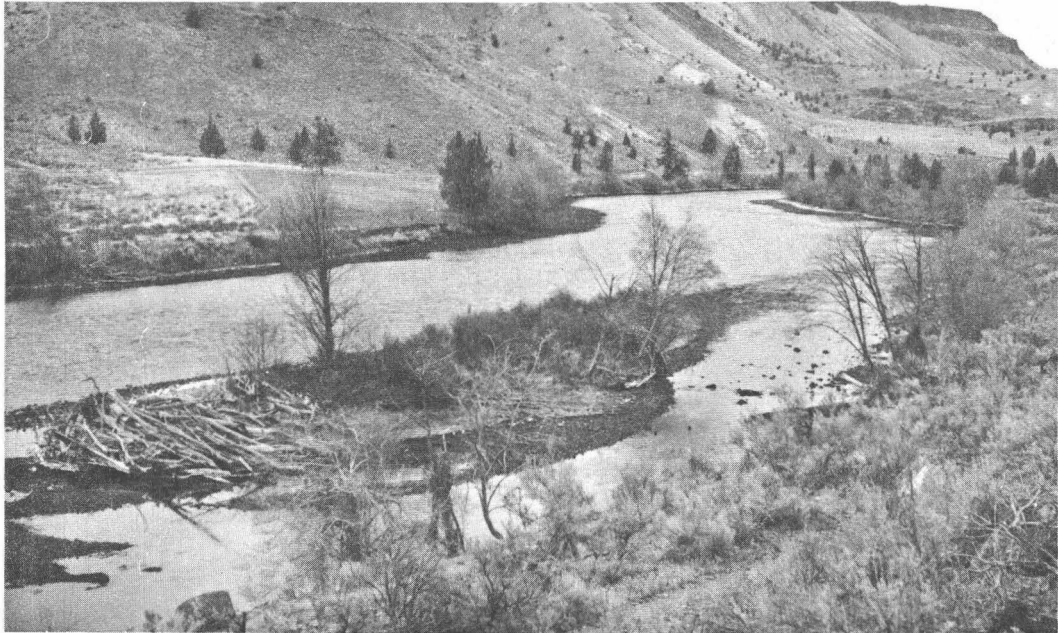
Much of the stream bottom was exposed at the study area and adjacent stream sections by the reduction in flow (Fig. 16 and 17). Several small chinook and rainbow, and one summer steelhead (marked LV-An) (Fig. 18), were entangled in the weed beds. Four sections of exposed bank 100 feet long and 3 feet wide were surveyed. The number of fish found stranded totaled 3 salmon fry and 6 rainbow fingerlings. However, the count of dead fish is believed to be only a fraction of the total mortality in the sections as fish slipped into crevices between rocks and were difficult to observe.

Fig. 17. Trout Creek study area at low water looking downstream from island in Figure 16. (Photo by Cummings)
