SURVEY OF ALSEA RIVER, OREGON.

*With letter of the Chief of Engineers, report of a survey of Alsea River, Oregon.*

**Map of  
ALSEA RIVER,  
OREGON.**

FROM THE FORKS TO ITS MOUTH  
SHOWING OBSTRUCTIONS TO BOAT NAVIGATION

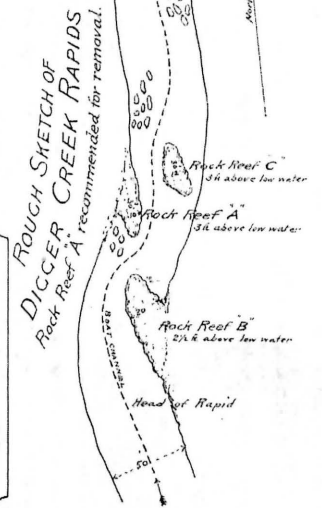
This forms a very bad reach of river. To effectually help matters will require (referring to accompanying sketch) the removal of the loose rocks along the left bank, a half dozen of those at the lower end upon the right bank, and about 20 feet of the outer end of the reef marked A, which stands about 3 feet out of low water.

All of the material is a soft sandstone and the loose rocks are of about one cubic yard volume each.
