# TESTS OF CARGO FLOORING R AND S FOR AIRCRAFT

No. 1550-E

FOREST PRODUCTS LABORATORY  
MADISON 5, WISCONSIN

J. A. LISKA, Engineer

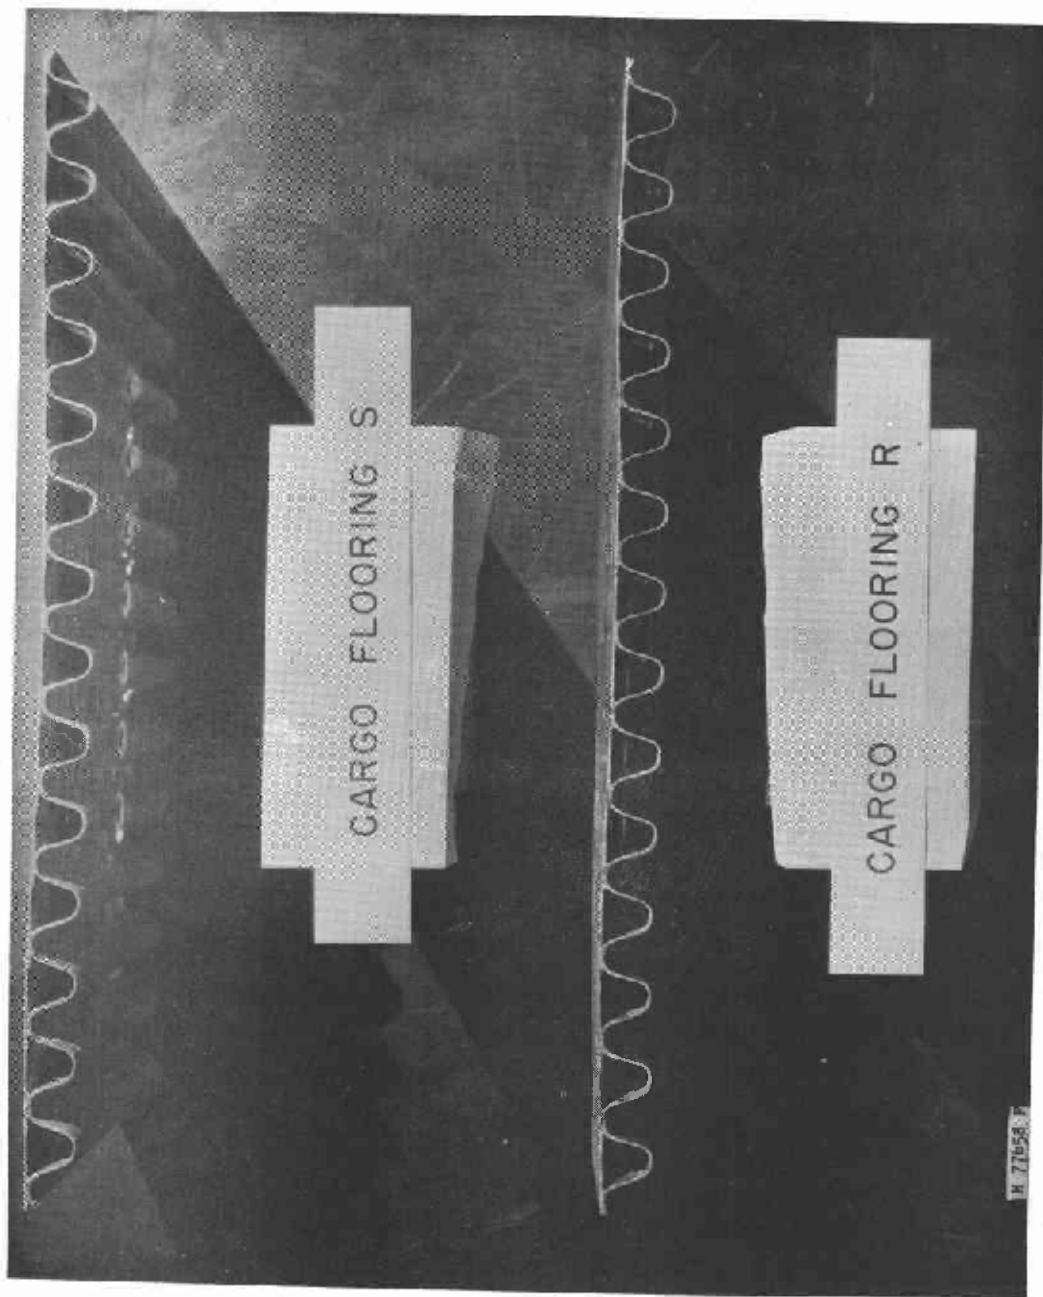
The 0.047-inch-thick aluminum sheet that formed the wearing surface of this flooring was riveted to the 0.040-inch thick aluminum corrugated lower sheet by 1/8-inch countersunk rivets. The rivets were spaced approximately 1-1/4 inches on centers both ways, and the corrugations in the lower sheet were also spaced about 1-1/4 inches on centers. Over-all floor thickness was 13/16 inch. Figure 1 gives an edge view of this flooring.

This flooring, figure 1, was identical with that of flooring R except that the aluminum used in the corrugated sheet was 0.047 inch in thickness.

Figure 1.--Edge view of cargo flooring panels R and S showing similarity of construction. The corrugations are spaced about 1-1/4 inches on centers and the corrugated sheet is riveted to the wearing surface at 1-1/4-inch intervals.

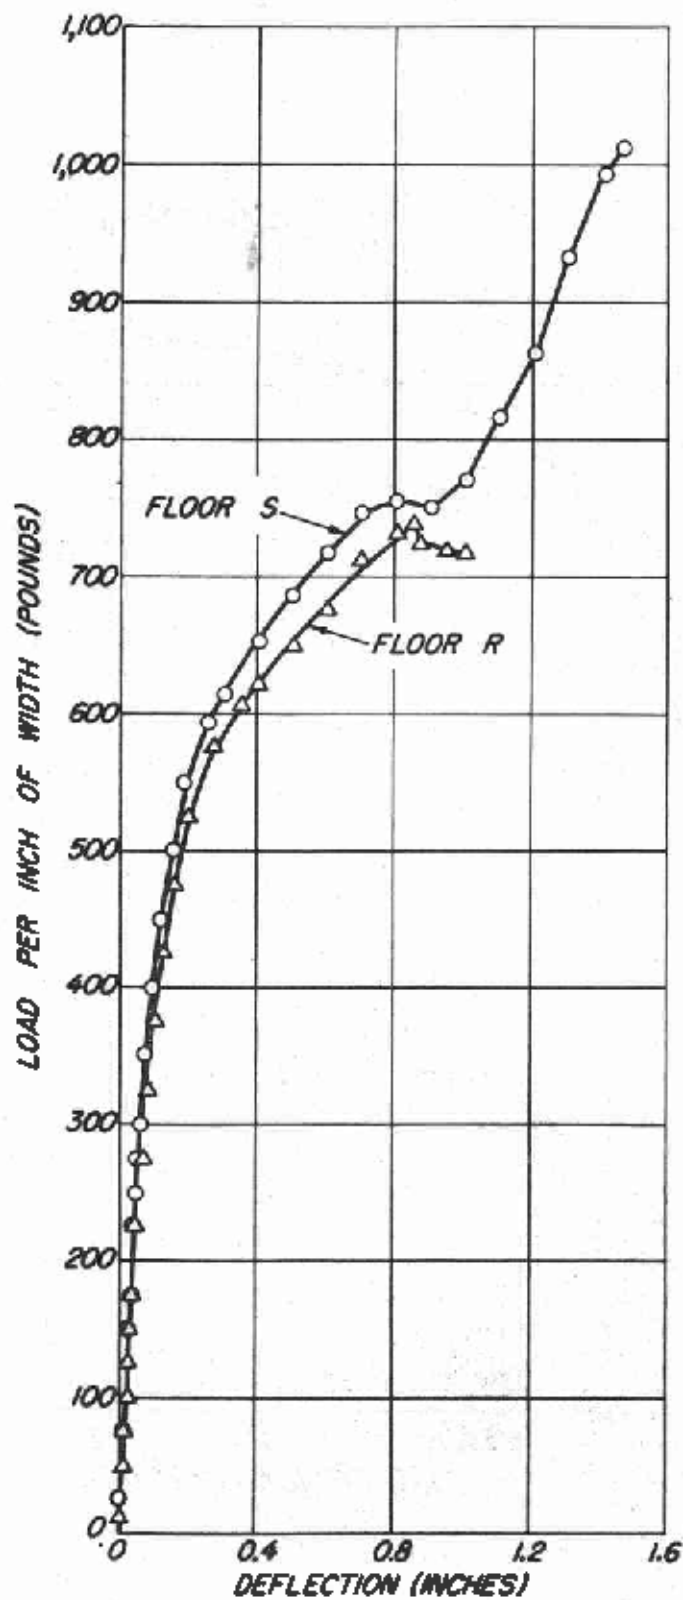
Three static-bending specimens of each flooring material and span length were tested over 8- and 16-inch spans. Typical load-deflection curves for each span length and material are presented in figures 2 and 3. Top and edge views of typical failures for each material and span length show in figures 4 and 5 the shearing of rivets that was encountered in every test.

Figure 2.--Typical load-deflection curves for static-bending tests of cargo floorings R and S, tested over an 8-inch span.

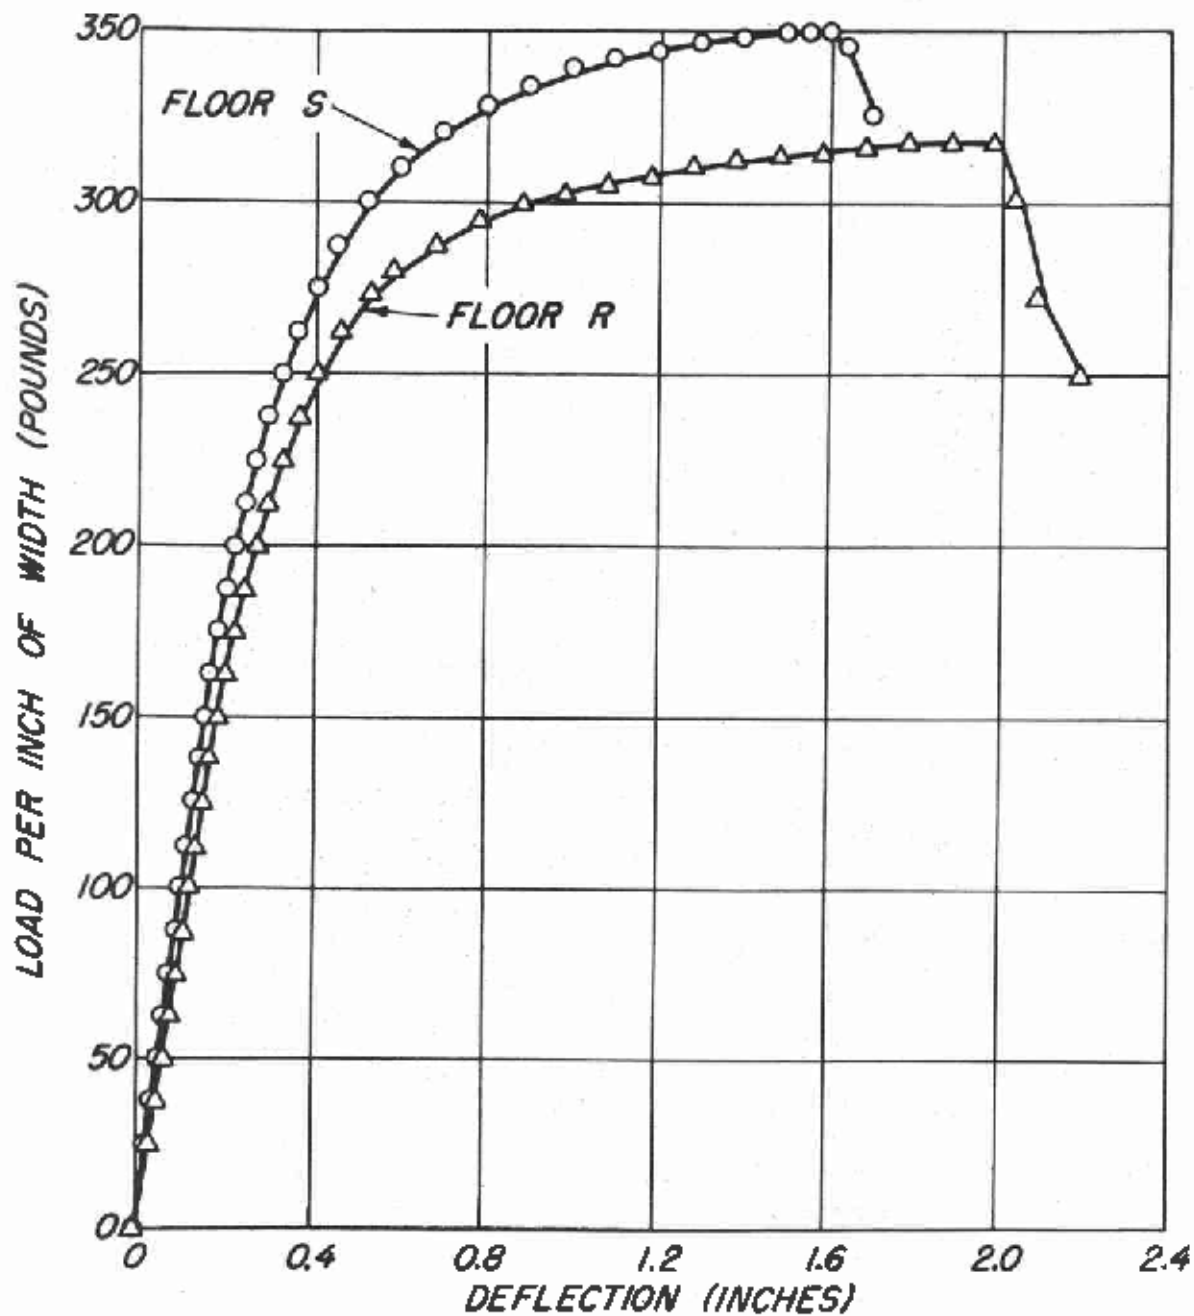
Figure 3.—Typical load-deflection curves for static-bending tests of cargo floorings R and S, tested over a 18-inch span.

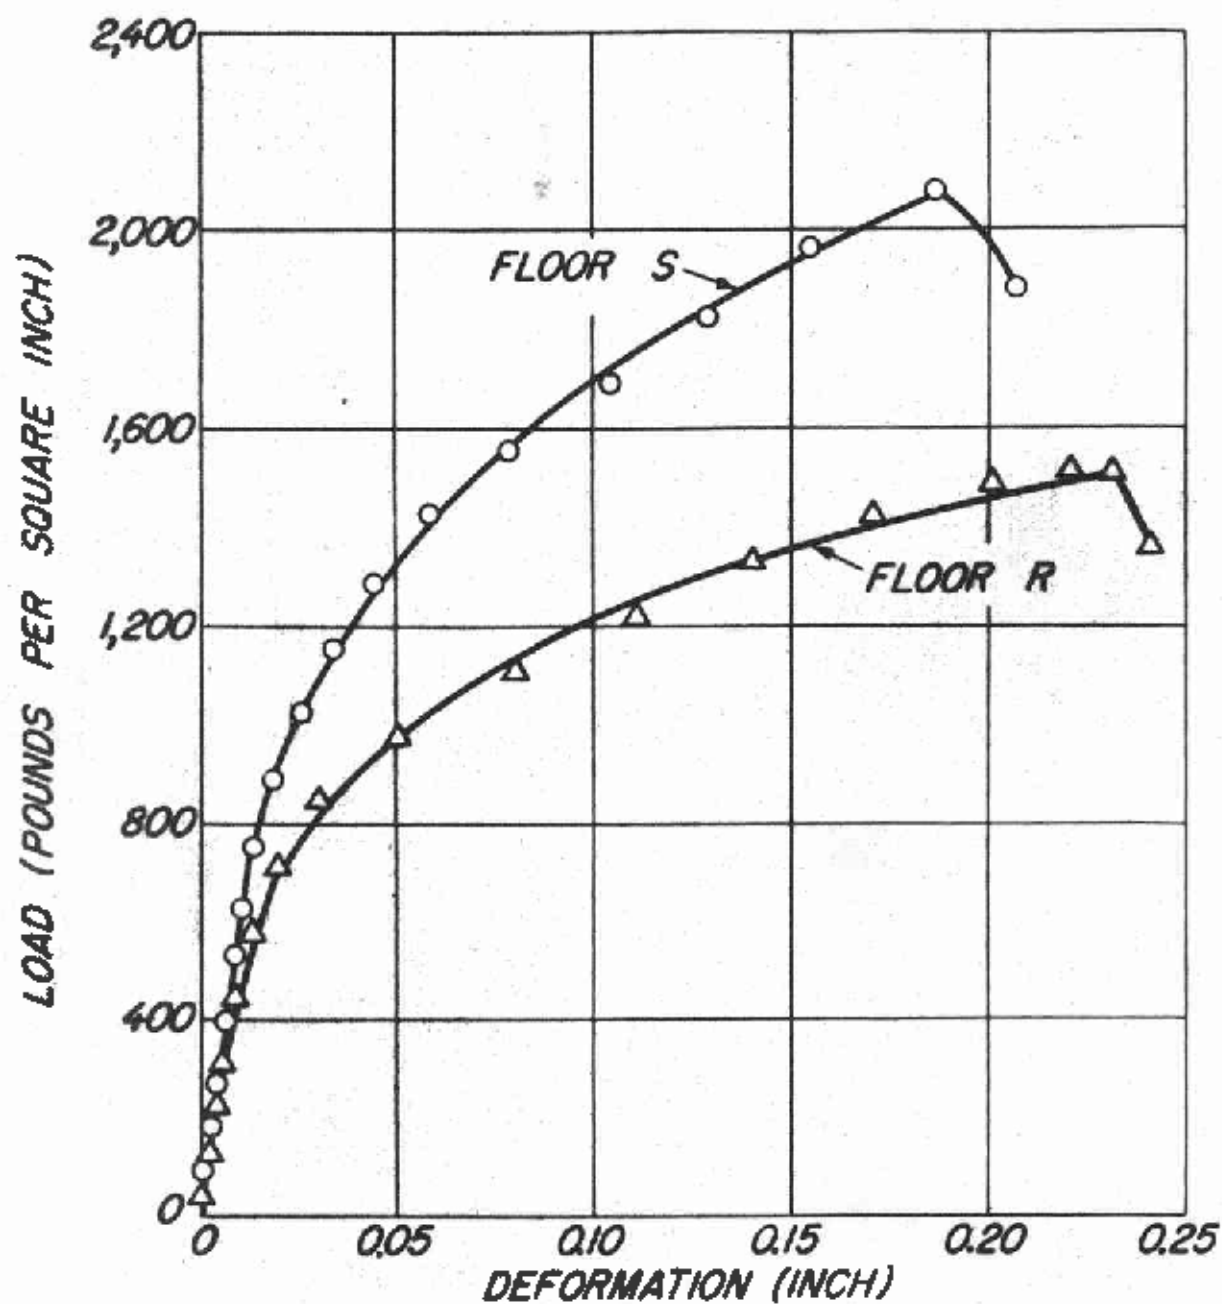
Load-deformation curves for strip-loading tests to simulate the effect of a floor beam on the under side of a loaded panel are plotted in figure 6. The appearance of the test specimens after having been loaded to produce this effect may be seen in figure 7.

Figure 6.--Typical load-deformation curves for strip-loading tests on cargo floorings R and S.
