SEISMIC EVALUATION

HMSC OFFICE BUILDING NEWPORT, OREGON

OREGON DEPARTMENT OF FISH & WILDLIFE

TO	State of Oregon, Department of Fish and Wildlife				
FROM	John Evans, P.E, S.E., Pillar Consulting Group, Inc.				
PROJECT	ODFW HMSC Office Building Seismic Study – Newport, Oregon				
SUBJECT	ASCE 31-03 Seismic Evaluation & Schematic Upgrade Design - FINAL				
DATE	6/22/2013	PROJECT #	2013007	MEMO #	EM-01

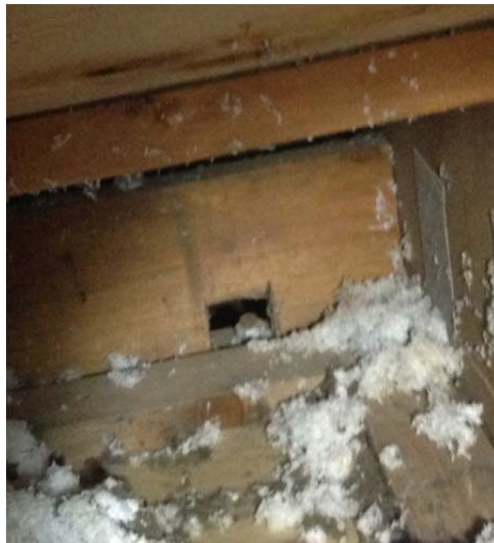
Photo 1-1: Wall plate anchor bolt

*Record drawing detail A on sheet 11 indicates "framing anchors" between the trusses and the wall top plate. **These anchors could not be located in the building.***

Details do not show blocking between diaphragm and top plate. Blocking is present but does not appear to be full depth and is therefore not able to transfer forces. No connection between blocking and diaphragm. See Photo 1-1 & 1-2.

Rank	Rank Name	Recommended Course of Action
1	Exterior Wall Out of Plane Anchorage	Design/Mitigate: Install anchors from wood top plate to concrete wall and add clips from roof framing to top plate. See drawings for a schematic solution.
2	Interior Wall Out of Plane Anchorage	Design/Mitigate: Add clips from roof framing to top plate. See drawings for a schematic solution.
3	Interior Wall Out of Plane Strength	Design/Mitigate: Install metal stud bracing walls on one side of each interior bearing wall. See drawings for a schematic solution. As an alternative, interior non-bearing partition walls could be removed.
4	Exterior In Plane Shear Transfer	Design/Mitigate: Install blocking and strapping. See drawings for a schematic solution.
5	Diaphragm Strength	Design/Mitigate: Install interior shear walls to reduce diaphragm span. See drawings for a schematic solution.
6	Mezzanine In Plane Shear Transfer	Design/Mitigate: Install interior shear walls to support the mezzanine and provide a transfer mechanism. See drawings for a schematic solution.

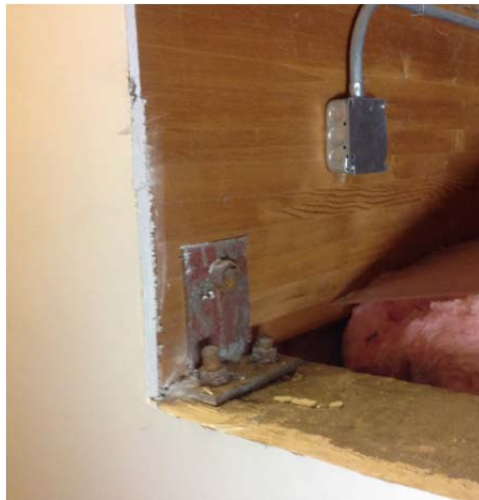
Photo 1-3: Connection Per F/11/10

Girders have a steel plate connection to wall per A/11/10, B/11/10 & F/11/10. See photos 1-3 & 1-4.

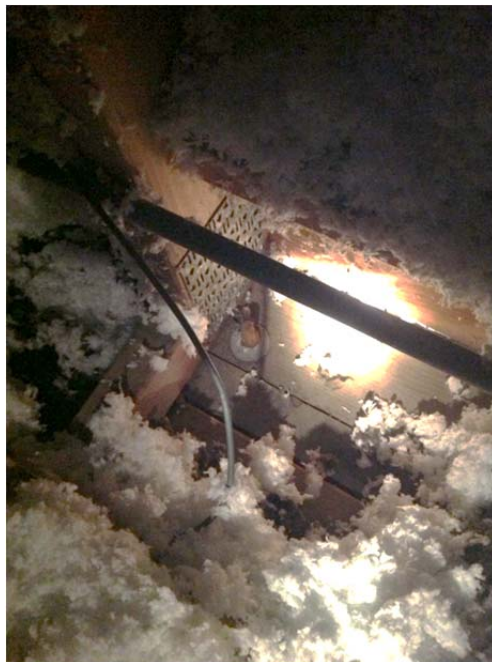
Photo 1-1: Wall plate anchor bolt

Roof trusses appear to be toe-nailed with (3) toe-nails at joist to top plate. Bolts to walls are ok. See calculations. Add clips to attach mezzanine joists to walls.

No connection between blocking and diaphragm. See Photo 1-1.

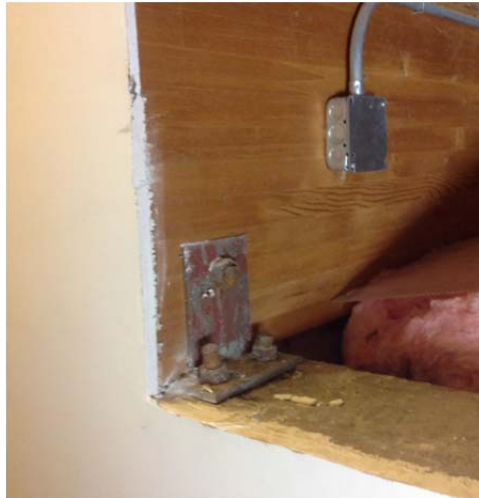
Photo 1-3: Connection per F/11/10

Girders have a steel plate connection to wall per A/11/10, B/11/10 & F/11/10. See photos 1-3 & 1-4.

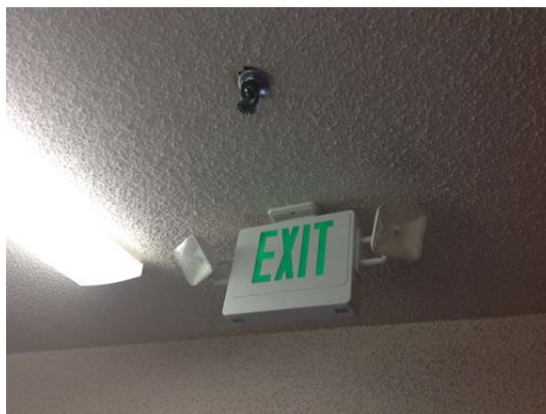
Photo 6-1: Exit Sign and Lights

Emergency exit lighting is attached to emergency exit signs. It is unclear how these are attached.

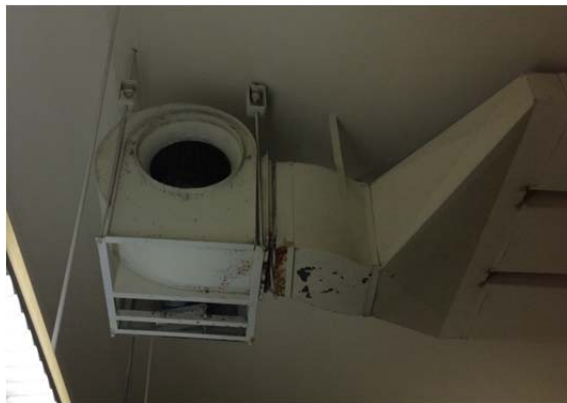
Photo 7-1: Fan with vibration isolators

A fan on the west side of the building is hung from the roof and uses vibration isolators. The fan appears to have no lateral restraint.
