# EFFECT OF DEFECTS ON STRENGTH OF AIRCRAFT TYPE SANDWICH PANELS

No. 1809-A

November 1951

FOREST PRODUCTS LABORATORY  
MADISON 5, WISCONSIN

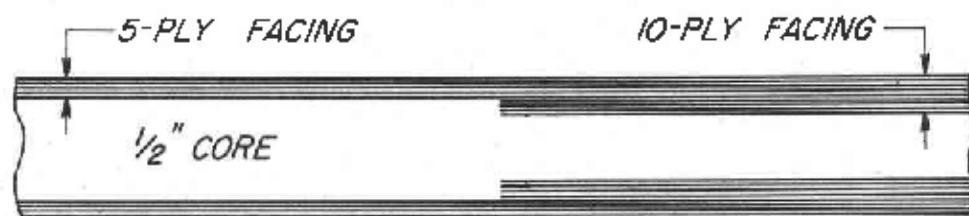
GRADUAL CHANGE IN FACING THICKNESS

ABRUPT CHANGE IN FACING THICKNESS

BUTT JOINTS IN GLASS-CLOTH FACINGS

Figure 1. --Diagrammatic sketches of details of sandwich construction with defect 4, variation in facing thickness, and defect 5, butt joints in glass-cloth facings.

4. Variation in facing thickness.--Test specimens including this defect were made with abrupt and gradual changes in thickness. Only one method of variation was incorporated in a test specimen, and the details of construction are shown in figure 1.

joints of every other ply were directly over one another, as shown in figure 1.

The abrupt and gradual methods of varying the facing thickness with glass cloth are shown in figure 1. The five short plies of cloth were placed nearest the core, and the plies that extended the full length of the panel formed the outer portion of the facing. Because of the variation in facing thickness, it was necessary to use bag-molding methods so that uniform pressure was applied to all parts of the panel.

The same fabrication procedures were applied to making these test panels as were used for the controls of the two glass-cloth-faced sandwich constructions, except that a butt joint was incorporated in each ply. Butt joints of adjacent plies were spaced 1 inch apart and directly over one another on alternate plies, as shown in figure 1.
