Title: Investigation of the Fatigue Behavior of Diagonally-Cracked CRC Deck-Girders Repaired with CFRP.

Investigation of the Fatigue Behavior of Diagonally-Cracked CRC Deck-Girders
Repaired with CFRP

A THESIS

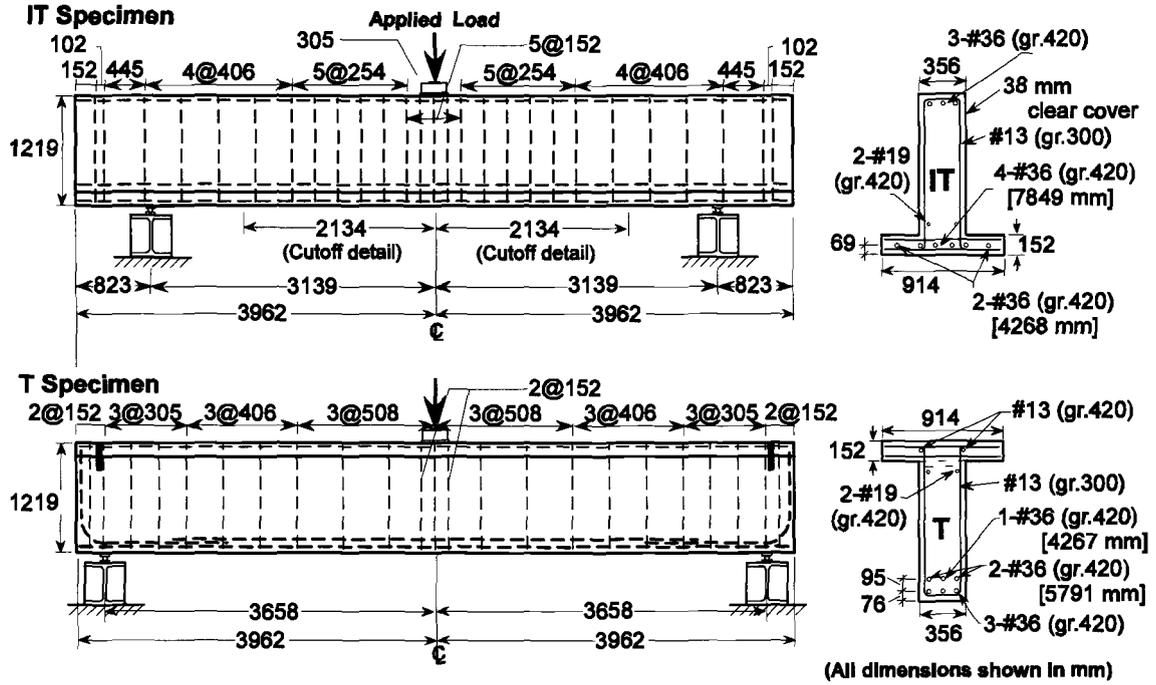
Fig. 2.1: Specimen configurations

All specimens were cast with the same cross-sectional geometry. Members had a height of 1219 mm (48 in.) with a stem width of 356 mm (14 in.) and a deck portion 914 mm (36 in.) wide by 152 mm (6 in.) thick as depicted in Fig. 2.1. Reinforcing bars for all of the specimens were from the same heats and tension tests were conducted to determine material properties, as summarized in Table 2.2. ASTM A615 Grade 420 (60 ksi) steel was used for the longitudinal reinforcing, with Grade 300 (40 ksi) steel for the stirrups. The stirrup grade is representative of intermediate grade steel used in the 1950's. A concrete mix design was used which produced compressive strengths similar to core samples obtained from ODOT bridges of around 24 MPa (3500 psi). The 28-day and day-of-test compressive strengths are shown in Table 2.3.

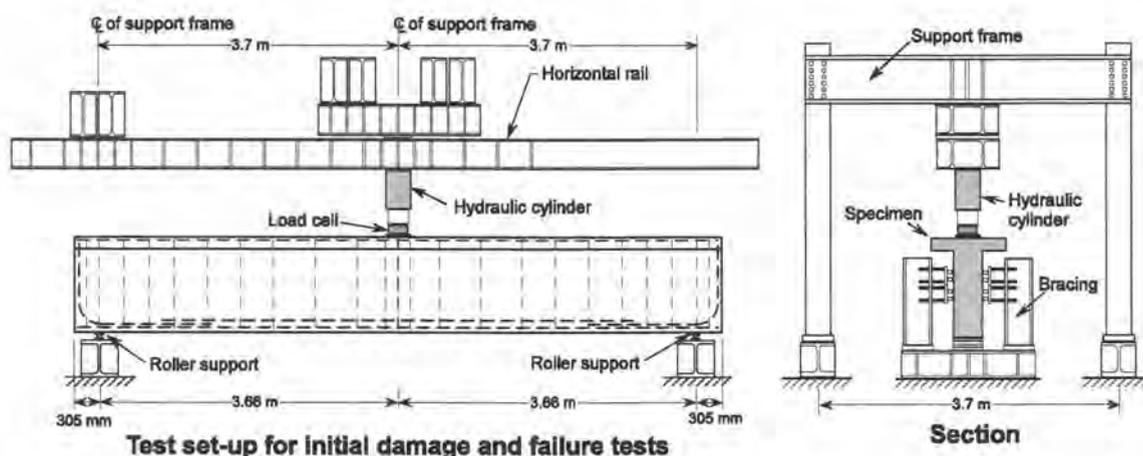
Fig. 2.2: Test setup

All tests were conducted using a three-point loading configuration as shown in Fig. 2.2. Inverted-T (IT) specimens were tested at a span length of 6280 mm (20.6 ft) between centerline of supports for both initial and failure loading schemes and the T-beam was tested at 7315 mm (24 ft) span. Force was applied through a 3560 kN (800 kip) capacity hydraulic cylinder operating on a 69 MPa (10,000 psi) system. The applied force was measured with a 2670 kN (600 kip) capacity load cell and was distributed through a 25 mm (1 in.) thick, 305 mm (12 in.) square steel plate. End reactions were provided through 102 mm (4 in.) wide steel plates resting on 51 mm (2 in.) diameter steel rollers, supported on steel beams attached to the strong-floor. High-strength grout was applied to the interface between the steel plates and concrete beams to ensure uniform bearing areas.

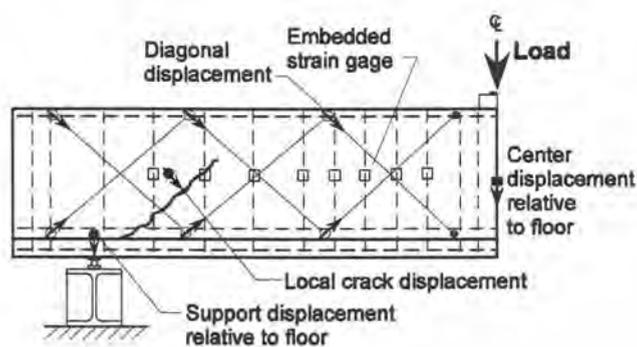
Fig. 2.3: Instrumentation

Instrumentation was installed to capture local and global behaviors. Strain gages were used to monitor internal steel reinforcing and external CFRP strains, displacement transducers were used to measure diagonal deformations, local crack motions, and support displacements at each corner of the reaction plates, and string potentiometers were used to measure centerline displacement. Typical instrumentation is illustrated in Fig. 2.3.

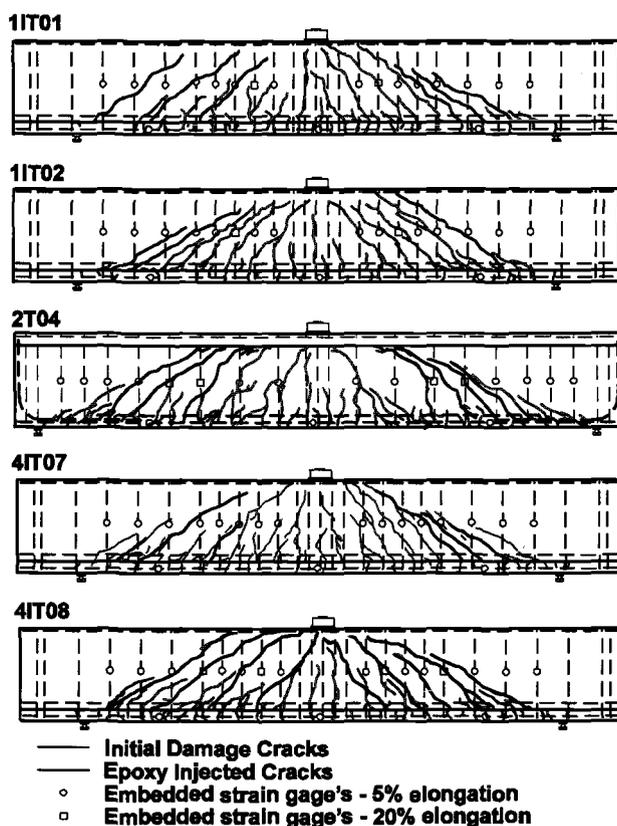
Fig. 2.4: Cracked specimens and internal steel strain gages

An initial loading protocol was performed to induce diagonal cracking representative of in-service CRC girders, based on field measured values from previous research (Higgins *et al.* 2004). Maximum diagonal crack sizes after loading of each beam are shown in Table 2.3, and ranged from 0.635 – 1.27 mm (0.025 – 0.05 in.). After reaching the desired level of cracking, the applied load was removed from all but one specimen. The subsequent crack patterns are shown in Fig. 2.4. Specimen 1IT01 was held at an applied load of 356 kN (80 kips) after reaching the desired level of diagonal cracking to study the influence of superstructure dead load during repair. The dead load magnitude is representative of the service-level dead load shear near an interior support location for a typical 1950's vintage three-span continuous CRC deck-girder bridge having 15.2 m (50 ft) spans and a uniform dead load of 23.3 kN/m/girder (1.6 kip/ft/girder). The applied laboratory dead load moment was somewhat higher than the service-level bridge dead load moment due to the span geometry.

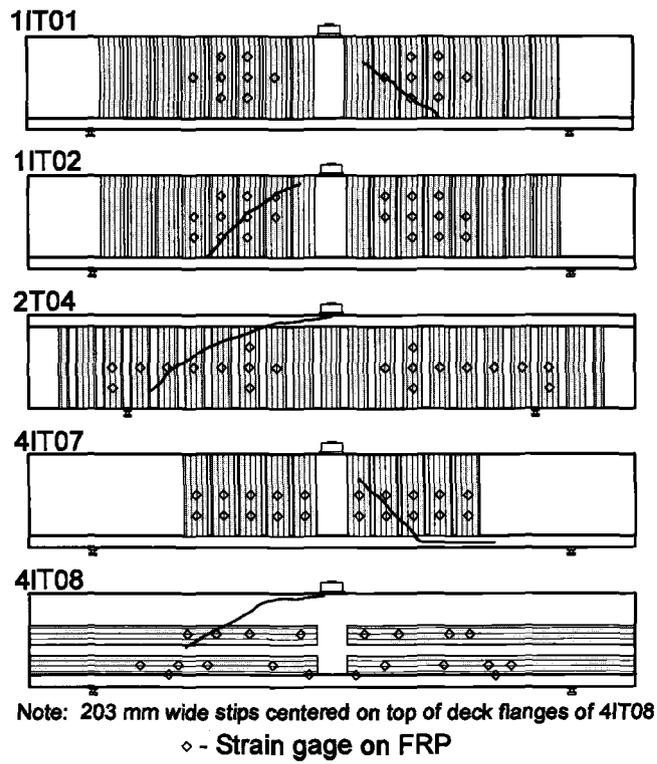
Fig. 2.5: Repaired specimen configuration and corresponding failure crack

Upon reaching the manufacturer recommended curing time, the specimens were instrumented and tested to failure. U-wrap laminate locations on each specimen are shown in Fig. 2.5. A 406 mm (16 in.) gap was used between CFRP strips at midspan of each IT specimen to simulate the transverse bent cap location in a bridge structure, where CFRP could not be applied. Specimens 1IT01 and 1IT02 were repaired with a single layer of 305 mm (12 in.) wide CF130 laminate spaced 256 mm (14 in.) on-center. This allows a 51 mm (2 in.) gap between strips to permit visual identification of cracking in the concrete stem and is representative of what is done in the field. Specimen 1IT01 was loaded in 188 kN (40 kip) increments, followed by unloading to a minimum of 222 kN (50 kips) until failure. All other specimens were loaded in 222 kN (50 kip) increments followed by unloading to a minimum of 22 kN (5 kips) until failure. The overall load-deflection responses for all specimens are shown in Fig. 2.6.

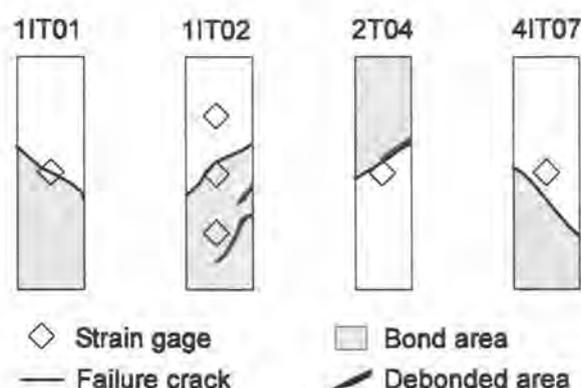
Fig. 2.7: Bond regions of primary load carrying CFRP u-wraps across failure cracks

The diagonal failure crack for the CFRP repaired specimens was generally observed to be at a steeper angle than those observed previously in similar unrepaired CRC girders (Higgins *et al.* 2004). None of the specimens exhibited fiber rupture. As fiber rupture did not occur at failure, the bond strength controlled the strength of the CFRP u-wraps. The condition of the single u-wrap remaining across the diagonal failure crack for each specimen prior to failure is shown in Fig. 2.7. The average bond stress (determined from the bonded area shown in Fig. 2.7) necessary to develop the measured CFRP strains at mid height of the u-wrap are shown in Table 2.1. Comparison of the average bond stress developed at the diagonal crack with the pull-off bond strength tests shown in Table 2.3 indicate that the actual bond stress developed in the specimens was below that measured in the pull-off tests except for specimen 4IT07 (discussed subsequently).

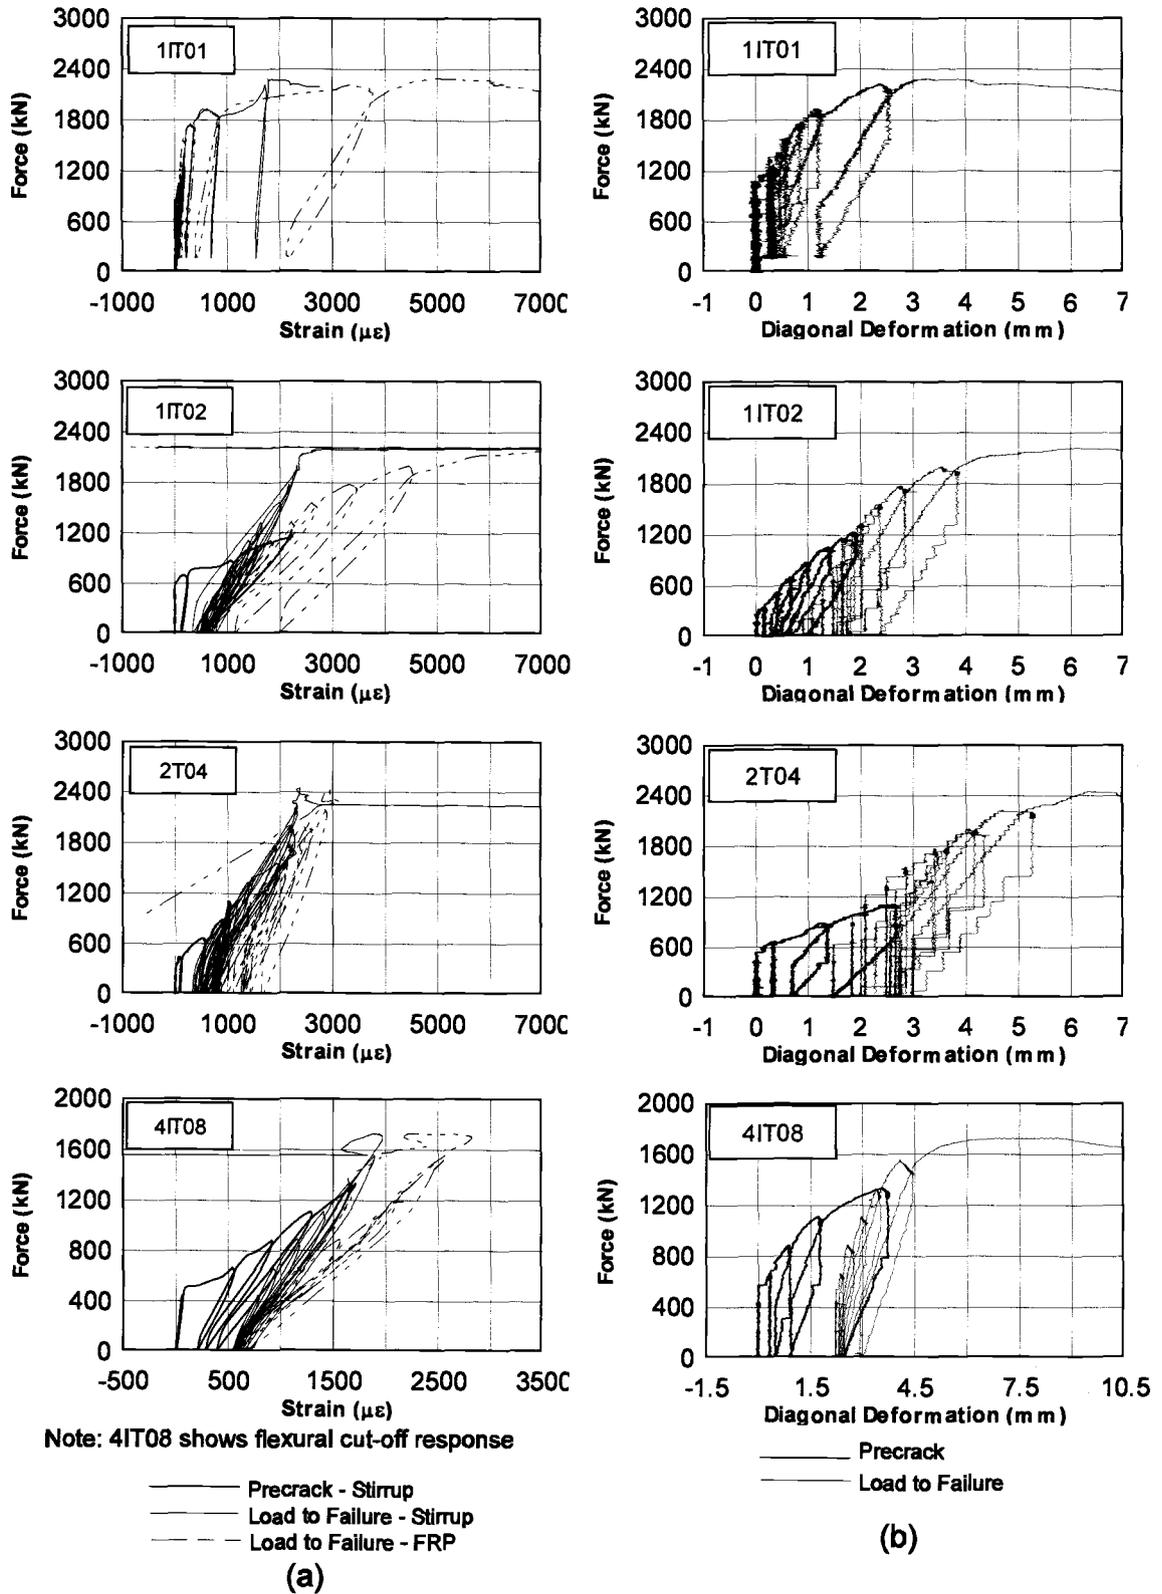
Fig. 2.8: (a) Strain Measurements, (b) Diagonal deformation of failure crack region

Example measured stirrup and CFRP strains across the failure diagonal crack show an uneven distribution in Fig. 2.8(a). The strains were larger in the CFRP than the stirrup at each load step. Also of interest, the diagonal deformation of the specimen across the failure crack in Fig. 2.8(b) showed larger values than any of the other specimens, but the deformations decreased upon unloading. Large regions of the CFRP material were observed to be debonded from the concrete surface, although the specimen continued to

Specimen 4IT08 was repaired using only longitudinal CFRP strips in the flexural tension zone. Strain readings of the continuous flexural bars at the flexural cut-off detail are shown along with the strain in the CFRP applied to the deck soffit directly above the end of the cut-off bar in Fig. 2.8(a). As seen in this figure, the CFRP exhibited higher strains than the adjacent flexural reinforcing bars. At an applied load of 1334 kN (300 kips), the strains in the flexural bars were only slightly less than that observed during the precrack phase (unrepaired). Considering the diagonal deformation response shown

in Fig. 2.8(b), the addition of the CFRP strips did reduce the amount of diagonal cracking compared to the unrepaired specimen at precracking, although there was no increase in shear capacity. The final failure crack on specimen 4IT08 was observed to develop slowly. As the applied shear increased, the crack continued to open further causing debonding and bending of the fibers in the CFRP strips at the diagonal crack locations. Addition of longitudinal CFRP alone was not effective in increasing shear capacity due to debonding and fiber bending at diagonal crack locations. Addition of transverse CFRP strips may improve the response for the longitudinal strips and this combination enable the longitudinal strips to better reduce flexural demands that cutoff locations. Additional study is required to validate this concept.

applied shear force at failure showed little overall difference between the specimens. For the sufficiently ductile stirrup reinforcement and flexural details, the level of dead load did not significantly impact overall member capacity. Strain gage readings for the internal stirrups and the external CFRP u-wraps at nearly the same location, mid-height along the diagonal failure cracks, for Specimen 1IT01 exhibited strain compatibility over much of the loading history, as shown in Fig. 2.8(a). The strains in the stirrup and the CFRP were similar until a load of approximately 2060 kN (463 kips). Afterward the CFRP strain increased at a higher rate than the proximate stirrups. In contrast, specimen 1IT02 showed a lack of strain compatibility between the internal stirrup and the CFRP. As seen in Fig. 2.8(a), the strain in the CFRP was higher than that of the stirrup at each particular load step. A difference in performance between these two specimens was also seen from the diagonal deformations across the failure crack as shown in Fig. 2.8(b). Specimen 1IT01 exhibited less deformation, and was stiffer, than specimen 1IT02. This was also seen in the midspan displacement of the two specimens in Fig. 2.6.

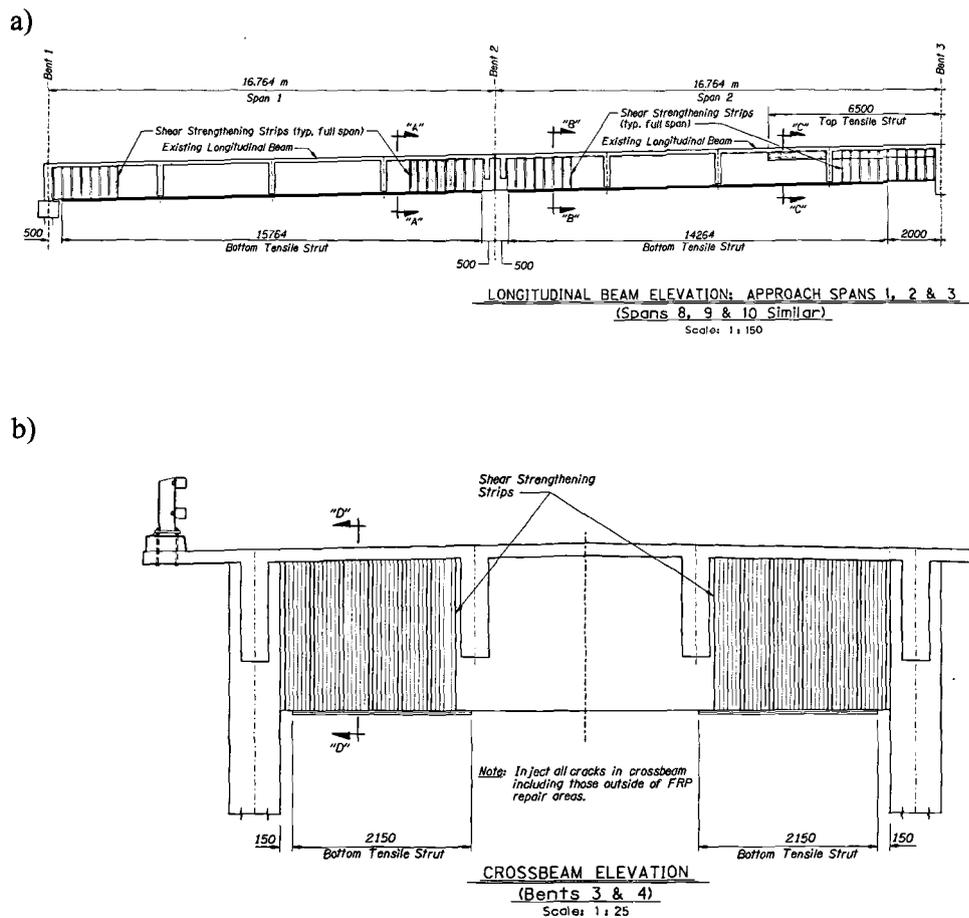
Fig. 3.2: CFRP repairs to a) main girders and b) bent caps

A deck-girder bridge designed in 1954 was investigated in the field testing portion of this research program. The Willamette River bridge (*Bridge Inventory Number 08156*) is located on Oregon Highway 219, near Newberg, OR. Inspection of the bridge in late summer of 2001 indicated significant diagonal cracking in the high-shear regions near the supports. The bridge consists of ten spans: four steel plate girder spans over water and three conventionally reinforced concrete approach spans at each end. Concrete approach spans exhibited significant diagonal cracks and were repaired using externally bonded fiber-reinforced polymer materials after completion of the initial inspection. The bridge has a regular layout with rectangular prismatic girders and the south approach spans were selected for instrumentation. The approach spans have three equal span lengths, 16.8 m (55 ft) each, and have a total width of 10.7 m (35 ft) as illustrated in Fig. 3.1. The spans are comprised of one simple span having five girders 368x1346 mm (14.5x53 in) and two continuous spans having four girders 330x1346 mm (13x53 in). Reinforced concrete diaphragms 229x1219 mm (9x48 in) are located at quarter points of each span. The approach spans have three simple supports and are continuous over one interior support with a transverse bent cap 419x1803 mm (16.5x71 in) supported by two columns. The specified concrete compression strength was 22.75 MPa (3300 psi) and reinforcing steel consisted of ASTM A305 intermediate grade deformed square and round bars with nominal yield stress of 276 MPa (40 ksi). The bridge was repaired primarily for shear with CFRP in the fall of 2001. The material used was CF130 unidirectional high-strength carbon fiber fabric, manufactured by MBrace. Prior

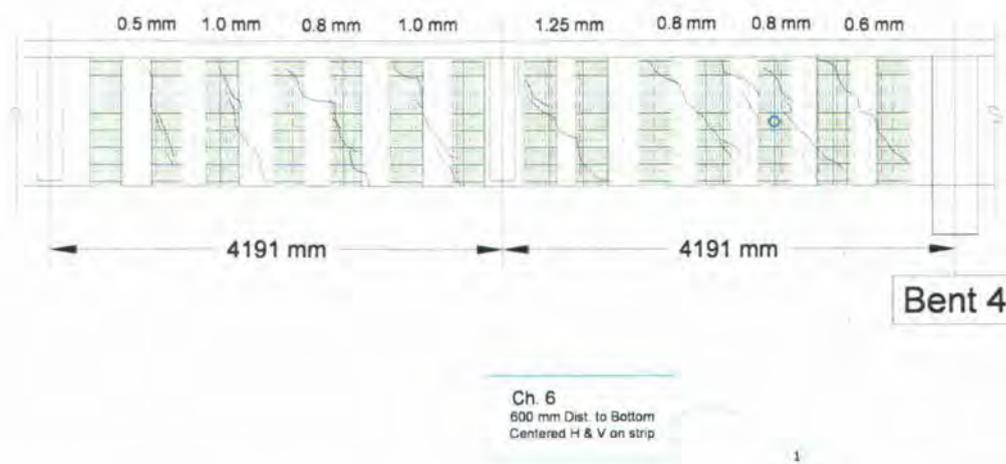
Fig. 3.3: Field measured cracking, embedded stirrups, and externally bonded CFRP on exterior girder

In October 2004, three years after installation of the CFRP repairs, the bridge was re-inspected, instrumented, and monitored under ambient traffic conditions to measure in-situ CFRP strain ranges at high shear locations. The bent caps and longitudinal deck girders were re-inspected to determine if cracking re-occurred and to identify the as-built locations of the CFRP strips. A Leica Disto Pro⁴ hand-held laser distance meter was used to rapidly locate cracks and CFRP strips relative to support locations. Examples of stirrup locations, original cracks, and CFRP strips, on the exterior girder,

are shown in Fig. 3.3. During the post-repair inspection, no new diagonal cracks were observed in the bent caps or girders. Flexural cracking was observed at only one location near midspan of the exterior girder.

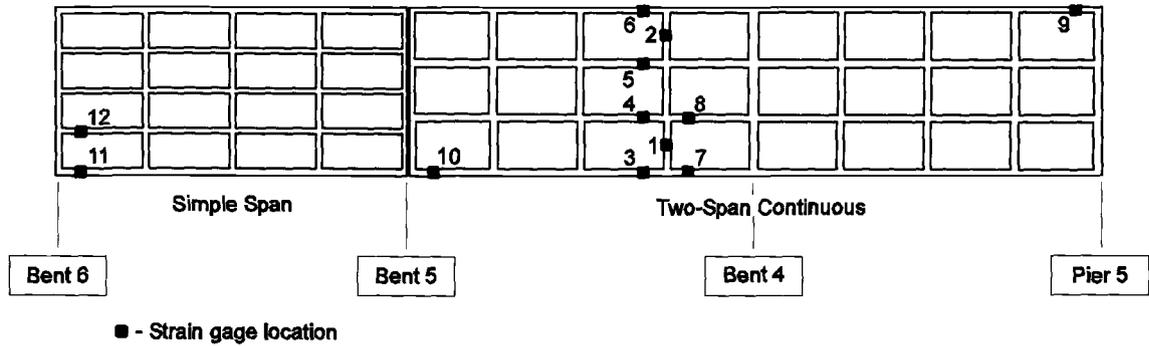
Fig. 3.4: Schematic of instrumentation locations

After inspection, strain gages were installed on individual CFRP strips at selected high-shear locations. Strain gages were bonded to the surface of the CFRP at mid-depth of the girder and oriented in the vertical (fiber) direction. The chosen strain gage had a gage length of 51 mm (2 in.), permitting strain averaging over several transverse weave fibers that were spaced approximately 8 mm (0.31 in.). Instrumented locations are illustrated schematically in Fig. 3.4. The strain gages were connected to a Campbell Scientific CR9000 data logger, a high-speed, multi-channel, 16-bit digital data acquisition system. To reduce noise and prevent aliasing in the data, both analog and digital filters were employed. During the ambient monitoring period, data were sampled at 100 Hz. A digital high-pass filter was utilized with a cut-off frequency of 40 Hz. The

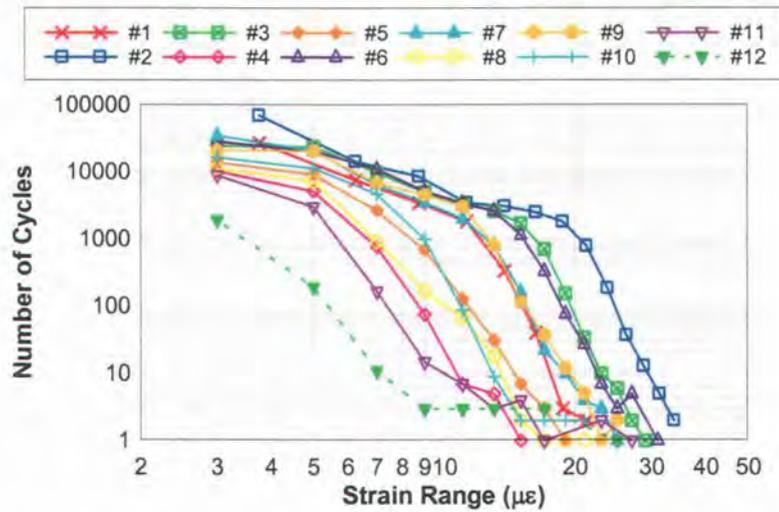
Fig. 3.5: Strain range-number of cycles measured under ambient traffic conditions at all instrumented locations

Ambient traffic induced CFRP strains at mid-depth of the girders and bent cap were monitored over a period of 32.6 days. The strain ranges and numbers of cycles recorded at the instrumented locations are shown in Fig. 3.5. The largest single strain range was measured at approximately $34 \mu\epsilon$ for location #2 on the bent cap. Using Miner's Rule (Miner, 1945), the variable amplitude strains were described as an equivalent constant amplitude strain-range for each of the instrumented locations:

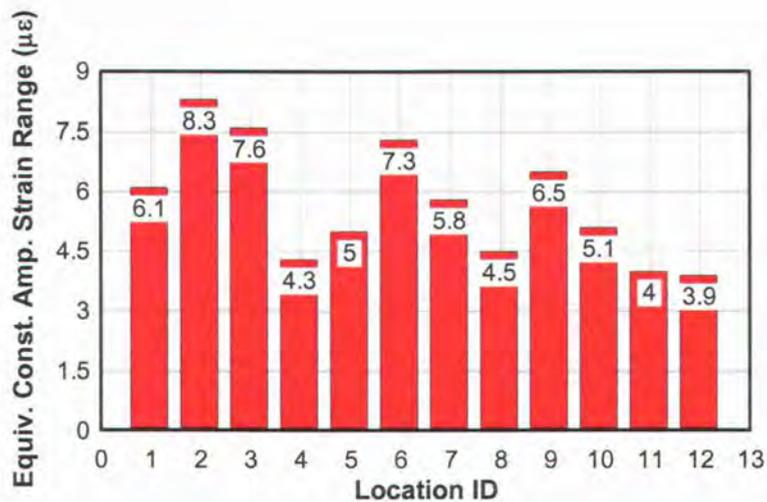
Fig. 3.6: Equivalent constant amplitude strain ranges for all instrumented locations

where SR_i is the i^{th} strain-range, n_i is the number of cycles observed for the i^{th} strain range, and N_{tot} is the total number of cycles at all strain ranges. The equivalent constant amplitude strain ranges were below $9 \mu\epsilon$ at all locations as shown in Fig. 3.6.

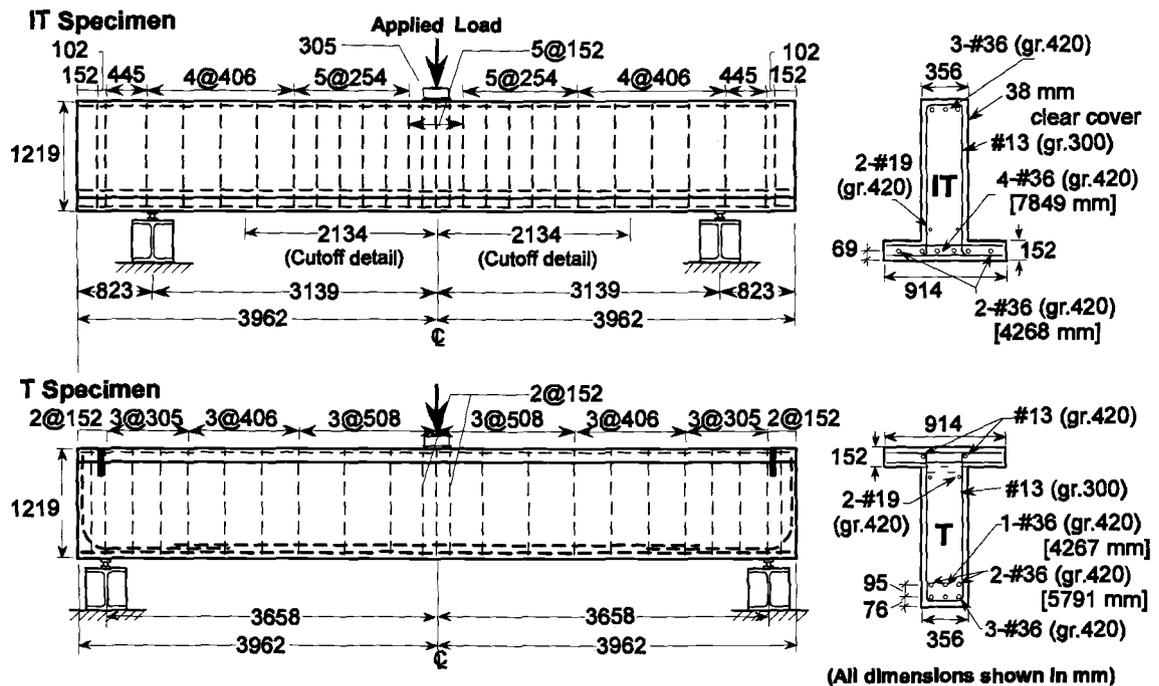
Fig. 3.7: Typical specimen details

Five specimens were tested as part of the experimental investigation. Two control specimens were tested monotonically and three under fatigue loading. Specimens were designed to reflect 1950's vintage proportions, materials, and details at full scale based on previous work done by Higgins *et al.* (2004). Two designs were used to test both positive (T-beam) and negative moment bending regions (inverted-T (IT)) with various flexural bar cut-off, hook, and stirrup spacing details as seen in Fig. 3.7. Specimens were initially loaded to produce diagonal cracking representative of that observed in

All specimens were cast with the same cross-sectional geometry. Members had a height of 1219 mm (48 in) with a stem width of 356 mm (14 in) and a deck portion 914 mm (36 in) wide by 152 mm (6 in) thick as depicted in Fig. 3.7. Reinforcing bars for all of the specimens were from the same heats and tension tests were conducted to determine material properties as summarized in Table 3.1. ASTM A615 Grade 420 (60 ksi) steel was used for the longitudinal reinforcing, with Grade 300 (40 ksi) steel for the stirrups. The stirrup grade is representative of intermediate grade steel used in the 1950's. A

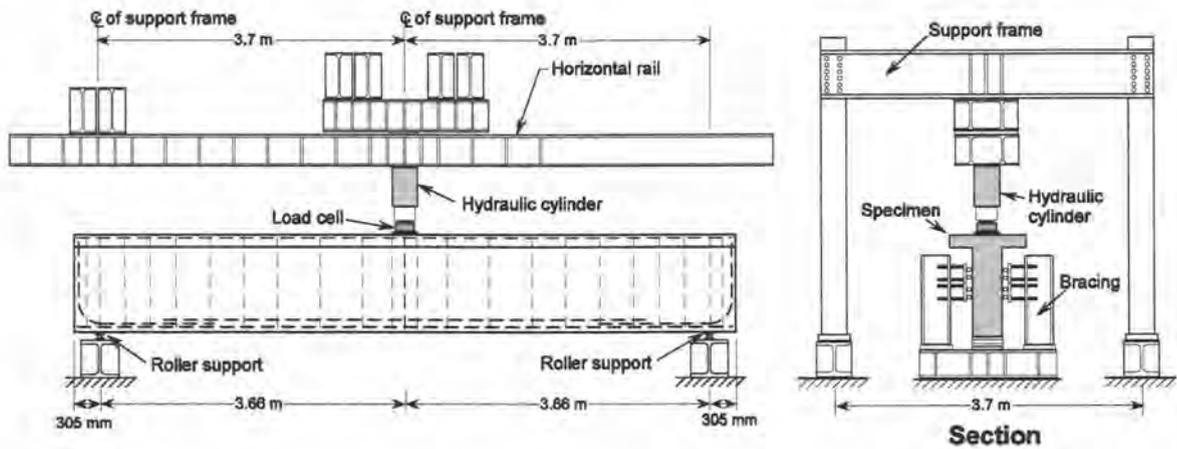
Fig. 3.8: Precrack and failure test setup

All tests were conducted using a three-point loading configuration. Precrack and failure tests were done in a setup as shown in Fig. 3.8. Load was applied through a 3560 kN (800 kip) capacity hydraulic cylinder operating on a 69 MPa (10,000 psi) system. The applied force was measured with a 2670 kN (600 kip) capacity load cell. Fatigue loading was performed using load-control in a setup shown in Fig. 3.9. Force was applied through a 980 kN (220 kip) capacity hydraulic actuator operating on a 21 MPa (3000 psi) system. Applied force was measured with a 980 kN (220) kip load cell. Load was distributed through a 25 mm (1 in) thick 305 mm (12 in) square steel plate in both setups. End reactions were applied through 102 mm (4 in) wide steel plates resting on

51 mm (2 in) diameter steel rollers, fastened to steel spreader beams attached to the laboratory strong-floor. High-strength grout was applied to the contact surfaces between the steel plates and specimens to ensure level and even bearing areas. Inverted-T (IT) specimens were tested at a span length of 6280 mm (20.6 ft) between centerline of supports for both precrack and failure loading schemes and at 7315 mm (24 ft) span for fatigue. T-beams were tested at 7315 mm (24 ft) spans for all three loading phases.

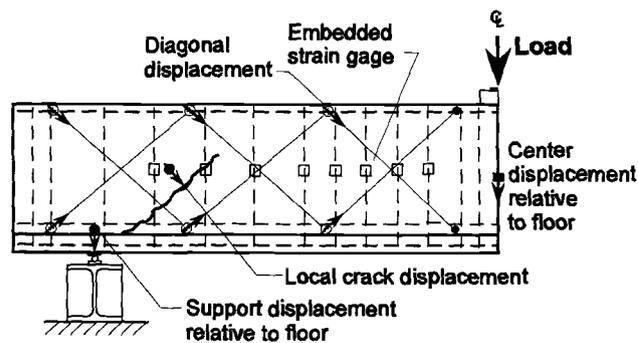
Fig. 3.10: Typical instrumentation layout

Instrumentation was applied to each specimen to capture local and global behaviors. Strain gages were used to monitor internal steel reinforcing and external CFRP strains, displacement transducers were used to measure diagonal deformations, local crack motions, and support displacements at each corner of the reaction plates, and string potentiometers to measure centerline displacement. Typical instrumentation is shown in Fig. 3.10.

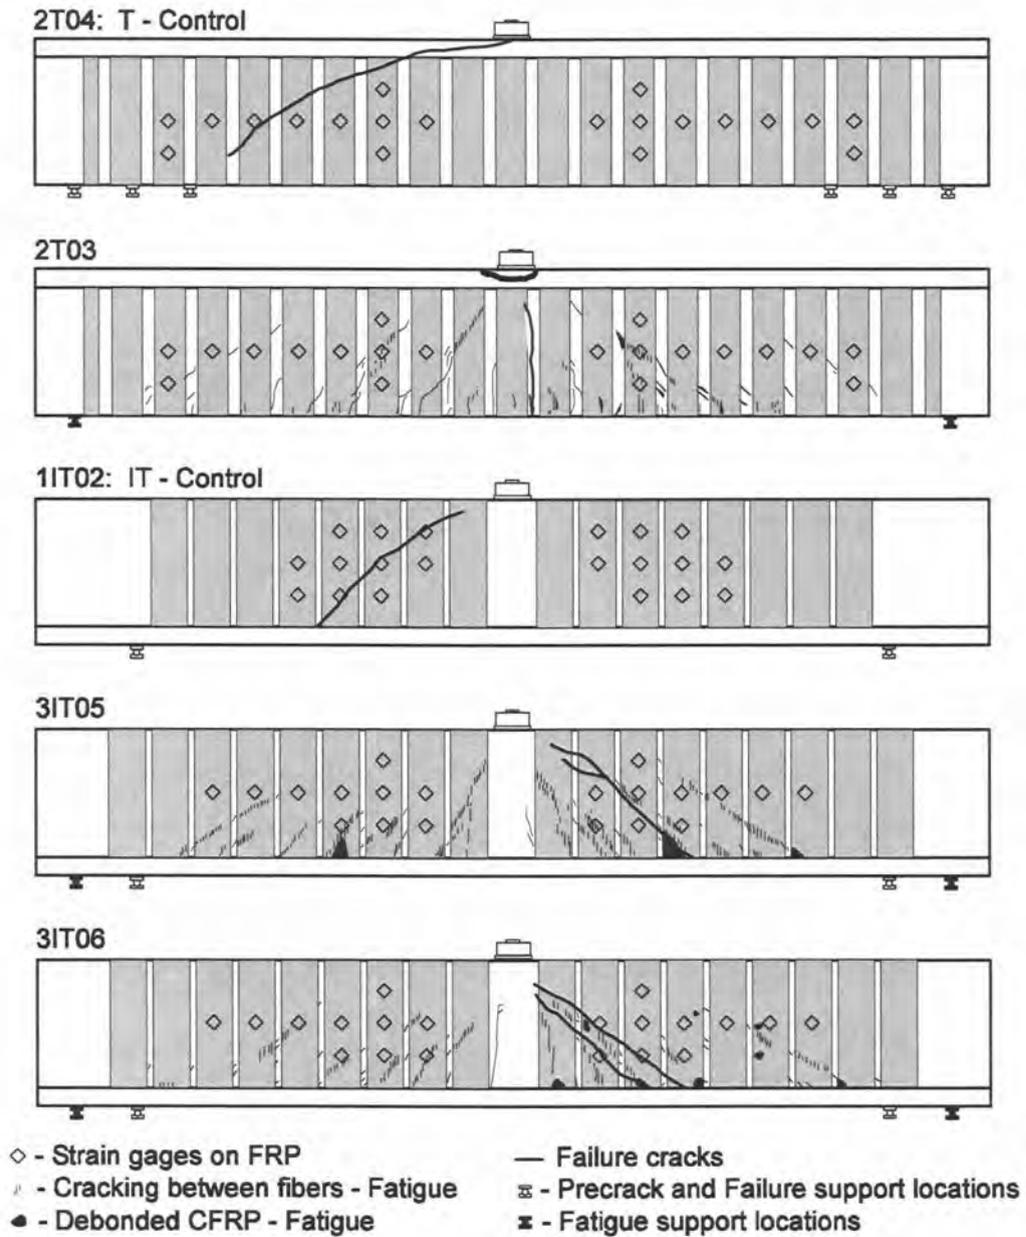
Fig. 3.11: CFRP repair layout, fatigue damage, and failure cracks and debonding

Upon reaching the manufacturers recommended curing times, the specimens were instrumented, fatigued (except 1IT02 and 2T04), and tested to failure. U-wrap laminate locations on each specimen are shown in Fig. 3.11. A 406 mm (16 in) space in the center of each IT specimen was included to simulate the bent cap location in a bridge structure where it is not possible to apply the CFRP. Specimens 1IT02, 3IT05, and 3IT06 were repaired with a single layer of 305 mm (12 in.) wide CF130 laminate spaced 256 mm (14 in.) on center. Specimens 2T03 and 2T04 were repaired with a single layer of 254 mm (10 in.) wide CF160 laminate spaced 256 mm (14 in.) on center.

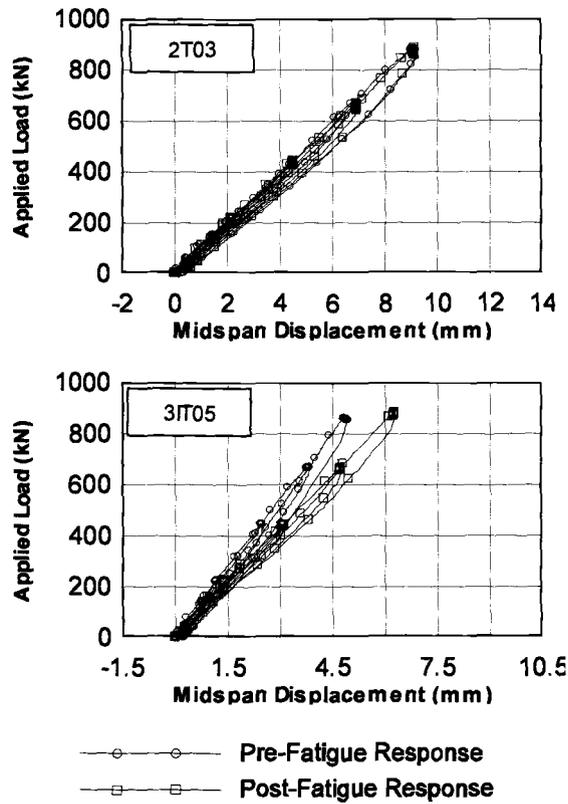
Fig. 3.12: Midspan displacement response comparison of specimens prior to and after fatigue loading

IT specimens produced additional overall displacement under fatigue loading as progressive debonding of the CFRP strips and internal stirrups occurred. The T specimen did not exhibit changes in overall displacement as shown in Fig. 3.12. The higher load range produced softening in specimen 3IT05, comparing the start and end of fatigue testing. Changes in local diagonal crack widths were observed during fatigue as shown in Fig. 3.13. It was evident that the higher load range produced larger diagonal crack opening after one million cycles than the lower load range. Diagonal deformation response within a section of the shear span of the IT specimens also showed similar results. The deformation responses of a section 1067 mm (42 in) wide by 991 mm (39 in) high in the same location on the stem for the control and two fatigue IT specimens are shown in Fig. 3.14. The control specimen 1IT02 was much stiffer with negligible deformation up to 1000 kN (225 kips) of applied force. Specimens 3IT06 and 3IT05 experienced greater deformations, respectively, than the control at corresponding loads. This trend continued through most of the load-deformation response until the load began to approach ultimate. At ultimate, all of the diagonal deformation magnitudes were similar, and all failed at approximately the same applied shear force as shown in Table 3.4.

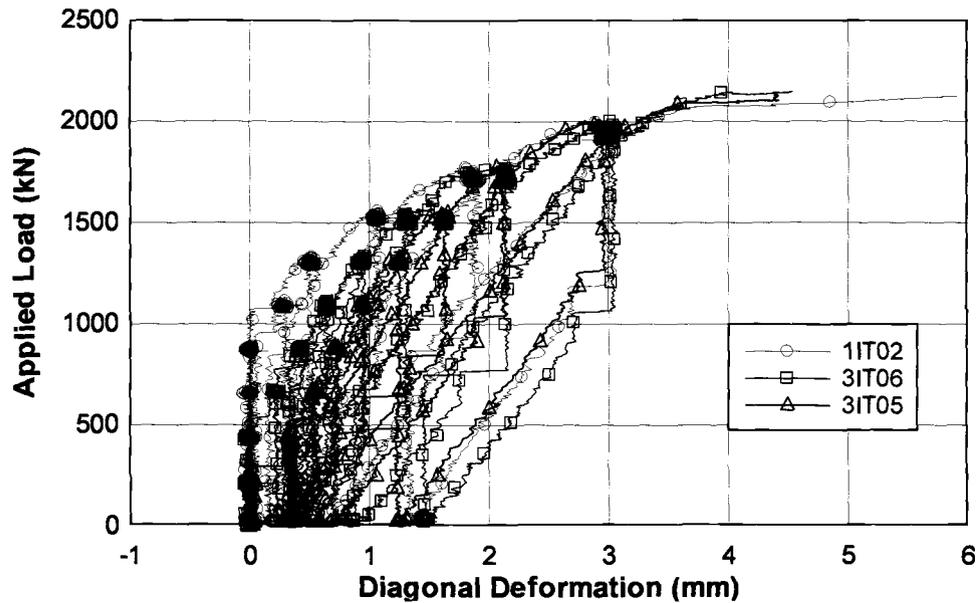
Fig. 3.14: Diagonal deformation response of IT specimens

In the fatigue specimens, diagonal cracks had already developed during the initial reload after repair and been worked during the fatigue loading. This allowed greater deformations to occur at corresponding loads due to local CFRP debonding and stirrup bond fatigue (between concrete and stirrup legs) associated with the diagonal crack locations. The IT fatigue specimens also contained regions of debonded CFRP material at the strip termination at the flexural tension region along the deck/stem interface. These locally debonded areas were sufficiently small so that as higher loads were reached during failure tests the member capacity was not impacted. Indeed, there was no marked change in the visual condition at the onset of failure between fatigued and unfatigued specimens. Failure was controlled for all specimens by bond failure as the CFRP u-wraps peeled away from the web, allowing diagonal cracks to propagate. The

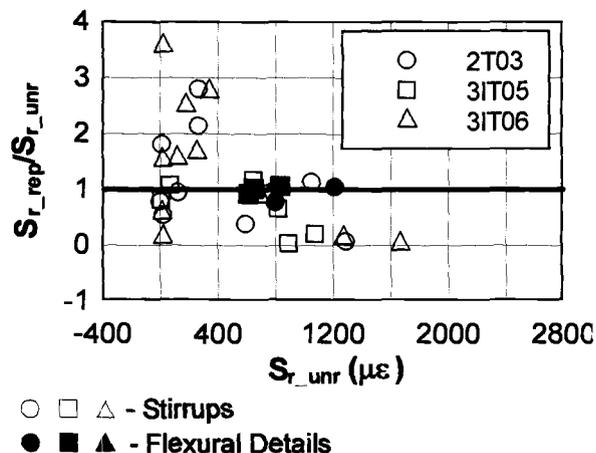
Fig. 3.15: Internal steel reinforcing strain reduction due to application of CFRP shear repair

The intent of a CFRP retrofit for shear is to extend the service life of the member by providing additional capacity and/or reducing demand on the internal reinforcing steel. Comparison of the stirrup and flexural rebar strains before application of CFRP and during failure testing after fatigue showed that the CFRP material tended to decrease the stirrup demands, particularly when the initial stirrup strain was large (those that would control the performance), as shown in Fig. 3.15. Application of the CFRP strips for shear did not significantly change the flexural steel demands at the cut-off locations.

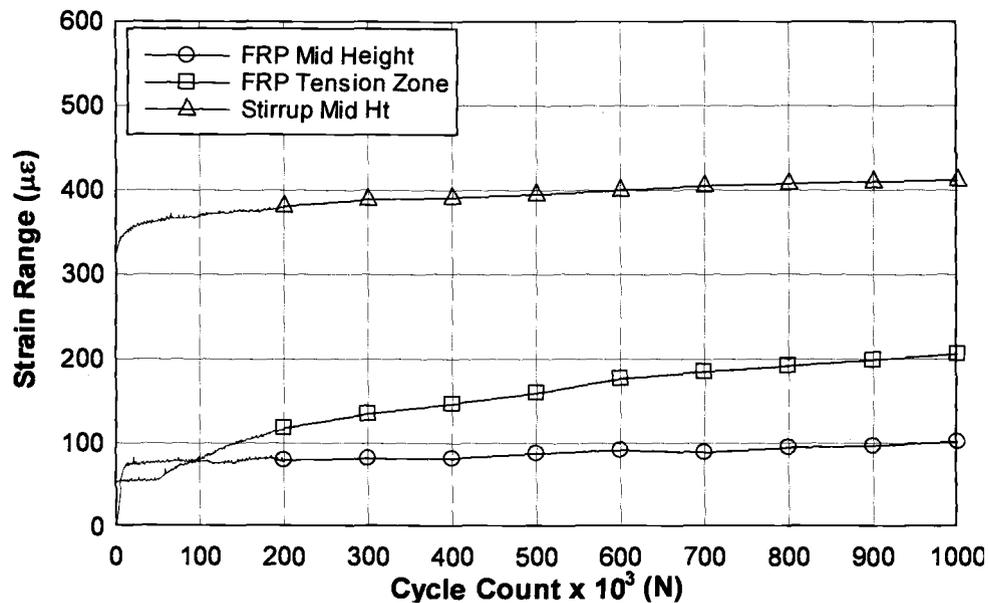
The stirrup strain near mid-height is shown at a location near the eventual failure crack

region. The stirrup strain range was far below the threshold of $830 \mu\epsilon$ based on Eqn. 3.1 for inducing metal fatigue over one million cycles. In the T-beam specimen, shear demand was sufficiently low so that the stirrups showed very little change in strain throughout fatigue loading, and several showed a slight decreasing trend. The stirrup strain ranges were all well below the threshold required for long life.

Fig. 3.16: Representative strains measured during fatigue loading

Representative strain behavior of the stirrups at mid-height of an IT member and of CFRP u-wraps at mid-height and in the flexural tension zone are shown in Fig. 3.16.

Strain response in the CFRP under fatigue varied depending on the instrument location relative to diagonal cracks and strip termination locations along the deck/stem interface. CFRP strain ranges near diagonal cracks tended to exhibit a nonlinear response, with strains increasing at a higher rate during initial fatigue cycles and then gradually increasing at a lower rate, as shown in Fig. 3.16. CFRP strains measured closer to the flexural tension zone near the terminated edge of the u-wraps trended upwards at a

higher rate in early cycles and gradually moved towards a steady-state. For the CFRP strain gage near the edge shown in Fig. 3.16, strain ranges during the initial cycles were unchanged because no cracks or CFRP debonding had yet propagated near the gage location. Once a crack propagated or debonding progressed (typically early in the fatigue history), the CFRP strain range increased at an initially high rate and then began to slow as stresses were redistributed, cracking does not continue to propagate, and debonding slows. The observed initial plateau does not necessarily exist, if the u-wrap bond to the surface of the specimen is near initial cracks or debonded prior to fatigue cycling. The representative strain at mid-height of the CFRP u-wraps exhibited a different behavior. The CFRP strain gage location shown was near a diagonal crack visible on both sides of the u-wrap. Strain range in the CFRP increased at the onset of fatigue cycling and then reached a near stationary value. During fatigue loading, diagonal cracks opened and closed. The crack surfaces wear against each other and small pieces of concrete at the crack interface may ravel and fall into the crack. This debris does not allow the crack to close and produced some small additional strain observed as an increase in the mean strain value. At the same time, the CFRP u-wraps gradually and locally debonded from the concrete surface while the stirrup legs undergo bond fatigue whereby the stirrup provides less constraint across the diagonal crack. Eventually near steady-state conditions were reached, and the strain ranges became almost constant. However, the observed strain ranges did not reach true steady-state conditions, and it may be projected that the CFRP debonding and stirrup bond fatigue continue to occur. Based on the level of CFRP debonding observed prior to failure in
