AN ABSTRACT OF THE THESIS OF

RONALD DAVID TASKEY for the DOCTOR OF PHILOSOPHY degree in SOIL SCIENCE presented on September 12, 1977

Title: RELATIONSHIPS OF CLAY MINERALOGY TO LANDSCAPE STABILITY IN WESTERN OREGON Redacted for Privacy

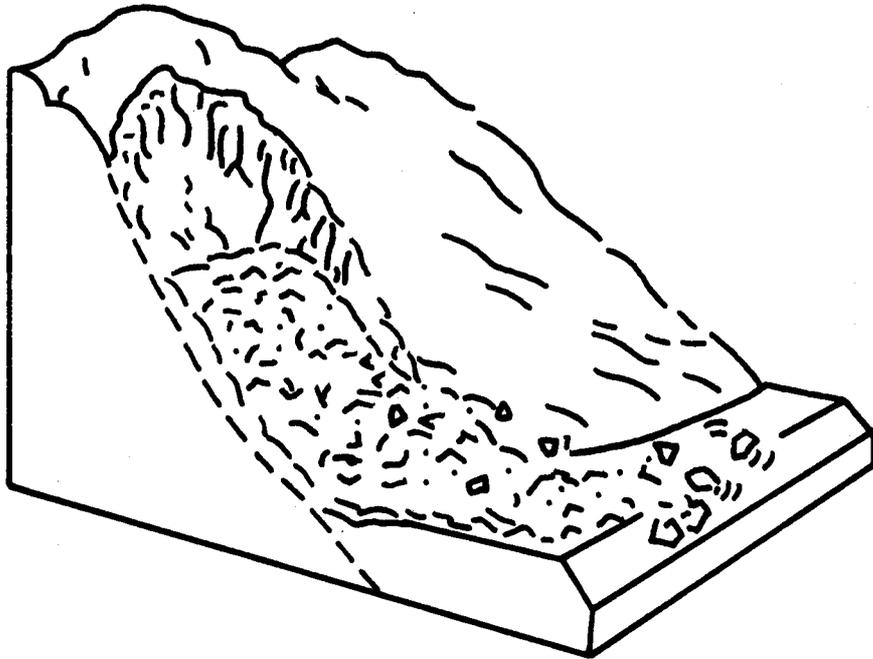
Figure 1. Debris avalanche of noncohesive material overlying a sub-surface discontinuity (after Varnes, 1958).

Translational or planar failures are those in which the longitudinal dimension far exceeds the depth. They consist of a simple downslope sliding of cohesionless soil, or blocks of cohesive soil, along a relatively flat plane of weakness. The failure plane commonly occurs at a lithic or hydraulic discontinuity which roughly parallels the soil surface. Hillslopes composed of heterogeneous layers of materials typically suffer the translational type failures. In the Pacific Northwest, translational failures are best exemplified by the debris avalanche, which is a rapid downslope sliding of shallow, cohesionless soil (Figure 1). Debris avalanches are the most common type of mass failure in western Oregon and usually occur during or immediately following a period of intense rainfall (Dyrness, 1967; Swanston, 1969, 1970, 1976).

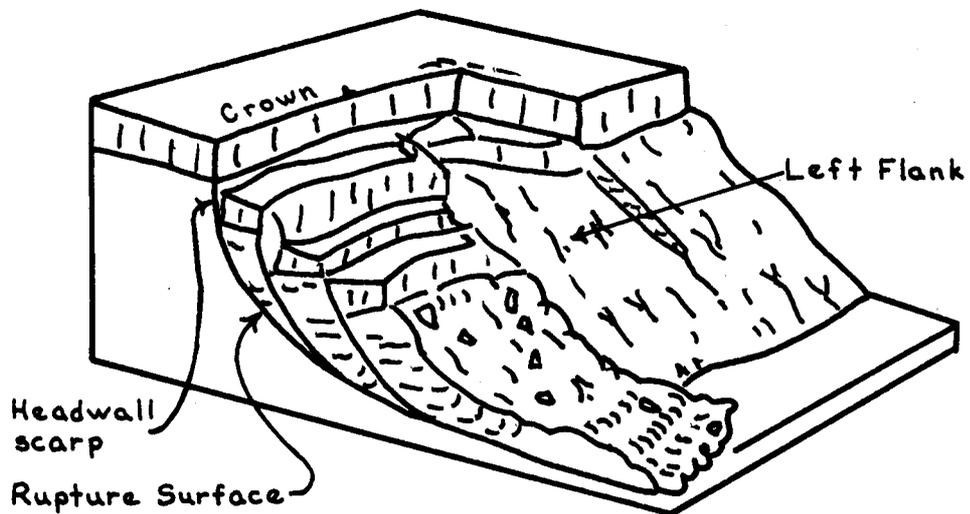
Figure 2. Slump-earthflow of homogeneous soil with overburden of hard volcanic rock (after Varnes, 1958).

Rotational failures have lengths and depths of comparable magnitude. They involve deep homogenous masses of wet cohesive soil, and are characterized by a failure surface which is concave upward in an elliptical arc (Figure 2). The failure surface does not

necessarily coincide with a subsurface discontinuity; instead it is controlled by the moments of forces acting upon the center of gravity of the soil mass (Tersaghi and Peck, 1967; Wu, 1976).

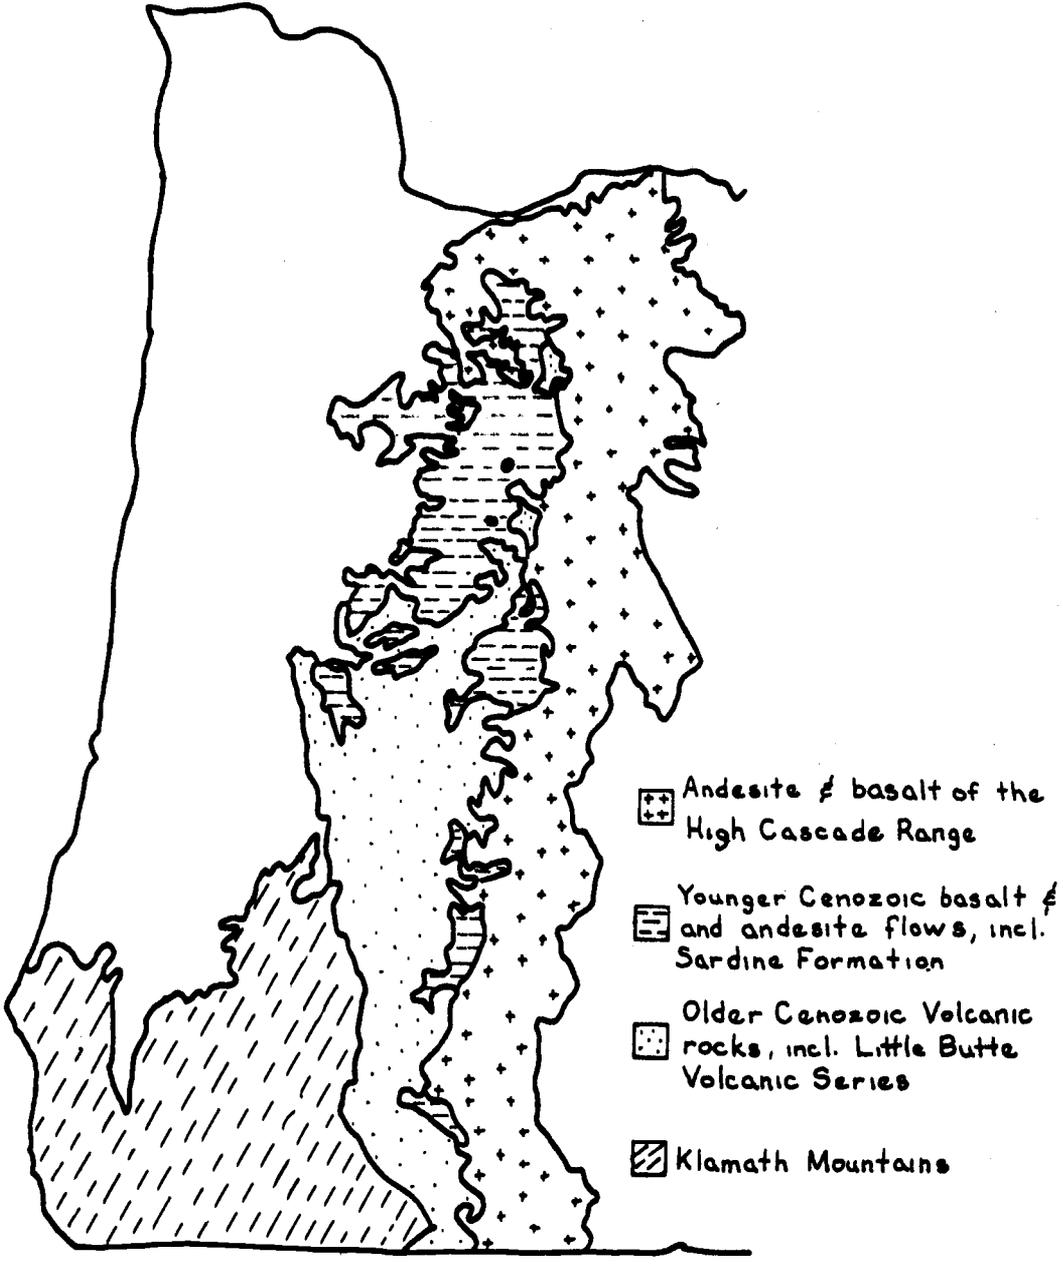
Figure 3. Geologic outline of those portions of western Oregon included in study (Walker and King, 1969).

A geologic outline (Figure 3) of those portions of western Oregon included in this study shows that the southern half of the Coast Range is dominated by Cenozoic sedimentary rocks; the Klamath Range is a composite of mesozoic sedimentary, igneous and metamorphic

lithologies; and the Cascade Range is composed of Cenozoic volcanic materials.

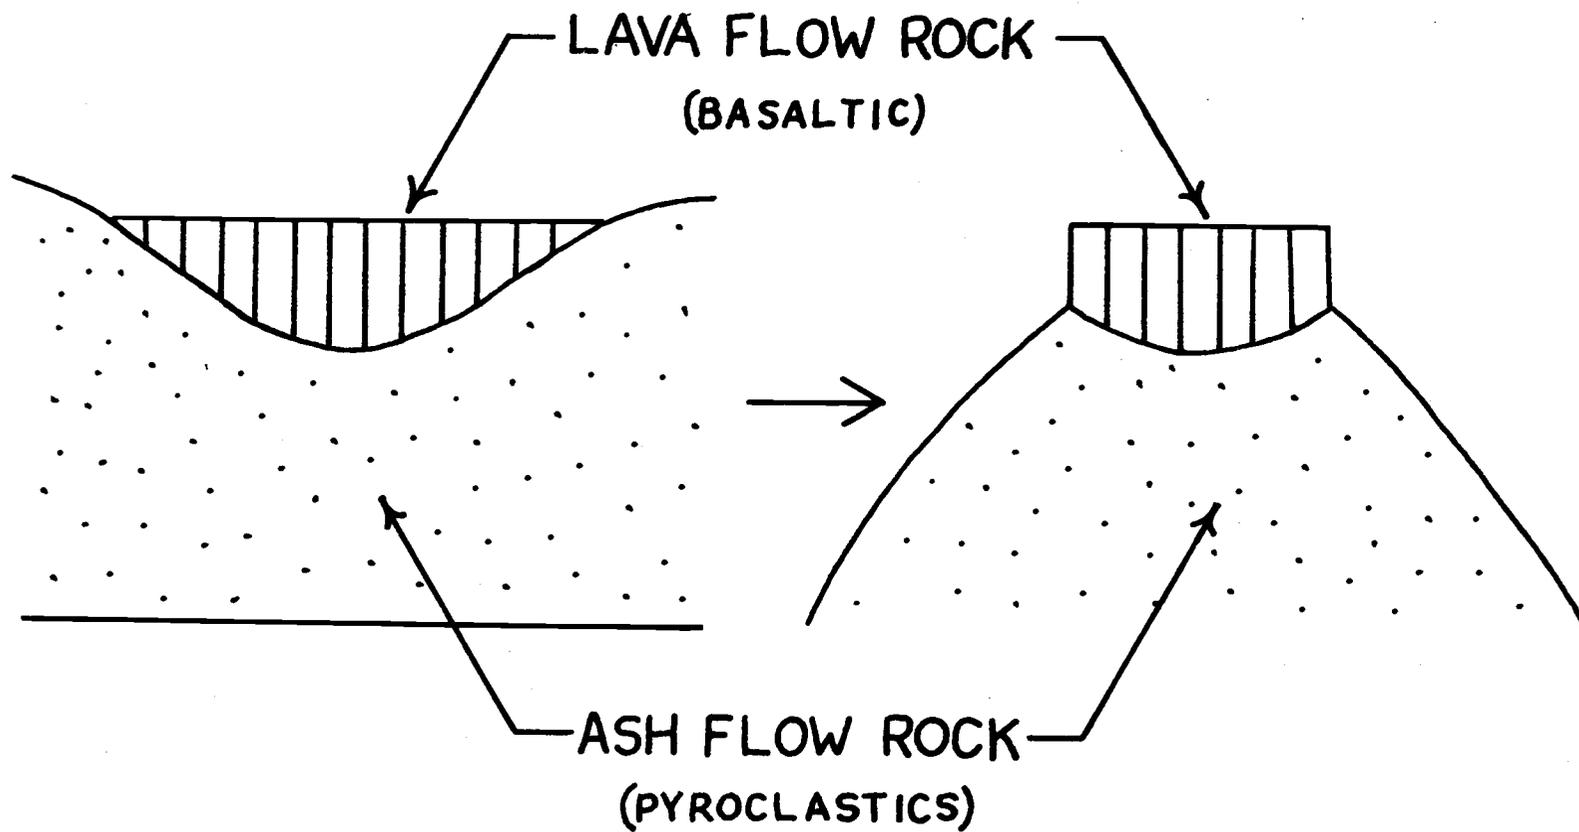
Figure 4. Landscape reversal due to differential weathering and erosion of contrasting materials in the Western Cascades (adapted from McKee, 1972).

Millions of years later, during the late Miocene (perhaps 15 million years ago) more eruptions filled the valleys with new lava which solidified into hard volcanic rock (basalt and andesite), which comprises the Sardine formation, north of the McKenzie River. As more millions of years passed erosion continued to remove the older, softer pyroclastic materials, but the younger rock in the valleys was, for the most part, hard and more resistant to erosion. The result was a landscape reversal, that is, the ridge tops became valley bottoms, and vice versa (Figure 4).

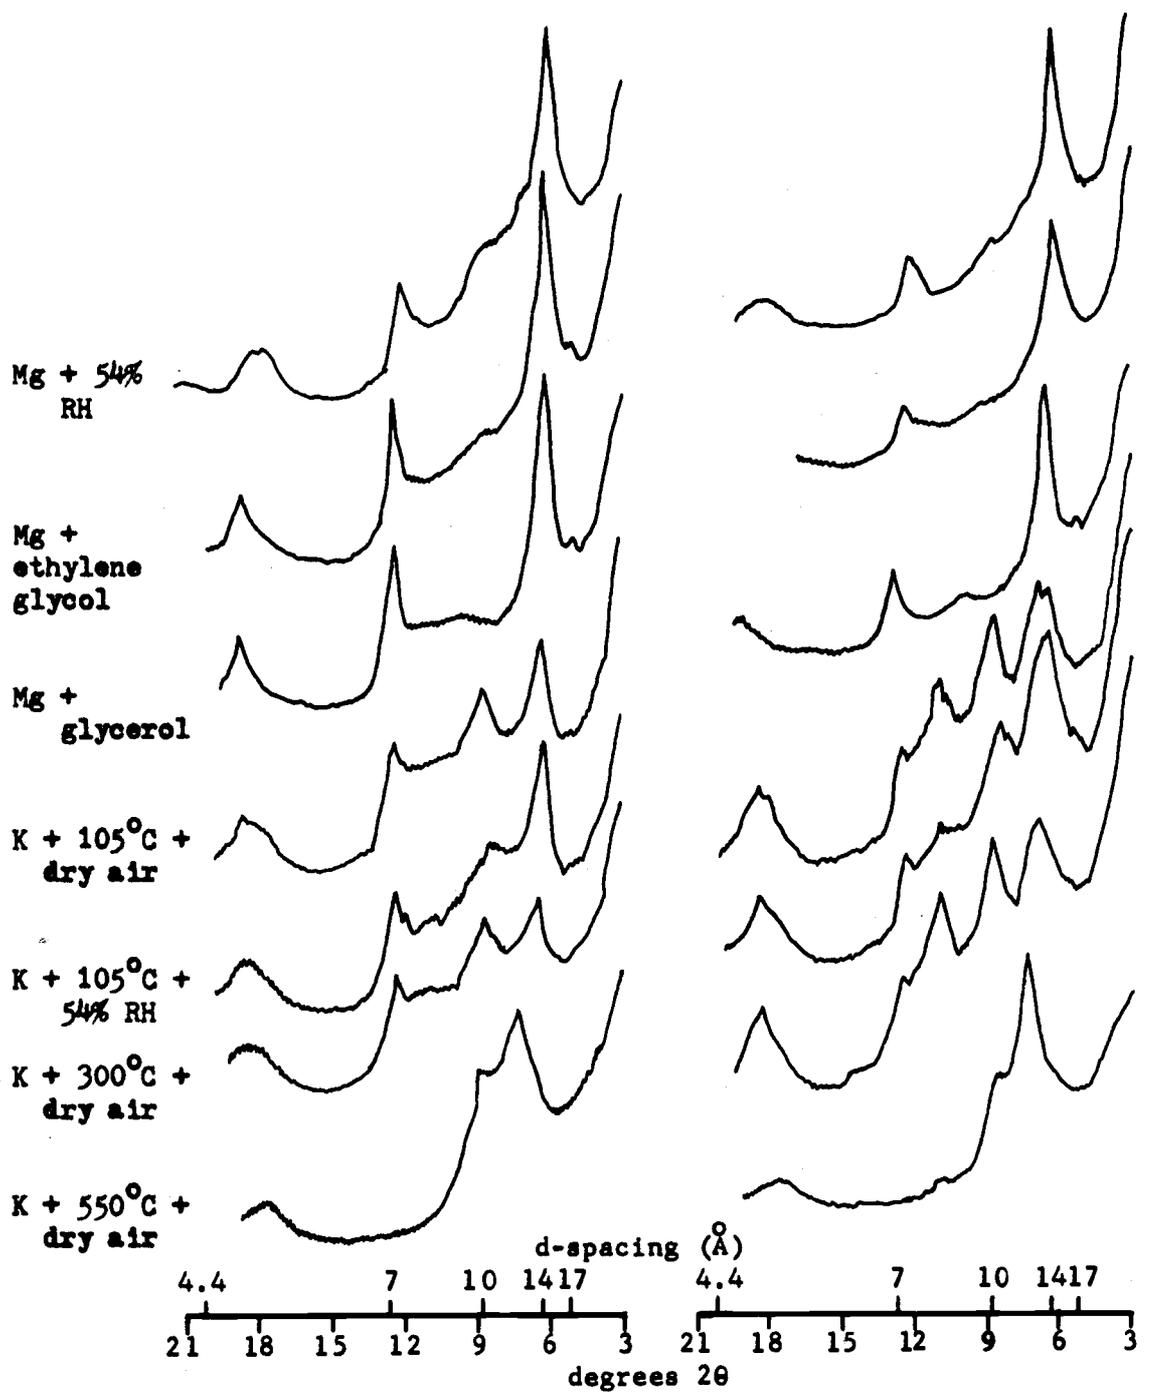
Figure 6. Site SS-SF-5 XRD patterns. Sample b (left), from left flank, 75 cm depth. Sample c (right), from midslope slip plane in altered rock outcrop.

There is little mineralogical difference between the overlying soil mantle and the underlying weathered bedrock surface upon which failure occurred at site SS-SF-5 (Figure 6). Samples of both materials show strong evidence of chlorite and chloritic intergrade minerals as indicated in the XRD patterns by nonexpanding  $14 \text{ \AA}$  peaks which partially resist collapse upon heating. Vermiculite becomes discernible with K-saturation as the moderately strong  $10 \text{ \AA}$  peaks, although there may be traces of smectite and mica as well. Halloysite in various stages of hydration is revealed in the broad  $7.5\text{-}10 \text{ \AA}$  region which disappears with heating at  $550^{\circ}\text{C}$ . Kaolinite is probably present as the sharp  $7.1\text{-}7.2 \text{ \AA}$  peaks, although its identification is uncertain in the presence of chlorite (Brindley, 1961). (Kaolinite giving similar XRD patterns was identified by TEM at site SS-SF-7 which is nearby and has somewhat similar soil.) Iron oxide components were indicated in the  $3.2\text{-}3.6 \text{ \AA}$  region (not shown), and a trace of amorphous material appeared as a weak band in the XRD pattern from about  $17$  to  $30 \text{ 2}\theta$ .

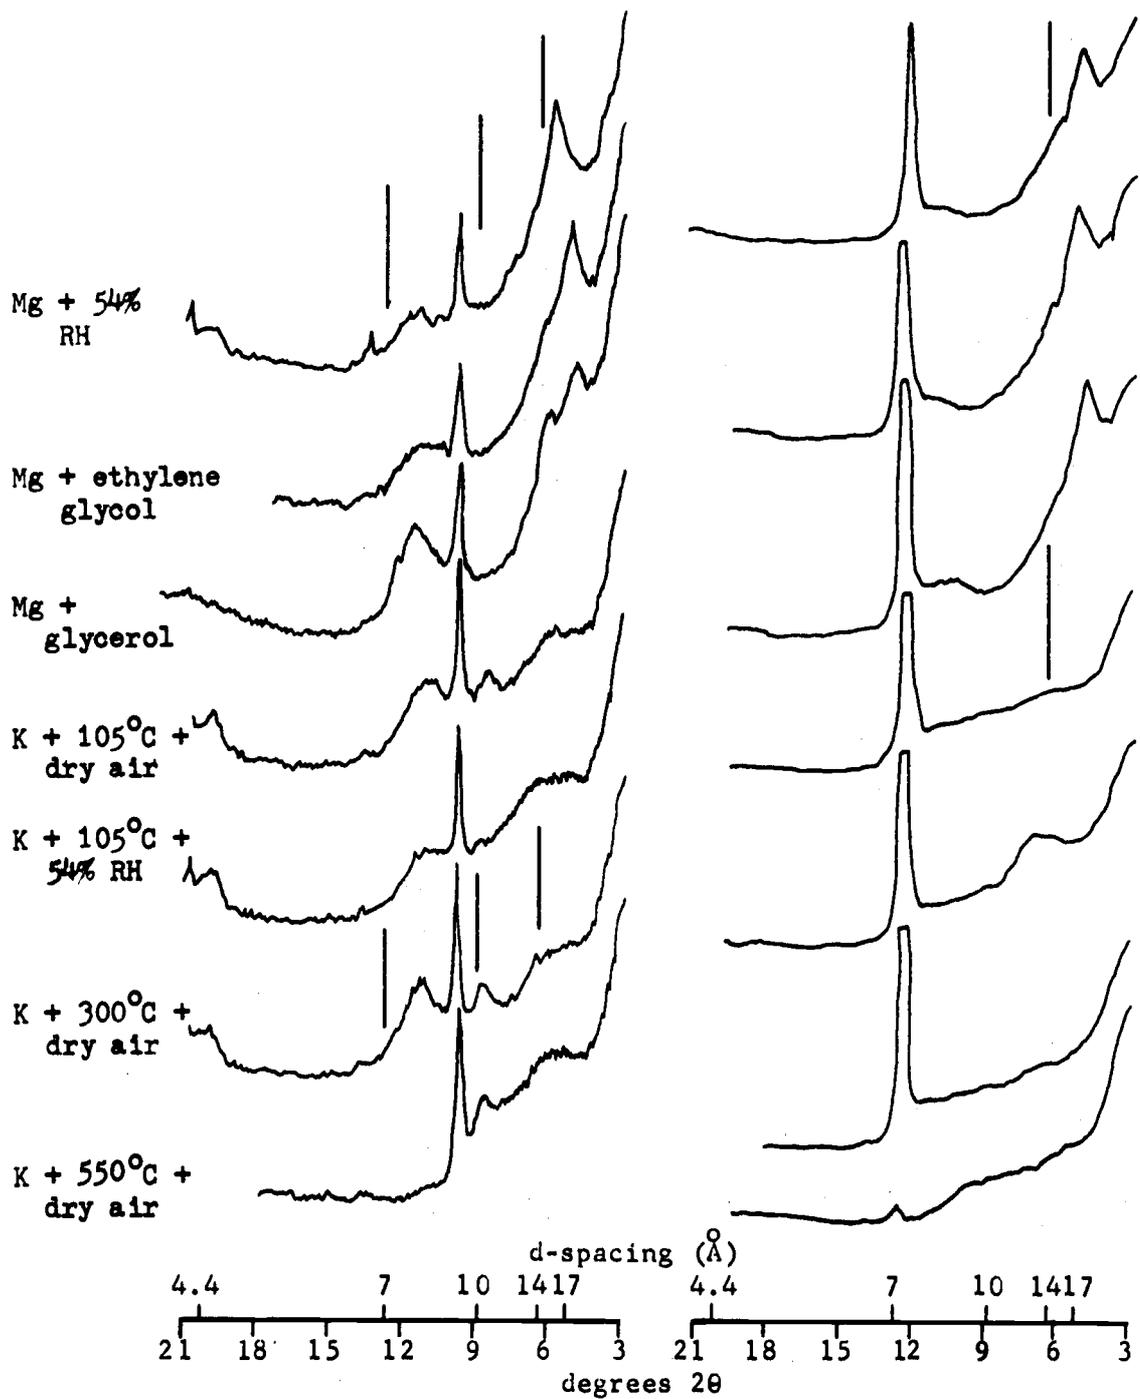
Figure 7. XRD patterns of shallow, relatively dry soils which failed as debris avalanches over bedrock at sites SS-1 (left) and R-SP-1 (right).

XRD patterns of failed soils from sites SS-1 and R-SP-1 show the presence of chloritic intergrade mineral in both soils (Figure 7). The underlying rock surface is different at the two sites, however, in that the rock of site SS-1 consists of moderately weathered

greenish pyroclastic rock of the Little Butte Series and that of site R-SP-1 is less weathered, less mafic and appears to be a rhyolitic breccia. Site SS-1, the wetter of the two sites, represents an area which is less stable. These differences are reflected mineralogically by the presence of zeolite, halloysite and hydroxy interlayered smectite at site SS-1, and by the strong presence of kaolinite at site R-SP-1. In the SS-1 patterns the zeolite appears as the sharp 9 Å peak; the halloysite as the broad 7.5-8 Å peak which disappears with heating at 550°C; and the hydroxy interlayered smectite as the 15 Å peak which partially expands with solvation, and collapses to 10 Å with some difficulty with K-saturation. Kaolinite in the R-SP-1 patterns is indicated by the distinctive 7.1 Å peaks.

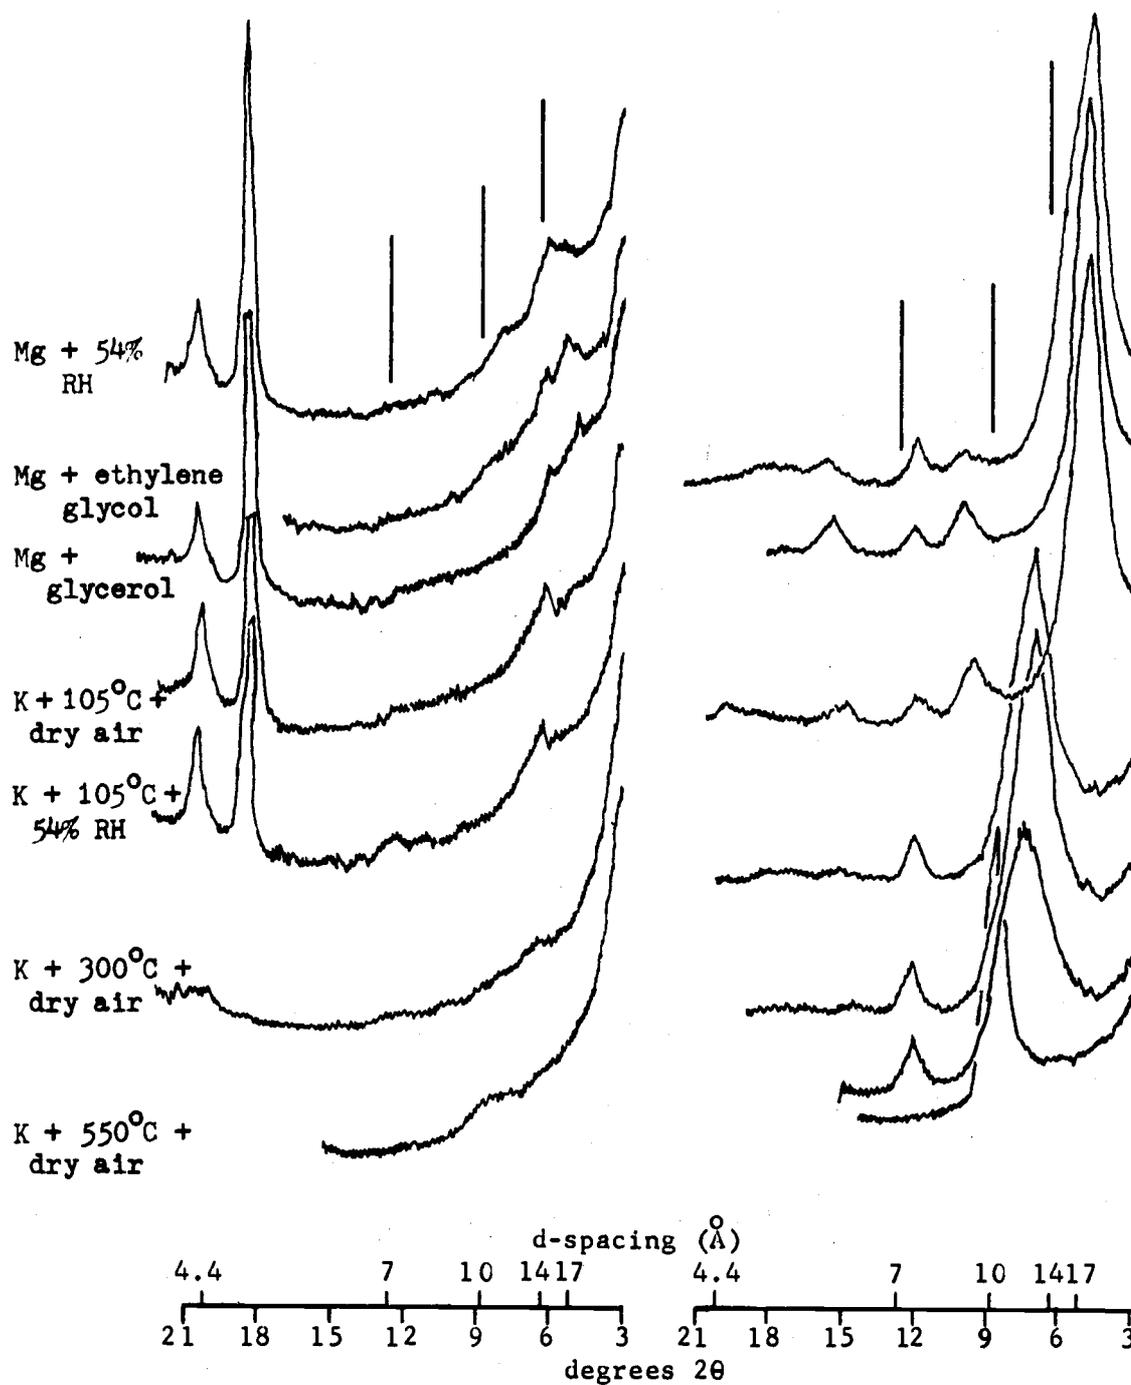
Figure 8. Site NS-BC-1 XRD patterns. Sample b (left), from head of slide, surface material above failure plane, 45 cm from crown. Sample d (right), from failure plane, reddish clay.

Sites NS-BC-1 and MFW-B-1 are examples of debris avalanches involving soil mantles similar to those just discussed, but which overlie steep, smooth layers of cohesive clay instead of bedrock. The soil mantle of site NS-BC-1 has little clay development; the XRD patterns (Figure 8, sample b) show that the clay consists of amorphous material, poorly crystalline, slightly expandable chloritic intergrade, well developed gibbsite (sharp, strong 4.8 Å peaks) and perhaps a hint of halloysite. Electron microscope observations revealed tubular and spheroidal halloysite in the sample, as well as microaggregates of these and other clay sized particles held together by strands and films of amorphous components. (Although micrographs of this sample are not presented due to the very low quality of pictures obtained, similar clays and aggregates found at other sites are shown later.) The underlying sliding surface (sample d) consists of a highly contrasting zone of montmorillonite, with some halloysite and probably zeolite.

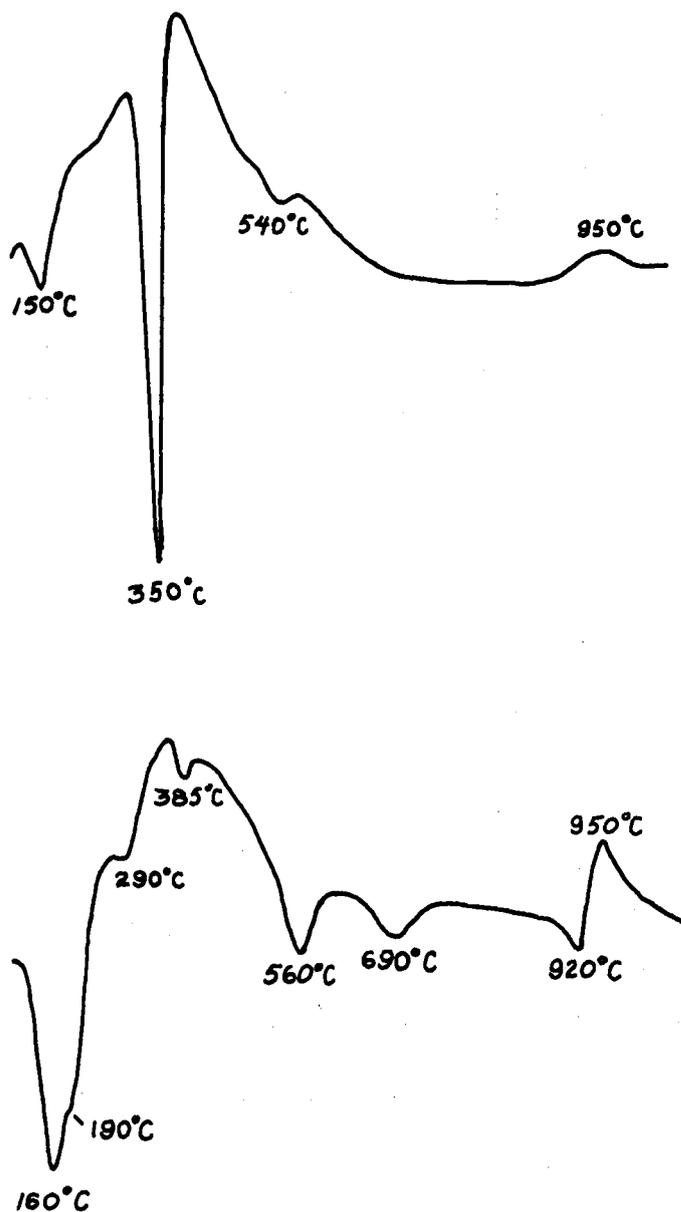
Figure 9. DTA patterns of failing soil, NS-BG-1b, at head of avalanche (top) and of reddish plastic clay, NS-BG-1d, over which failure occurred.

These components are also indicated by DTA patterns (Figure 9), of which the one for sample b shows a low temperature (150°C) dehydration endotherm, a strong 350°C gibbsite endotherm, a small 540°C endotherm probably due to halloysite dehydroxylation and a high temperature (950°C) exotherm due to halloysite or chloritic intergrade (Mackenzie, 1970). The pattern for sample d shows a somewhat broader low temperature

dehydration endotherm at 160°C, a halloysite dehydroxylation endotherm, a smectite dehydroxylation endotherm at 690°C and an endothermic-exothermic smectite inversion in the range of 920 to 950°C which is probably combined with the high temperature halloysite exotherm,

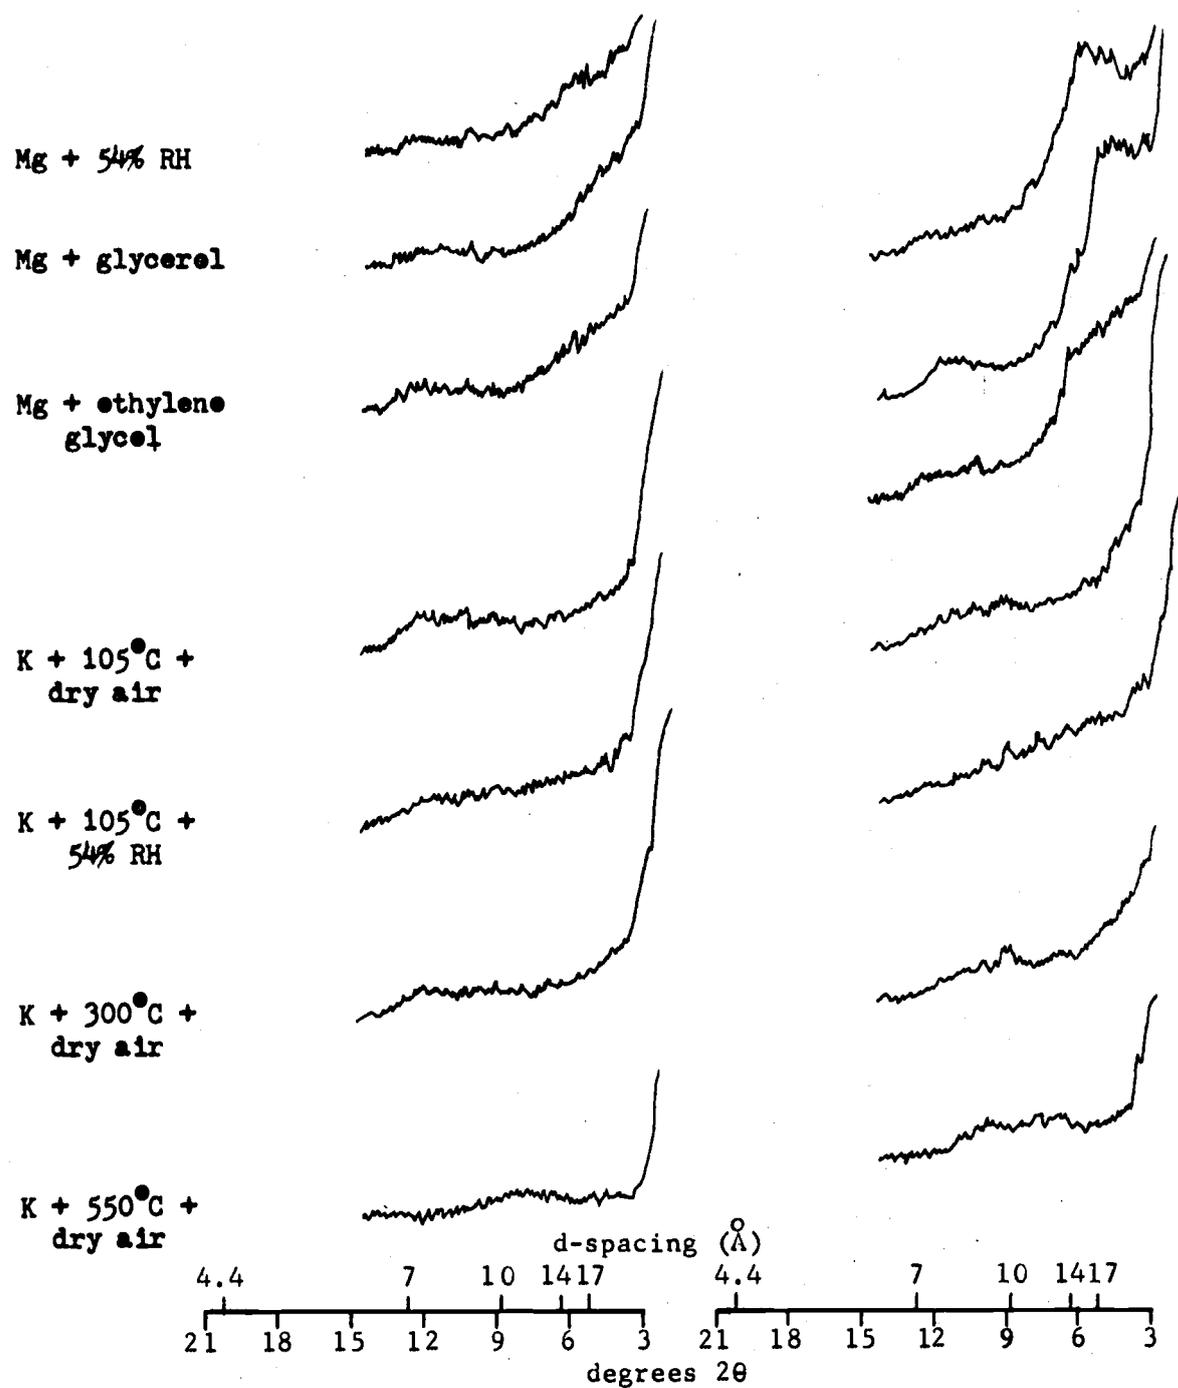
Figure 10. Site MFW-B-1 XRD patterns of dry soil mantle (taken from Youngberg et al., 1971).

In the case of the Buck Creek slide area (MFW-B-1), upstream from the Hills Creek Reservoir, the relatively dry soil mantle formed in basaltic colluvium shows little clay development; the XRD patterns reveal only amorphous material and some poorly defined chloritic intergrade (Figure 10). However, the zone of the failure plane, which is saturated year around, consists primarily of well developed montmorillonite with some accessory halloysite, seolite and perhaps mica (Figure 11),

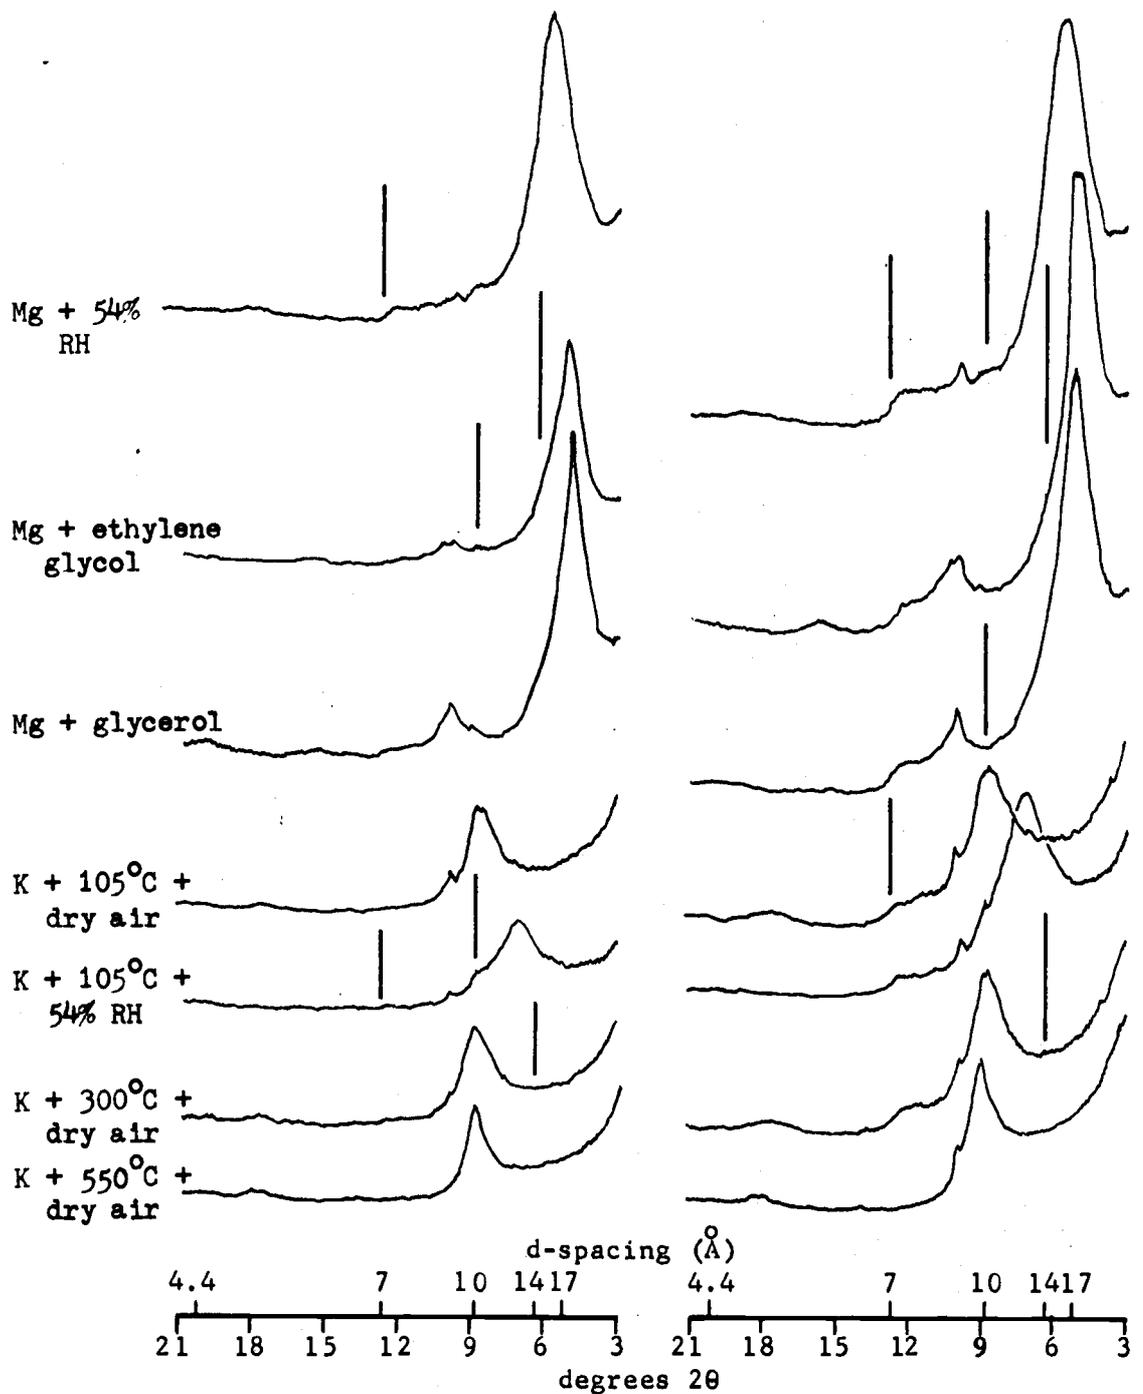
Figure 11. Site MFW-B-1 XRD patterns. Sample a (left), near top of failure plane 10 cm below surface. Sample c (right), just below failure plane 30-50 cm below surface.

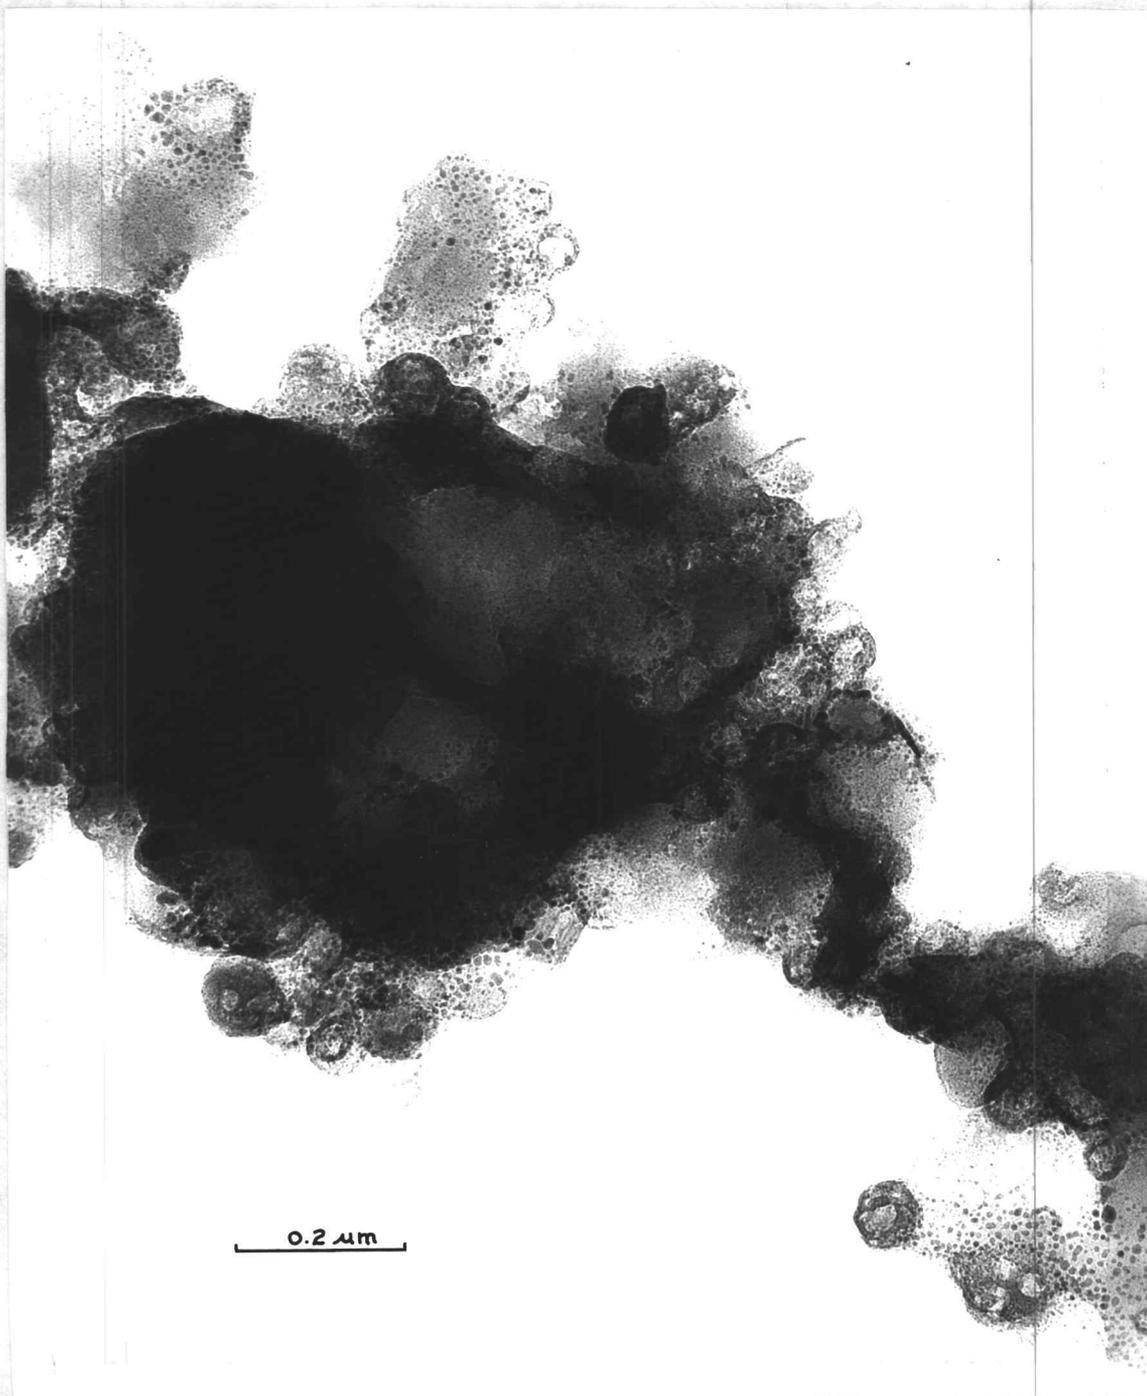
Plate 1. Electron micrograph of clay, sample MFW-B-1c, showing growths of small hollow spheres.

Electron micrographs (Plates 1 and 2) of sample c, which is a blue colored clay, show what is thought to be thin sheets of montmorillonite (Beutelspacher and Van Der Marel, 1968; Gard, 1971), many of which are covered with a gel-like coating which gives rise to small ( $< 0.04 \mu\text{m}$ ) hollow spheres. The true identity of the spheres is unknown, but it is proposed that they might be specimens of the spheroidal form of halloysite in a very early stage of formation. Unfortunately, no additional micrographs of samples from site MFW-B-1 were made, nor were electron diffraction analyses conducted.

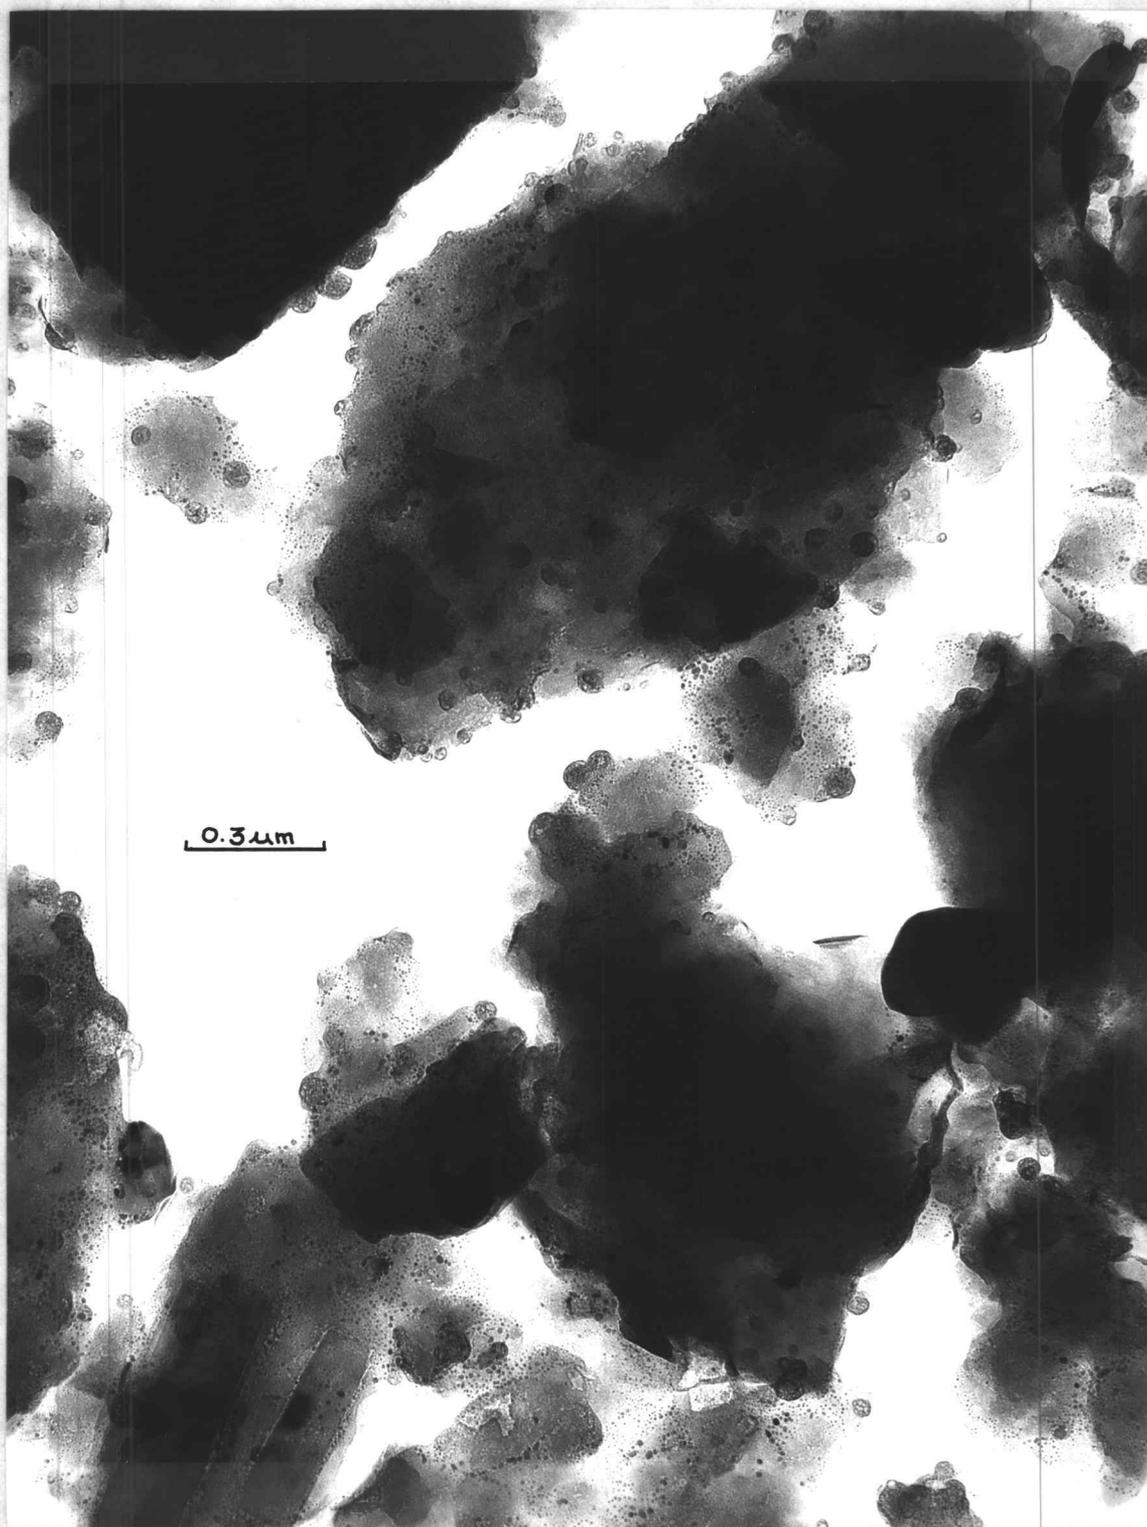
Plate 2. Electron micrograph of clay, sample MFW-B-1c, showing growth of small hollow spheres.

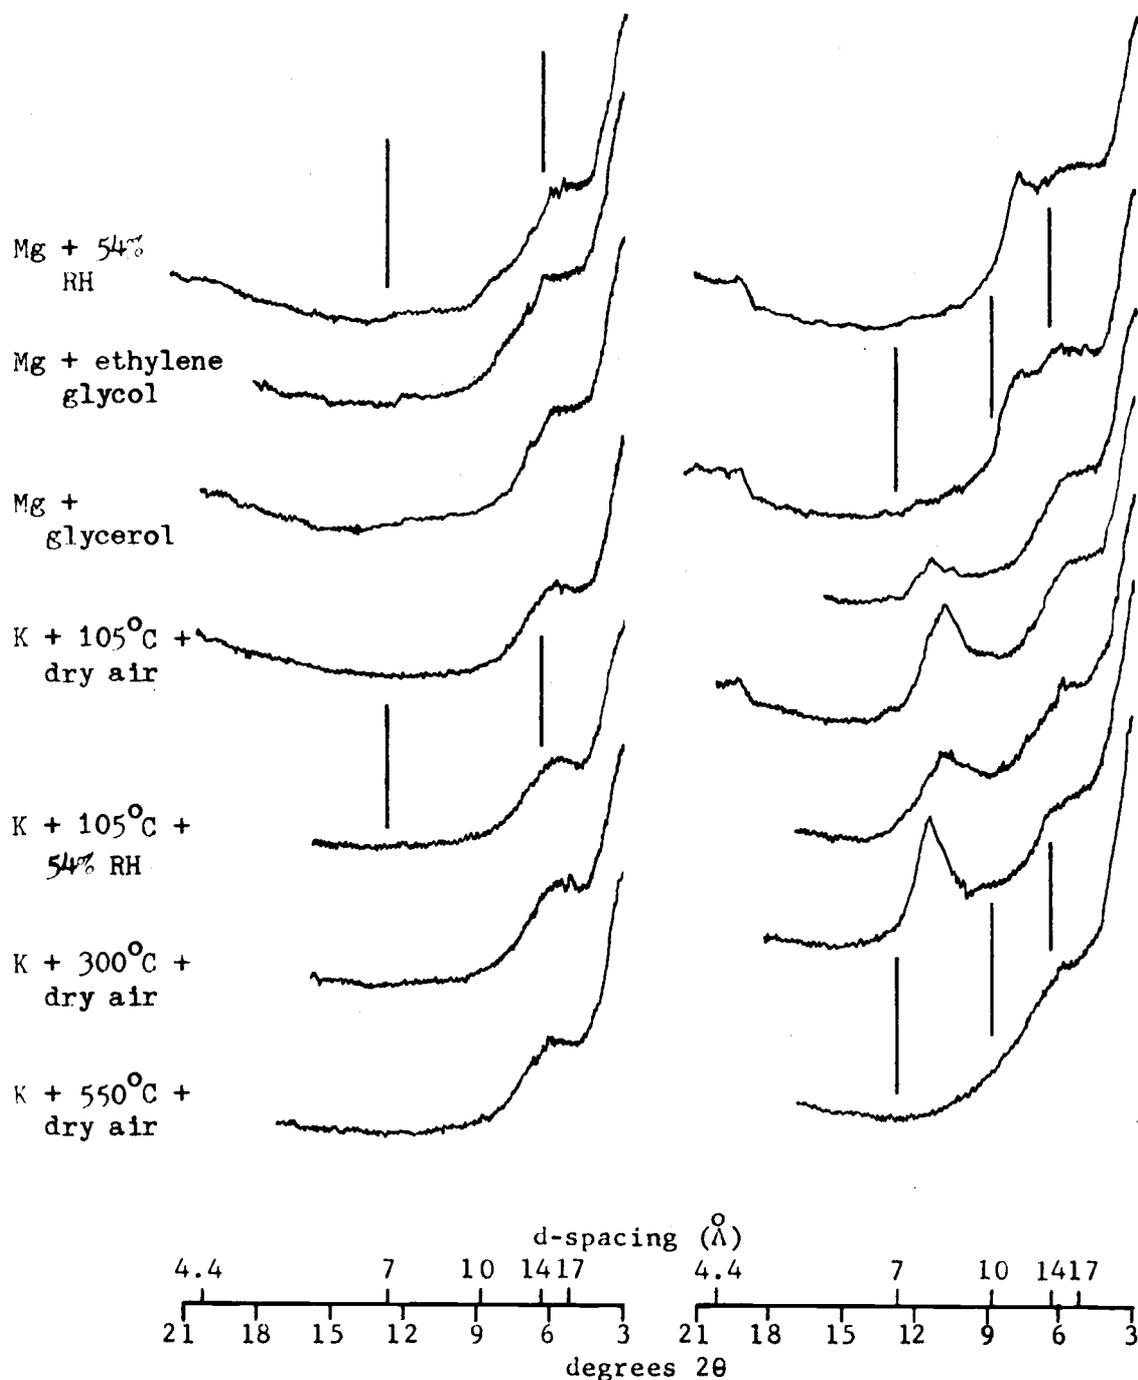
Figure 12. Site MS-P-1 XRD patterns. Sample b (left): dry, stable soil upslope from failure, 75 cm depth. Sample f (right): wet, flowing soil in failure, 75 cm depth.

saturated and flows readily when disturbed, was taken from downslope of the crown in the unstable colluvial soil lying just above the recent road-caused disturbance (Figure 12). A major difference between the two samples, both of which contain amorphous material and chloritic intergrade, is that the saturated sample f contains considerably more hydrated halloysite than does sample b. This is indicated in f by the 10.8 Å peak in the unsolvated Mg-saturated treatment which shifts to 7.5-8 Å upon drying and K-saturation, and disappears with heating at 550°C; and in sample b by the subtle indication in the region of 7.3 Å.

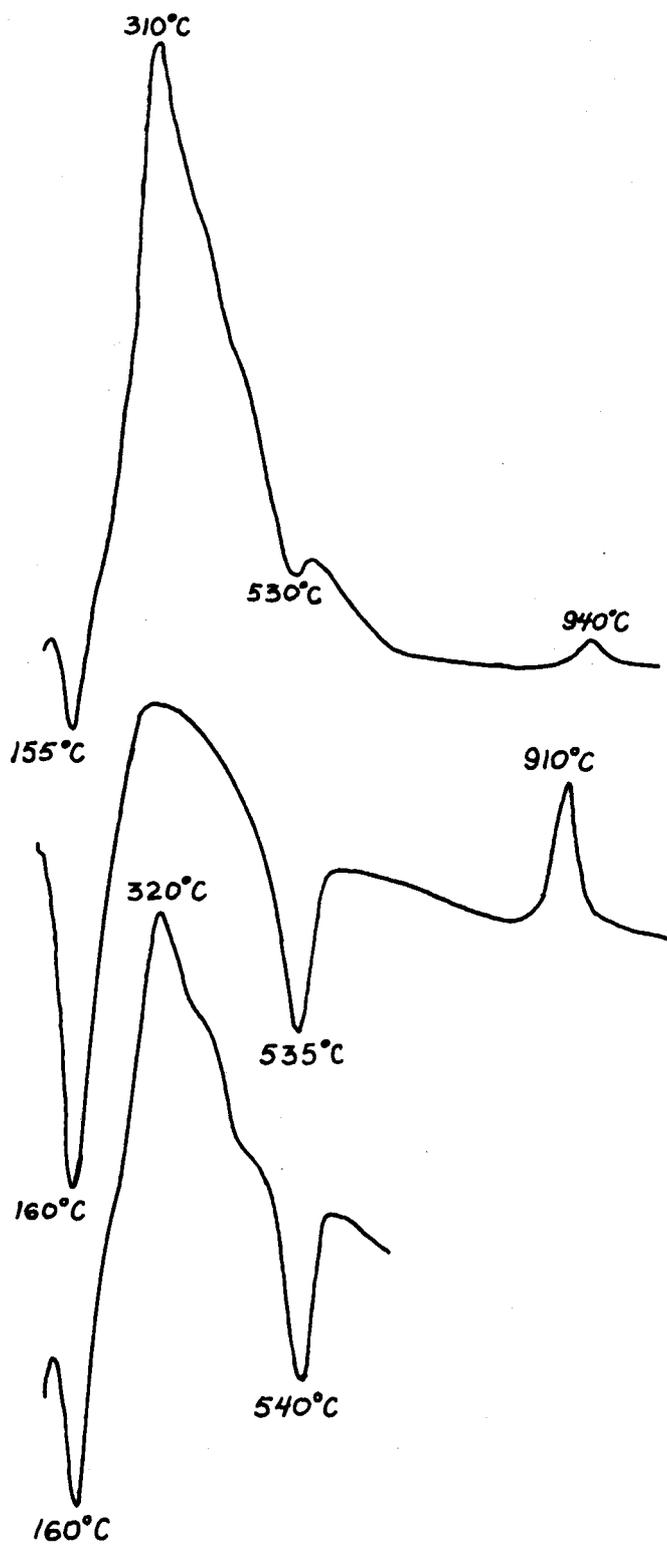
Figure 13. DTA patterns for samples MS-P-1b, MS-P-1e, and MS-P-1f.

DTA patterns (Figure 13) indicate the presence of halloysite in the two samples by the low temperature dehydration endotherm, the dehydroxylation endotherm and the high temperature exotherm. Amorphous material cannot be separated from halloysite in the patterns because of the congruity of their low temperature endotherms and high temperature exotherms. The large exotherms in the vicinity of 310°C are unexplained, but are probably a function of the particular furnace, as a significant rise in the reference material pattern also commenced immediately after the start of heating. Furthermore, the exotherm did not appear nearly as dramatically in the pattern of another sample, e, which is comparable to sample f, and was heated in another furnace. Plant opal, which was seen in the samples under the electron microscope, could also contribute to these exotherms (Wilding, 1976 and personal communication). It is doubtful that the exotherms were caused by organic matter oxidation because the samples were first subjected to a vacuum and then heated in an N<sub>2</sub> atmosphere. One effect of these large peaks is to decrease the apparent intensity of the dehydration endotherms.
