AN ABSTRACT OF THE THESIS OF

RONALD DAVID TASKEY for the DOCTOR OF PHILOSOPHY degree in SOIL SCIENCE presented on September 12, 1977

Title: RELATIONSHIPS OF CLAY MINERALOGY TO LANDSCAPE STABILITY IN WESTERN OREGON Redacted for Privacy

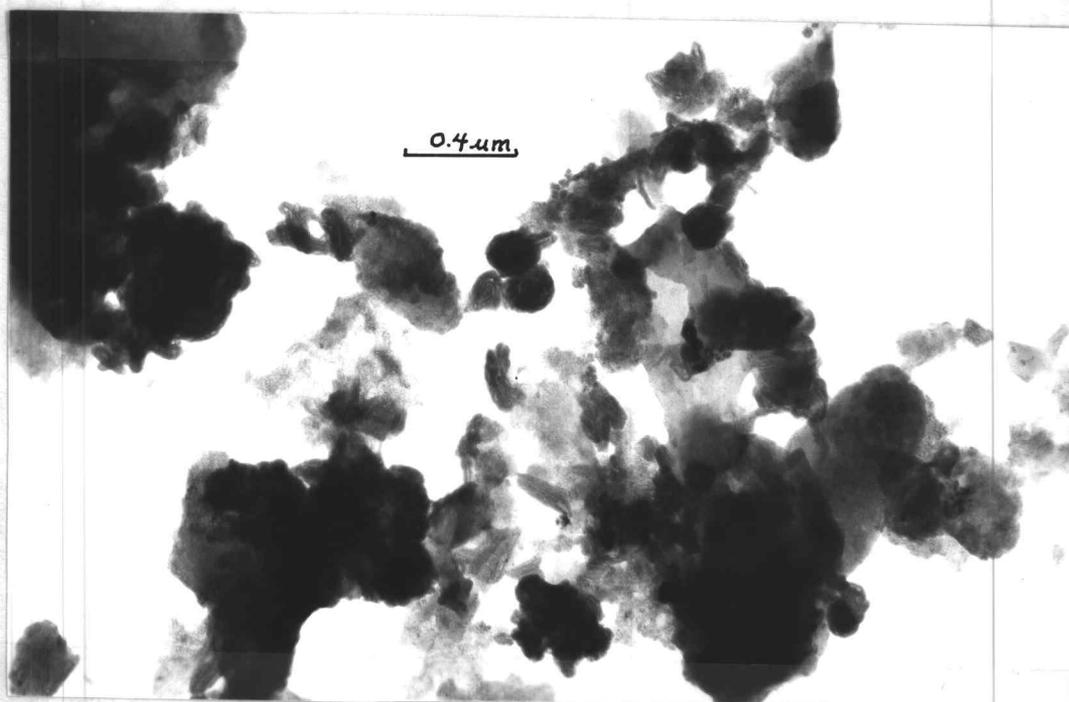
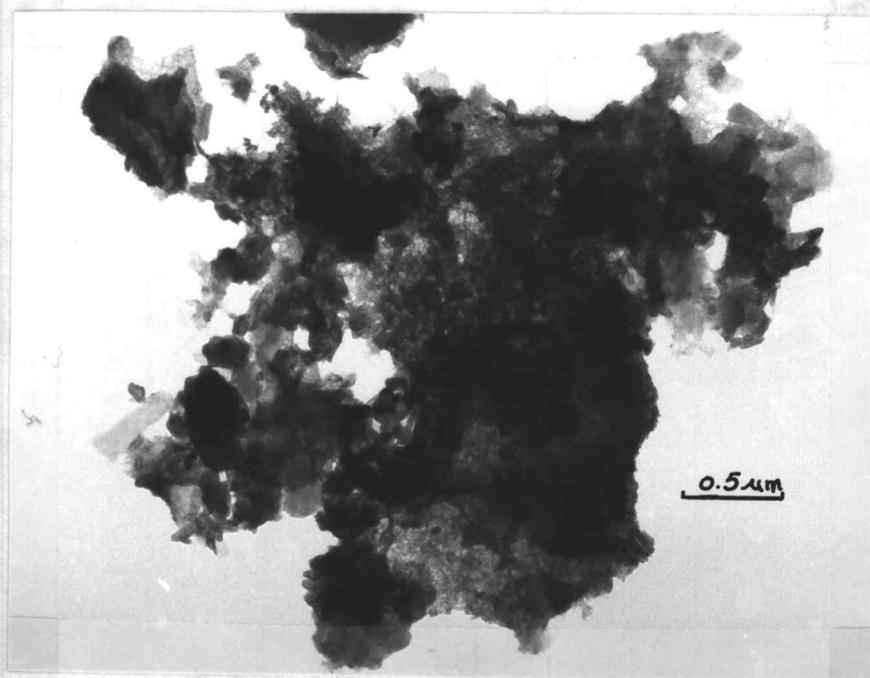
Plate 3. Electron micrographs of clay sample MS-P-1b.

Although the XRD patterns indicate a much stronger presence of halloysite in sample f, electron micrographs clearly show the presence of some spheroidal and tubular halloysite in sample b (Plate 3). Additionally, the amorphous component of the drier sample, b, tends to form microaggregates, the components of which are bound together by a network of amorphous films and strands which resemble imogolite

(Plate 3). (The microaggregate shown is similar to that described previously for the debris avalanche sample NS-BC-1b.) The saturated sample, f, clearly contains a greater abundance of tubular and spheroidal halloysite (Plate 4). The amorphous component of sample f generally appears more gel-like, and has a tendency to occur in relatively large bulbous masses (not shown) which are more susceptible to disintegration under the electron beam (Jones and Uehara, 1973). The greater abundance of halloysite in the saturated, less stable soil, and the different forms of amorphous material noted in the two samples most likely play a key role in the water holding characteristics and shear strength characteristics of the two soils.

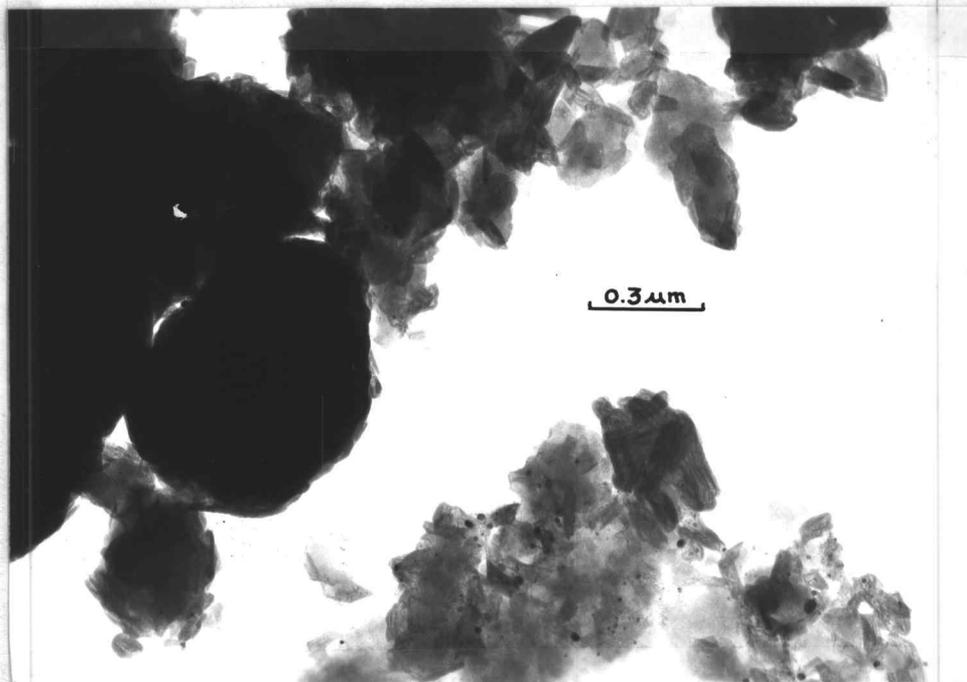
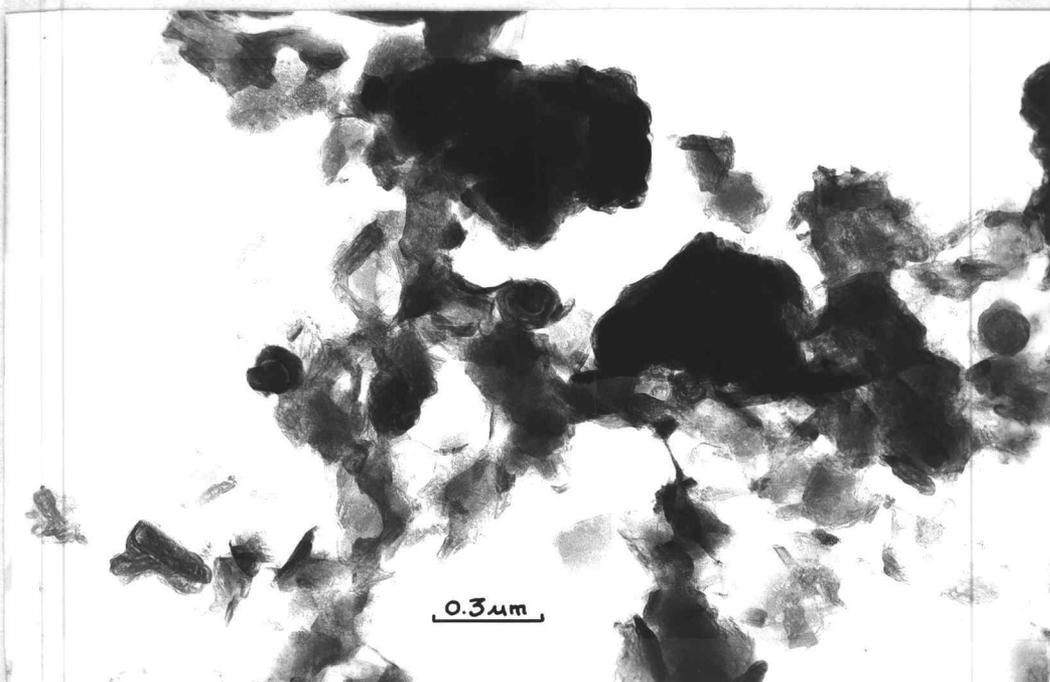
Plate 4. Electron micrographs of clay sample MS-P-1f.

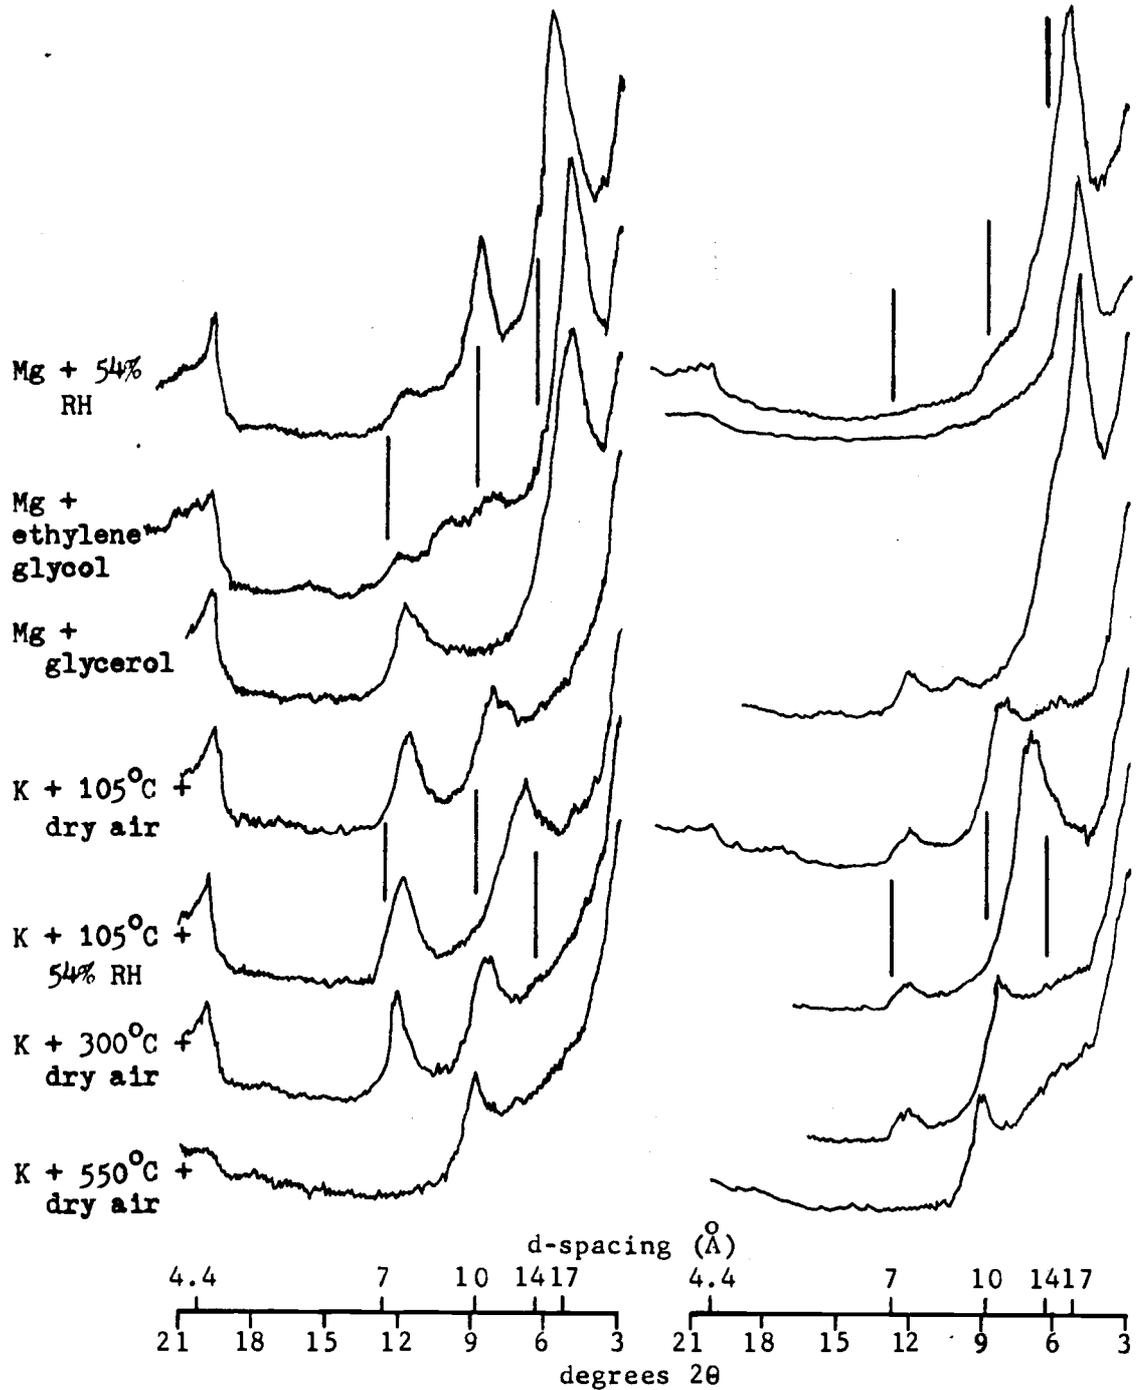
Figure 14. Site MS-P-1 XRD patterns. Sample 1 (left), random sample of mixed, failed material. Sample h (right), plastic clay underlying flowing soil and which supports perched water table.

Samples i and h (Figure 14) were collected a short distance downslope from sample f in the area where the failure was cut through during road construction. The presence of montmorillonite is quite strong in these samples, and the hydrated halloysite in sample i is sharper and stronger than in the other samples, indicating a better developed mineral at this location. Halloysite is also indicated in sample h, but its presence is not nearly as strong. Careful observation of the site suggests that sample i originated from near the debris flow failure plane in the perched water zone at the contact of the colluvium and the weathered pyroclastic rock, whereas sample h originated in the weathered pyroclastic material beneath the failure plane and upon which the water table is perched. However, sampling difficulties caused by the saturated conditions of the soil and by the natural and man-caused disturbances made it impossible to determine the precise relationships of these samples to each other and to others collected at the site.

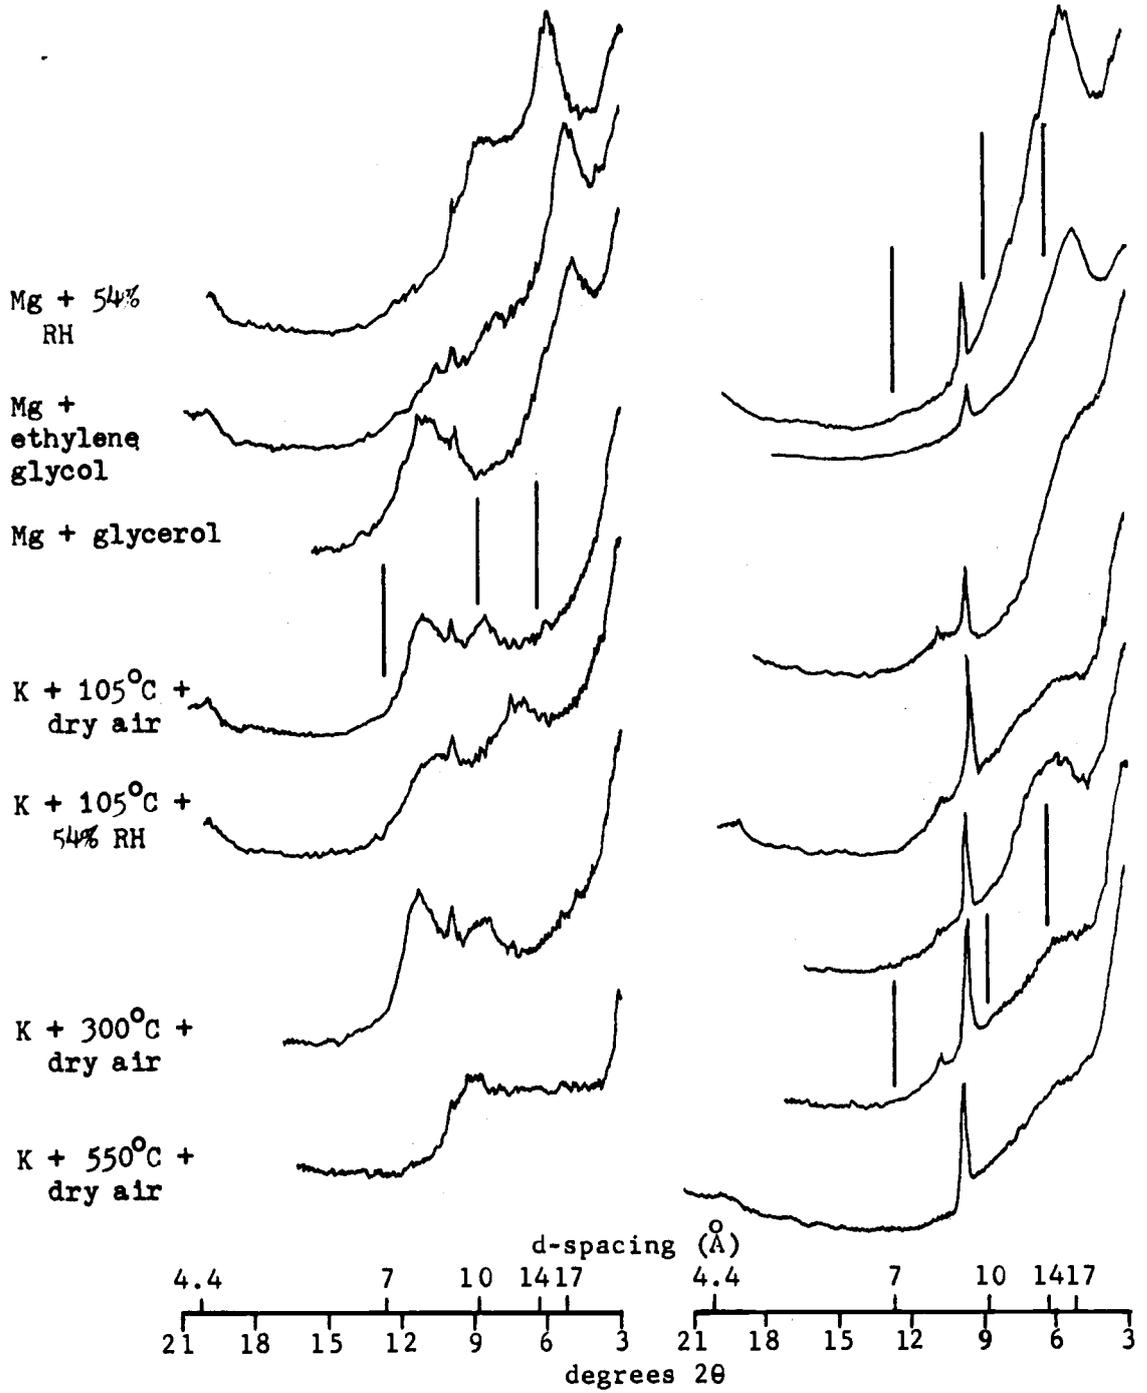
Figure 15. Site MS-P-1 XRD patterns. Sample j (left), somewhat drier, more stable (?) cutbank at the right edge of failure area. Sample g (right), dry, stable cutbank to left of failure area.

The slopes bordering the failure area are relatively stable. This is especially true of the left slope (considered as the failure's left), the soil of which is dry, coarse textured and generally poorly developed. The XRD pattern for this sample indicates the presence of chloritic intergrade, zeolite and possible traces of halloysite and amorphous material (Figure 15).

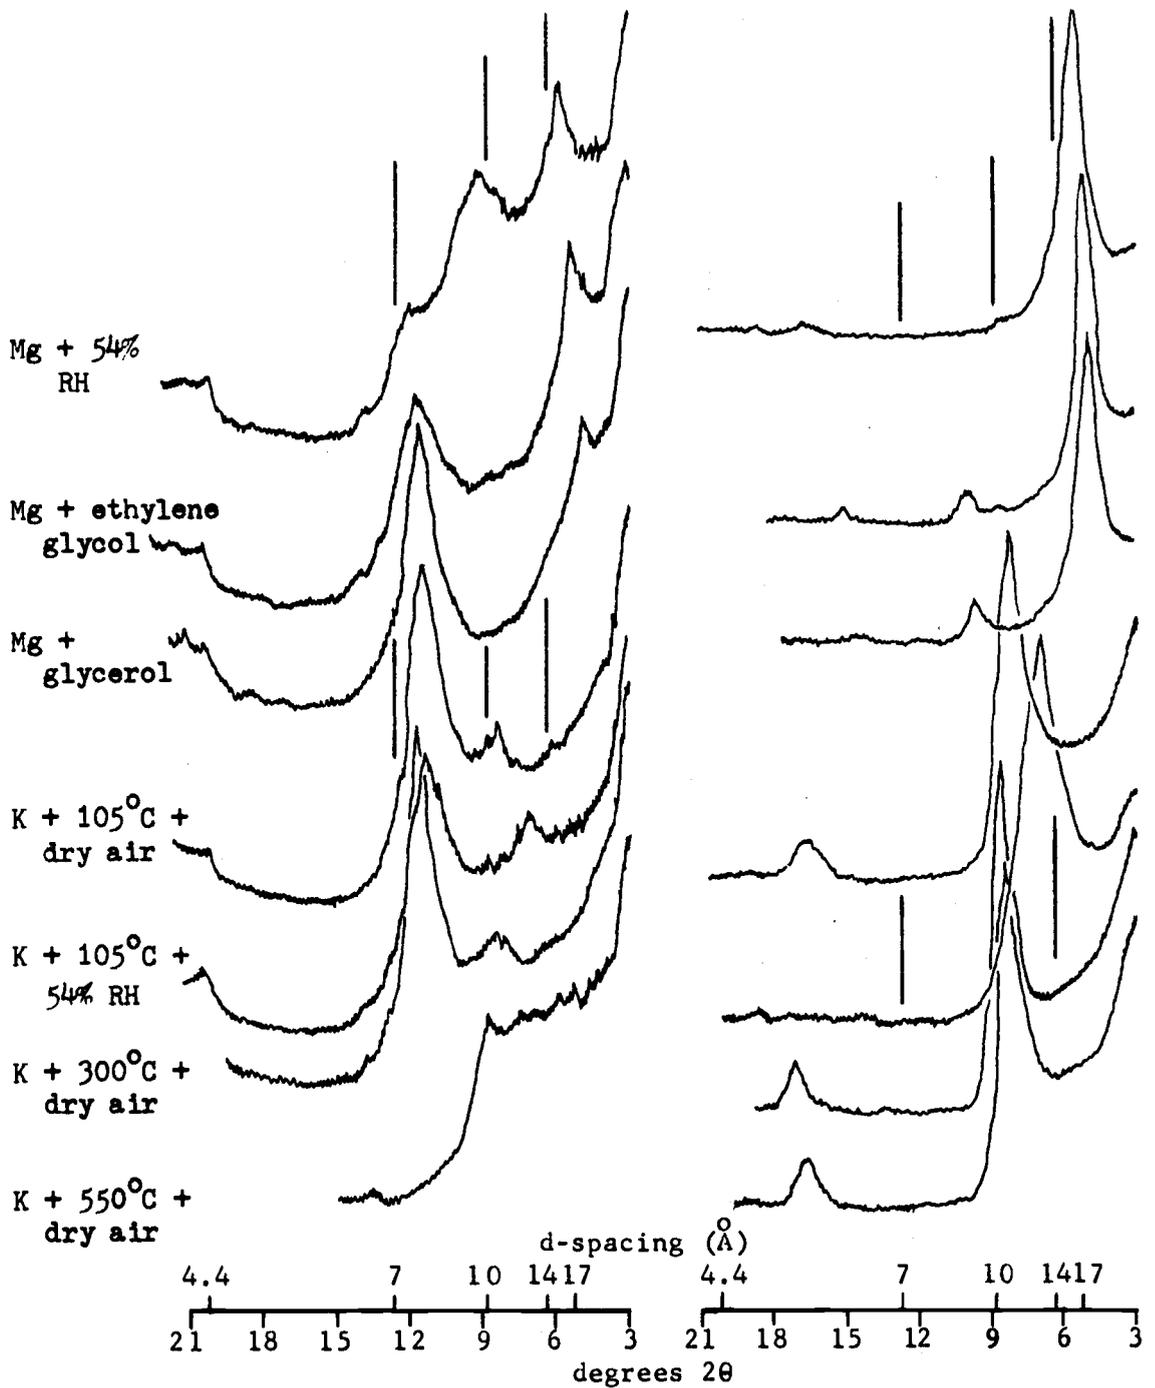
Figure 16. Site MS-1 (left) XRD patterns, 20 cm deep into remaining bank of large debris flow road failure. Site MS-2 (right) XRD patterns of material similar to that underlying MS-1

The failure site MS-1 is a fairly large debris flow, again involving soil with a high water holding capacity, and which is slippery but only slightly sticky. XRD analyses (Figure 16) and DTA (Figure 17) show the very strong presence of hydrated and dehydrated halloysite and amorphous material, with some smectite and chloritic intergrade. These materials are also shown in the electron micrographs (Plate 5).

Figure 16 also gives the strong montmorillonite patterns of the soil from site MS-2 which was collected from an area of deep soil creep and rotational slumping located about a mile from MS-1 in the same drainage. Field observations suggest that the clay of site MS-2 is probably similar to that underlying the deposit at MS-1.

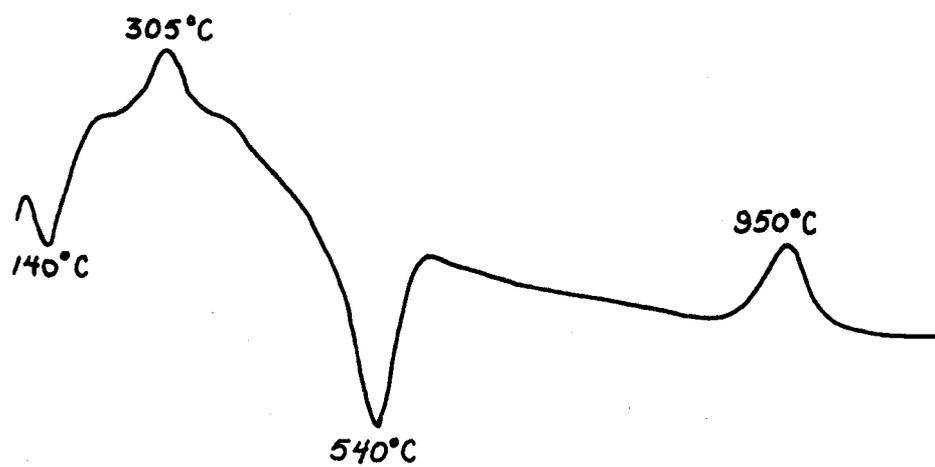
Figure 17. DTA pattern for sample MS-1.

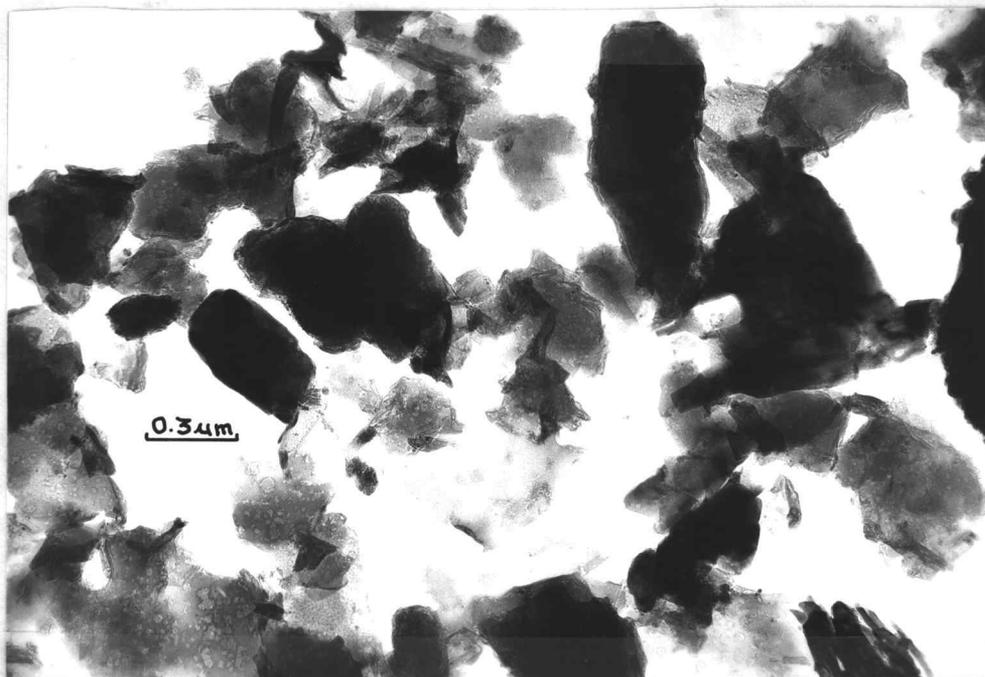
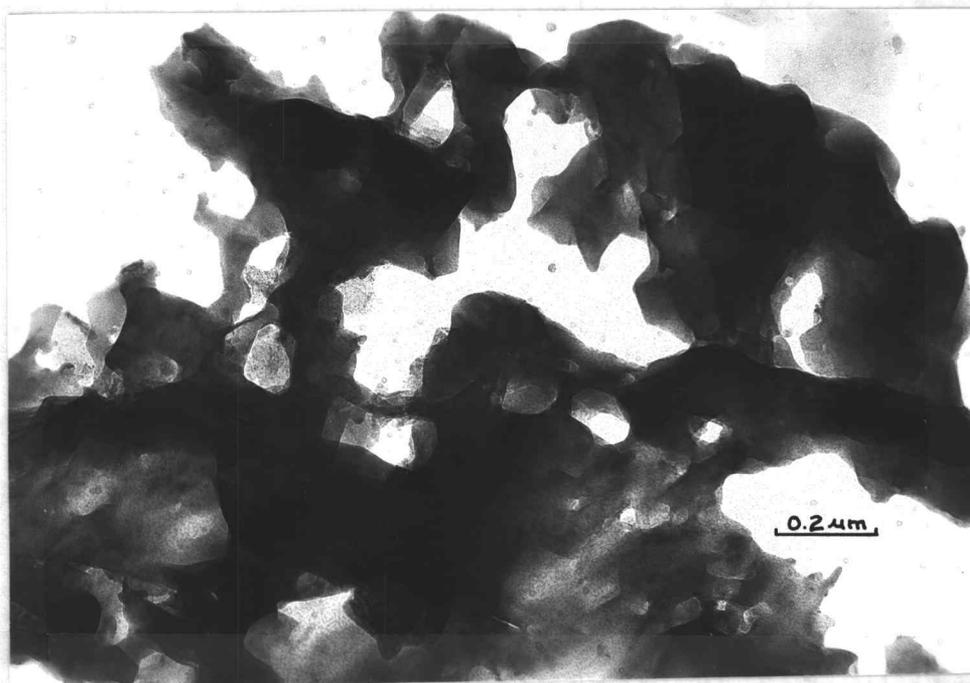
Plate 5. Electron micrographs of site MS-1 clay.

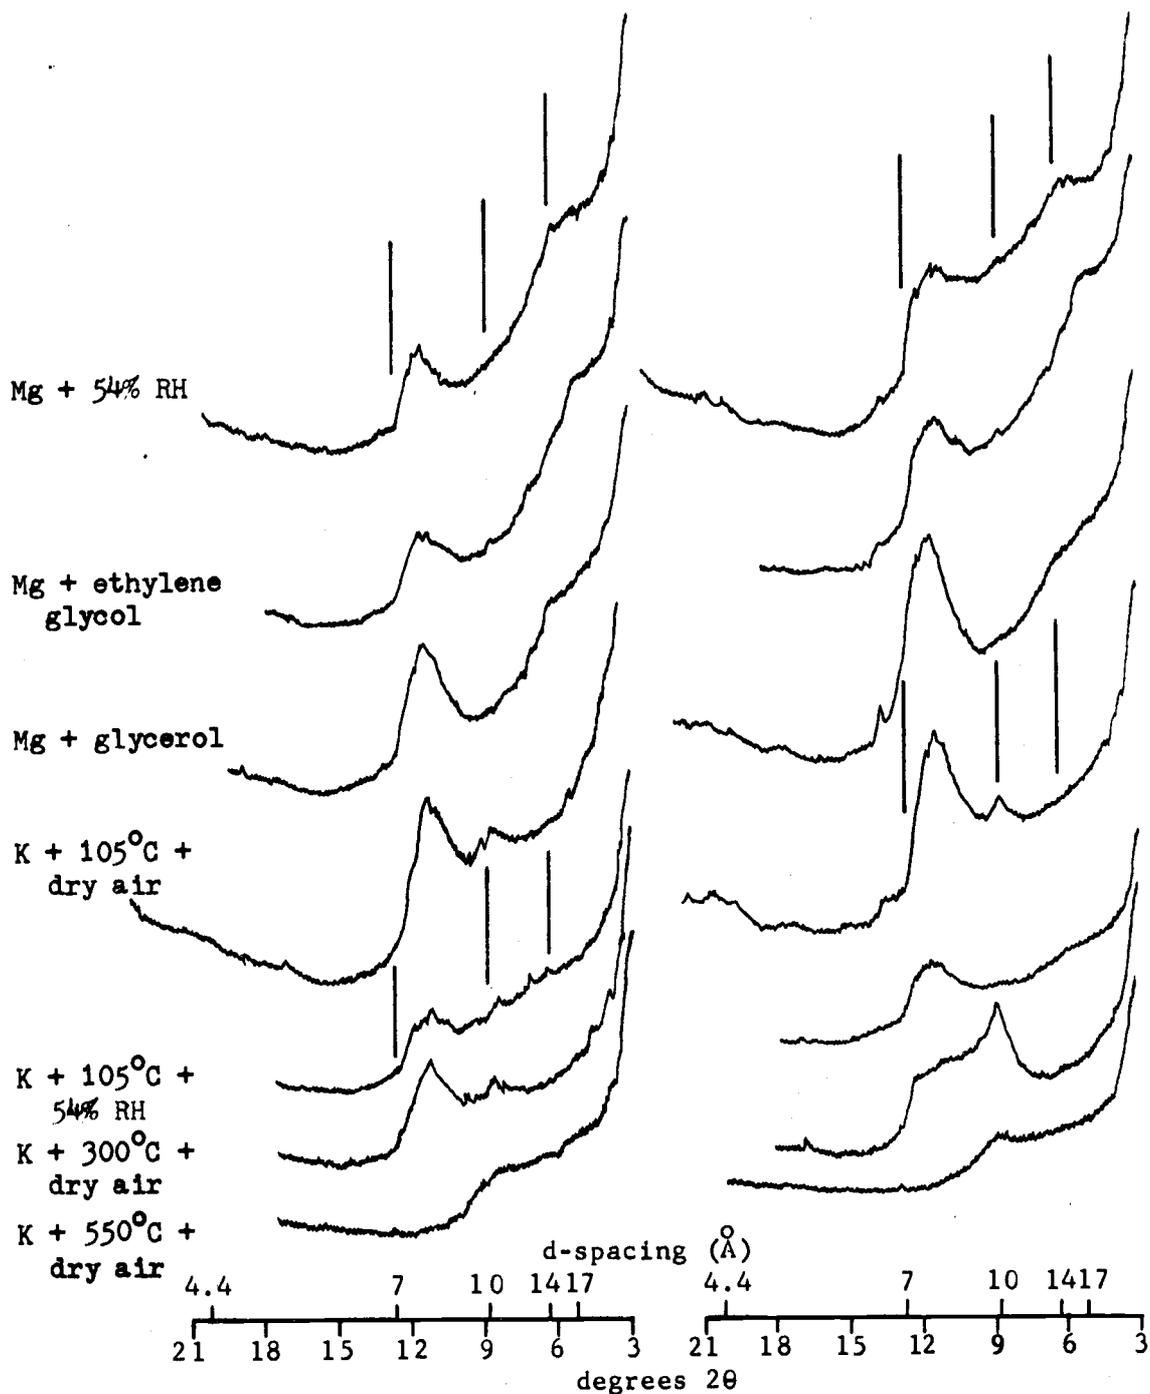
Figure 18. Site R-CM-1 XRD patterns. Sample a (left), headwall region of failure, 1 m from crown. Sample c (right), failure surface at level of emerging water, 2½ m from crown.

Similar relationships of saturated soil containing halloysite, amorphous material and chloritic intergrade failing as a debris flow over montmorillonite are shown by the clay fractions at site R-CM-1. Samples a and c (Figure 18) represent different depths in the material which is subject to flowage. Sample b, which was collected from saturated soil at the failure plane, generally shows greater evidence of hydrated halloysite and stronger smectite than does sample a, which was collected from moist soil approximately one meter above the current perched water table. (The strengthening of the  $7.6 \text{ \AA}$  peak and concurrent diminishing of the plateau in the vicinity of  $10 \text{ \AA}$  with glycerol solvation of the Mg-saturated treatment is due to dehydration of the halloysite, caused by heating the sample during vapor solvation.) The small sharp peak at  $6.4 \text{ \AA}$  is probably due to plagioclase.

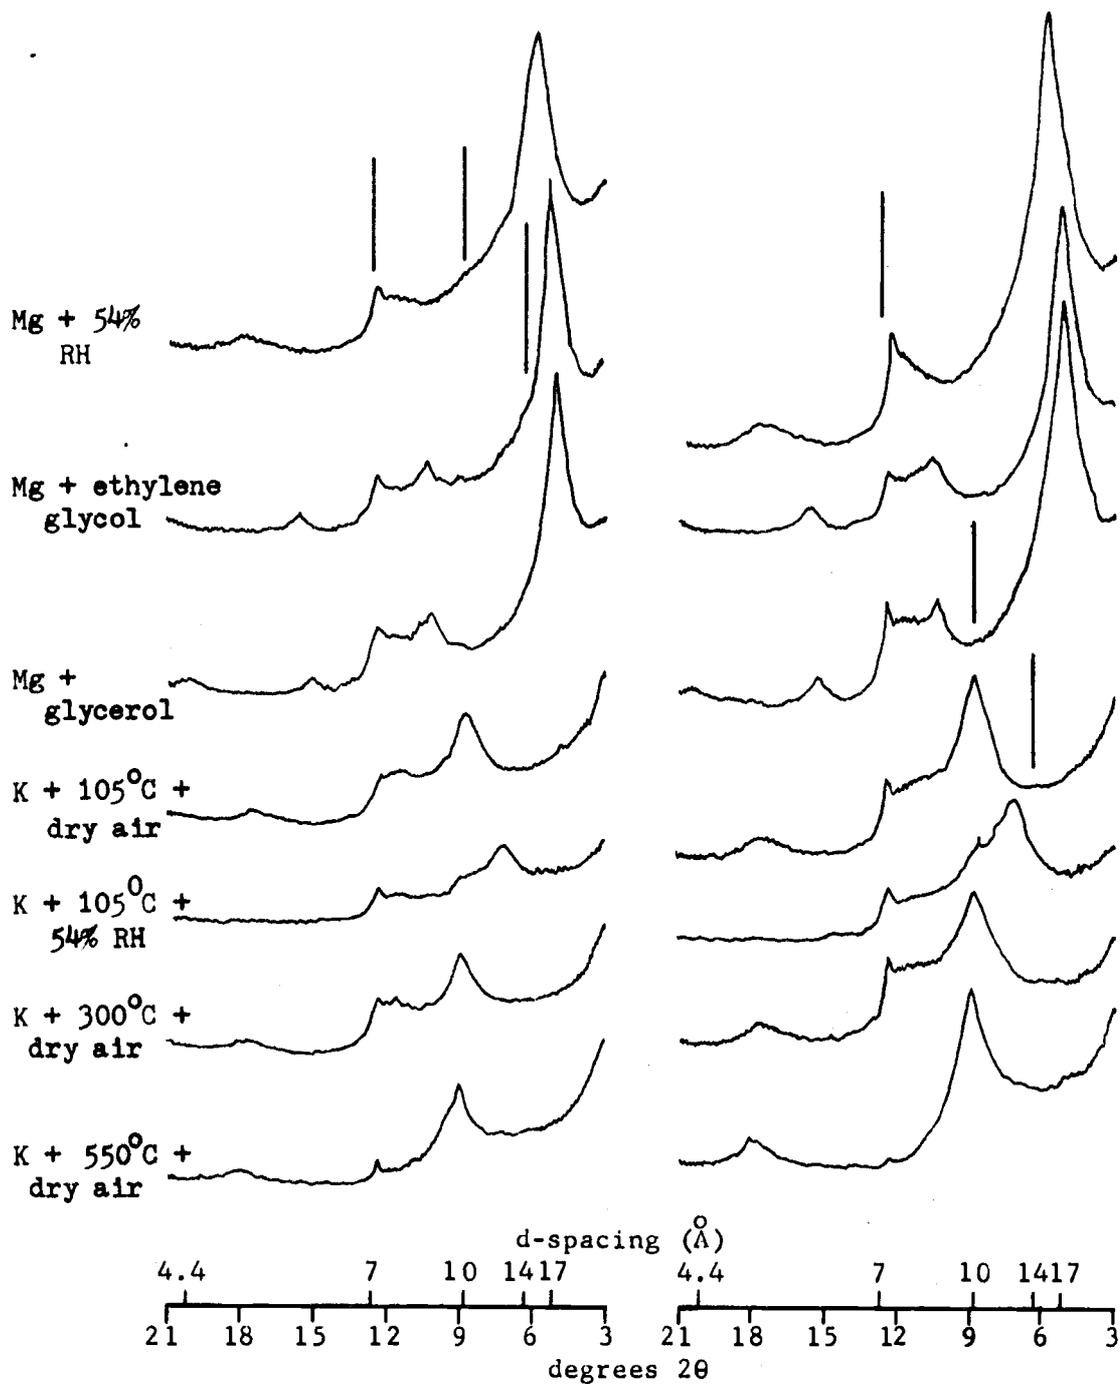
Figure 19. Site R-CM-1 XRD patterns. Sample d (left), plastic clay below failure plane. Sample f (right), gleyed, sample of plastic clay adjacent to failure.

The soils represented by samples d and f (Figure 19), which give strong montmorillonite peaks and weak halloysite peaks, are stable as compared to the overlying saturated soil, but nonetheless have undergone rotational slumping at greater depths. Surprisingly, the plastic clay samples d and f also exhibit small but distinct  $7.16 \text{ \AA}$  peaks which may be indicative of kaolinite. The presence of kaolinite in this sample may indicate additional erosion of better drained soil from further up the slope, as it is highly unlikely that

kaolinite would form under the environmental conditions of this site. These may, however, be nothing more than unusually sharp peaks of dehydrated halloysite.

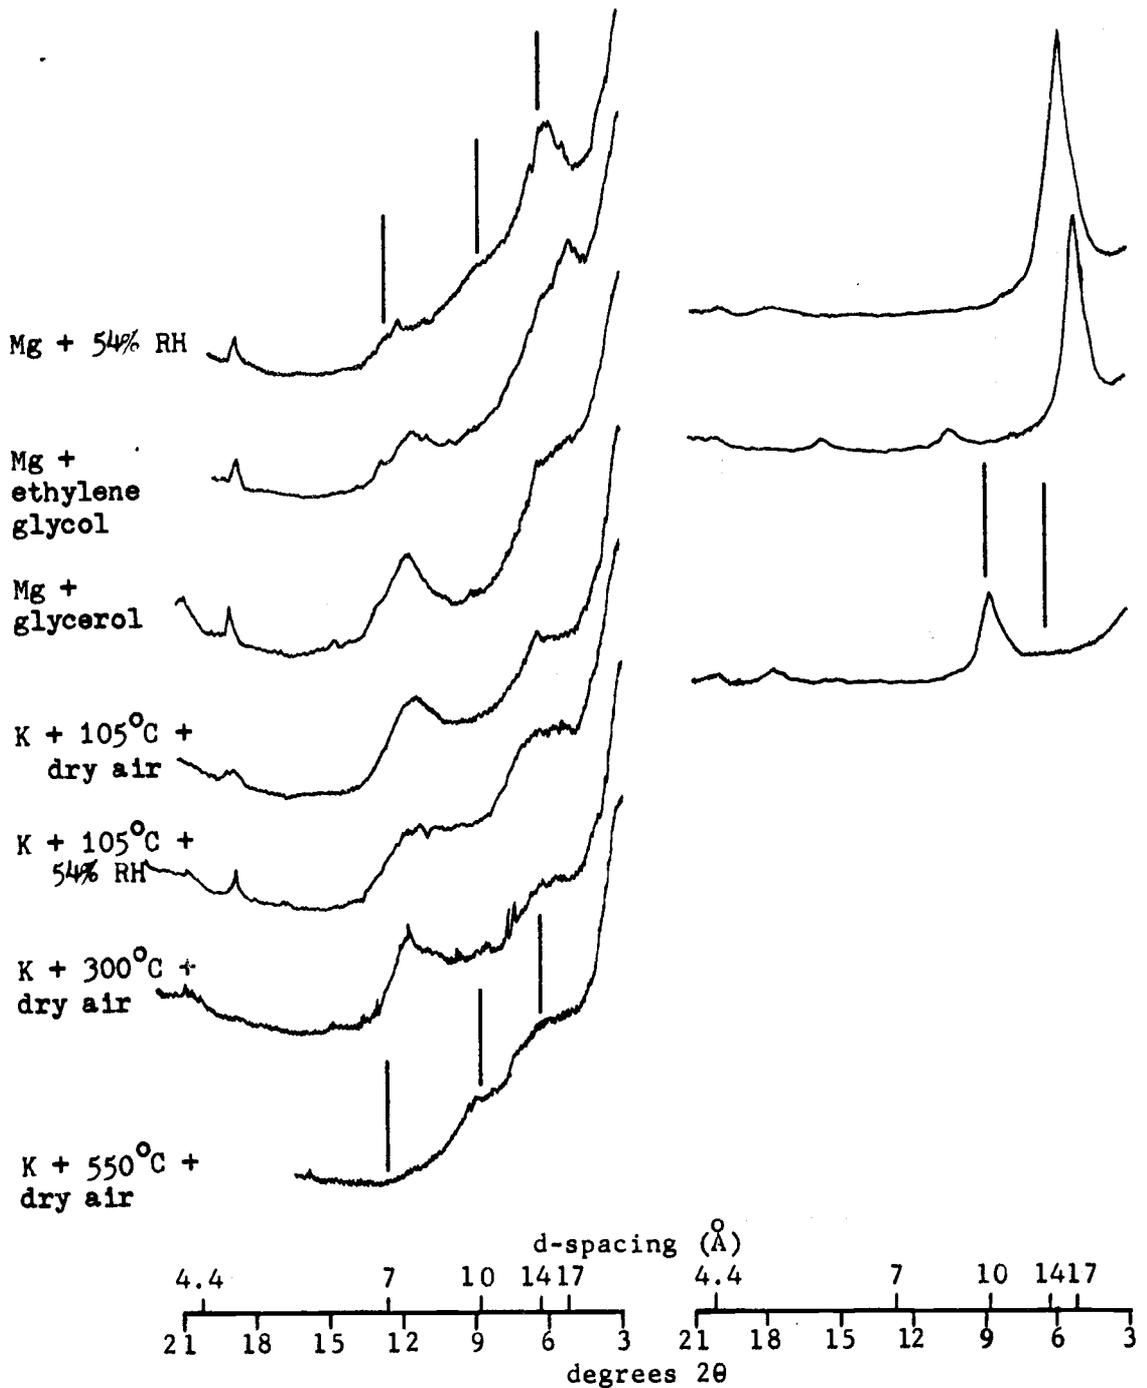
Figure 20. Site SS-SF-1 XRD patterns. Sample e (left), flowing soil neartop of perched water table, 1 m depth. Sample h (right), gleyed plastic clay beneath perched water table, 4 m depth.

The clay of sample e, site SS-SF-1 was collected from a layer containing basaltic colluvium and volcanic ash, and consists of halloysite, amorphous material, some gibbsite and chloritic intergrade with indications of smectite (Figure 20). This material which is approximately two meters in depth, has failed by the flowage process on a 30% slope underlain by montmorillonite (Figure 20, sample h).

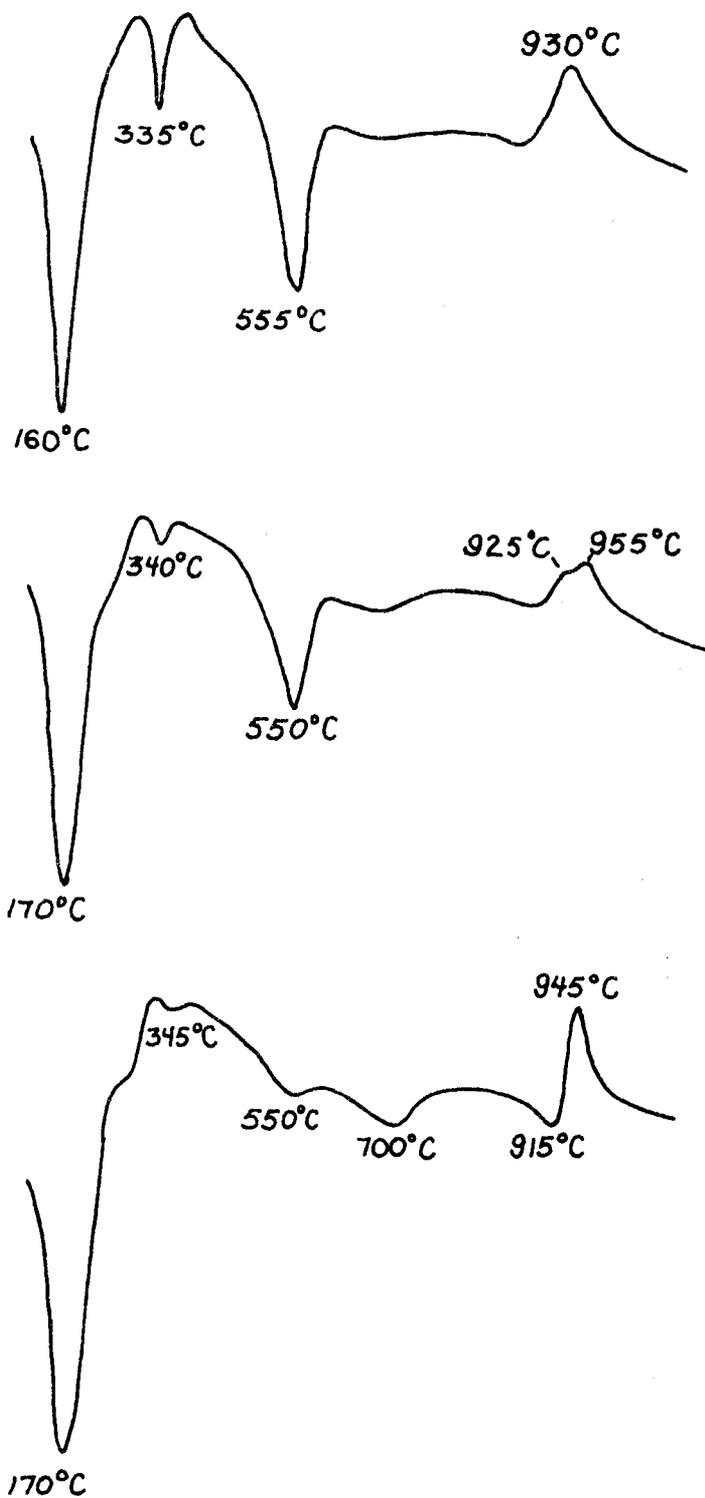
Figure 21. DTA patterns for samples SS-SF-1f, SS-SF-1g, and SS-SF-1h.

These trends are also shown in the DTA patterns (Figure 21) for samples f, g, and h. Sample f, which is comparable to sample e, gives a typical halloysite pattern with the large dehydration endotherm, strong dehydroxylation endotherm and high temperature exotherm. The endotherm at 335°C is due to gibbsite. Sample g, which was collected from near the top of the saprolite and transitional between f and h, shows weaker halloysite peaks and definite signs of montmorillonite, with a shallow endotherm at approximately 675°C and a high temperature exotherm. The pattern of sample f, collected at approximately one and one-half meters deep into the saprolite, indicates much stronger montmorillonite, XRD patterns for samples f and g are given in Appendix III.

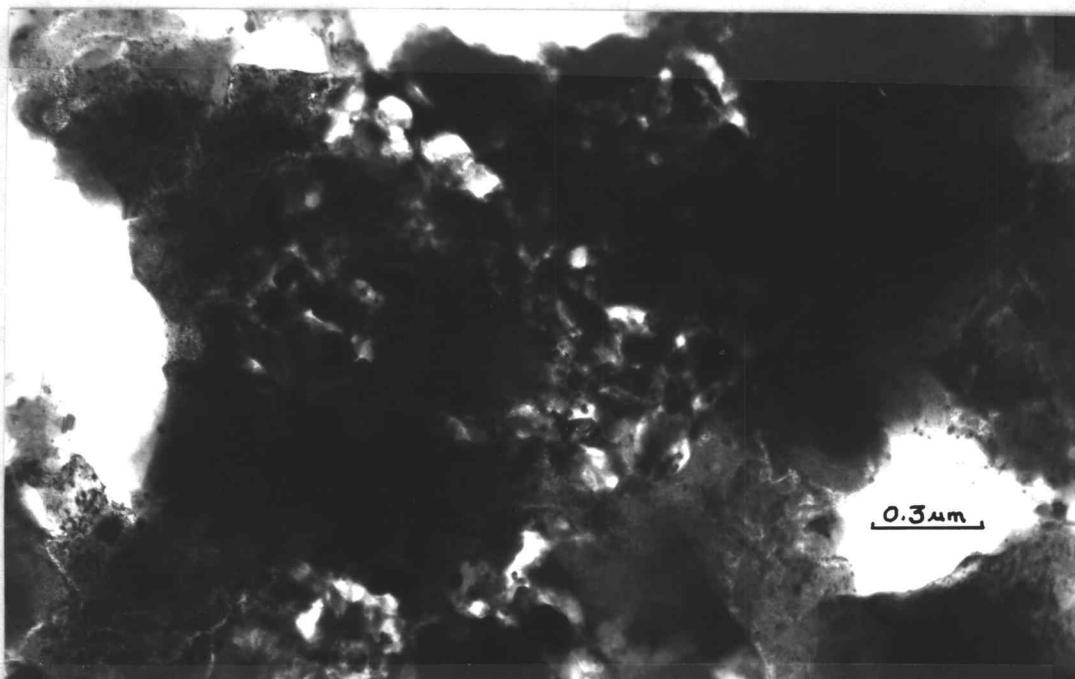
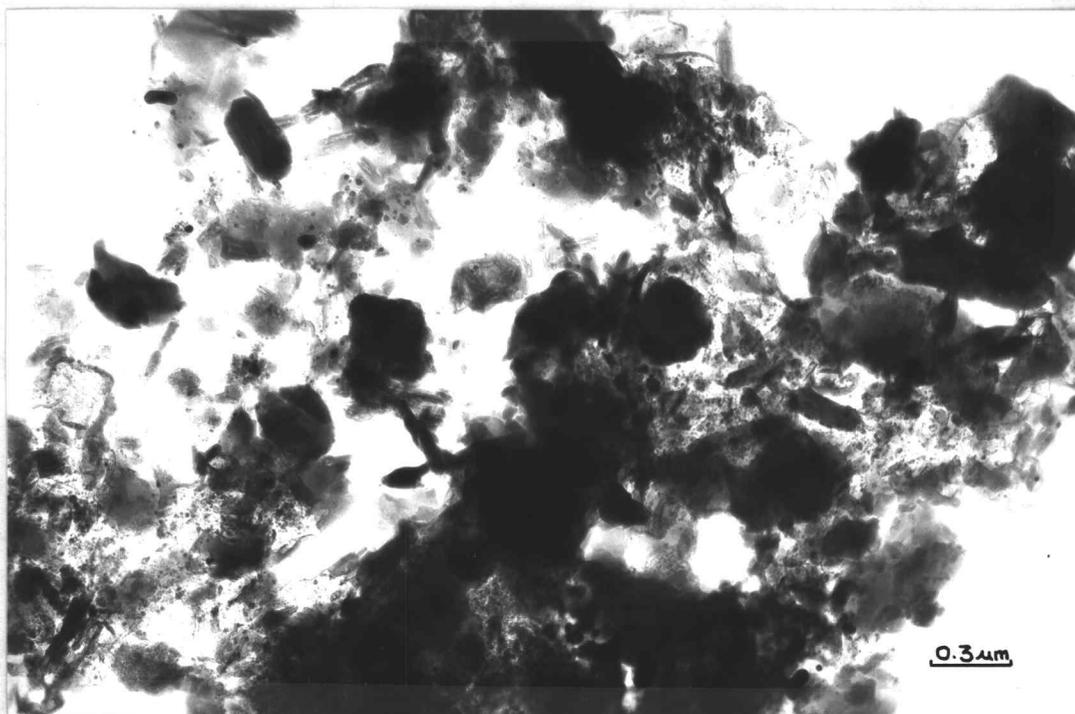
Plate 6. Electron micrographs of clay sample SS-SF-1j from above the debris flow failure plane, before (above) and after (below) disintegration of amorphous gel under the electron beam (different areas of the sample holding grid).

Electron micrographs (Plate 6) of the clay fraction of the soil from above the failure plane show bulbous masses of amorphous gel, which appear similar to those described earlier for sample MS-P-1f. These gel masses are highly unstable under the electron beam, and upon disintegration reveal numerous individual clay particles as well as amorphous material which is more stable under the beam. Thus, it appears that these kinds of masses are analagous to microscopic balloons consisting of a gel-like membrane and filled with clay particles with a high affinity for water. It seems reasonable to suggest that in the field these "balloons" are also filled with water which would be released upon rupture of the membrane. This hypothesis could explain in part the unusual sensitivity of these soils. Unfortunately, the "water balloons" were difficult to photograph due

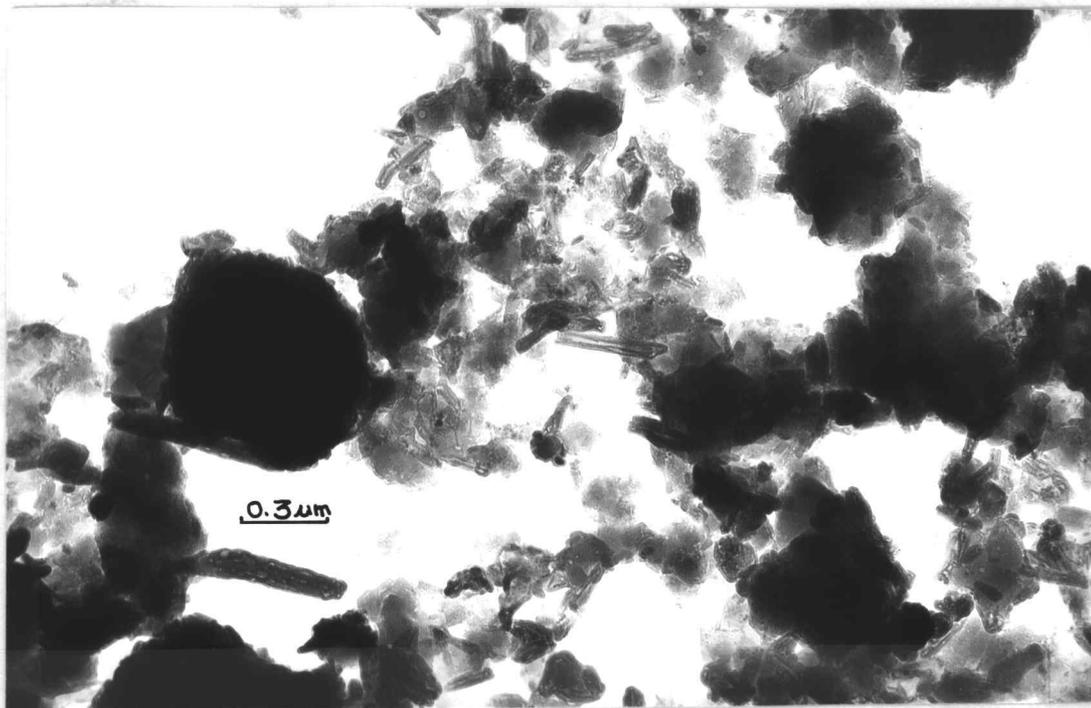
Plate 7. Electron micrograph of clay from above the plane of failure at site SS-SF-1 (sample j).

An additional micrograph of the same sample shows halloysite, amorphous material and chloritic intergrade which are not coated with the gel (Plate 7). Montmorillonite with some halloysite and amorphous material from below the plane of failure, and which supports the perched water table, is also shown (Plate 8).

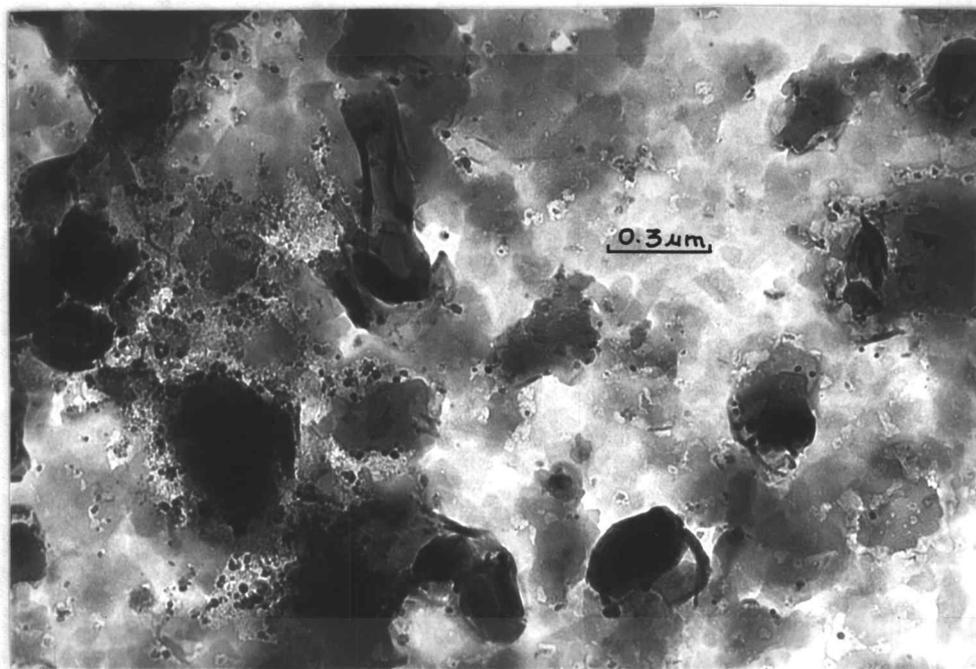
Plate 8. Electron micrograph of clay from below the plane of failure at site SS-SF-1 (sample g).

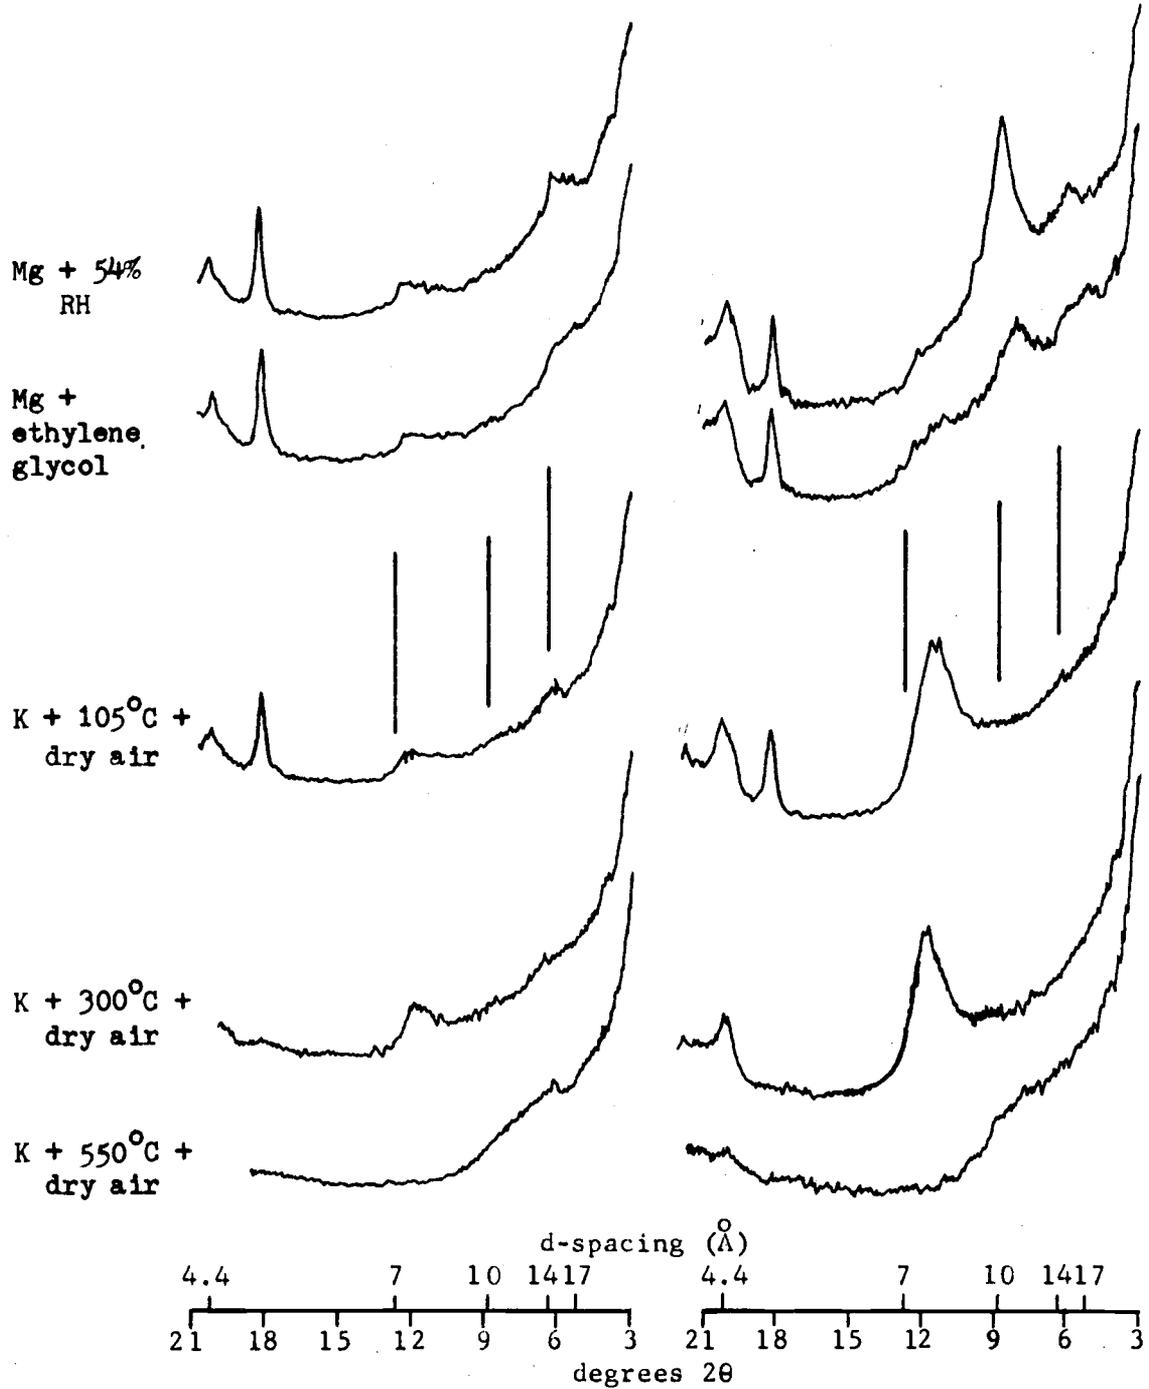
Figure 22. Site SS-SF-3 XRD patterns. Sample a (left), moist, failing soil at failure plane. Sample b (right), wet, mixed soil beneath failure plane.

patterns (Figure 22) show the presence of amorphous material, halloysite, chloritic intergrade, and gibbsite ( $4.8 \text{ \AA}$ ) in the failing soil (sample a), but they do not show the strong smectite peaks in the underlying clay (sample b) as seen at other failure sites. Instead, the patterns of the underlying and overlying clays are strikingly similar--except for the significant presence of strong, sharp, hydrated halloysite peaks in the yellowish material below the flowage plane. This mineralogical change with depth appears to coincide with a hydraulic discontinuity on the site. However, these relationships are indistinct due to the disturbance which has occurred.

The apparent mineralogical anomaly may be explained by the possibility that samples a and b do not actually represent soil from above and below the plane of failure. The combined presence of well developed hydrated halloysite and gibbsite in sample b suggests that there has been considerable mixing of the profile, as the conditions of formation are very different for these two minerals (Rai and Lindsay, 1975). This suggestion is supported by the fact that the basaltic colluvium is well mixed into the underlying saprolite. Deeper into the slope the soil gradually exhibits stronger characteristics of cohesive, smectite clay, which on previously mentioned sites has marked a sharp boundary at the base of the perched water table. (Laboratory analyses were not conducted on this cohesive clay.) It is interpreted that the failure processes at this site, which are quite complex, involve flowage of surficial material which was undercut by road construction; soil creep, and perhaps slow flow, extending to some greater depth into cohesive clay; and ancient, deep seated progressive rotational failure at even greater depths.
