AN ABSTRACT OF THE THESIS OF

RONALD DAVID TASKEY for the DOCTOR OF PHILOSOPHY degree in SOIL SCIENCE presented on September 12, 1977

Title: RELATIONSHIPS OF CLAY MINERALOGY TO LANDSCAPE STABILITY IN WESTERN OREGON Redacted for Privacy

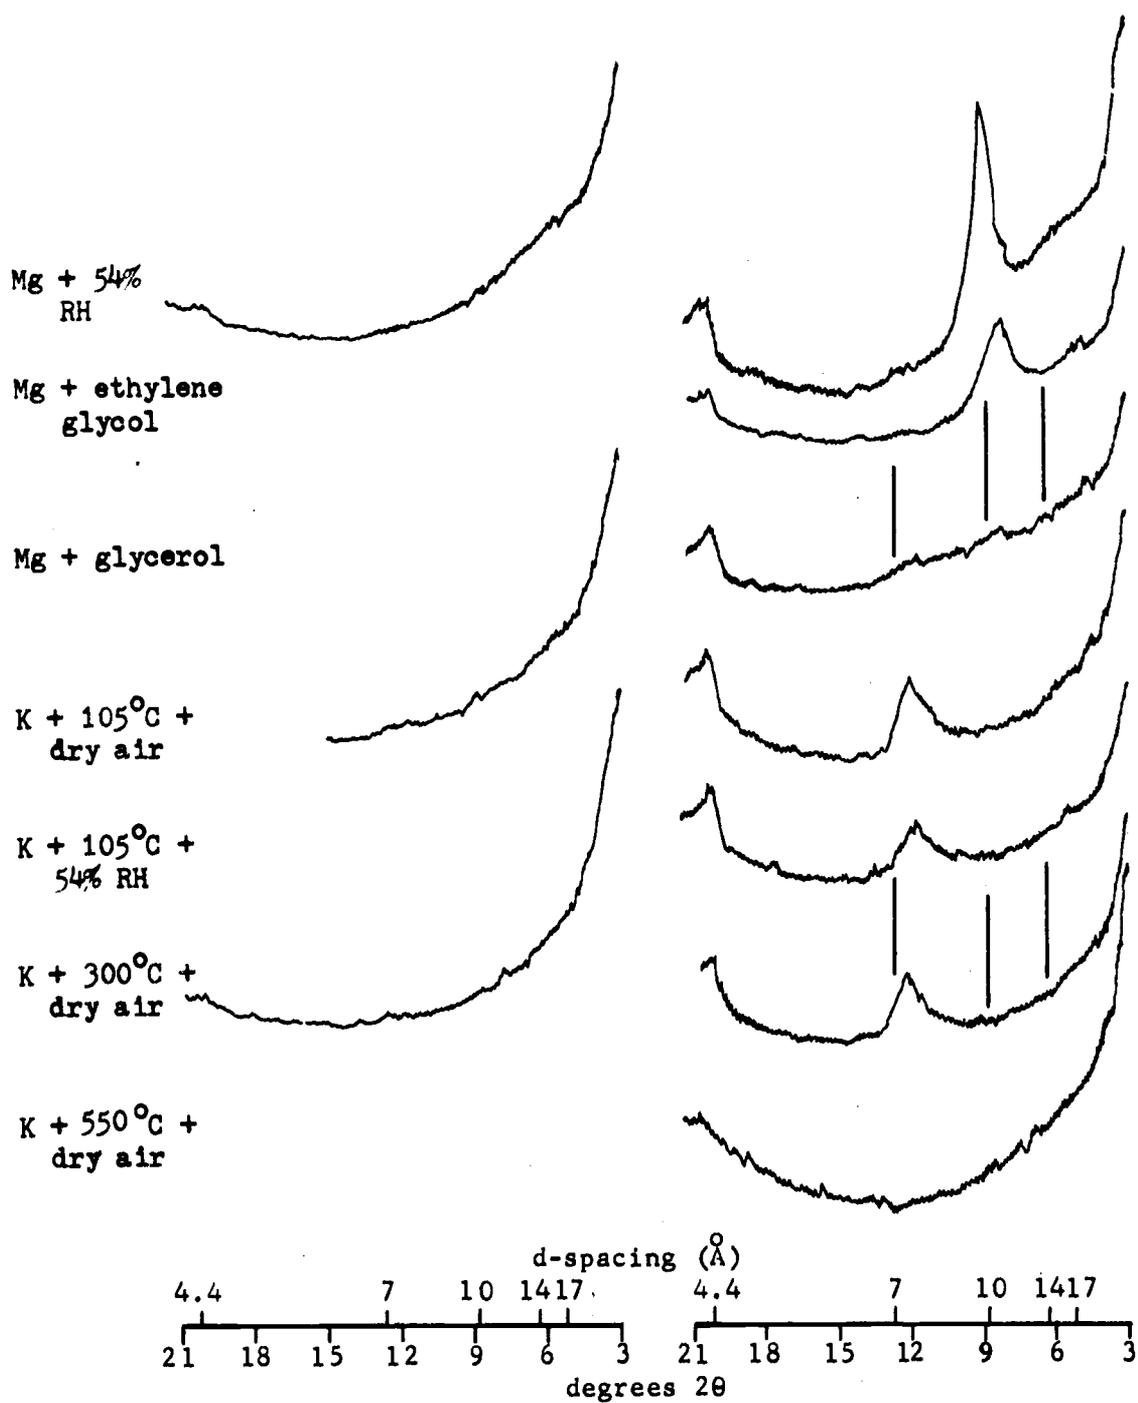
Figure 23. Site MK-D-1 XRD patterns. Sample a (left), failing soil of lateral failure plane. Sample b (right), wetter soil beneath failure plane.

by the left-hand sets of diffractograms in Figures 23, 24, and 25. In each case, the soil remaining on the failure is saturated at only a few centimeters beneath the surface at some point about midway down the failure. This soil contains amorphous material and well developed hydrated halloysite, as indicated by the right-hand sets of patterns. DTA patterns for the two samples at site MK-D-1 and for sample d, site MS-Q-1 show similar results (Figure 26).

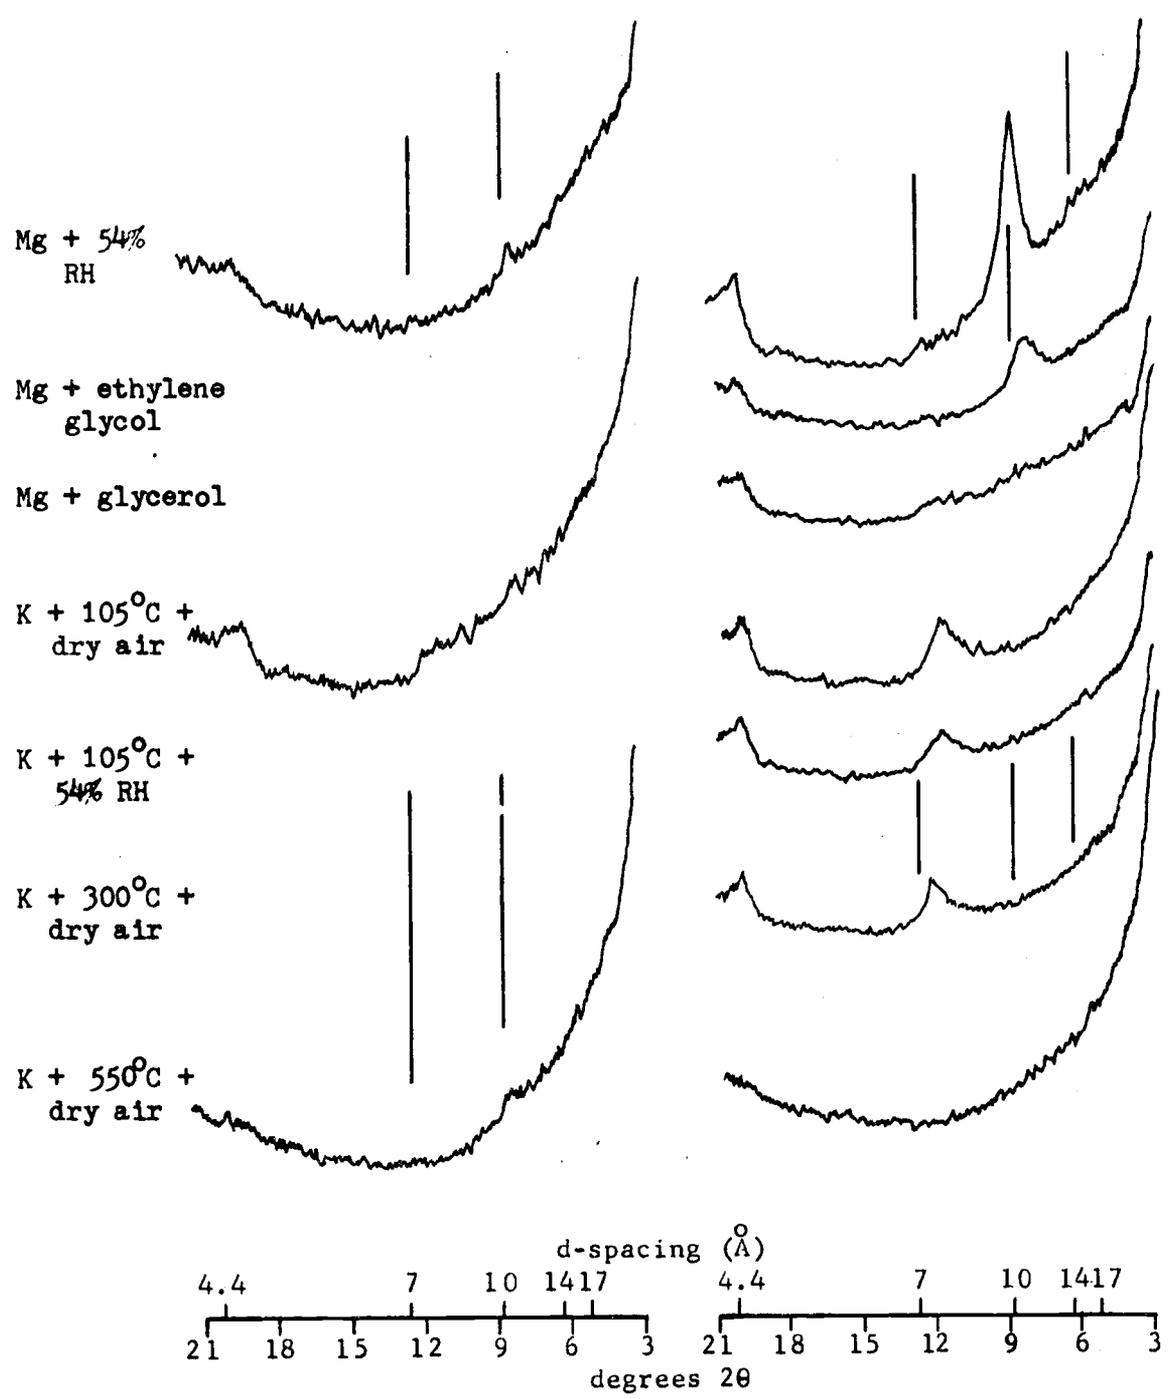
Figure 24. Site MFW-D-1 XRD patterns. Sample a (left), relatively soil of failure headwall. Sample b (right), wet soil remaining on failure surface.

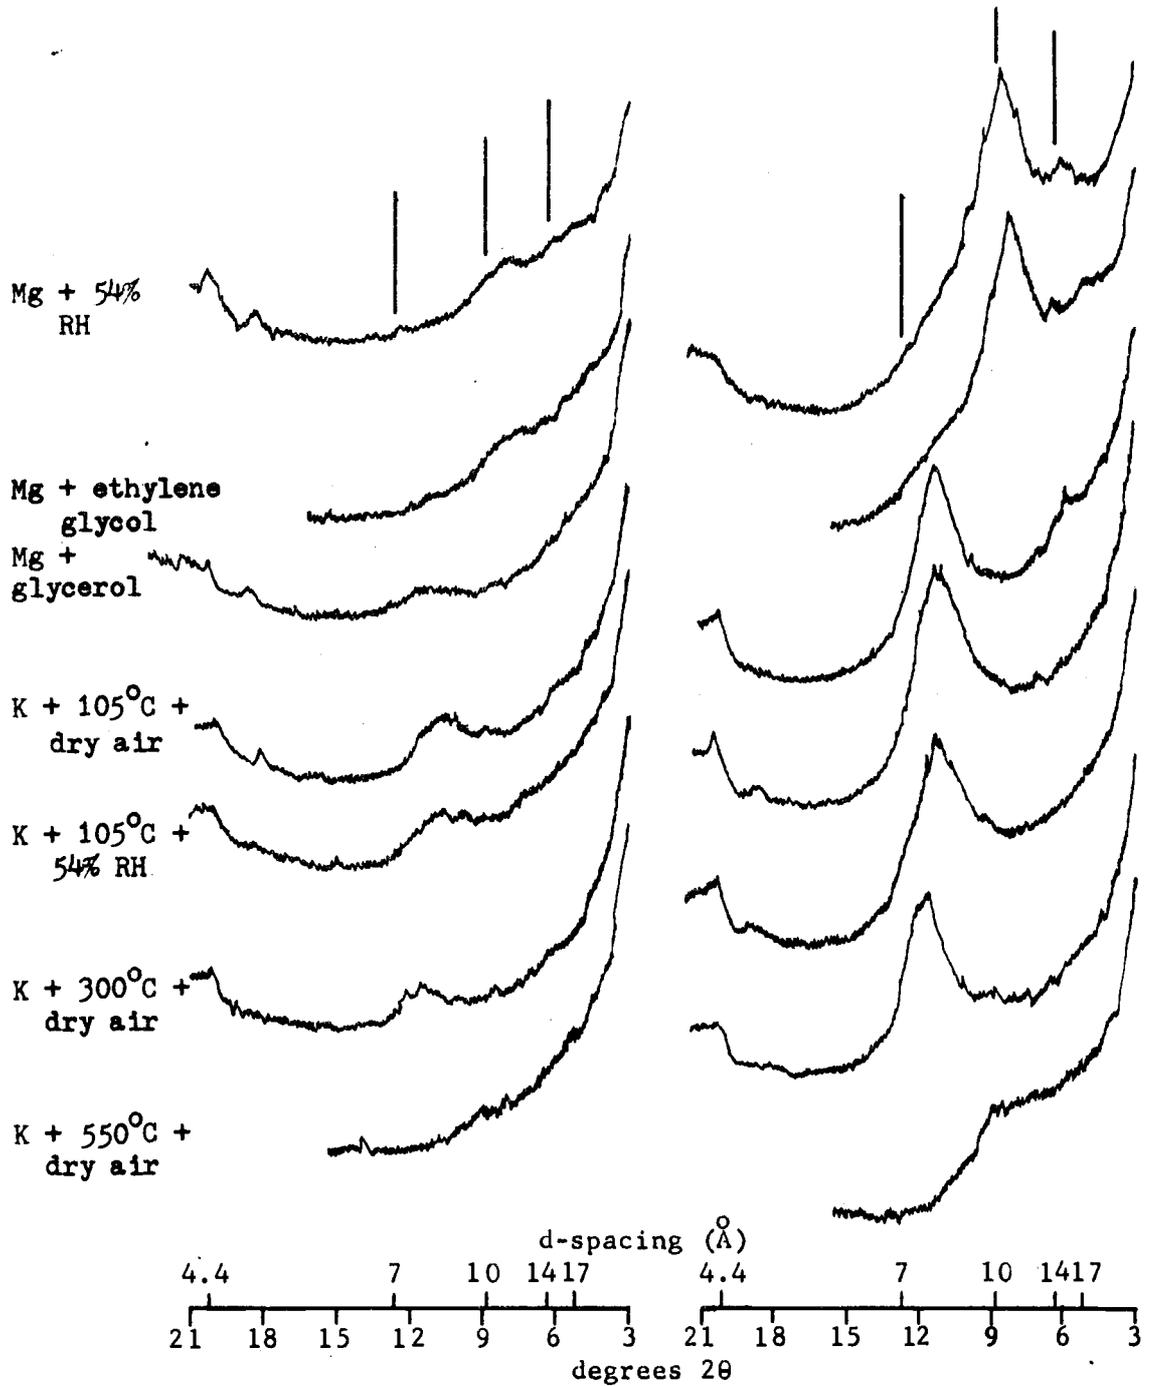
Figure 25. Site MS-Q-1 XRD patterns. Sample c (left), relatively dry soil 30 cm beneath fresh failure surface. Sample d (right), wet soil 75 cm beneath fresh failure surface.

The XRD patterns of the clay fractions of two samples taken from near the surface of the earthflow on Quartzville Creek were presented in Figure 25 (site MS-Q-1). These samples, which originated from a debris flow failure within the larger earthflow, contained very strong evidence of hydrated halloysite and amorphous material. An additional shallow sample (not shown) taken from the base of the debris flow also contained strong hydrated halloysite and amorphous material and gave a pattern nearly identical to that of sample d.

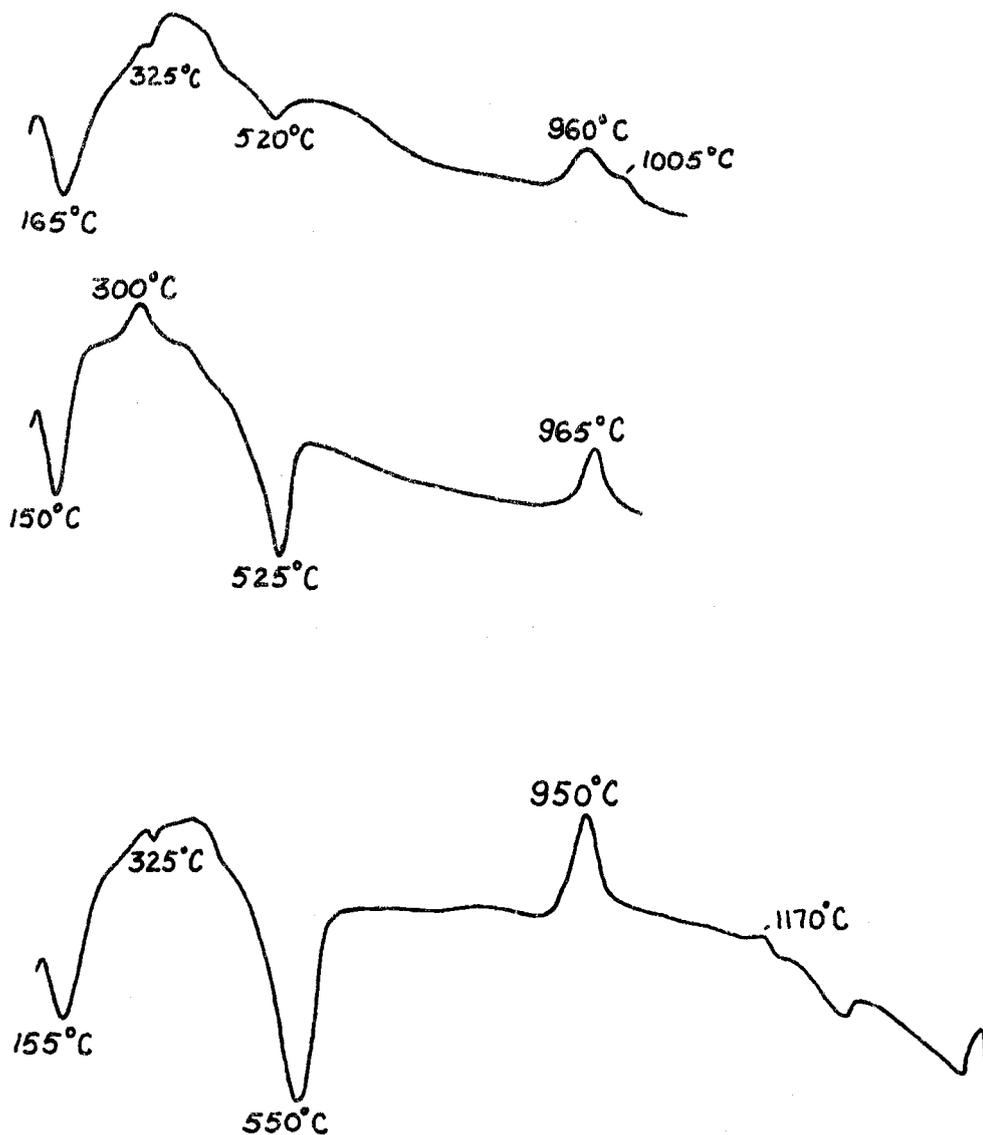
Figure 26. DTA patterns for samples MK-D-1a, MK-D-1b, and MS-Q-1d.

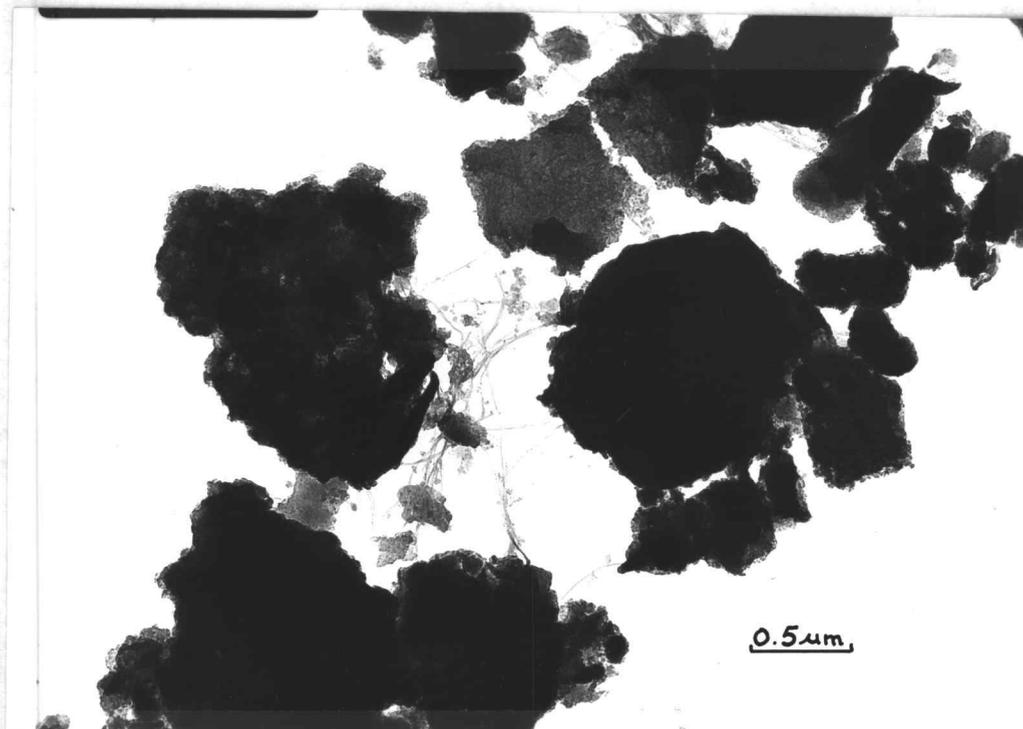
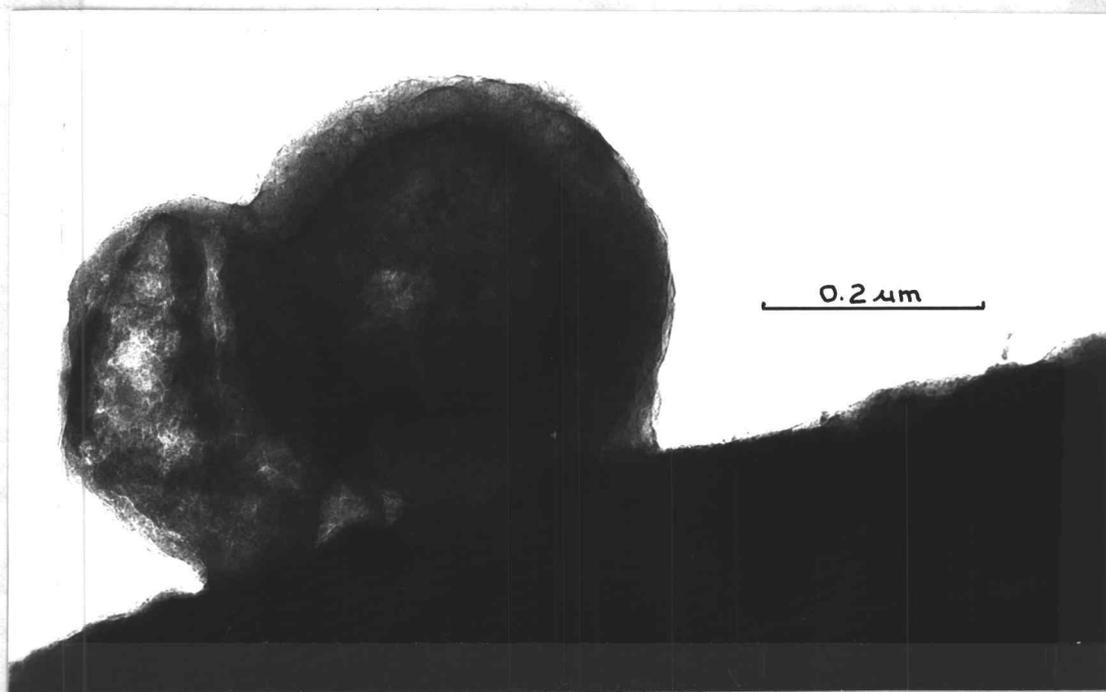
Plate 9. Electron micrographs of clay sample MK-D-1a.

Electron micrographs of sample MK-D-1a reveal fragments of devitrified glass linked by imogolite strands, as well as occasional unidentified spherical bodies which appear to be growing from a particle edge (Plate 9). The devitrified glass and imogolite are similar to that found in Mazama ash (Dingus, 1973). Sample MK-D-1b (Plate 10) contains a considerable amount of tubular and some spheroidal halloysite with coatings and attachments of amorphous gel. Careful examination suggests that the tubular forms are forming by the rolling of the gel and by peeling off of the spheroids. A relatively large, unidentified lath-like particle and silica bodies (?) are also present.

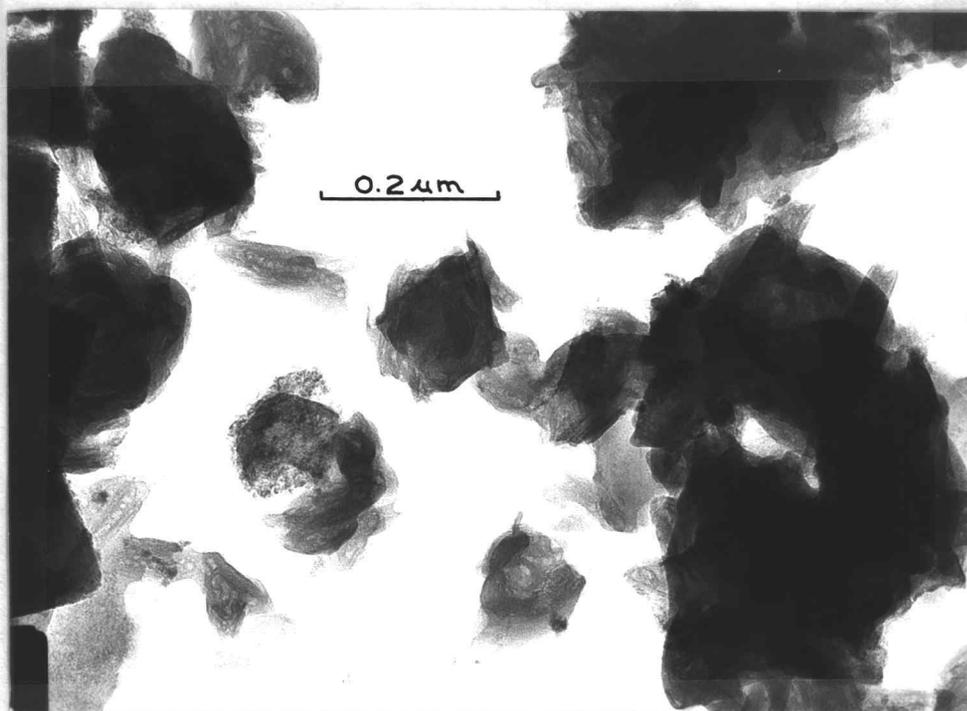
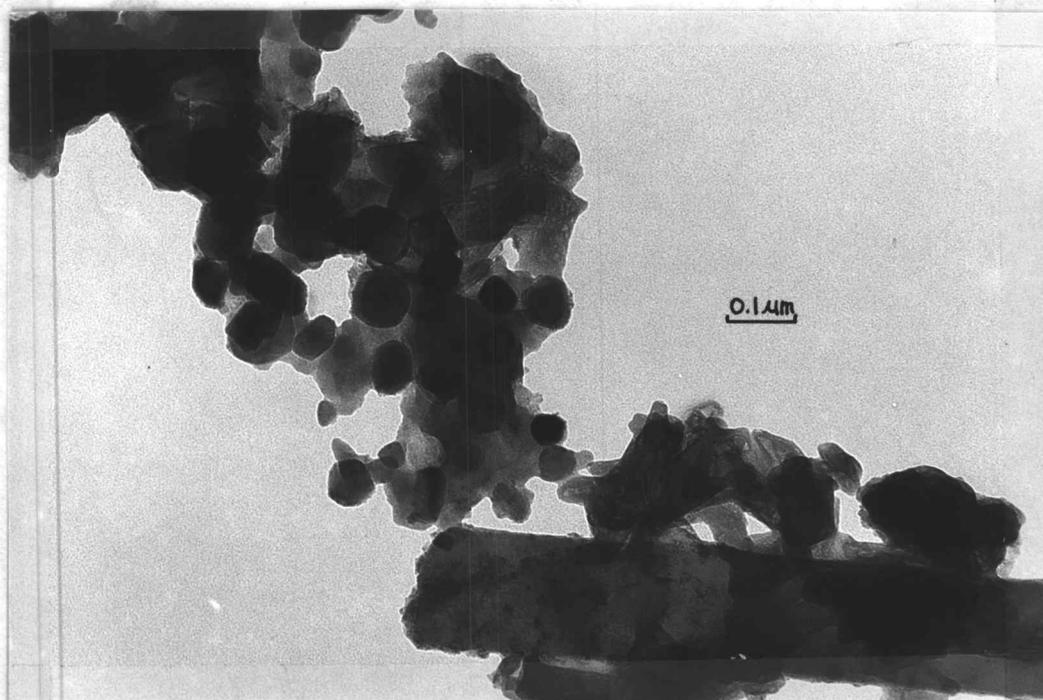
Plate 10. Electron micrographs of clay sample MK-D-1b.

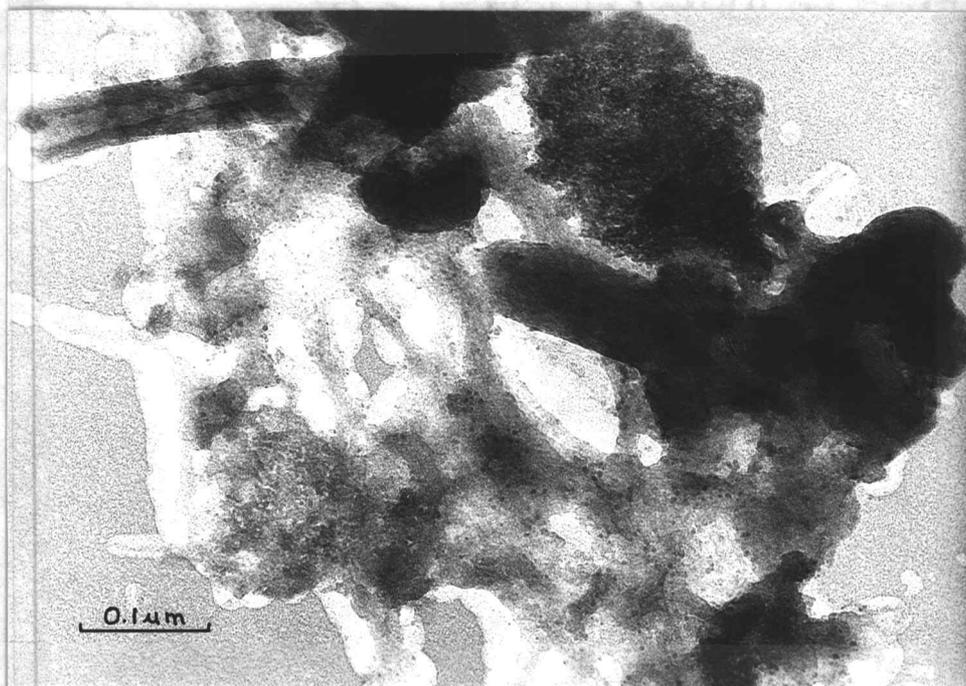
Plate 11. Electron micrograph of clay sample MFW-D-1a.

The micrograph of sample MFW-D-1a (Plate 11), from the relatively dry soil of the failure headwall at Dome Creek, shows several features, including the gelatinous nature of the amorphous material; several rough surfaced, broken spheroidal particles which appear similar, but smaller in size, to those noted in sample MK-D-1a; and a particle of tubular halloysite which may have formed, at least partially, in the vacuum of the microscope, as suggested by the low density appearance of the surrounding support film.

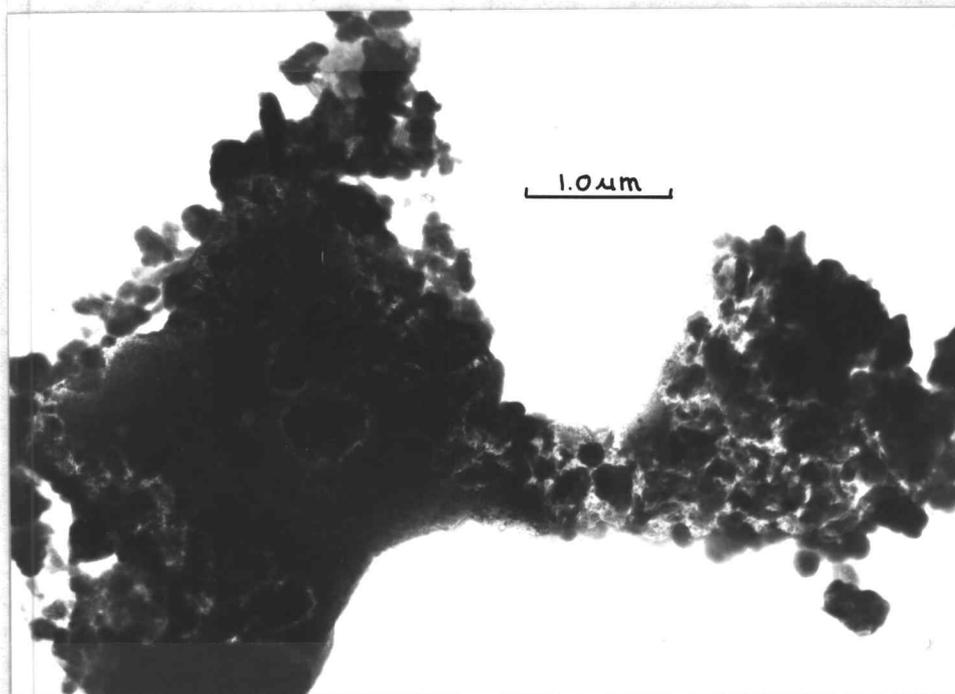
Plate 12. Electron micrograph of clay sample MFW-D-1b.

Sample b (Plate 12), from a more moist area at the same site, shows an aggregate which before exposure to the electron beam was entirely covered by a bulbous mass of gel-like material--similar to the "water balloons" described at sites MS-P-1 and SS-SF-1. This mass is highly unstable under the beam; and at the time of exposure of the micrograph negative, the coating on the left portion of the aggregate had disintegrated, while that on the right was still largely intact. As the gel disintegrated it revealed a myriad of distinguishable clay particles--including spheroidal and tubular halloysite--which appear to be supported on a translucent sheet of glass (?) which gives the aggregate its irregular shape.

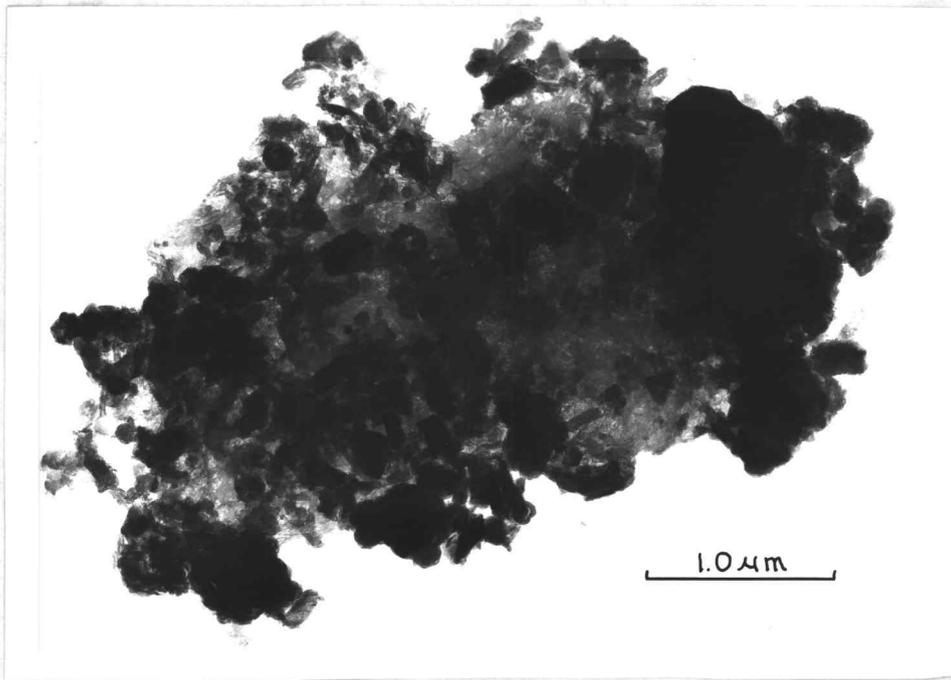
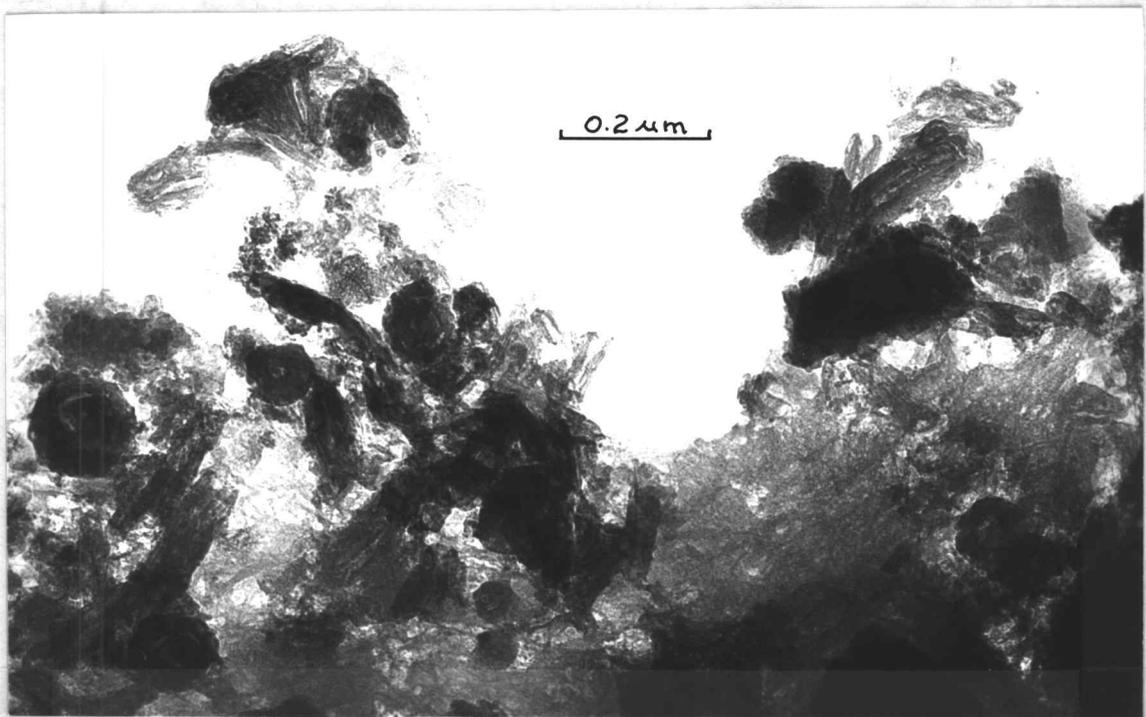
Plate 13. Electron micrographs of clay sample MFW-D-1b. Bottom photograph is a blow-up of the top one.

Additional micrographs of portions of sample MFW-D-1b which had been air dried for several weeks and then heated at 105°C for one hour on the support grid show aggregates similar to that shown in sample MS-P-1b (Plate 13) and described for sample NS-BC-1b. These aggregates are composed of halloysite and other particles and are bound together by an intricate web of amorphous strands, as shown in the blow-up of a portion of the aggregate. These kinds of aggregates were noted most frequently in those portions of failure soils which were drier and appeared to have the greatest strength. Unaggregated spheroidal and tubular halloysite and amorphous material from the same sample are also shown (Plate 14).

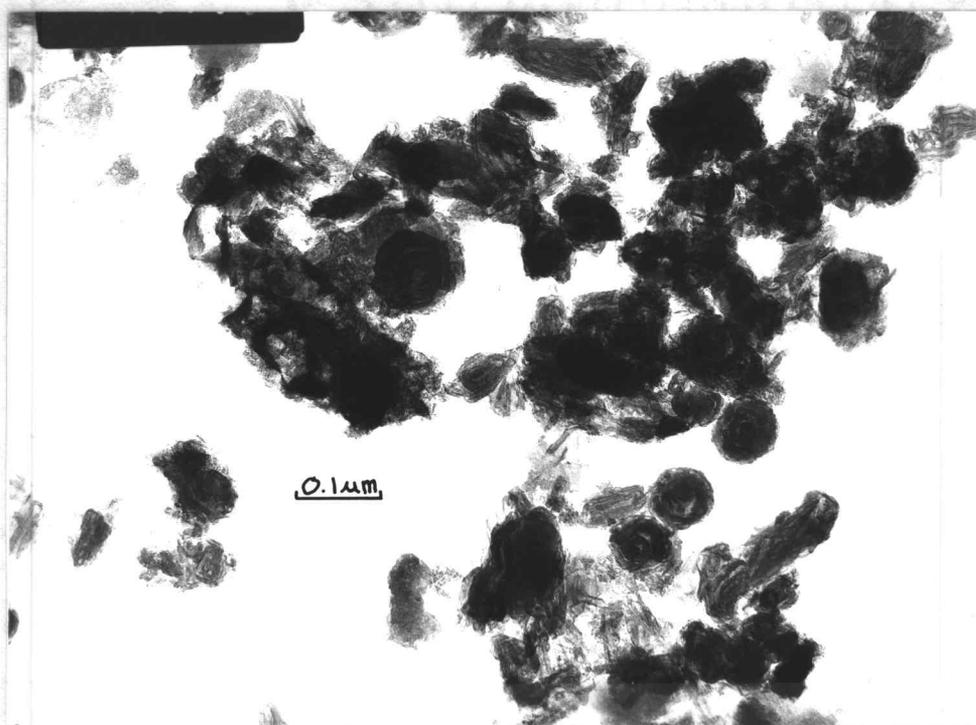
Plate 14. Electron micrograph of clay sample MFW-D-1b.

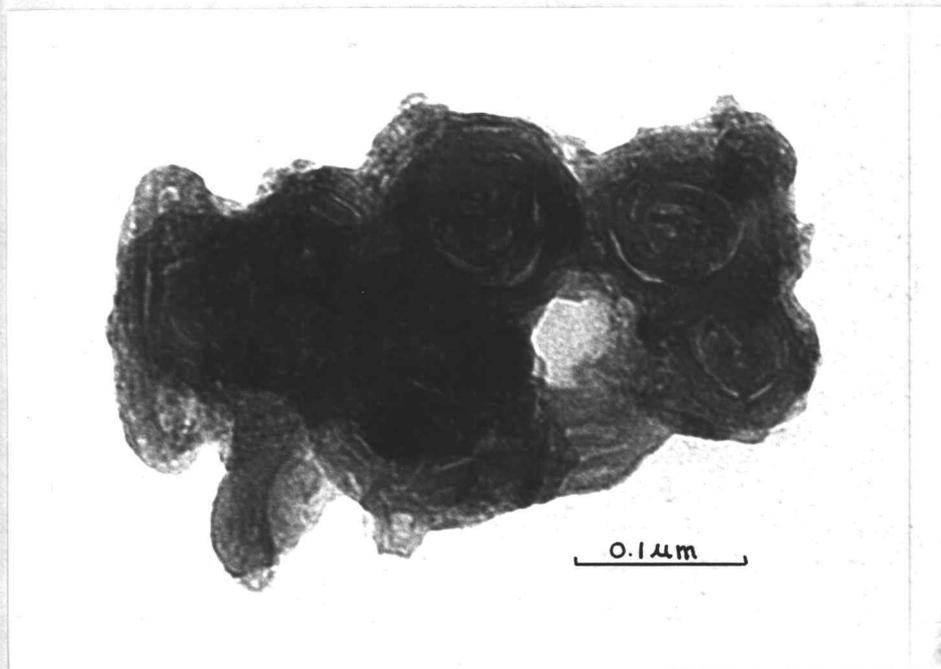
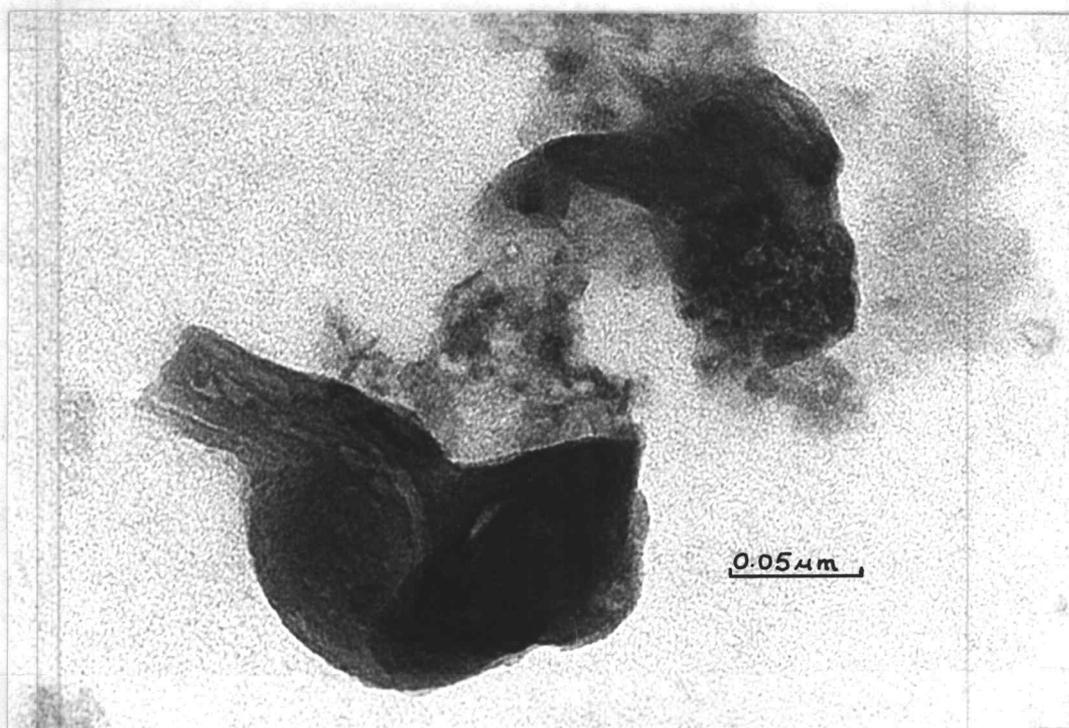
Plate 15. Electron micrographs of clay sample MFW-D-1c.

The sample from saturated soil MFW-D-1c (Plate 15) shows more of the rough textured, solid surfaced, multilayered spheroids that were noted in other samples. One of these spheroids has split partially and appears to be generating tubular halloysite. A cluster of spheroidal halloysite particles is also shown. Sample MS-Q-1d (Plate 16) shows many particles of tubular halloysite and amorphous films which appear to be generating bubbles similar to those noted previously.

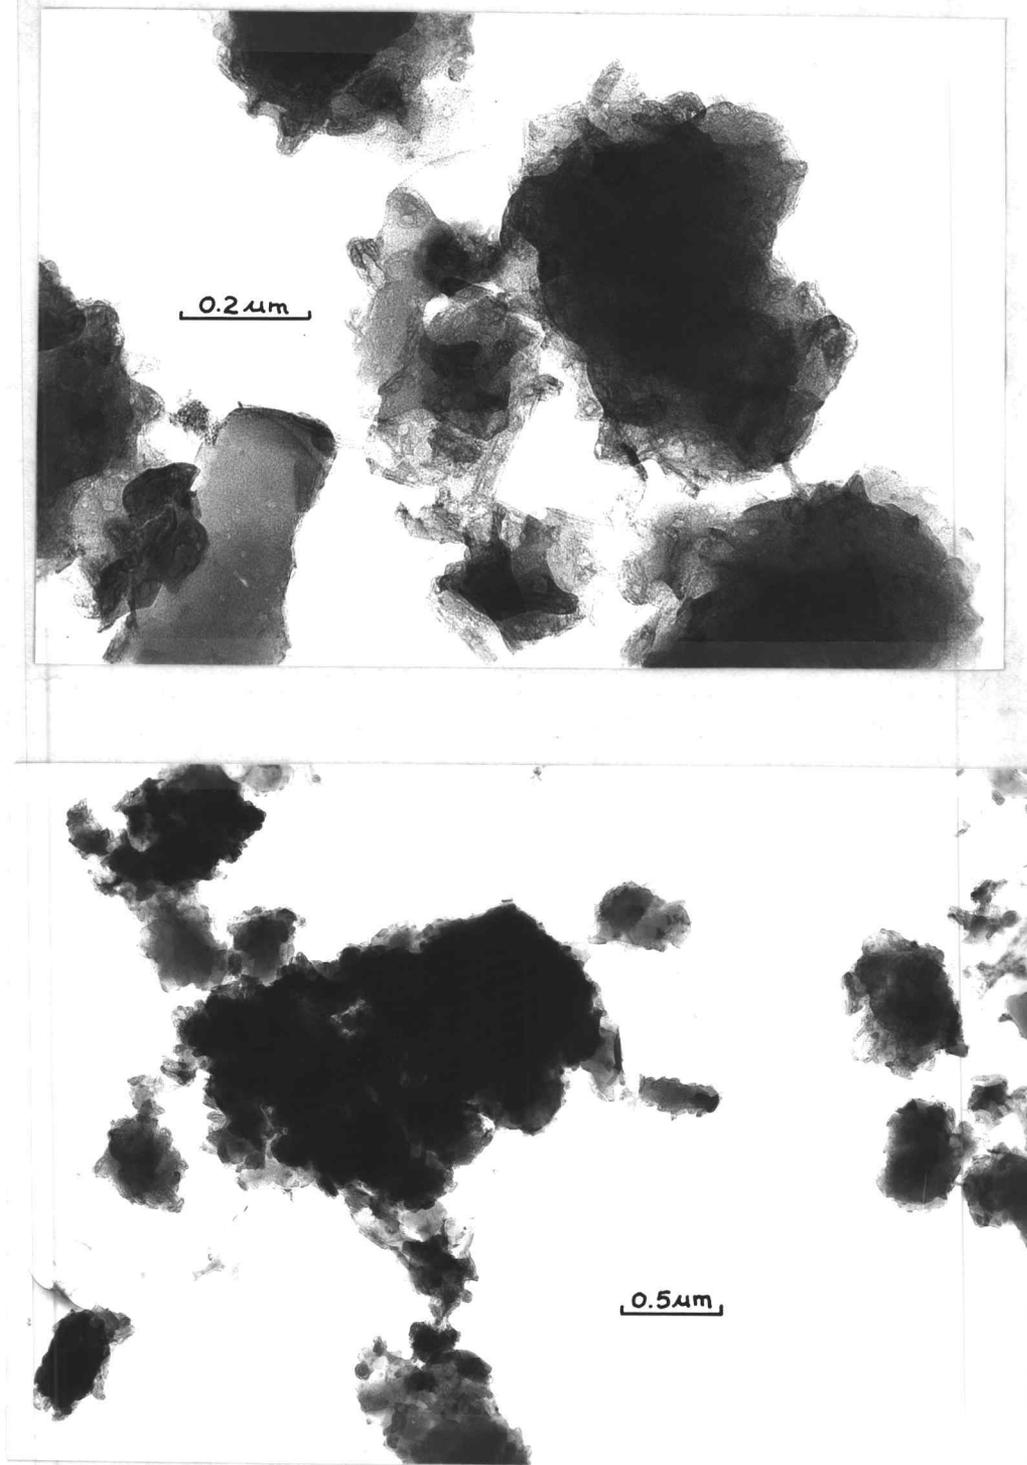
Plate 16. Electron micrographs of clay sample MS-Q-1d.

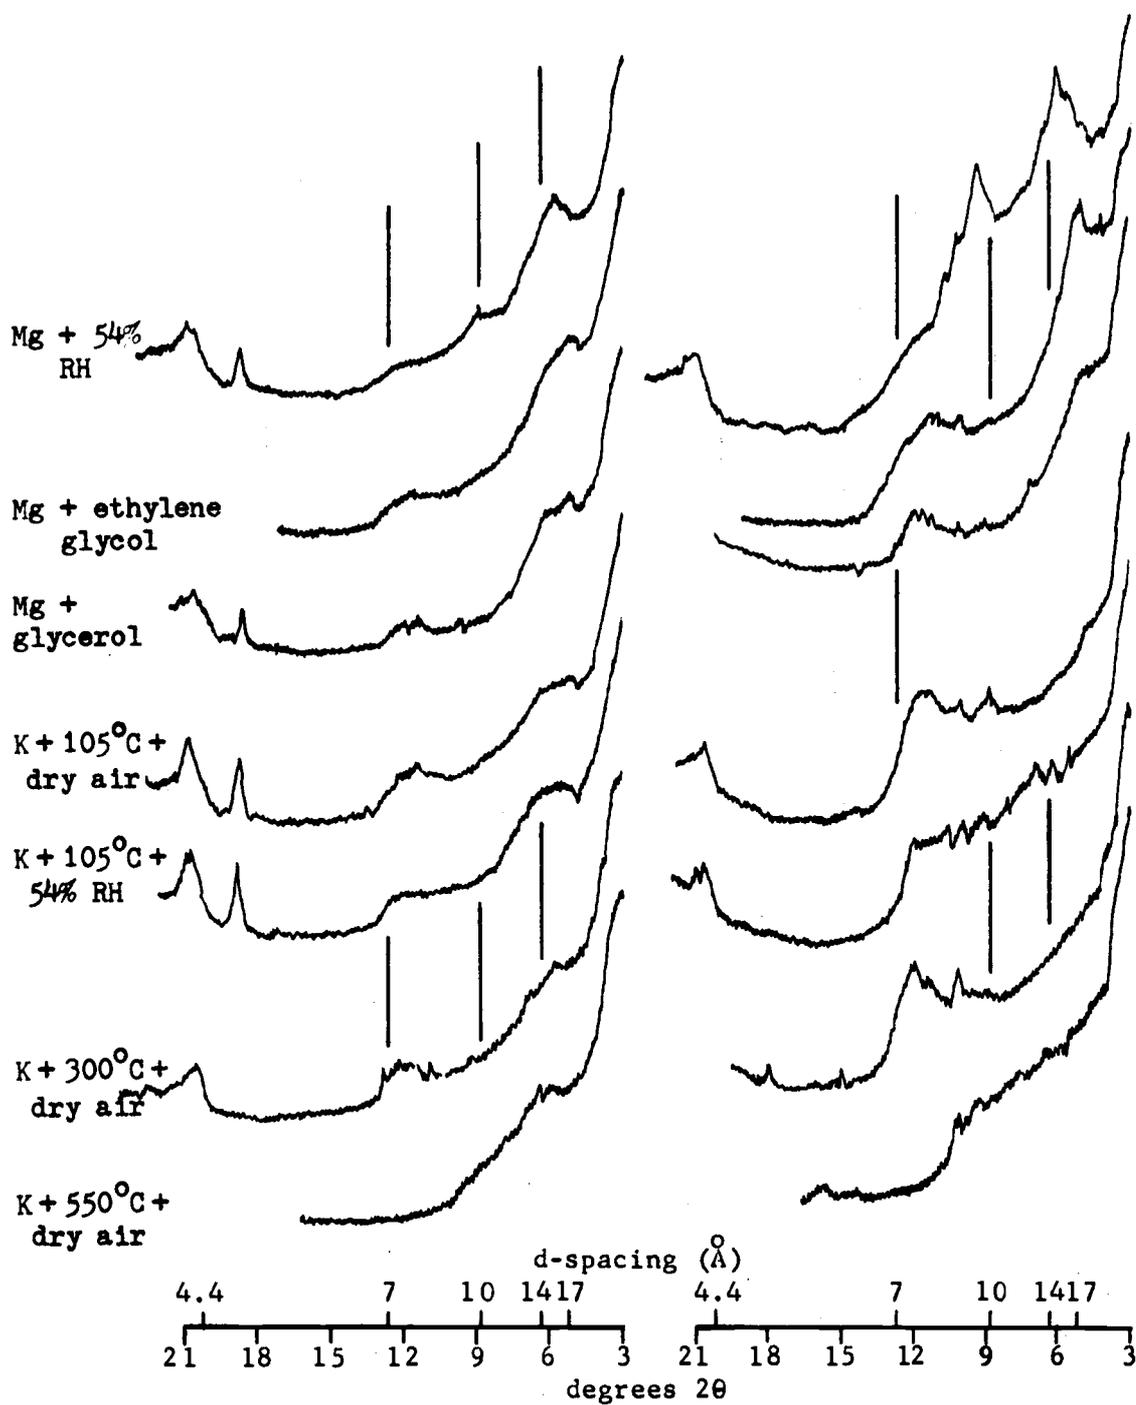
Figure 27. Site SS-S-3 XRD patterns. Sample a (left), left flank, A horizon, 10 cm depth. Sample C (right), beneath sample a,  $1\frac{1}{2}$  m depth.

Clay samples a, c, and d (Figures 27 and 28) were collected from various depths in the left flank, and sample f (Figure 28) was collected from the glacial material at the base of the headwall. The surficial soil (sample a), which is quite dry, has little relevance to the failure itself, but helps to show a progression of mineralogy with depth. It is composed of chloritic intergrade, halloysite, amorphous material, and gibbsite. Sample c, taken from greater depth at the flank and still above the failure surface, perhaps best represents the colluvial overburden which slid; the chloritic intergrade shows some smectite character; the halloysite is strong and hydrated; the amorphous band is strong; and there is evidence of zeolite.

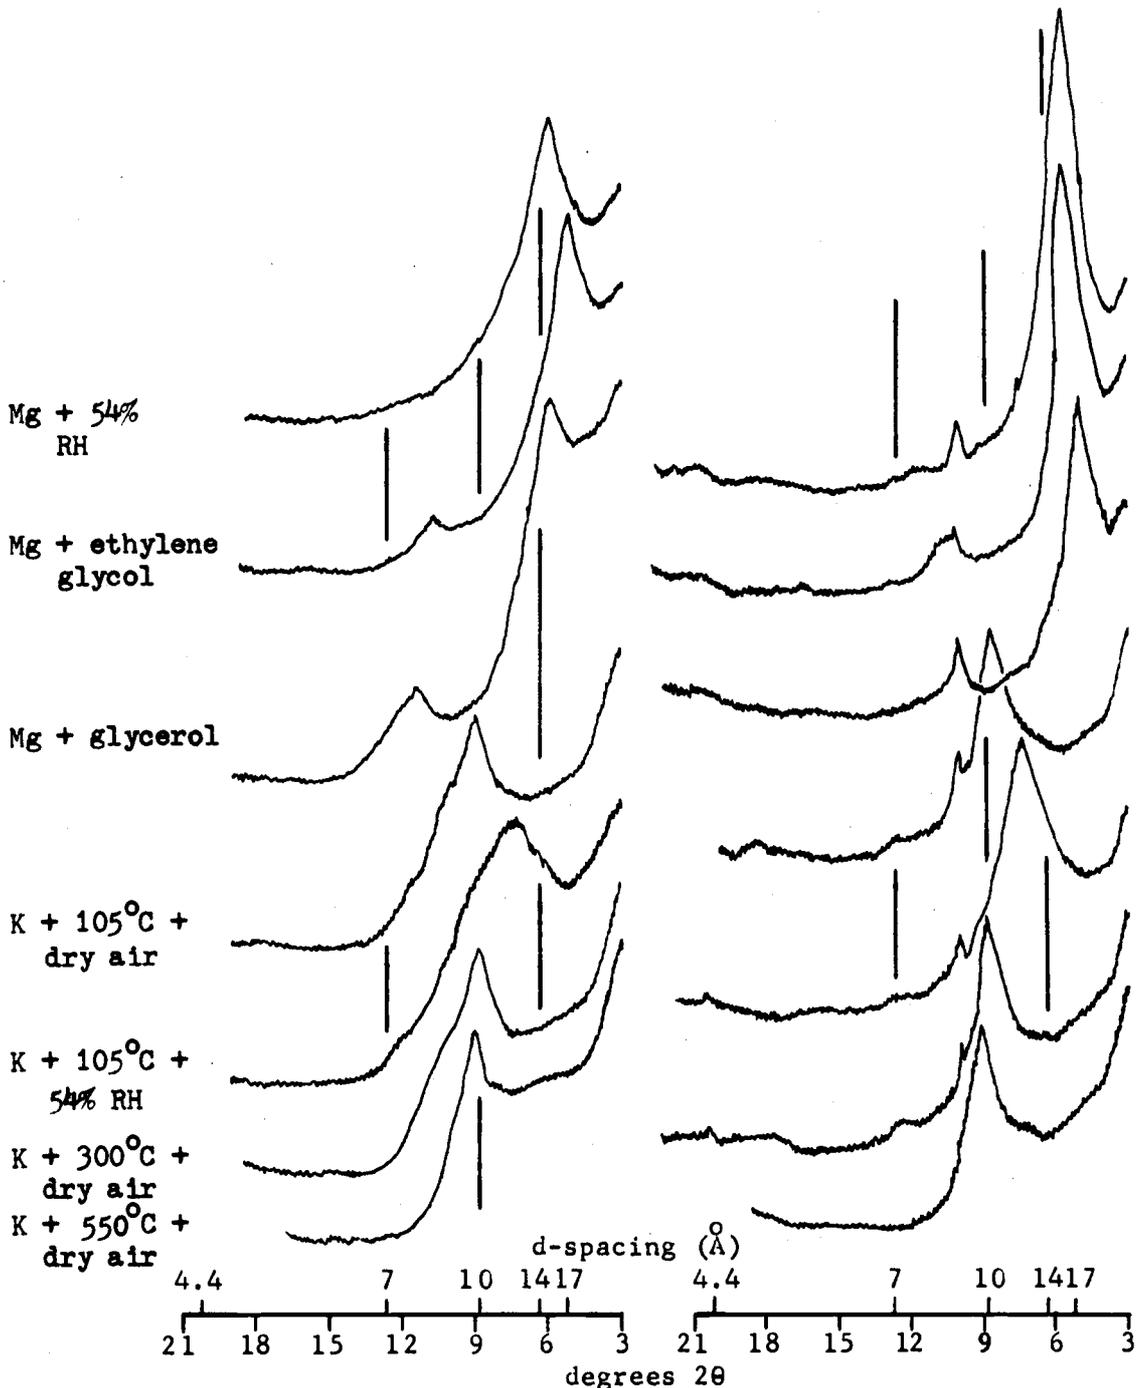
Figure 28. Site SS-S-3 XRD patterns. Sample d (left), beneath samples a and c in the left flank, 2 m depth. Sample f (right), gray glacial material of failure surface.

Sample d, which originated from very near the failure plane in the left flank, shows only a questionable trace of halloysite and no

discernible amorphous material; however, the smectite is much stronger than in the upper zones, although it does show evidence of hydroxy interlayering. Finally, sample f, from the failure plane in the central portion of the failure, exhibits the strongest montmorillonite, with negligible evidence of hydroxy interlayering. Zeolite peaks are also evident here.

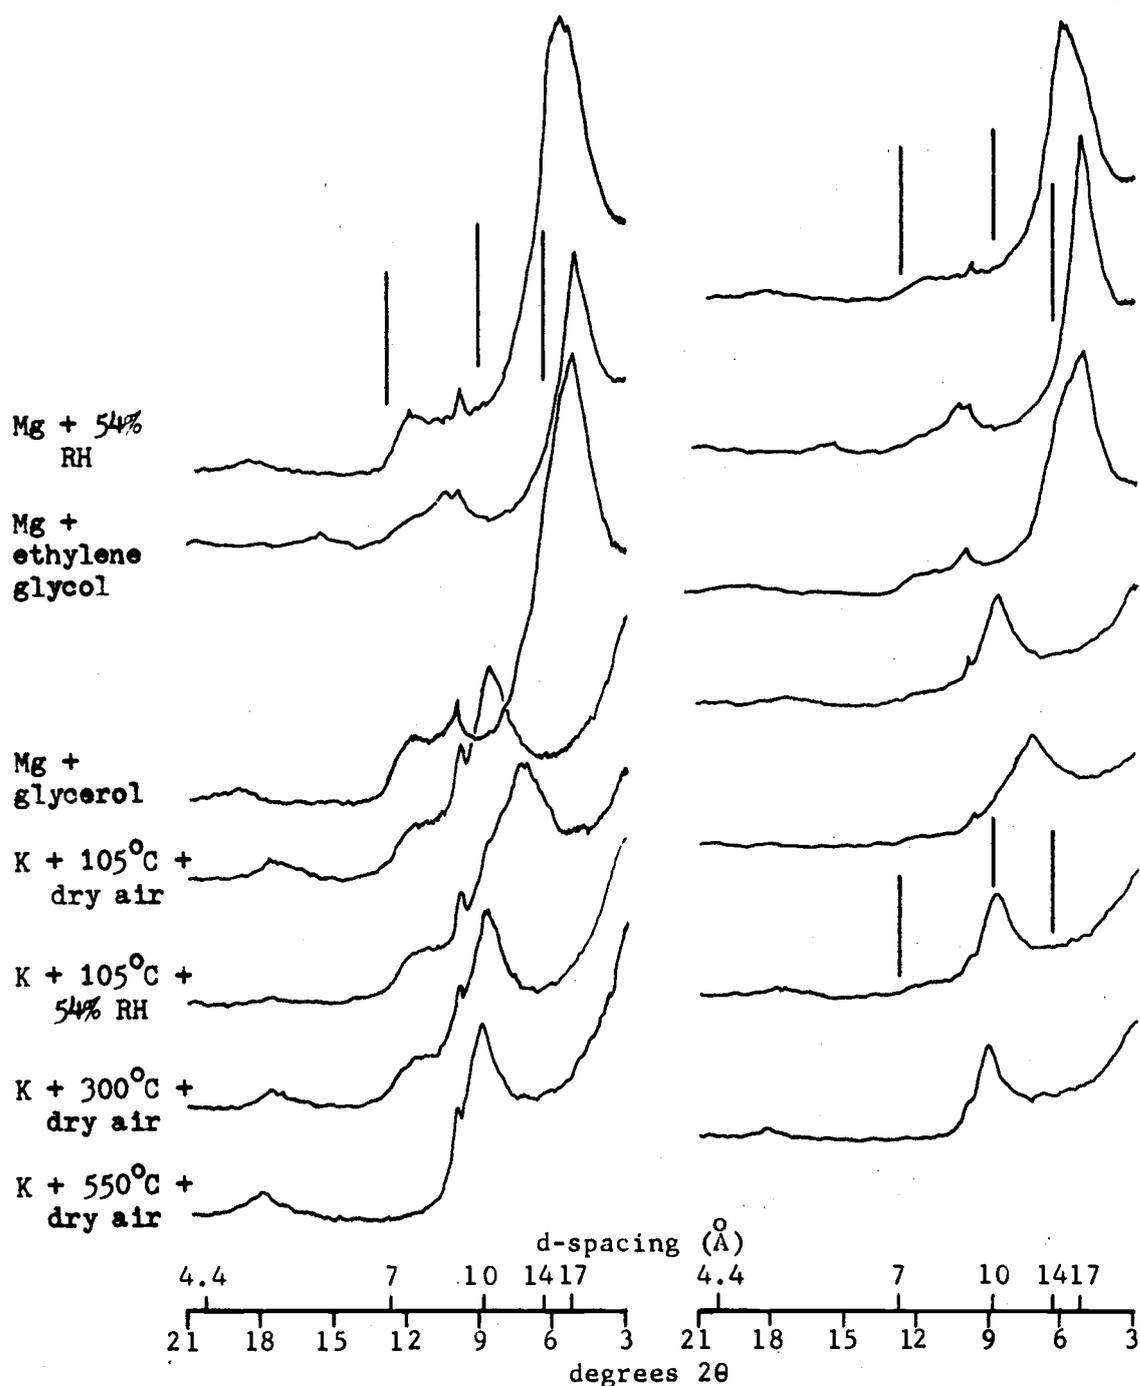
Figure 29. Site MFW-1 XRD patterns. Sample a (left), color banded clay above failure plane. Sample b (right), mottled clay beneath failure plane.

A relatively small planar failure with progressive rotational components and a small resultant earthflow was investigated at site MFW-1. The soil profile at the failure's flank consists of a thin layer of basaltic colluvium over two to three thin layers of color-banded plastic clay above the slip surface, and mottled plastic clay beneath the slip surface. The XRD patterns of both samples show strong montmorillonite peaks, slight zeolite, weak, broad halloysite and no amorphous band (Figure 29). The halloysite is more distinctive, however, in the clay from above the failure surface than in that from below it, and the smectite may be slightly more hydroxy interlayered in the upper sample. These latter observations are similar to, but much weaker than, the relationships of halloysite above the montmorillonite failure surface in the debris flows described earlier.
