AN ABSTRACT OF THE THESIS OF

RONALD DAVID TASKEY for the DOCTOR OF PHILOSOPHY degree in SOIL SCIENCE presented on September 12, 1977

Title: RELATIONSHIPS OF CLAY MINERALOGY TO LANDSCAPE STABILITY IN WESTERN OREGON Redacted for Privacy

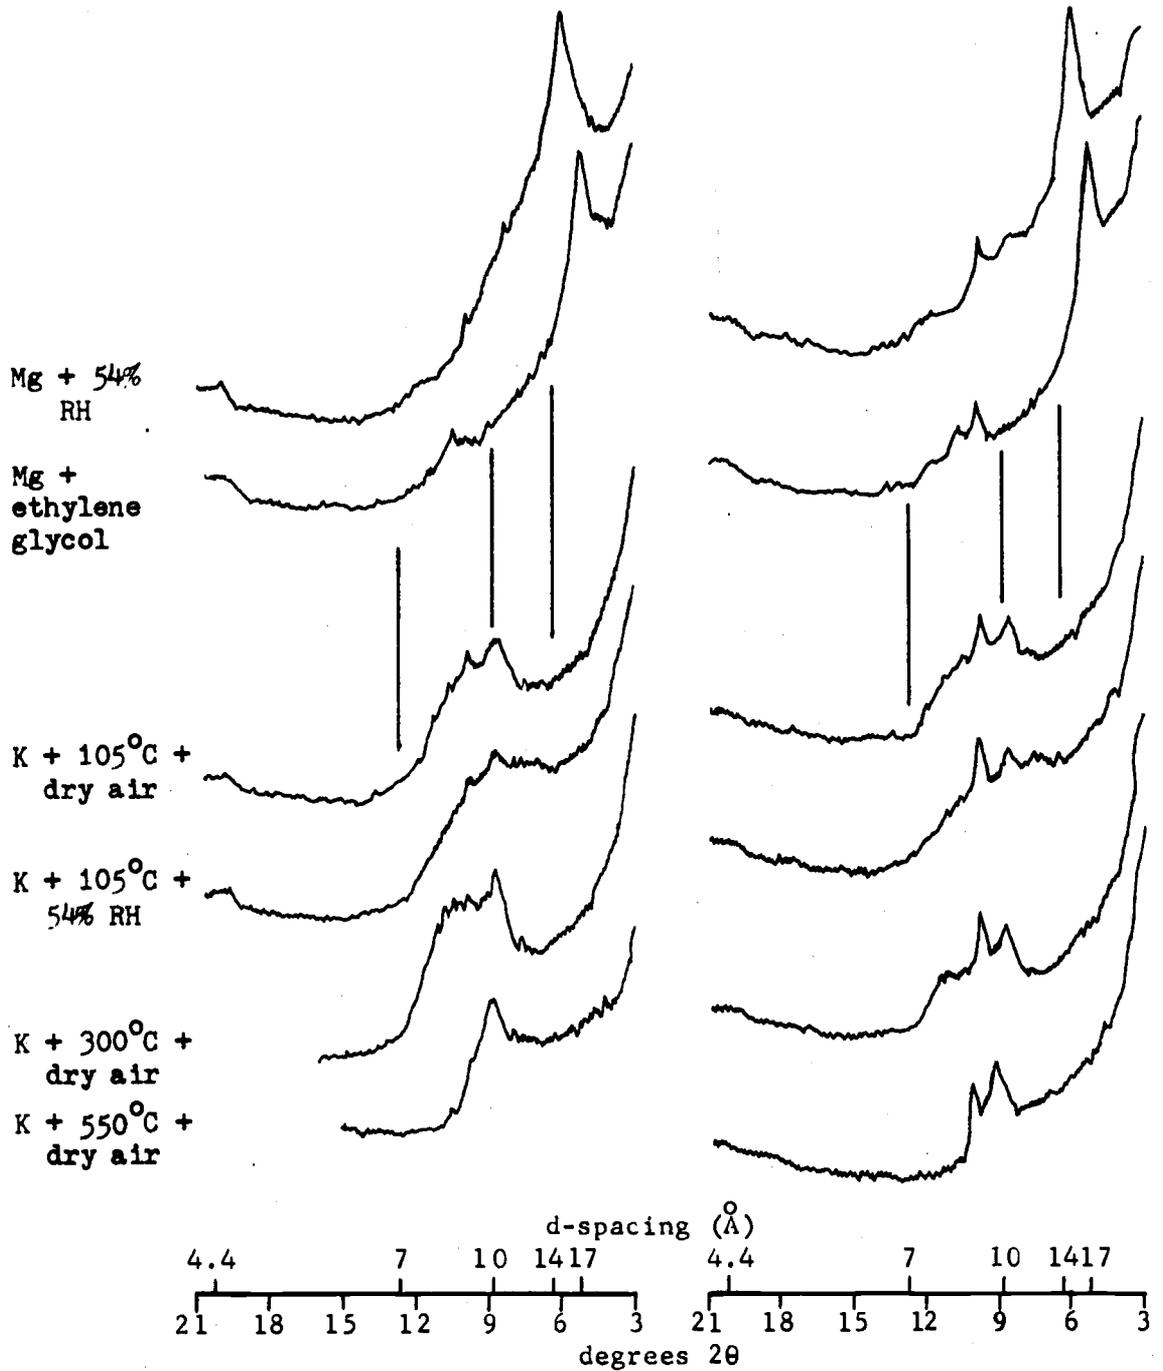
Figure 30. Site MS-B-1 XRD patterns. Sample a (left), failed material at failure surface. Sample b (right), beneath failure surface.

sampled at two positions, both of which contained strong smectite in the clay fractions (Figure 30). The X-ray patterns of these samples also show an amorphous component and halloysite in various states of hydration, as indicated in the Mg-saturated treatment by the broad shoulder in the vicinity of  $10 \text{ \AA}$  on the  $15 \text{ \AA}$  peak, and by broad  $7.5\text{--}8 \text{ \AA}$  peaks of the K-saturated heat treatments. It is very likely that the latter minerals are illuvial at these positions, as the weathered pyroclastic material is overlain by a shallow deposit of weathered basaltic colluvium. The deeper of the two samples (b) was taken from beneath the failure plane and shows a sharp seolite peak at approximately  $9 \text{ \AA}$ .

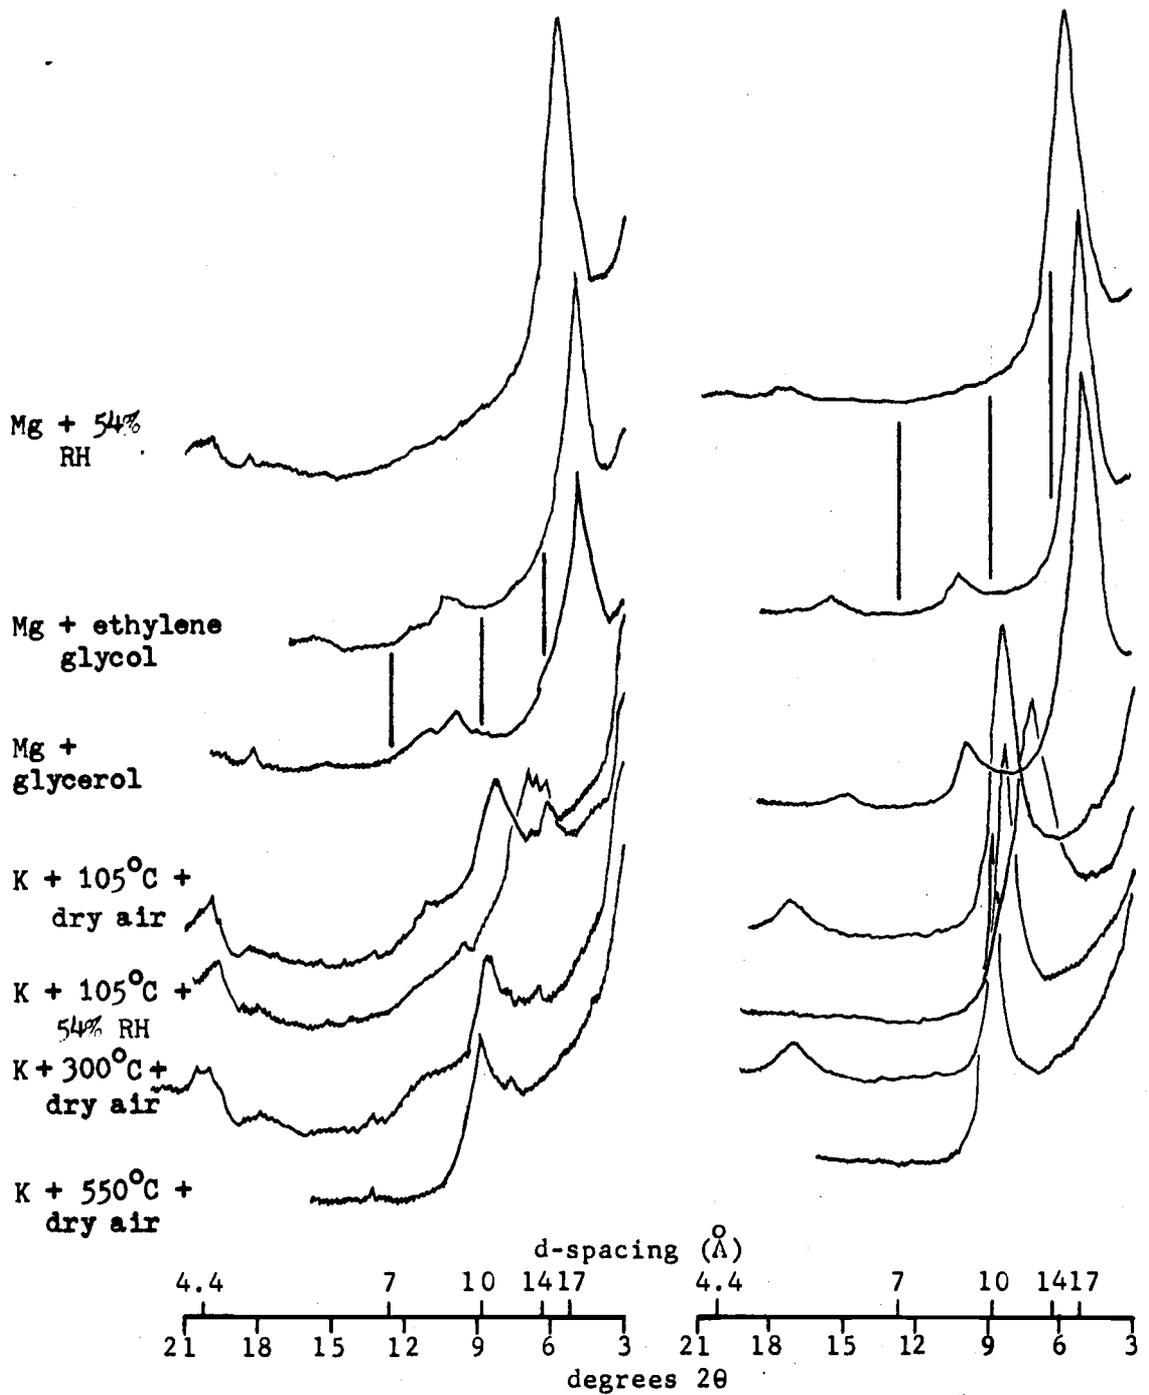
Figure 31. XRD patterns of clay from six meters depth, below the surface of rupture site MS-B-1c (left), and of random sample of slump block site MS-H-1b (right).

A third sample c was taken from deeper in the road cut, well below the plane of the small failure mentioned above. The patterns show very strong montmorillonite with some hydroxy interlayering, amorphous material, and perhaps a trace of halloysite (Figure 31). The small road cut slump occurs within a much larger slump block, with which this well developed montmorillonite is assumed to be involved.

A large, well defined rotational slump at site MS-H-1, which is very near site MS-B-1, was randomly sampled in a road bank which cuts through the slump block. Again, the materials are of pyroclastic origin and the clay fraction is nearly pure montmorillonite (Figures 31 and 34). The clay fraction of another small, distinct rotational surface of failure, site MFW-H-1, shows strong montmorillonite, kaolinite and some mica (Figure 32, sample a). The failure represented by this sample occurred at the top of a flank of a much larger, complex slump-earthflow. Additionally, the patterns of a random sample from the central portion of the earthflow, about 100 m downslope from the small failure show strong montmorillonite (Figure 32, sample b).

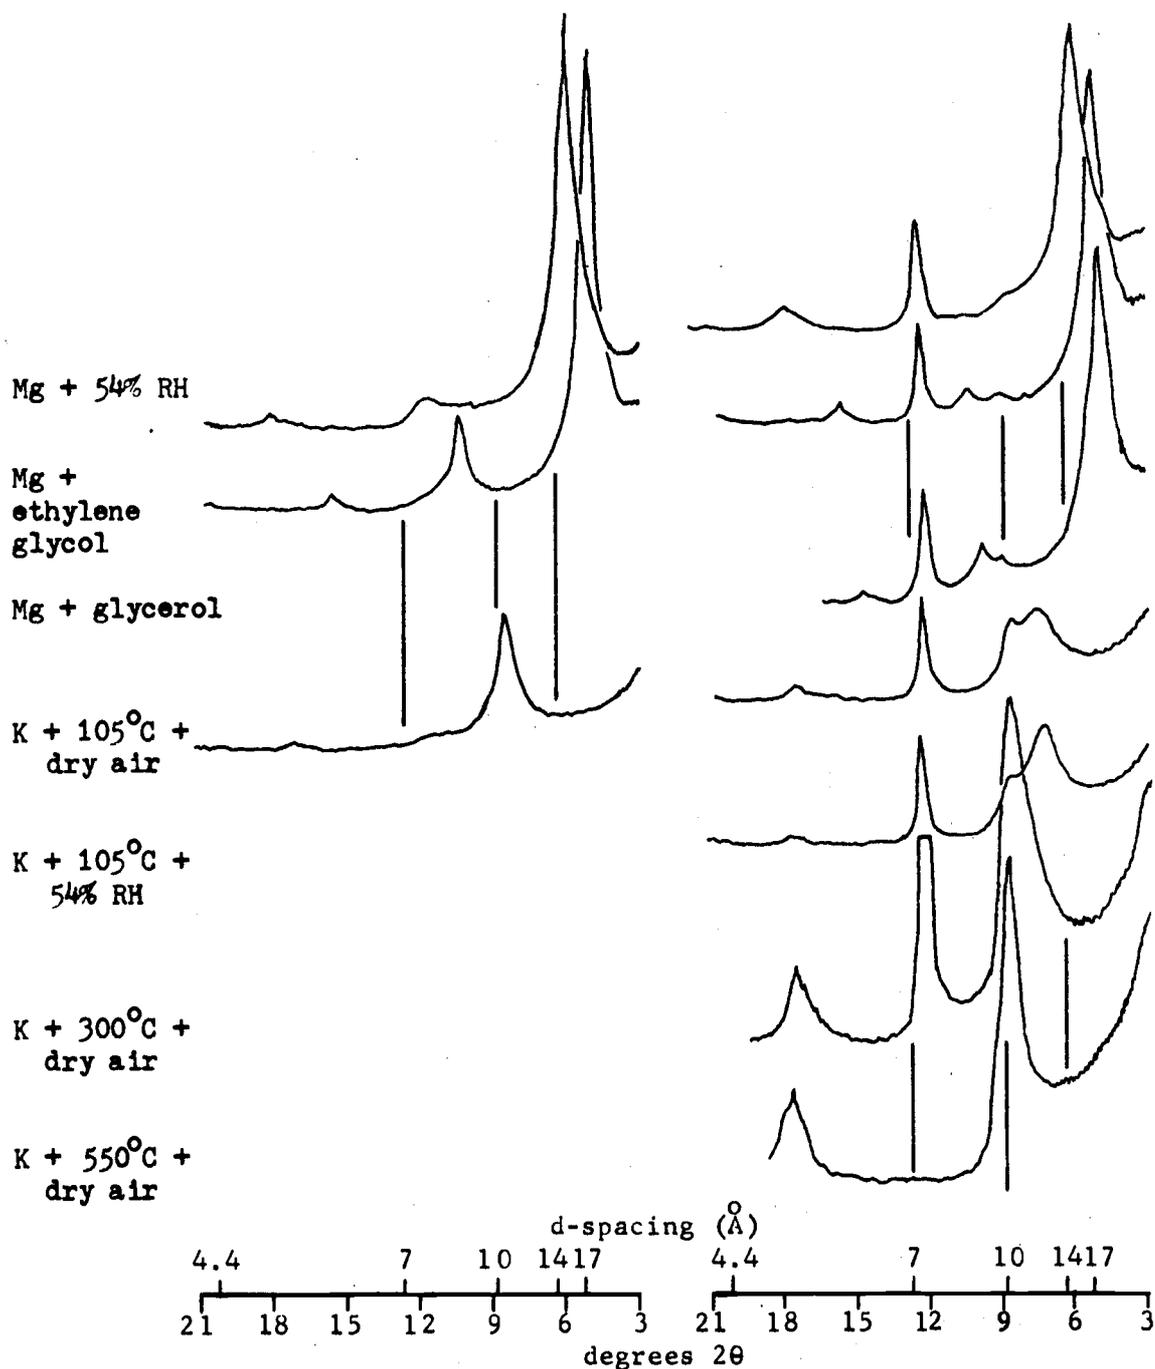
Figure 32. Site MFW-H-1 XRD patterns. Sample b (left), central portion of earthflow, 1 m depth. Sample a (right), flank of small rotational slump.

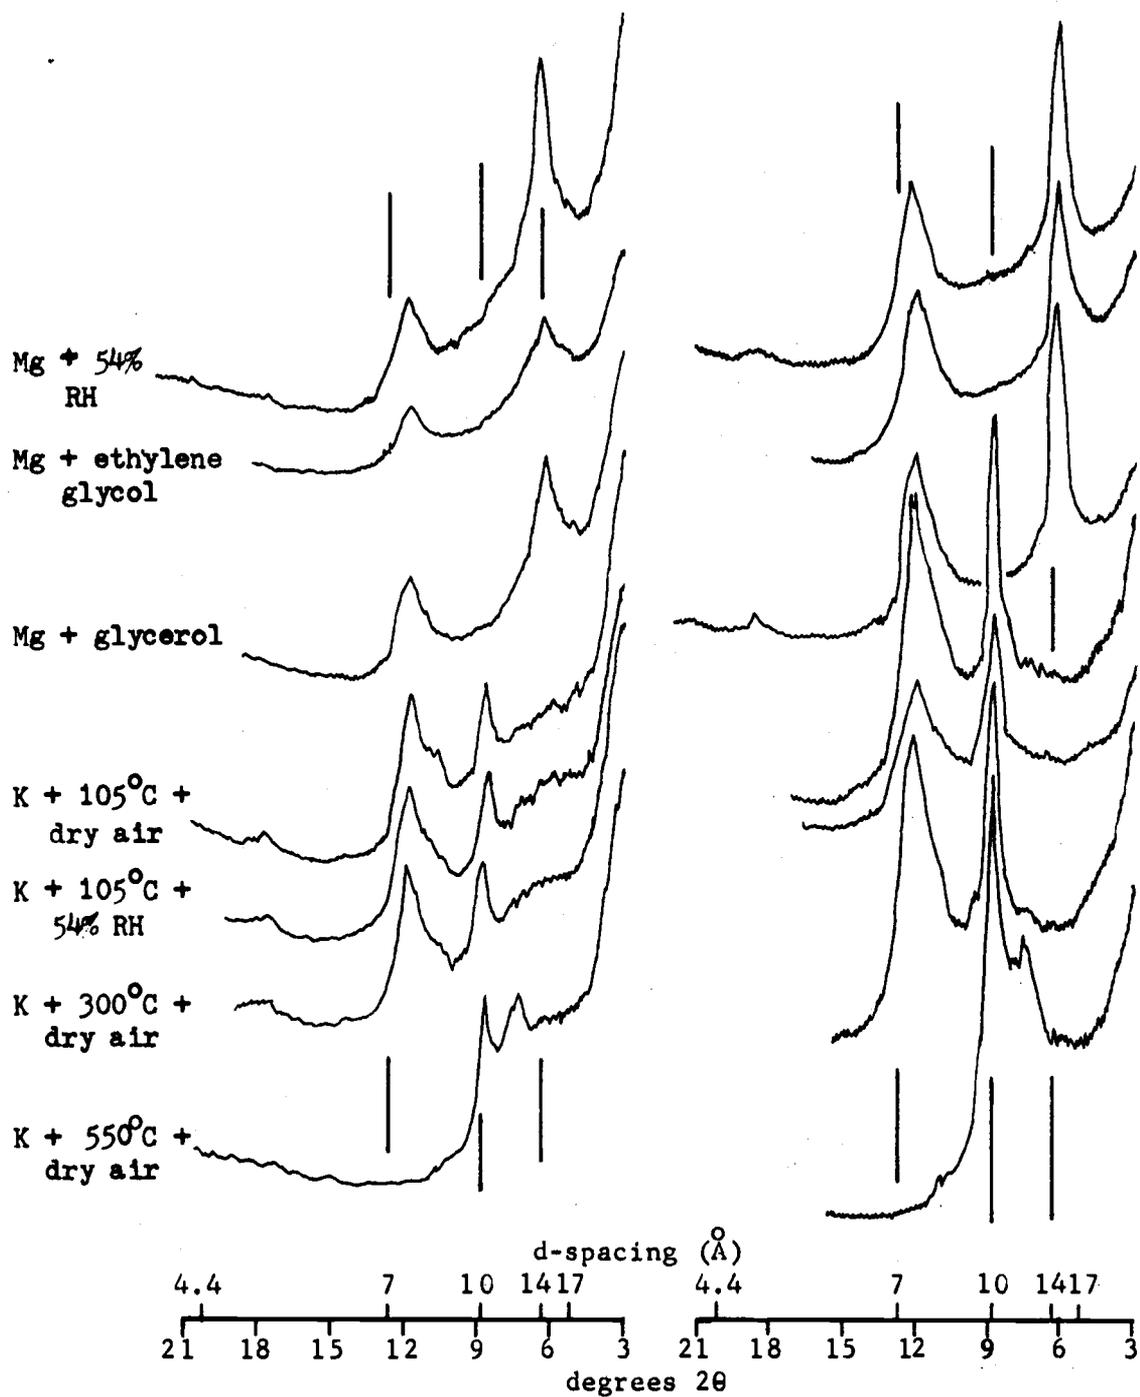
Figure 33. Site SU-C-1 XRD patterns. Sample c (left), right scarp wall, 2 m from original surface. Sample d (right), slump bench just above toe of failure.

within the failure (headwall scarp, left and right flanks, central terrace, and toe) revealed the clay mineralogy to be relatively homogeneous throughout. Dehydrated halloysite is indicated in the XRD patterns (Figure 33) by the somewhat broad  $7.3 \text{ \AA}$  peaks which disappear with heating at  $550^{\circ}\text{C}$ , and in the DTA pattern (Figure 34) by the two distinctive endotherms and exotherm. Chloritic intergrade and mica are also present.

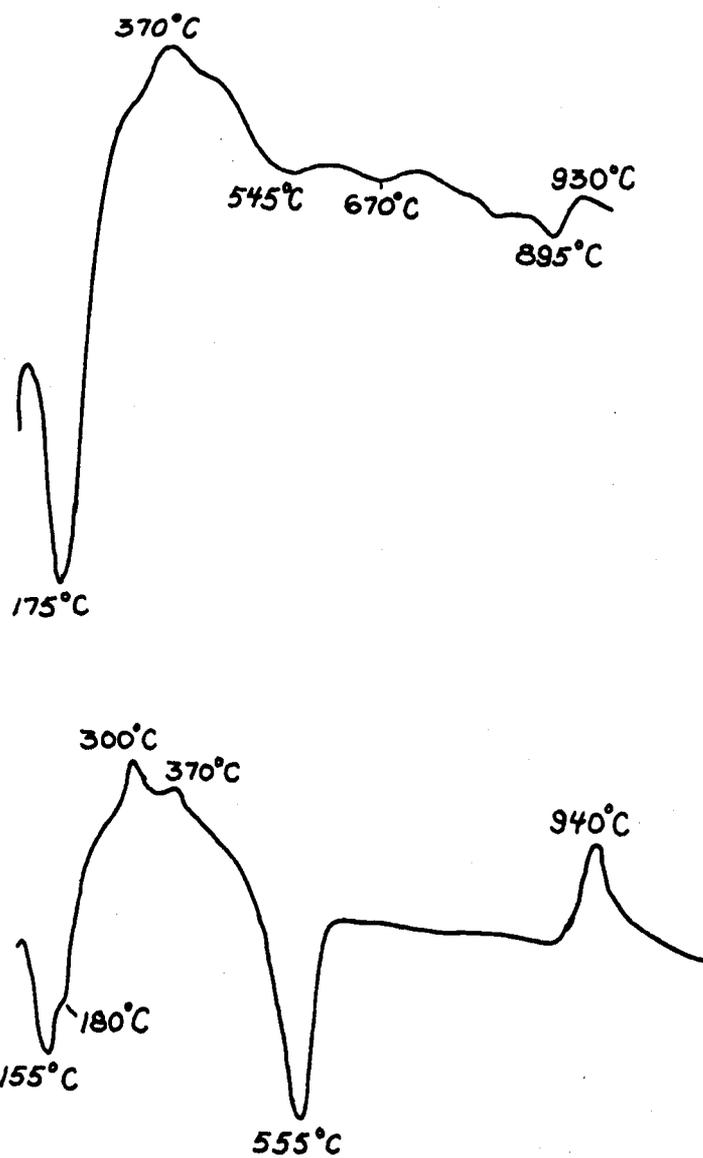
Figure 34. DTA patterns of samples MS-H-1b and SU-C-1b.

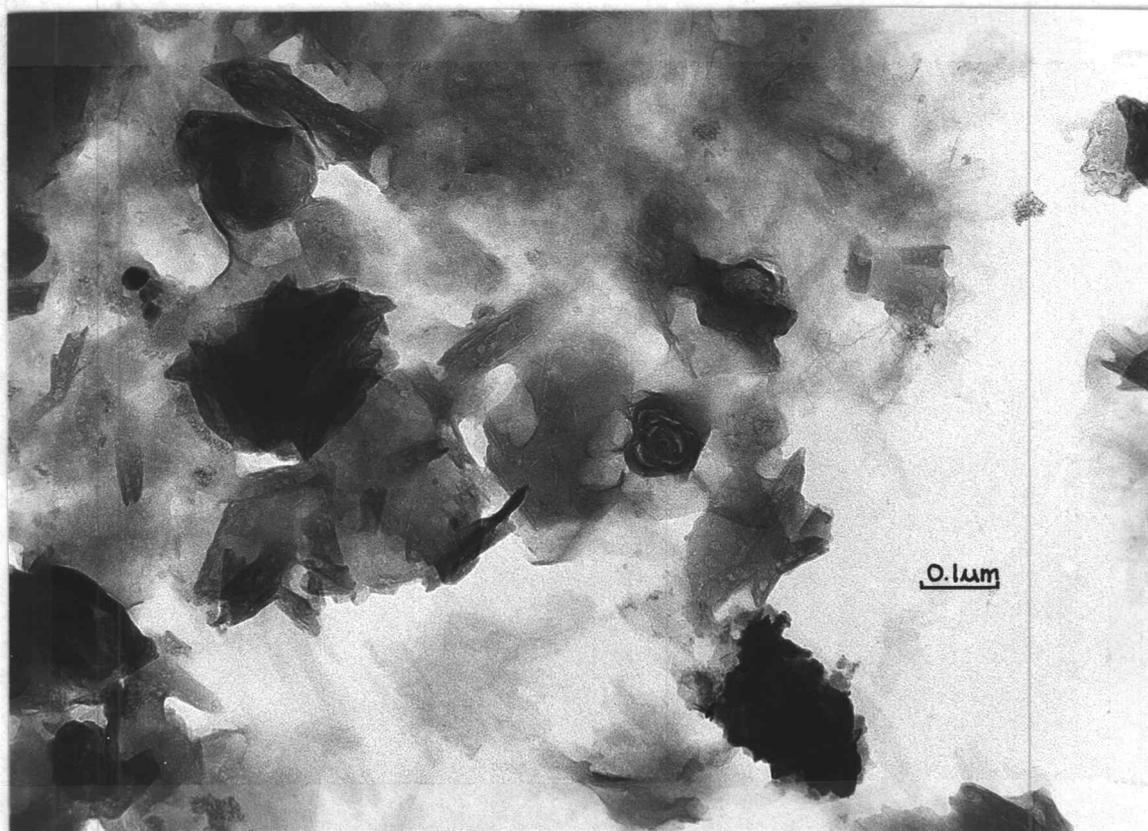
Plate 17. Electron micrograph of clay from site MK-L-3.

Three samples collected from two areas within the Lookout Creek earthflow (sites MK-L-2 and MK-L-3) gave surprisingly similar XRD patterns (Figure 35 and Appendix III). These patterns show the major constituents to be amorphous material, halloysite with a range of hydration, and chloritic intergrade. The electron micrograph (Plate 17) also shows these components. The samples of Figure 35 were taken some distance apart at depths of up to three meters in wet soil with a very high content of basaltic colluvium. Field characteristics of additional soils at various locations in the earthflow were investigated and found to be very similar to those collected. The earthflow runs into Lookout Creek, which continually carries away soil from the tip of the lobe as it sloughs into the creek. A cursory examination of the soil on the opposite side of the creek suggested the presence of smectite clay, which in turn leads one to speculate that deeper sampling of the earthflow might reveal a smectite surface on which the flow is moving.

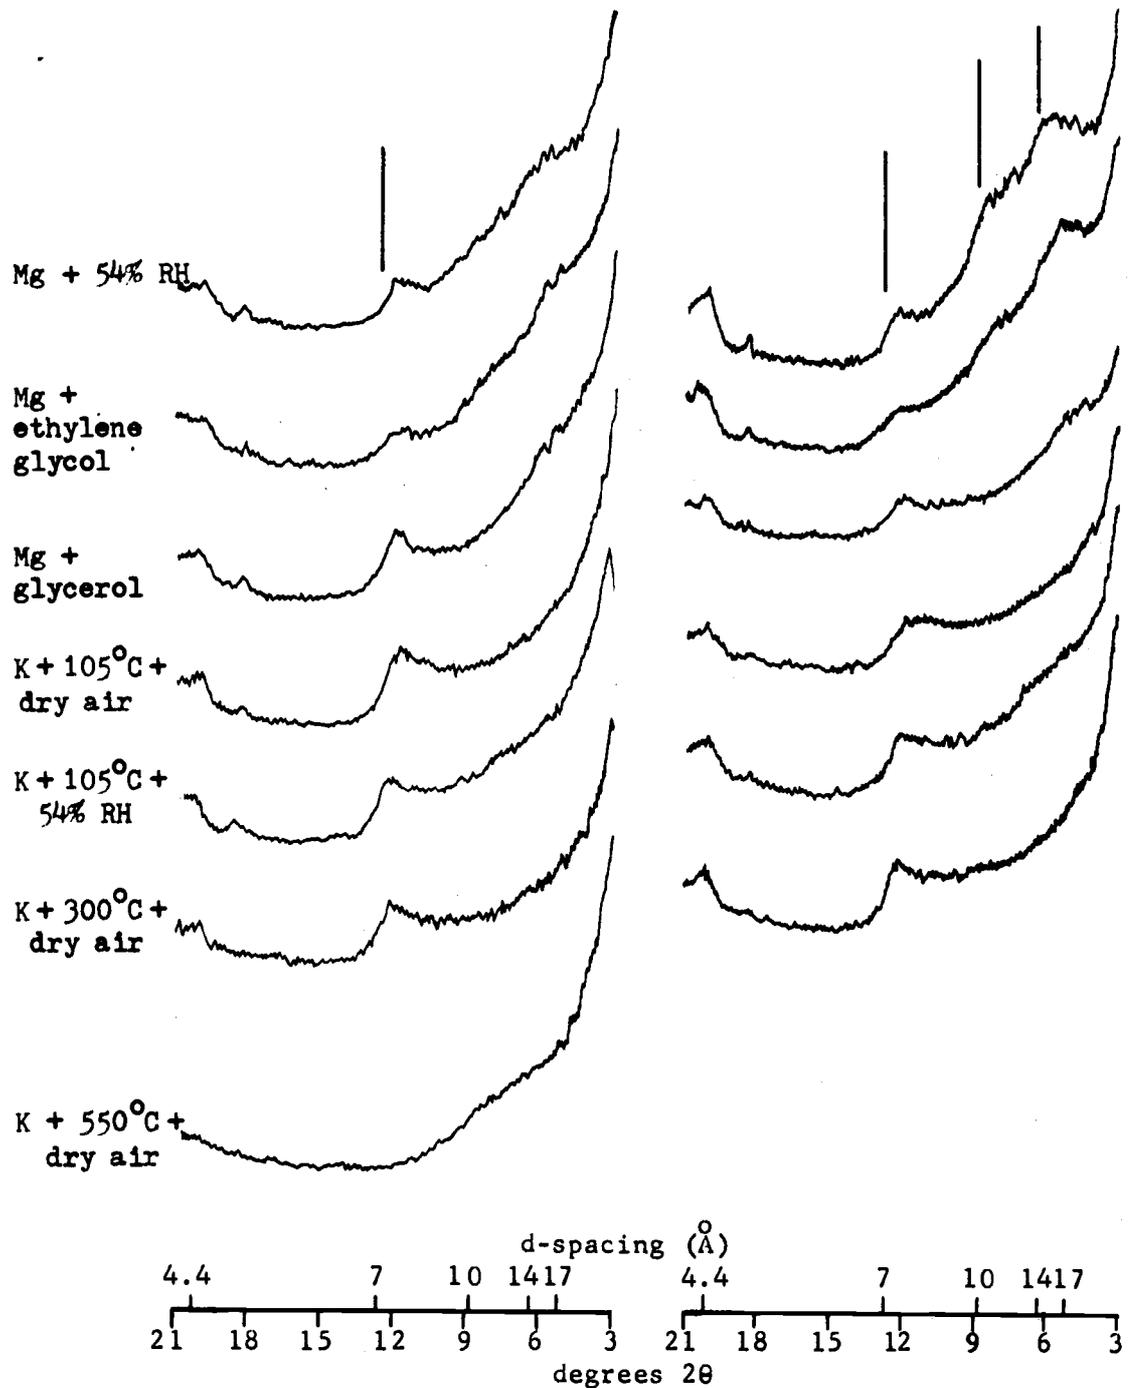
Figure 35. Sites MK-L-2b and MK-L-3 XRD patterns. Sample 2b (left), central region of earthflow, 2 m depth. Sample 3 (right), toe of earthflow 3 m depth.

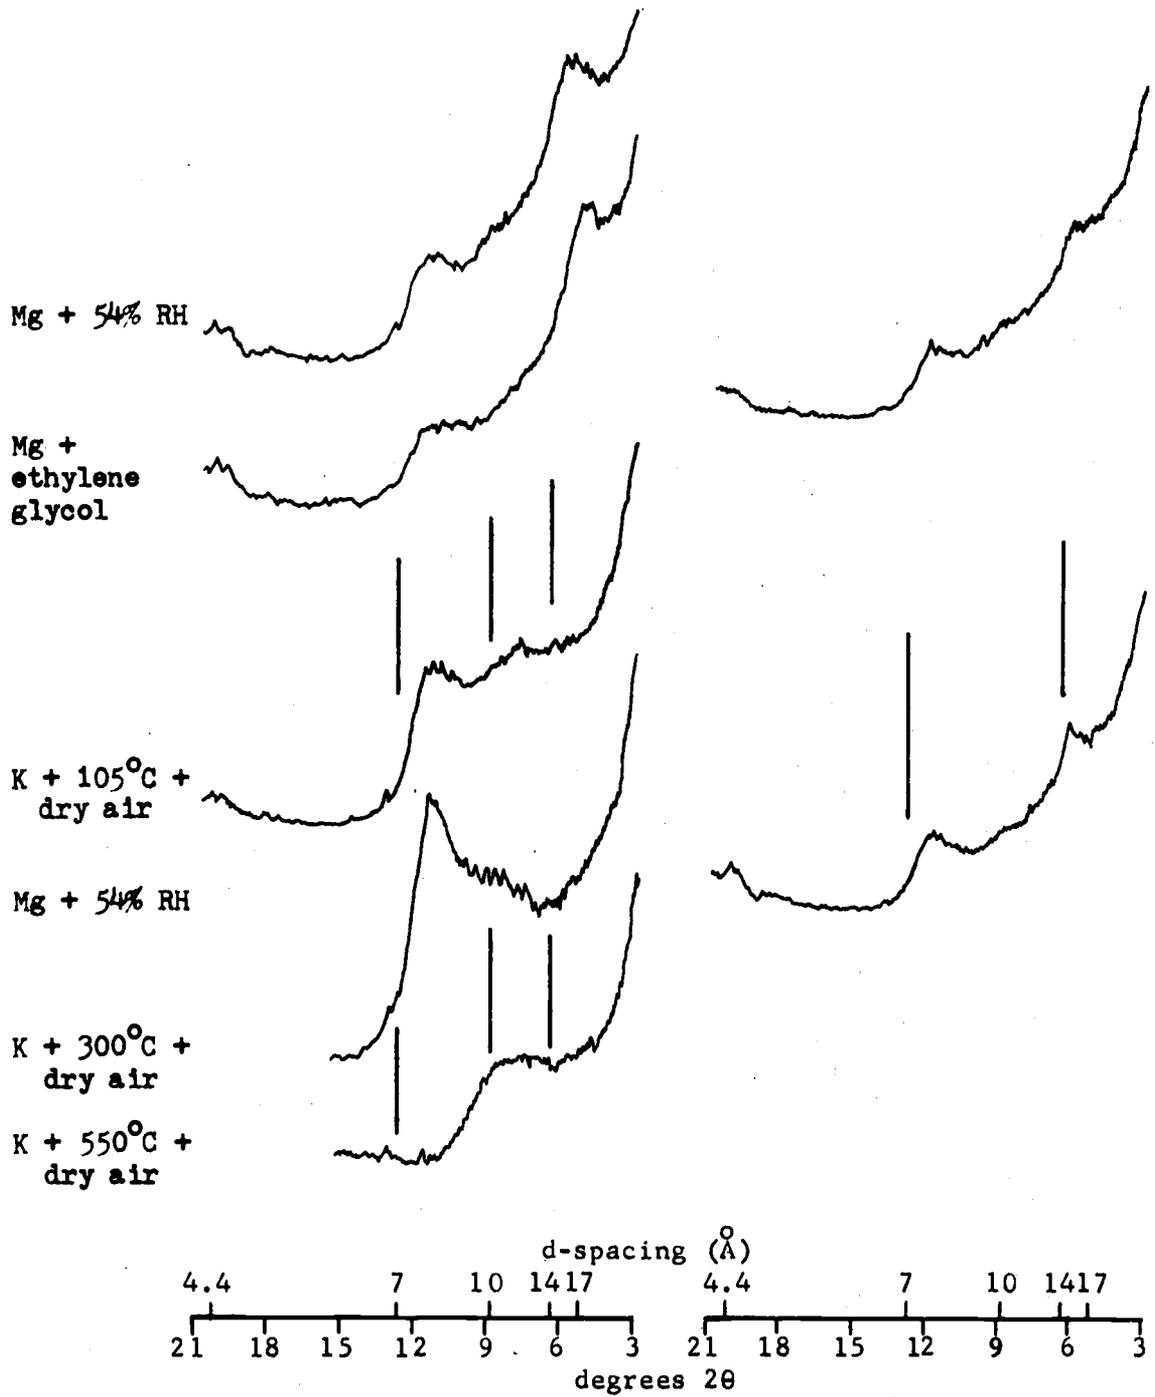
Figure 36. Site SFMK-B-1 XRD patterns. Sample b (left), gray sub-sample 1½ m depth. Sample a (right, top), homogeneous zone, 1 m depth. Sample d (right, bottom), maroon subsample 1½ m depth (Mg + 54% RH).

XRD patterns of five samples taken from a single location in the earthflow are given in Figures 36 and 37. Samples b, d, and c are subsamples of various colored materials collected within a few centimeters of each other. All samples display somewhat similar mineralogy, with the major components being amorphous material, halloysite and chloritic intergrade; however, for some unexplained

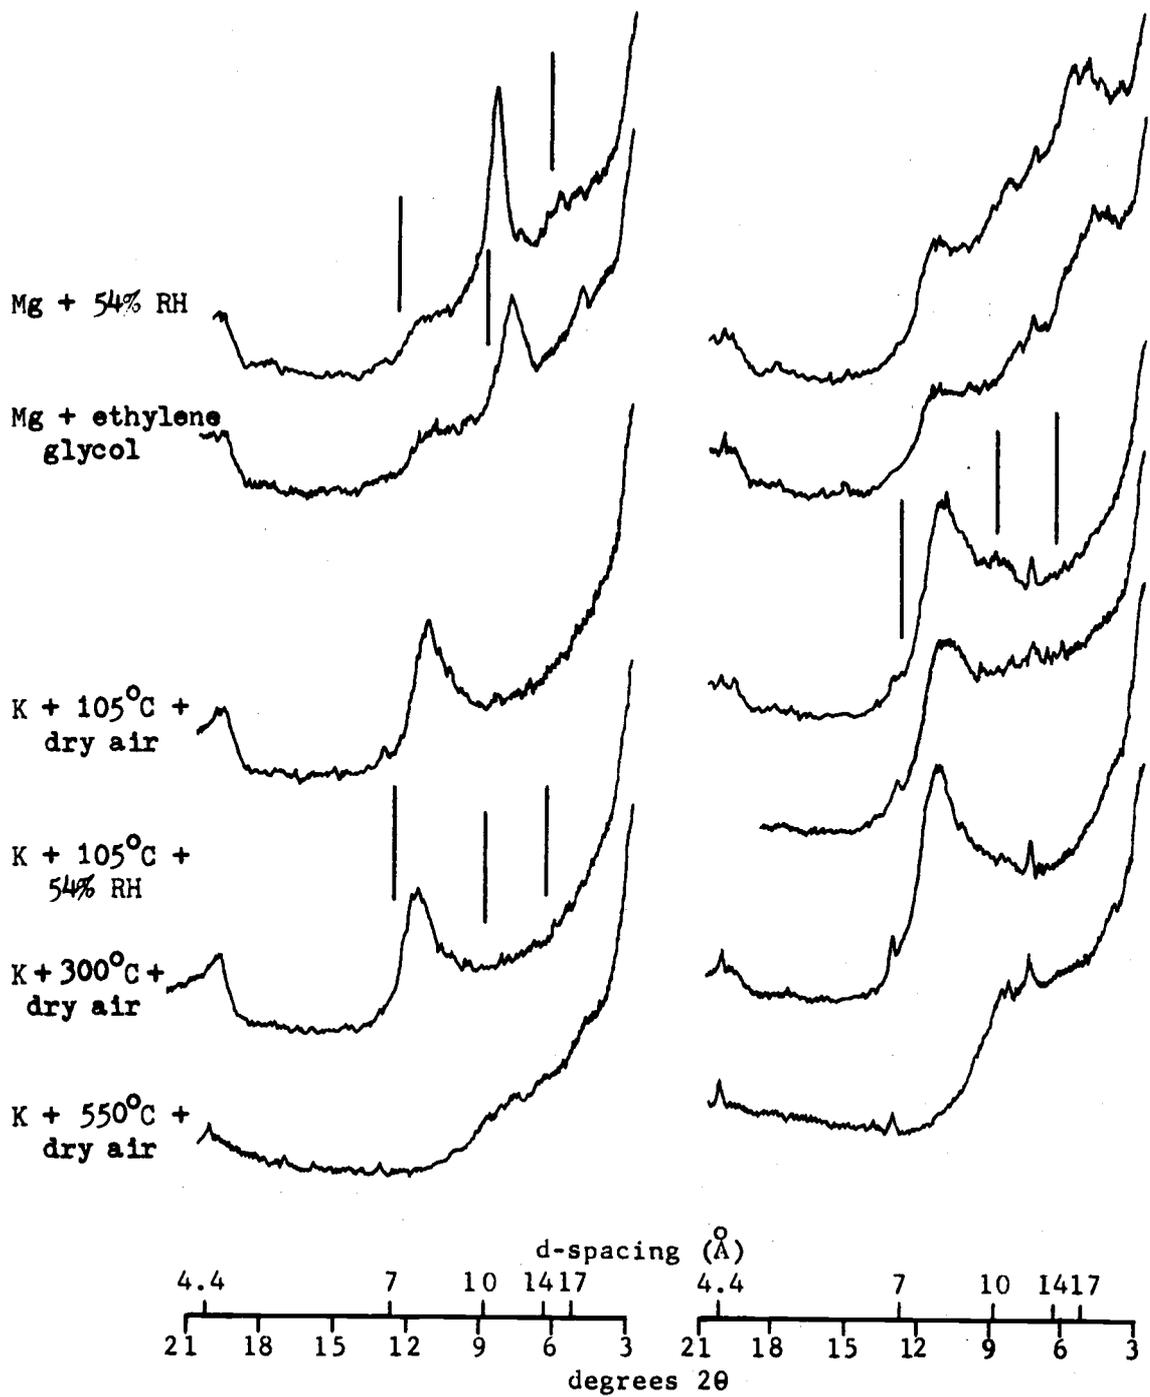
Figure 37. Site SFMK-B-1 XRD patterns. Sample c (left), reddish sub-sample, 1½ m depth. Sample e (right), 2 m depth.

reason the peak of the hydrated halloysite of the reddish subsample c is much sharper and stronger than those of any of the other samples. Based on field observations, sample e probably best represents the material of the earthflow in general. It is notable that, as in the Lookout Creek earthflow, there is little indication of well developed smectite in the moving material at this site.

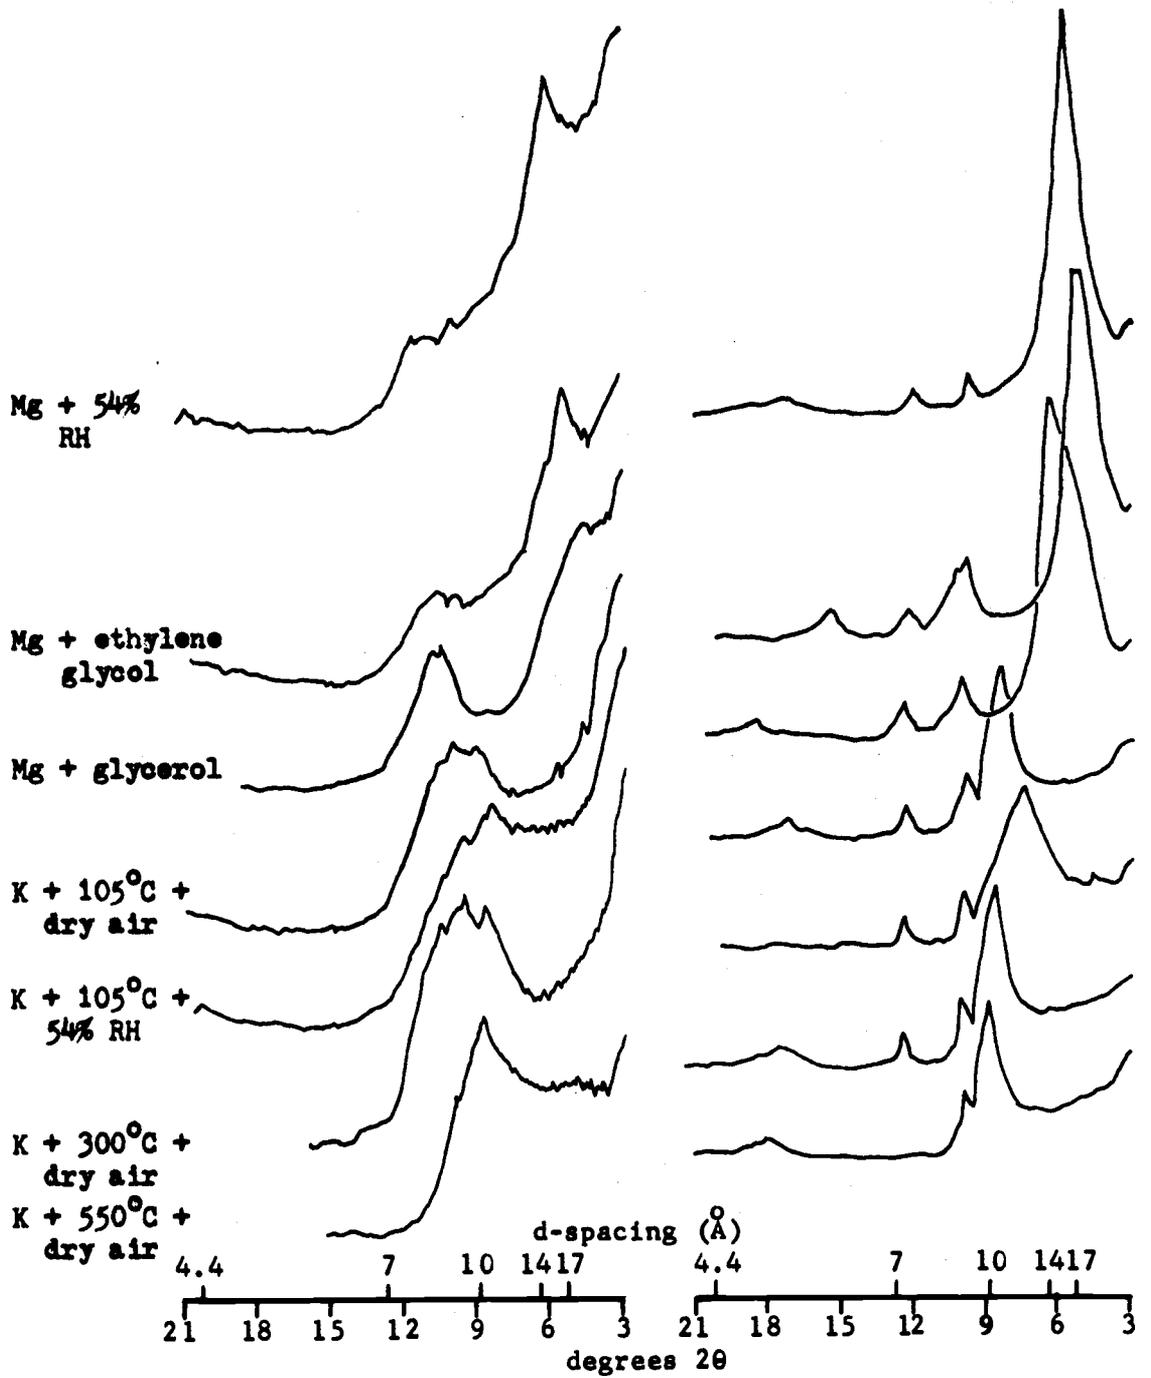
Figure 38. Site MFW-L-1 XRD patterns. Sample a (left), upper central portion of earthflow. Sample b (right), pressure ridge, 1 m depth.

The two clay samples from the Landes Creek earthflow have contrasting mineralogy (Figure 38). Sample a, from the central portion of the earthflow, contains amorphous material, halloysite and chloritic intergrade, as do the samples at Lookout and Boone Creeks. In addition, there are strong indications of hydroxy interlayered smectite. Sample b was taken from the top of a pressure ridge, the soil of which is considerably wetter than that of sample a. The ridge consists of highly weathered greenish breccia with some basaltic cobbles and lahar (?) rock. The soil's clay fraction is strikingly different from that of sample a in that it is composed largely of smectite, which may be either beidellite or hydroxy interlayered montmorillonite. The XRD patterns show no amorphous band, but they do show distinct, although weak, kaolin peaks and zeolite.

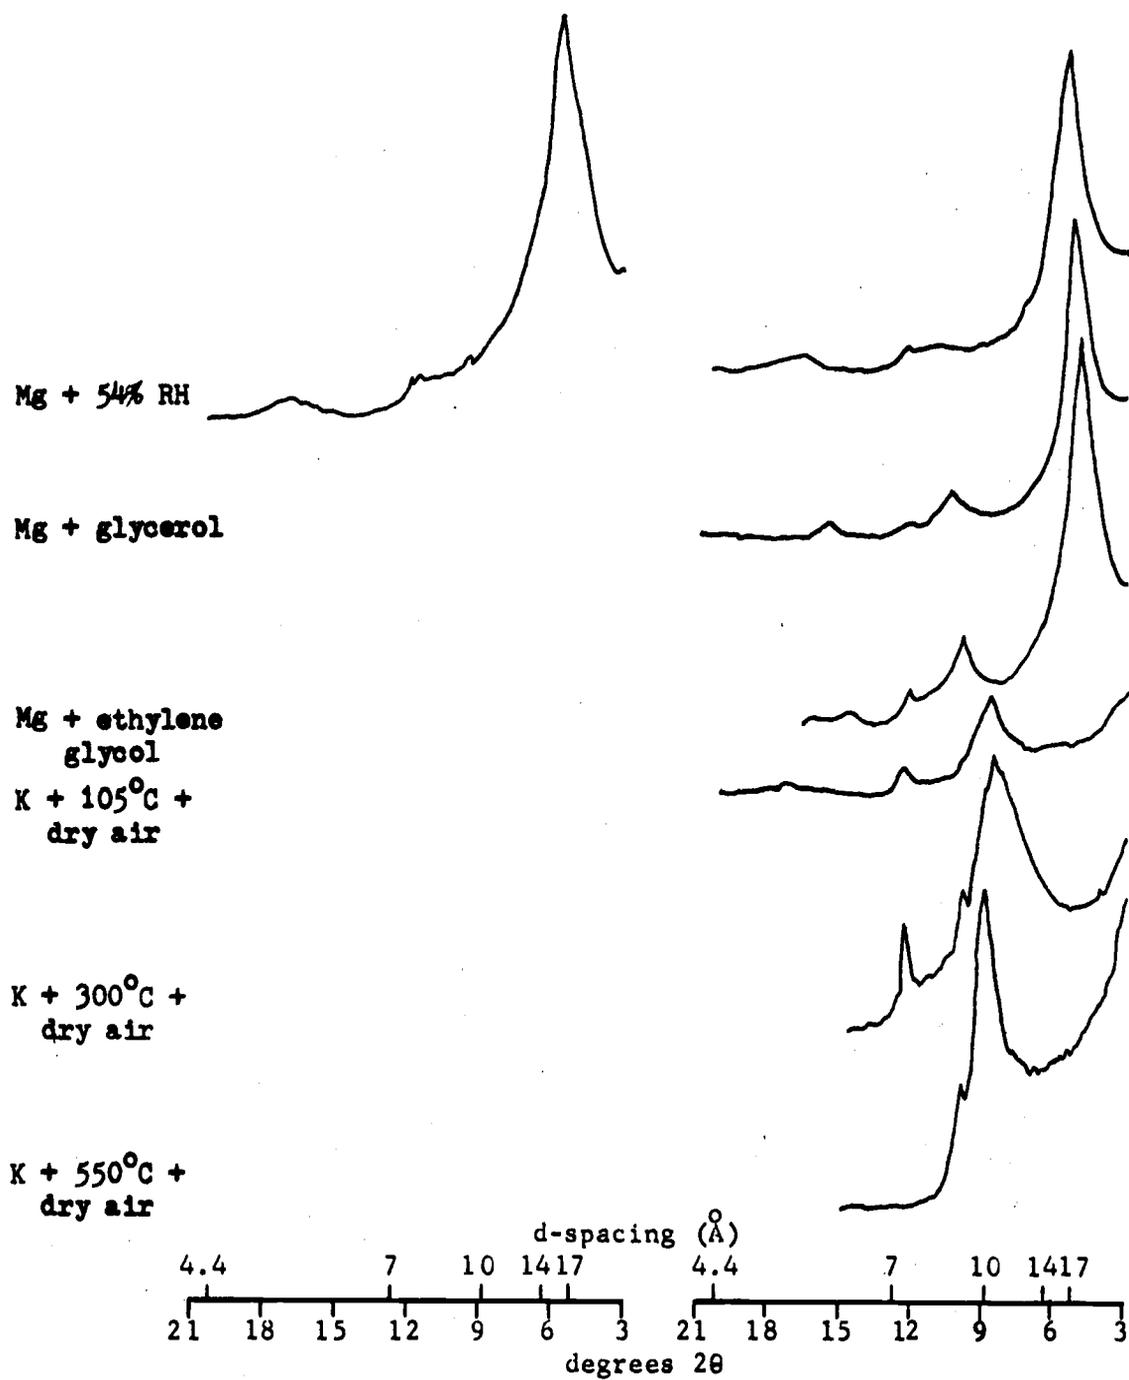
Figure 39. XRD patterns of smectite involved in deep seated soil creep, samples SU-J-1a and SU-J-1b.

Soil creep in the Western Cascades is most distinguishable in those regions where the landscapes have relatively little basaltic colluvium and volcanic ash, but which consist primarily of rock materials such as greenish breccia which have weathered to cohesive, smectite clays. Site SU-J-1, in the South Umpqua drainage, is a good example of this situation: the land surface here has the characteristic rumped appearance; small rotational cutbank failures are common; trees exhibit considerable sweep; and the soil is high in saturated, very plastic clay. Two clay samples from this site are nearly pure montmorillonite except for slight evidence of zeolite and a poorly defined kaolin component (Figure 39). The field characteristics of the two are nearly identical except that sample a is somewhat drier and less mottled than sample b.

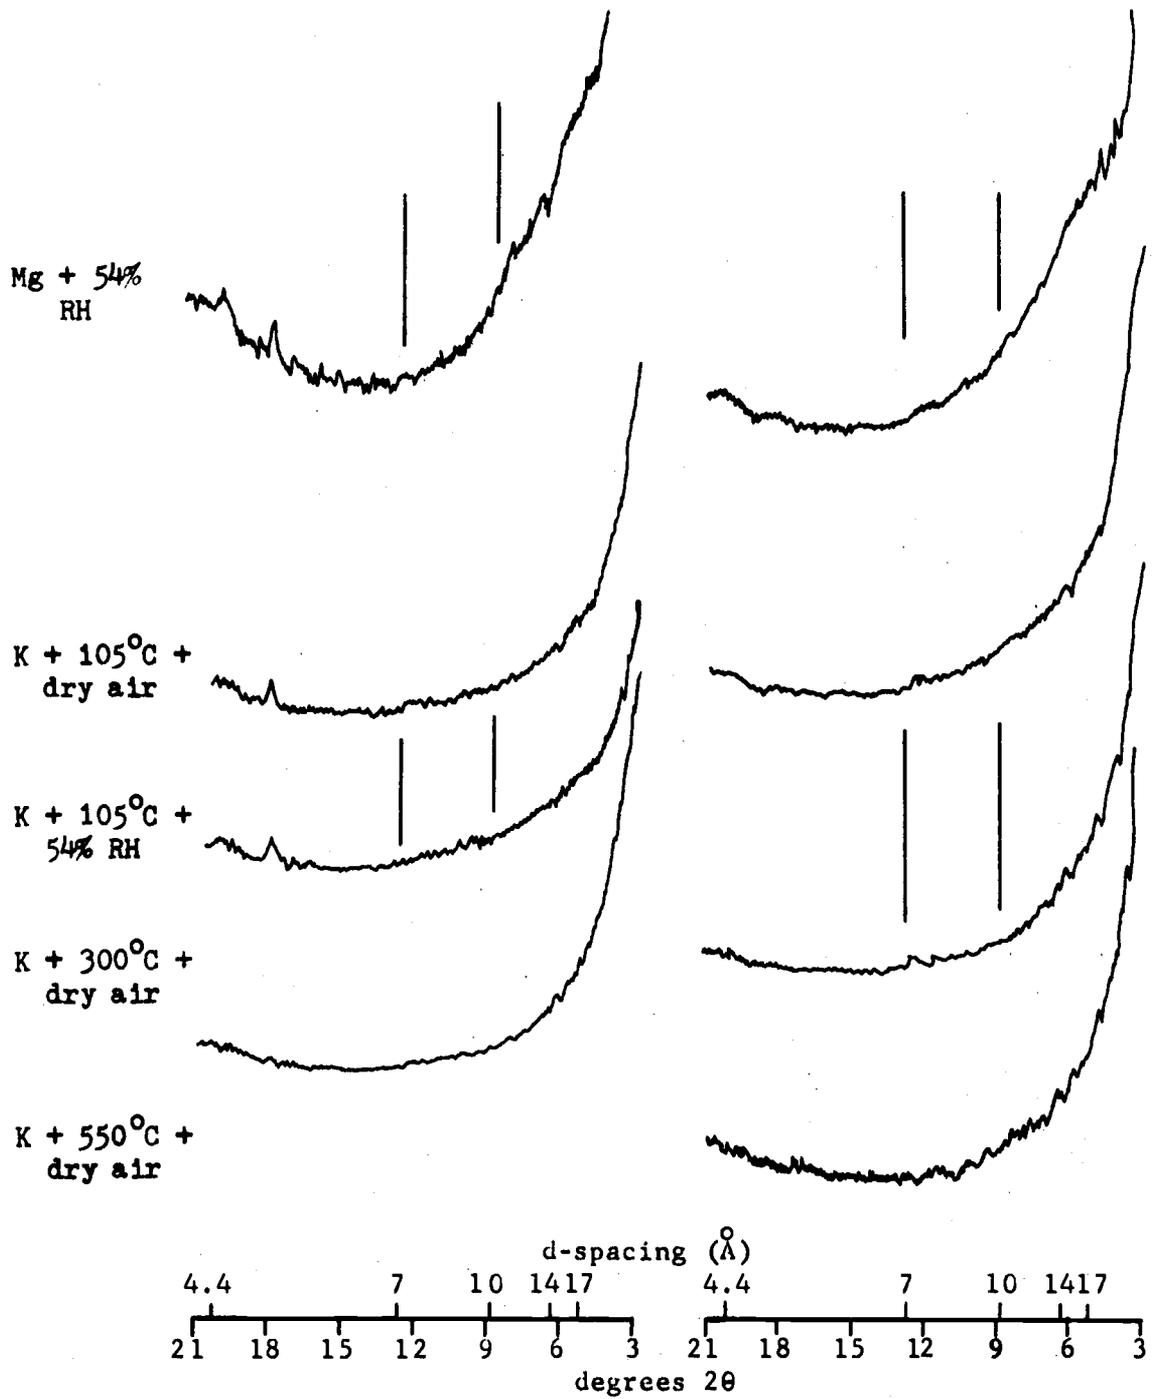
Figure 40. XRD patterns of coarse textured, stable soils MK-F-1 (left) and MK-L-1 (right).

The meager clay fractions of these sites give XRD patterns which are primarily amorphous bands, with a hint of chloritic intergrade, as noted in samples from sites MK-F-1 and MK-L-1 (Figure 40); the presence of gibbsite is also weakly indicated in MK-F-1. (Site MK-L-1 is located in the Lookout Creek drainage upslope from the earthflow reported in the previous section.) DTA patterns show similar components (Figure 41), as does electron microscopy (Plate 18).

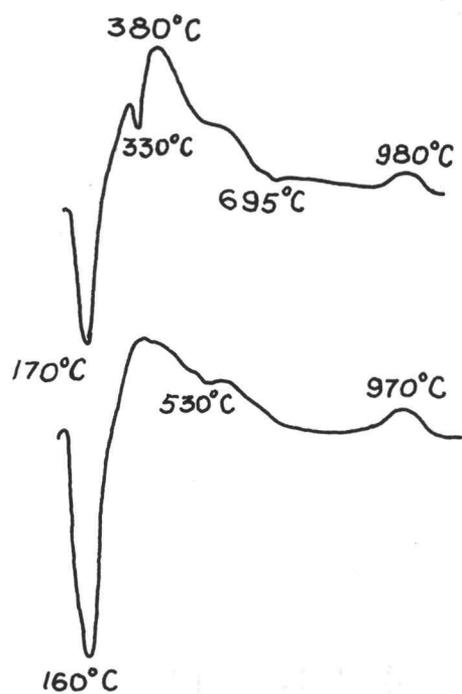
Figure 41. DTA patterns of clay from stable sites MK-F-1 and MK-L-1.

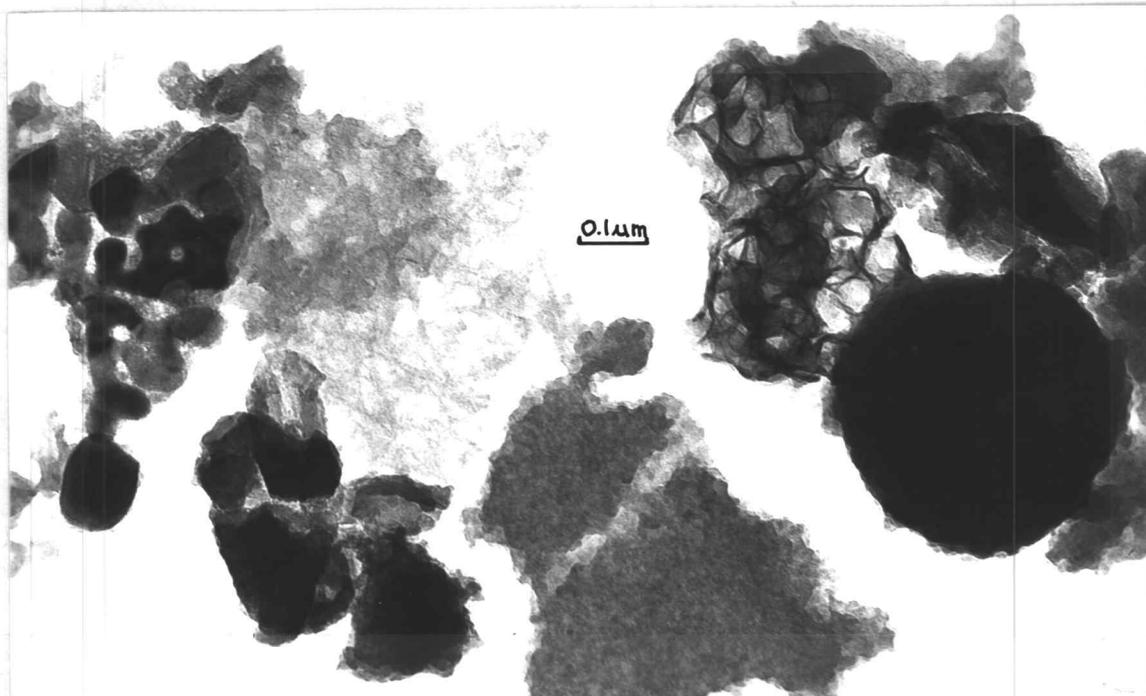
Plate 18. Electron micrograph of devitrified glass and other components, site MK-F-1.

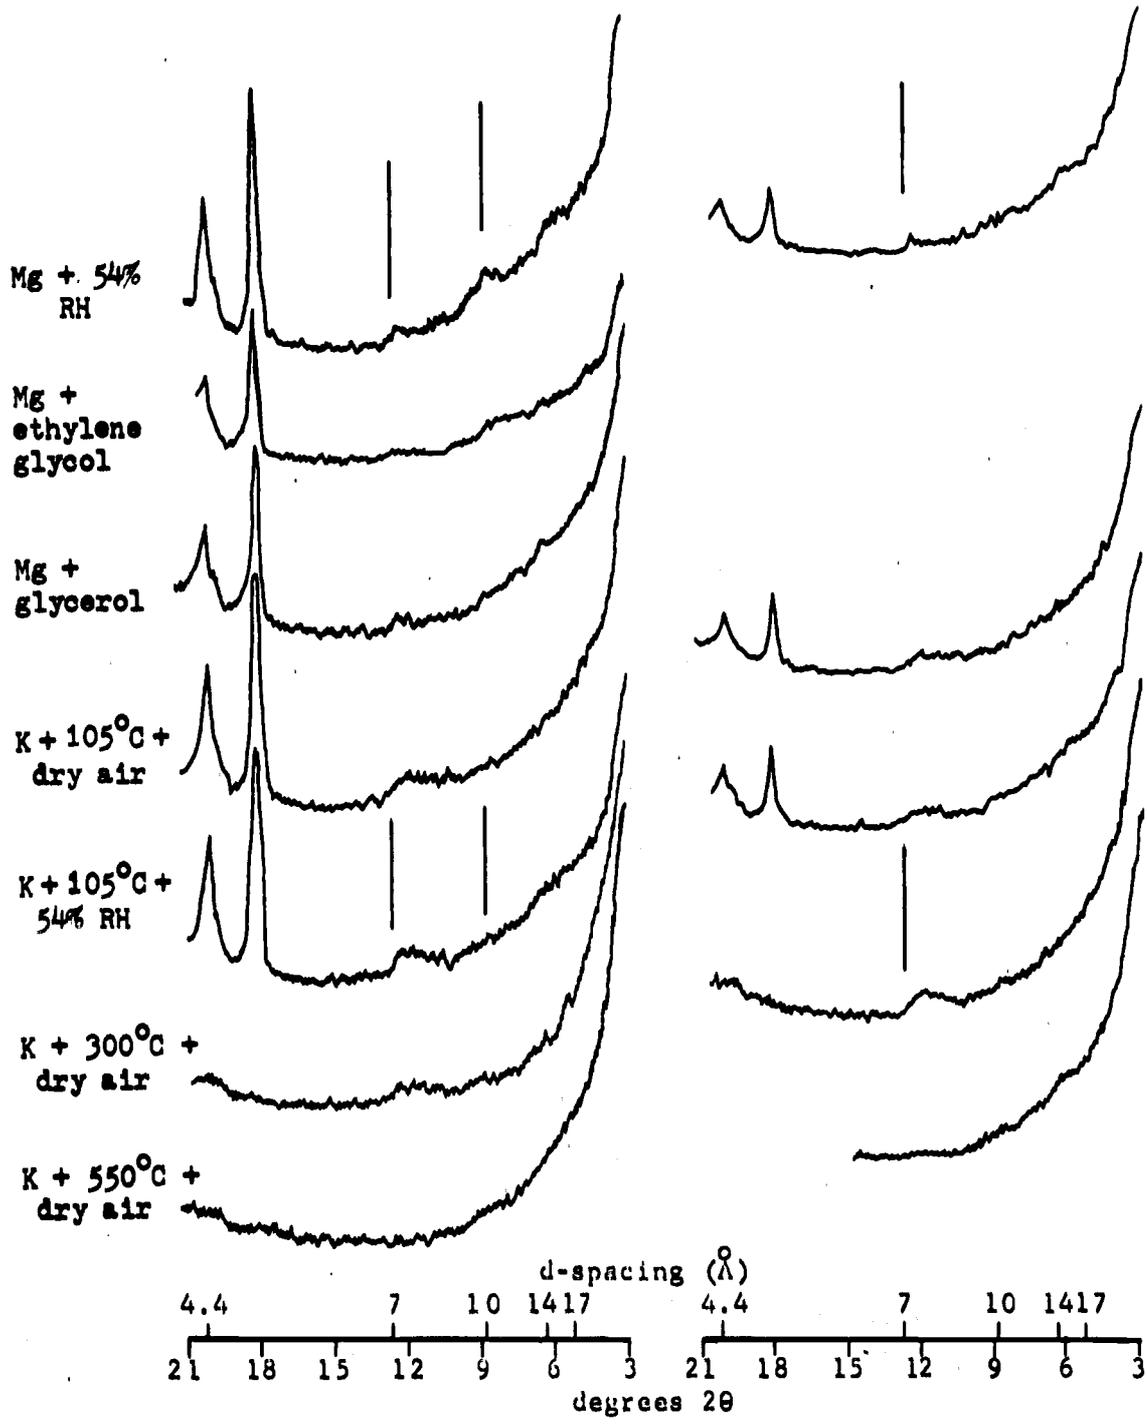
Figure 42. XRD patterns of clay fraction of shallow, stable soil at site NFMFW-C-1c (left) and adjacent failed soil at point of emerging water, NFMFW-C-1a (right).

Sample c of site NFMPW-C-1 was collected from relatively dry, shallow, coarse textured, stable soil at 1500 m elevation. The XRD patterns show strong, sharp gibbsite peaks, a significant amorphous band, and small indications of halloysite, chloritic intergrade and feldspar (Figure 42). Although this soil is generally stable it is subject to failure under conditions of a localized buildup of pore water pressures as occurred at the adjacent sample location, NFMPW-C-1a. Here, a spring emerging from a bedrock fissure just above the road cut caused a small planar failure of the soil over the surface of decomposing rhyodacite (?) porphyry.
