AN ABSTRACT OF THE THESIS OF

RONALD DAVID TASKEY for the DOCTOR OF PHILOSOPHY degree in SOIL SCIENCE presented on September 12, 1977

Title: RELATIONSHIPS OF CLAY MINERALOGY TO LANDSCAPE STABILITY IN WESTERN OREGON Redacted for Privacy

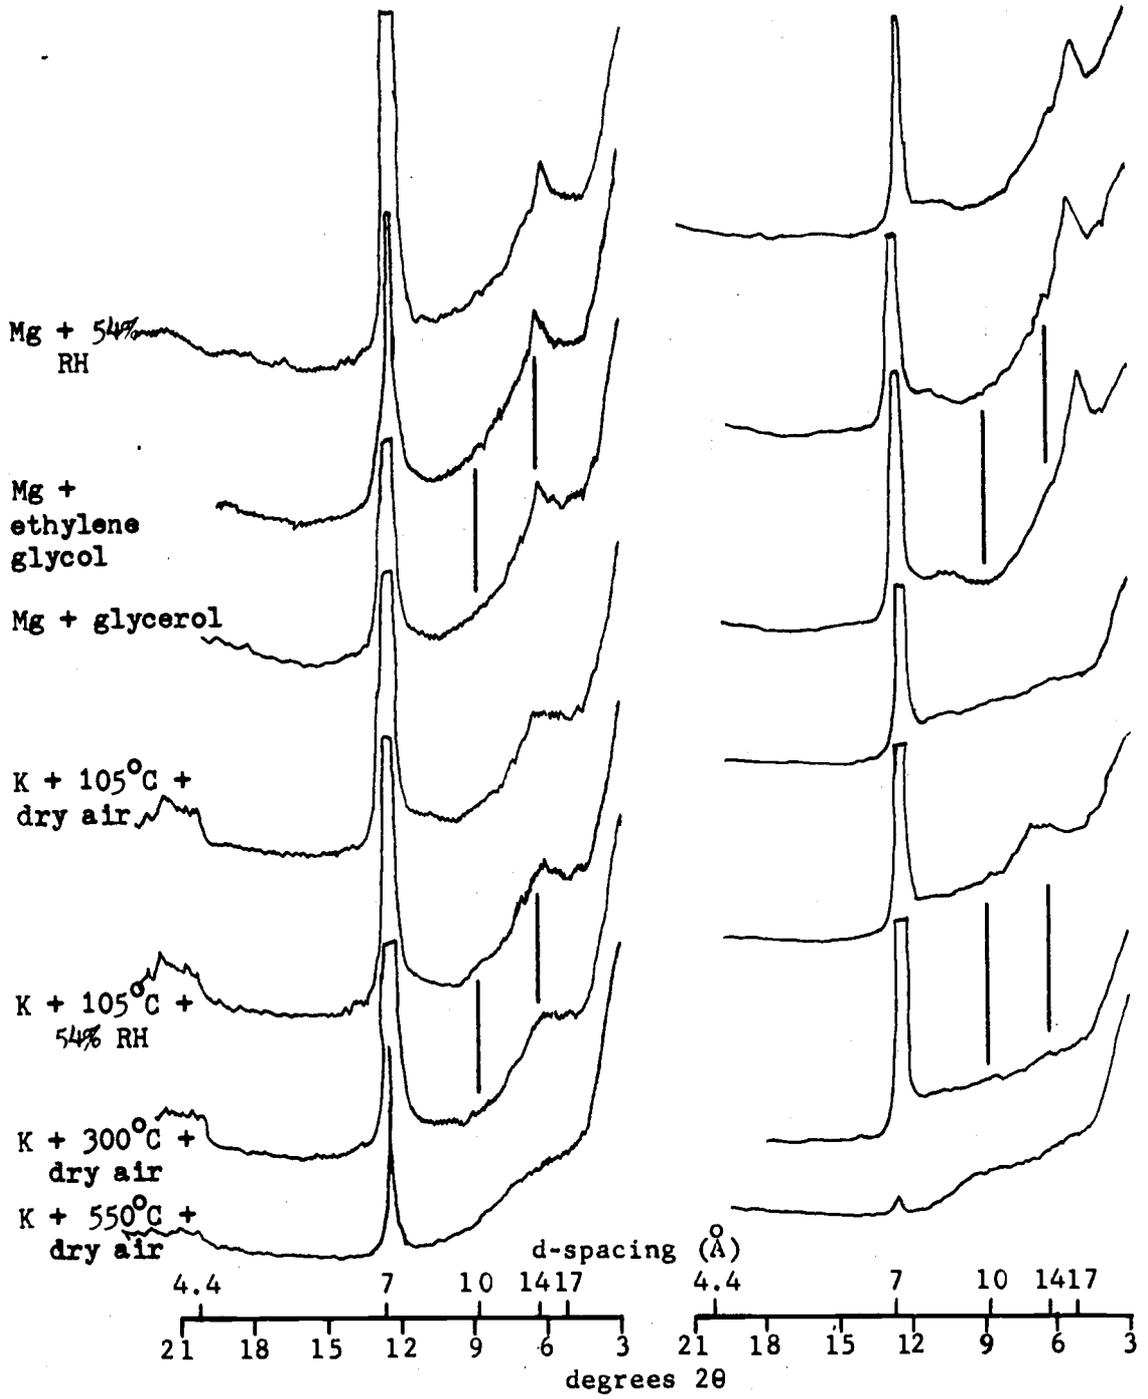
Figure 43. XRD patterns of clay of sites R-SP-2 (left) and R-SP-1 (right).

Other sites are unstable with respect to one type of mass movement but stable with respect to another. The best examples of this are the debris avalanche sites, which fail at relatively shallow discontinuities, but which are often stable at greater depths. Site R-SP-2 is near debris avalanche site R-SP-1 and has similar mineralogy, but is of gentler slope, and therefore more stable. The clay of these two sites contains chloritic intergrade and strong, sharp kaolinite (Figures 43 and 45).

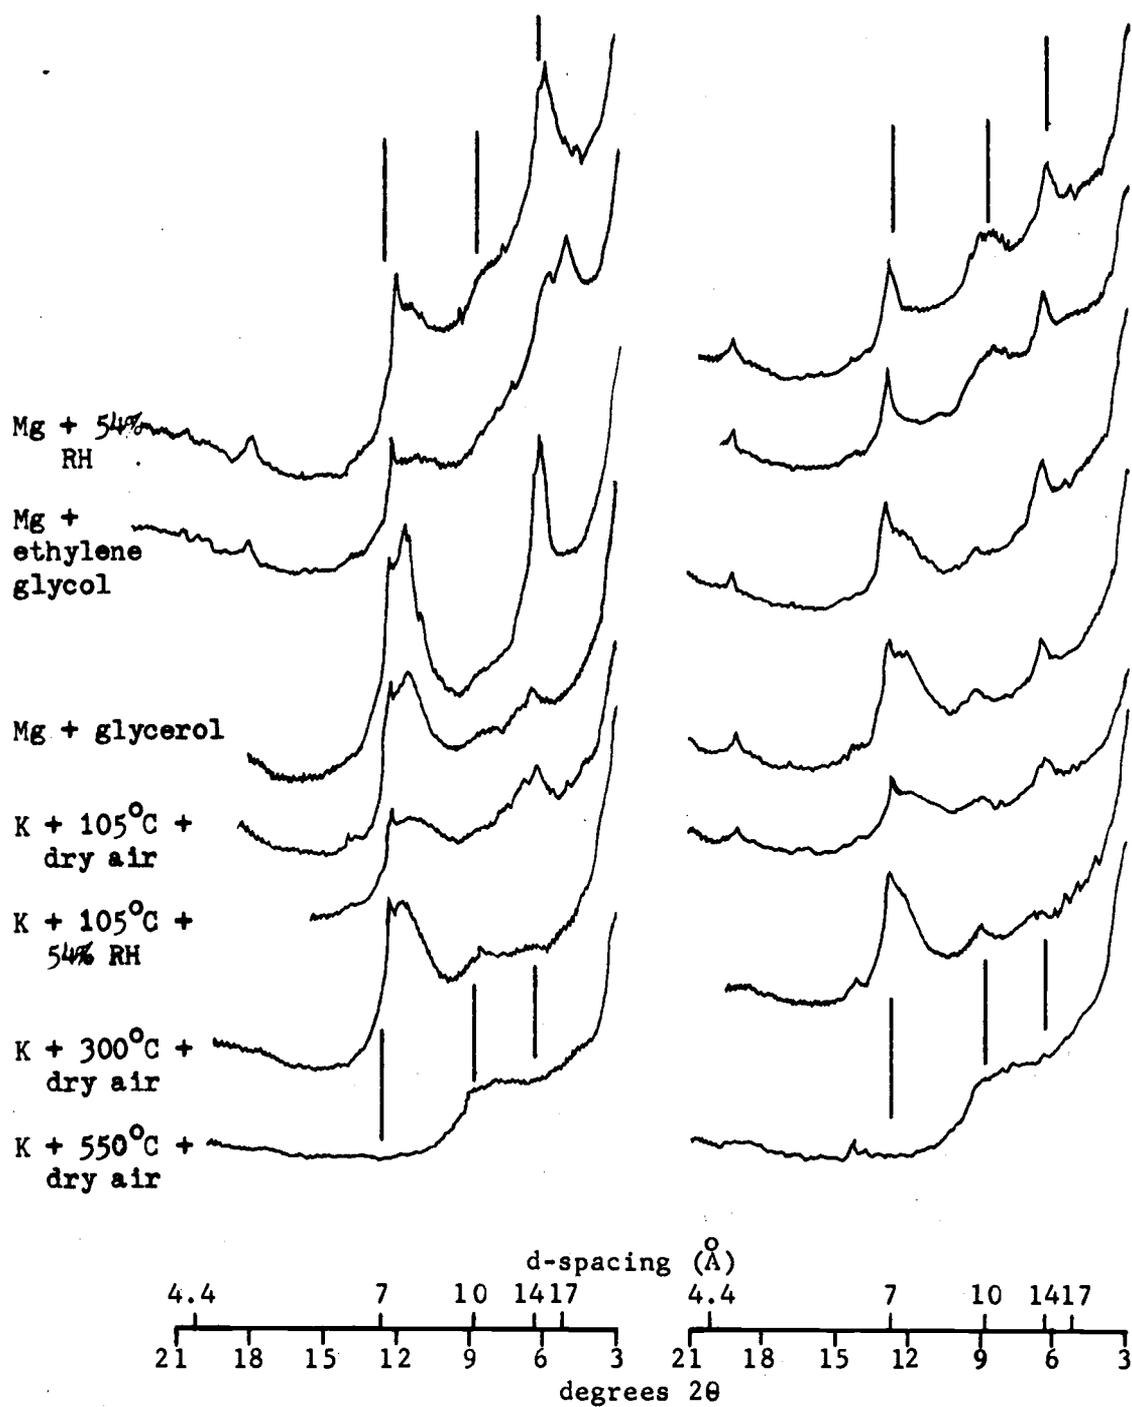
Figure 44. XRD patterns of clay from the relatively stable site SS-SF-6 (left) and the slightly more stable site SS-SF-7 (right).

Other examples involve the relatively shallow soils from the lower end of the Soda Fork drainage of the South Santiam. Site SS-SF-6 has suffered considerable abuse from improper timber harvesting and its related activities. The site has experienced a debris torrent and several small road related debris avalanches; nonetheless, it remains more stable than most of the sites investigated further up the drainage. The XRD patterns of the clay fraction of soil involved in the debris torrent indicate chloritic intergrade with some smectite character, halloysite, amorphous material, gibbsite, and kaolinite which is probably forming by alteration of the halloysite (Figure 44). The significant point here is that although the site contains clays that are normally associated with instability, it also contains clays which are more likely to be found on stable sites--namely, sharp  $7 \text{ \AA}$  kaolinite, and halloysite that is largely dehydrated.

A site with still greater stability can be found down the drainage a short distance at site SS-SF-7. The clay fraction (Figures 44 and 45) is somewhat similar to that of site SS-SF-6 except that the chloritic intergrade has little if any smectitic character, and the kaolinite appears better developed. Electron micrographs (Plate 19) show tubular halloysite particles coalesced with amorphous material to form the beginnings of plate-like particles. The amorphous films appear to be generally thicker and stronger than those noted at previous, unstable, sites. The arrangement of tubular halloysite surrounding the amorphous material was noted frequently

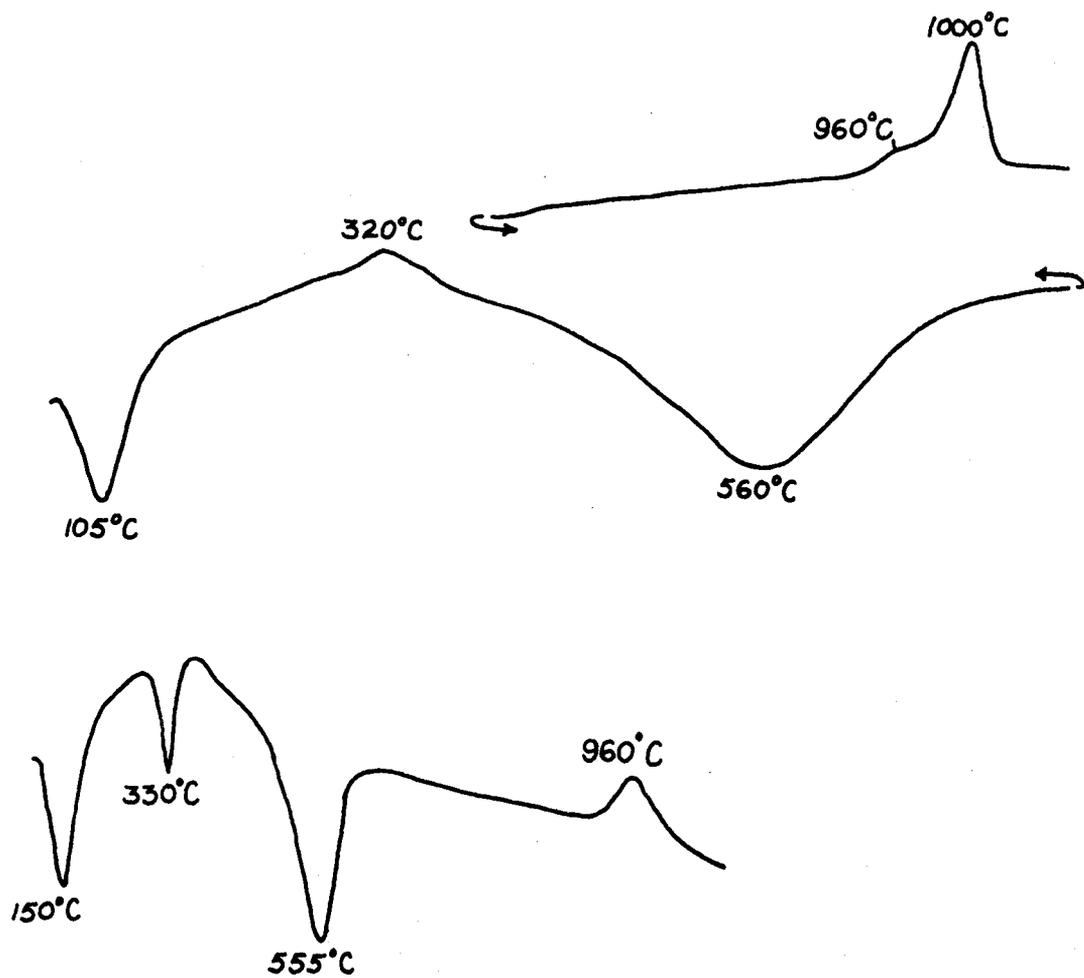
Figure 45. DTA patterns of clay samples R-SP-2 and SS-SF-7. (Note different scales.)

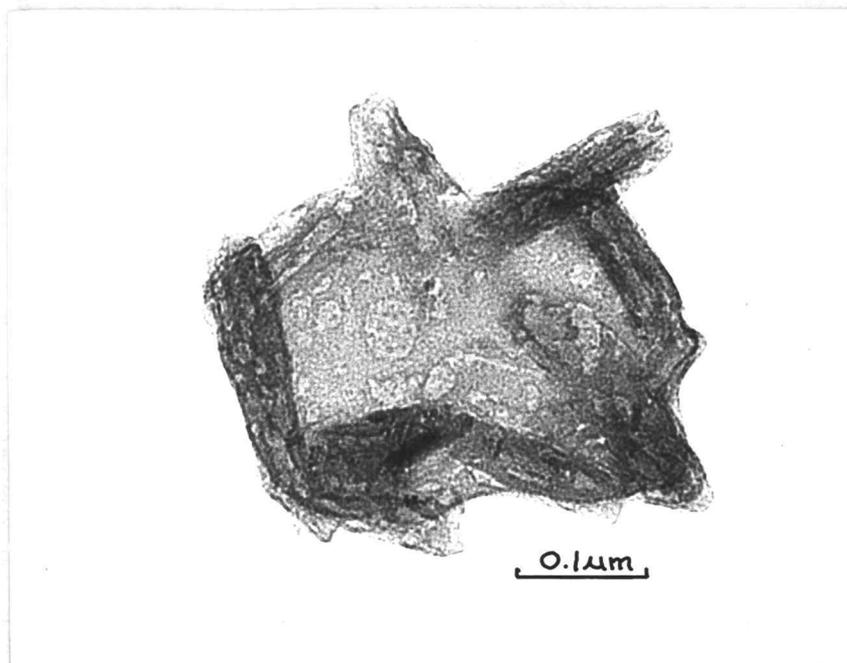
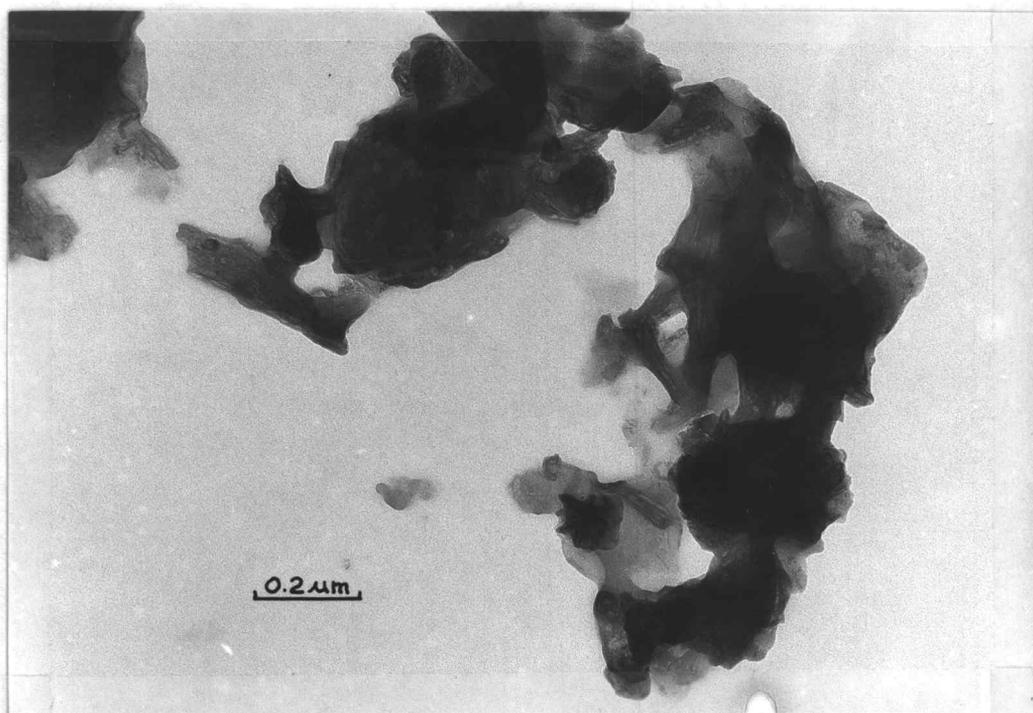
Plate 19. Electron micrographs of halloysite and amorphous material, site SS-SF-7.

under the electron microscope and appeared to be more distinctive (viz., ordered) in samples from the better drained sites which show indications of kaolinite in the XRD patterns. (An analogous arrangement of amorphous material within spheroidal halloysite was reported by Askenasy et al., 1973.) Often the conjugated masses were seen to take on a shape which roughly resembles that of kaolinite--crystals of which were also noted. Unfortunately, the micrographs of the better formed of these masses and of kaolinite crystals are of very low quality, and are therefore, not included.

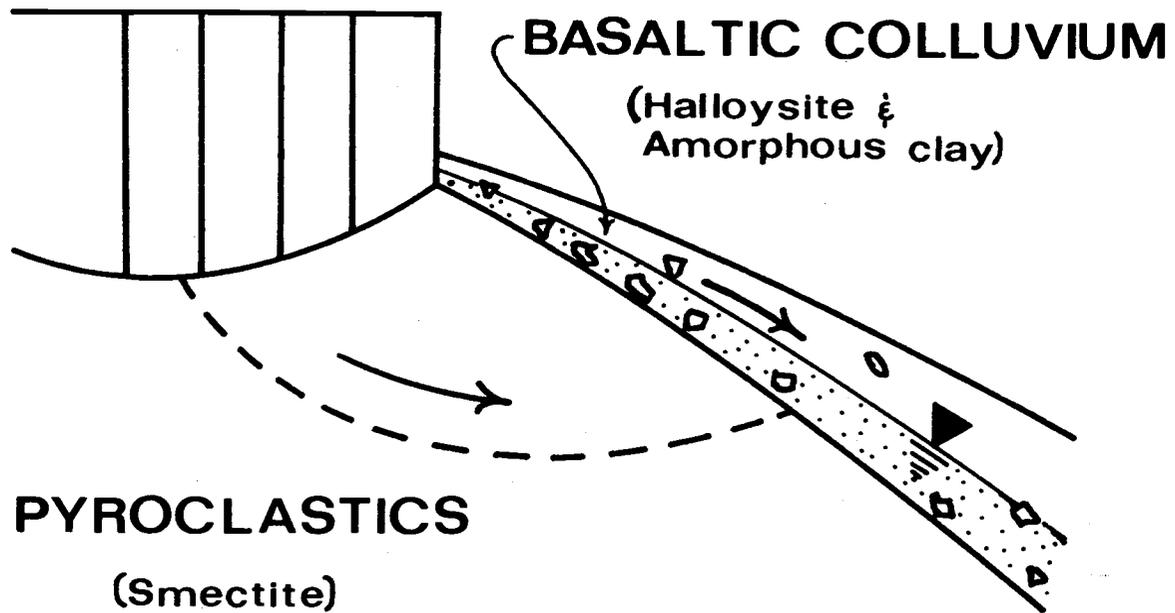
Figure 46. Rotational slump in smectite-rich, decomposed pyroclastic material capped by lava flow rock, and planar failure of basaltic colluvium containing halloysite and amorphous clays and a perched water table.

Large, well defined rotational slumps seem to be most prevalent in the headwater regions where lava flow rock, which provides a substantial overburden pressure, overlies weathered ignimbrite (Figures 4 and 46). Downcutting of the stream channel proceeds with relatively little resistance in the pyroclastic material, thus creating stream banks the heights of which rapidly approach the critical value (Capper and Cassie, 1976; Terzaghi and Peck, 1967). Concurrently, the critical height value decreases due to a reduction in cohesive strength of the slope materials by weathering. The result, once the critical height is attained, is a large rotational slump. The process is especially notable along the contacts of the Sardine and Little Butte Formations--areas which appear to have experienced the most spectacular mass failures. These relationships have also been observed by other investigators (Swanson and James, 1975; Personal communications with F. J. Swanson, Geologist and D. N. Swanston, Principal Geologist, Pacific Northwest Forest and Range Experiment Station, U. S. Forest Service, Corvallis, Oregon).

The andesitic or basaltic overburden gradually breaks into cobbles which move downslope, forming a layer of colluvium over the weathering pyroclastic material (Figure 46). Additionally, on many sites volcanic ash from more recent eruptions (e. g., Mt. Mazama) has become mixed with the colluvial deposits. The presence of the underlying montmorillonitic clay and plentiful water lead to the development of perched water tables in this soil. [The colluvial debris and ash weather to amorphous gel and hydrated halloysite, which in turn help to maintain the soil's relatively high water content throughout the year.] The combination of mineralogy, water and slope provides ideal conditions for the debris flows which commonly occur on top of the larger slump blocks.

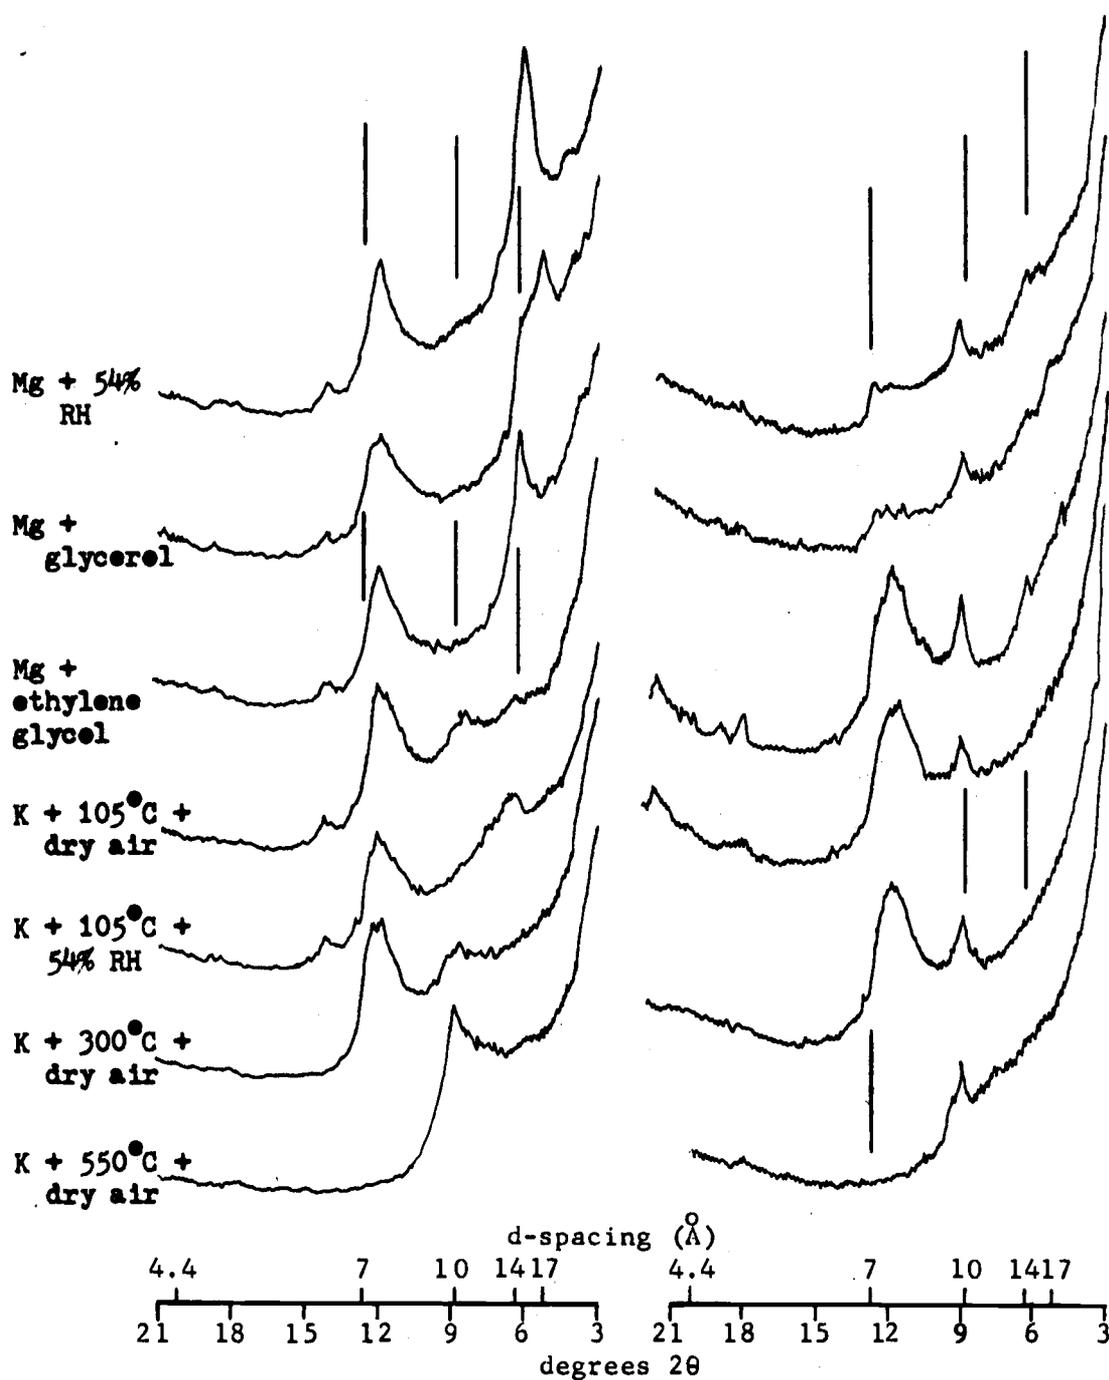
Figure 47. Site W-S-1 XRD patterns. Sample a (left), 1.5 m depth. Sample b (right), 2½ m depth.

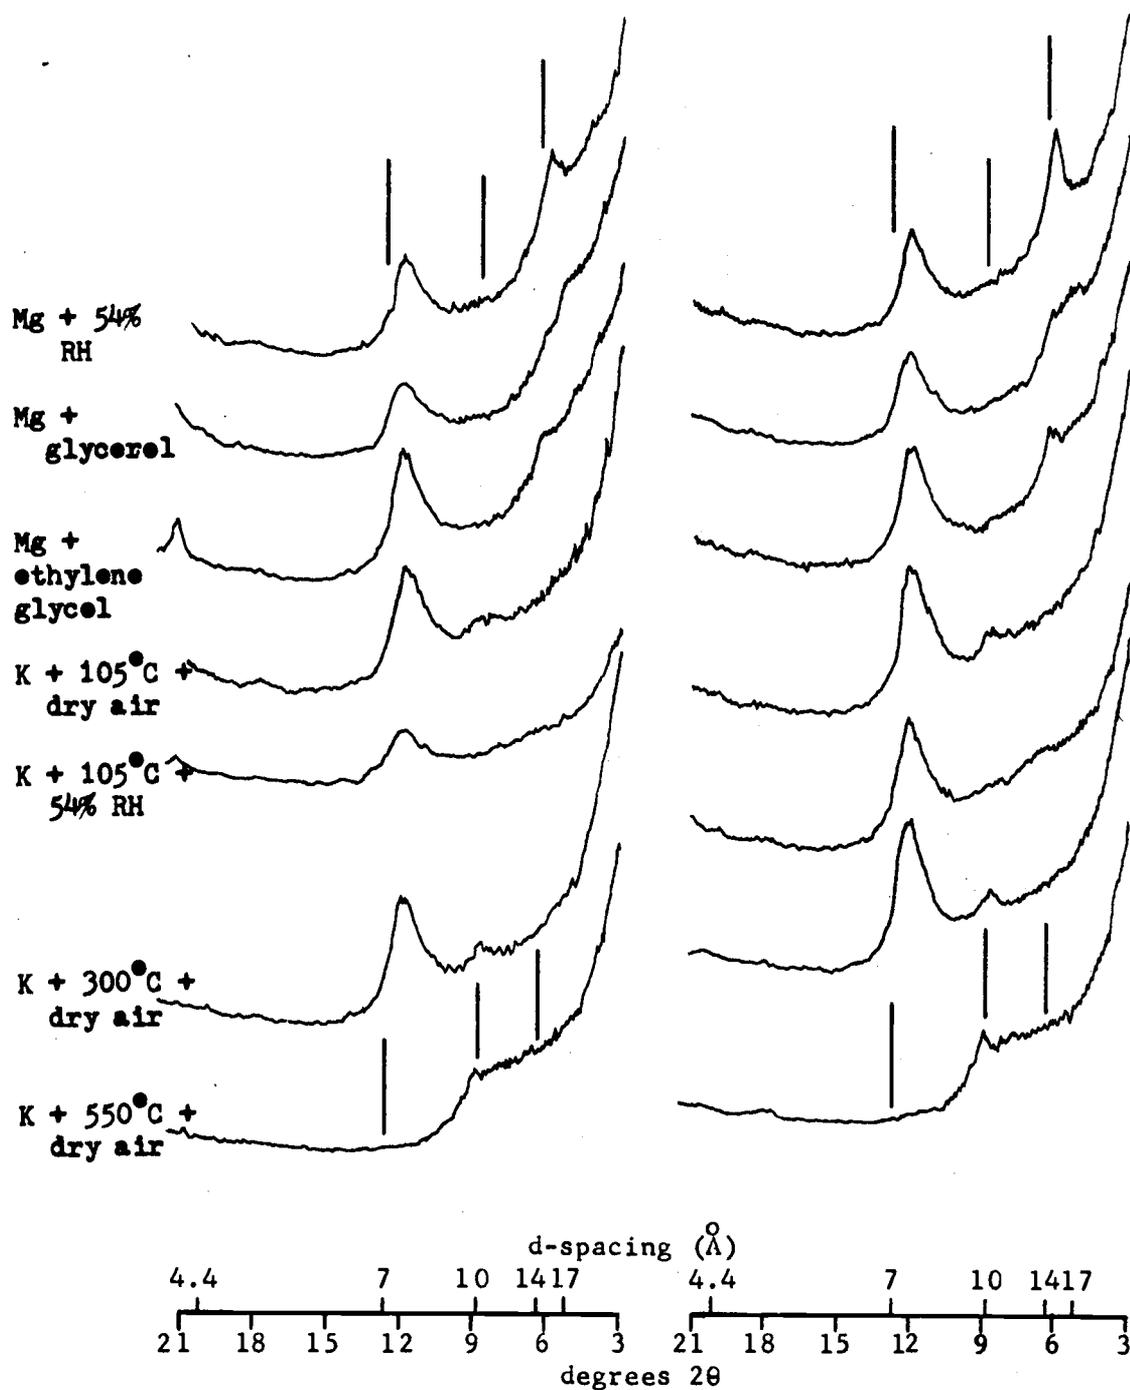
Figure 48. Site W-S-1 XRD patterns. Sample c (left), 3 m depth. Sample d (right) 4½ m depth.

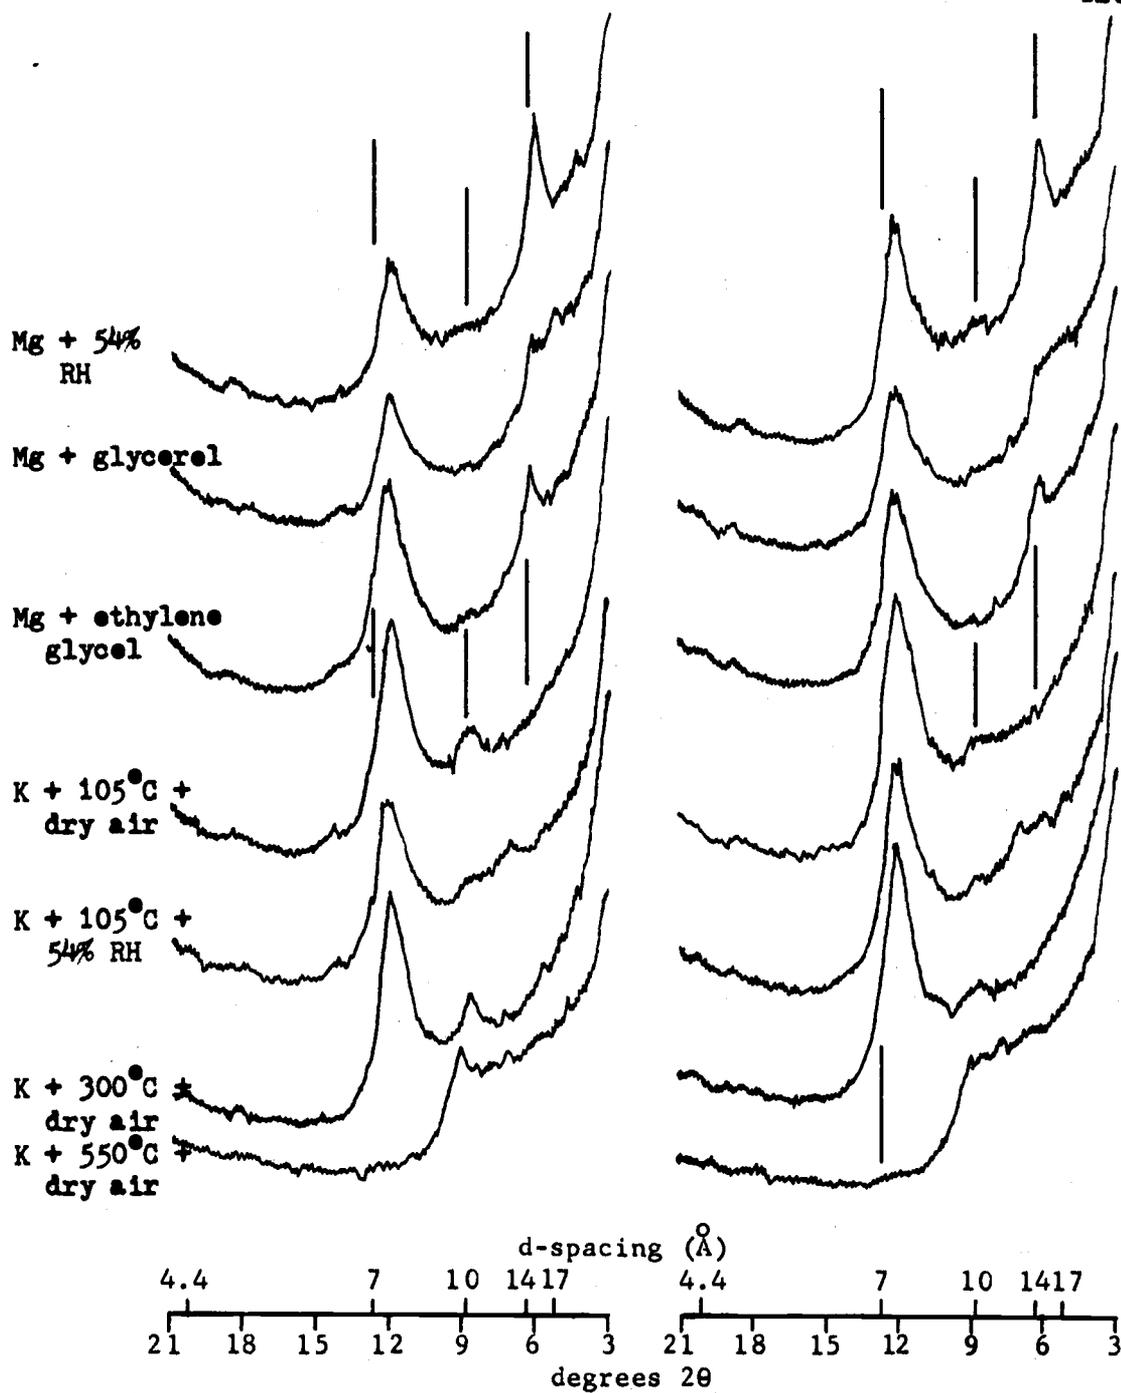
Figure 49. Site W-S-A XRD patterns. Sample 3 (left) 6 m depth. Sample f (right) 6 3/4 m depth.

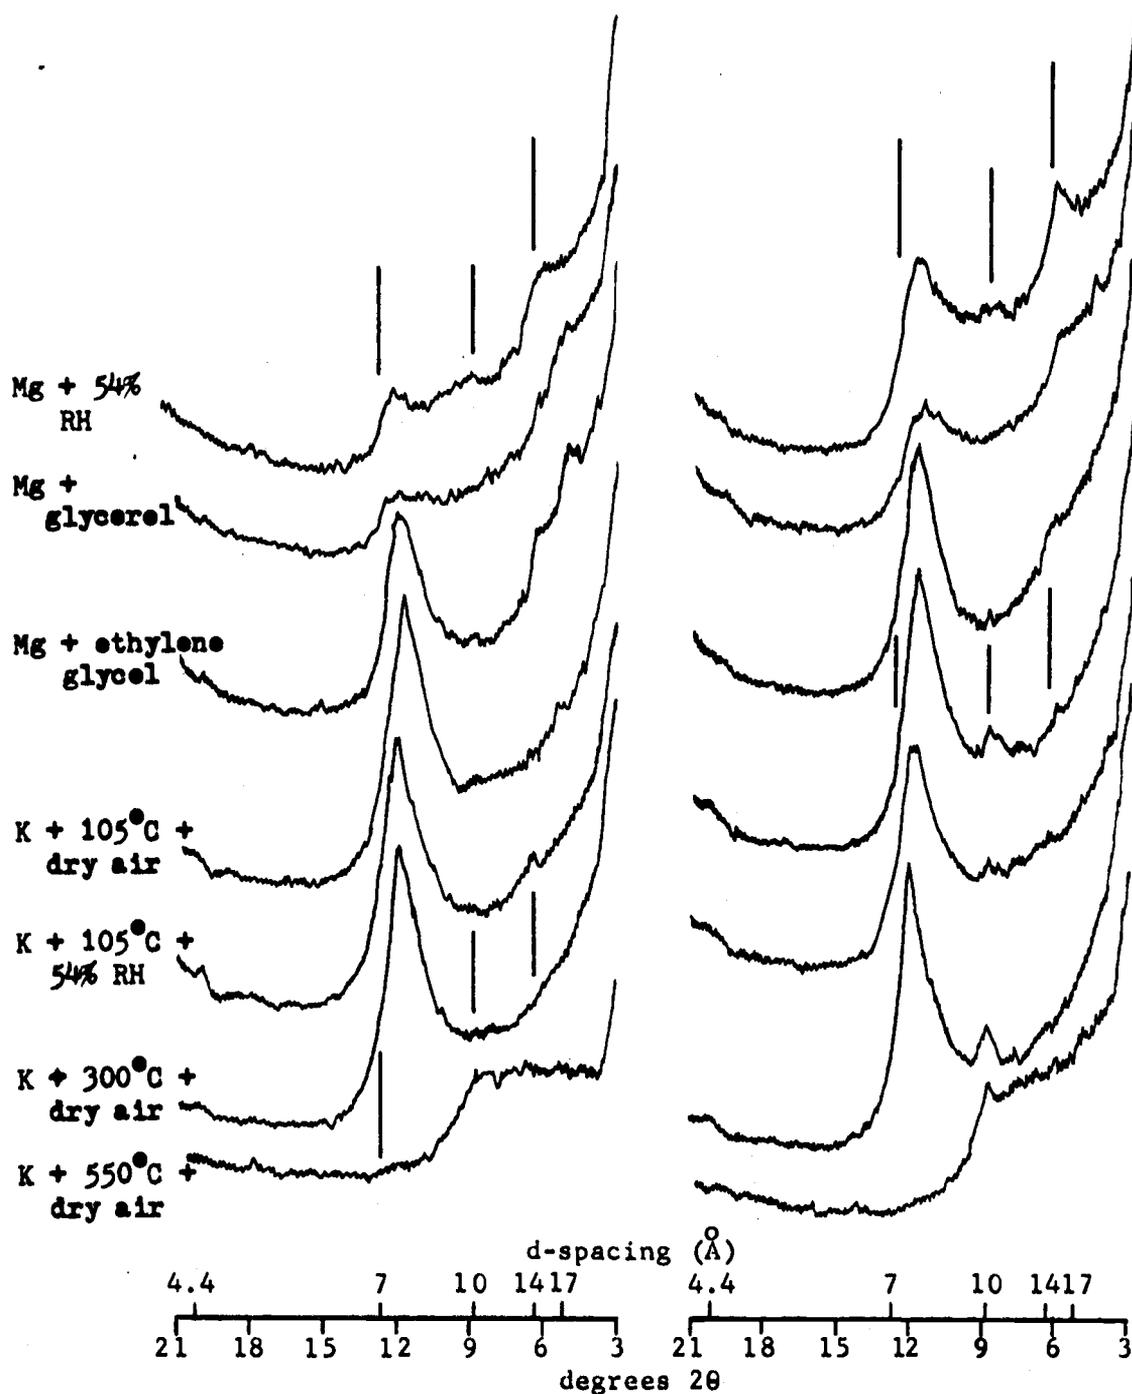
Figure 50. Site W-S-1 XRD patterns. Sample g (left), 8 m depth. Sample h (right), 10 m depth.

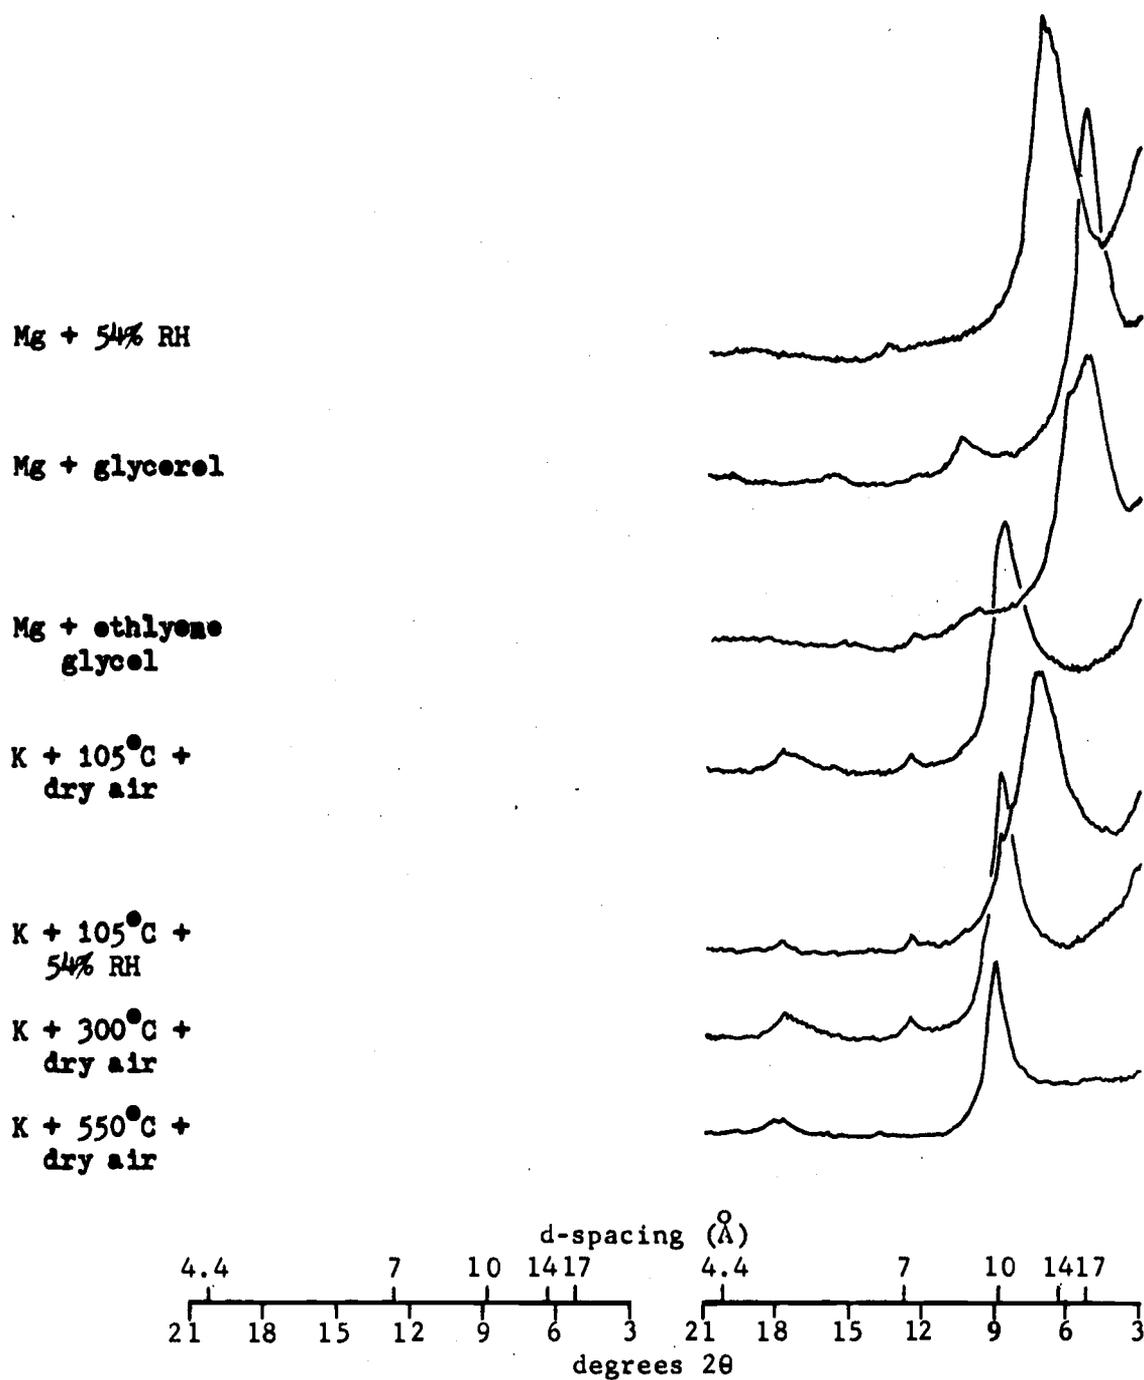
Figure 51. XRD patterns of montmorillonite clay from site JD-1, along the John Day River.

The other additional site outside of the Klamath Mountains, JD-1, is located along the highway near the John Day River north of Mitchell, Oregon. It consists of a moderate sized rotational failure with a well defined scarp wall in multicolored, clayey soil. The soil here, which has formed from the pyroclastic debris of the John Day Formation, appears typical of much of the plastic, clayey soil of the John Day country which has experienced some tremendous slumps in the distant past. As expected, the clay fraction consists of nearly pure smectite, most of which is montmorillonite, but with perhaps a beidellite component as well (Figure 51).

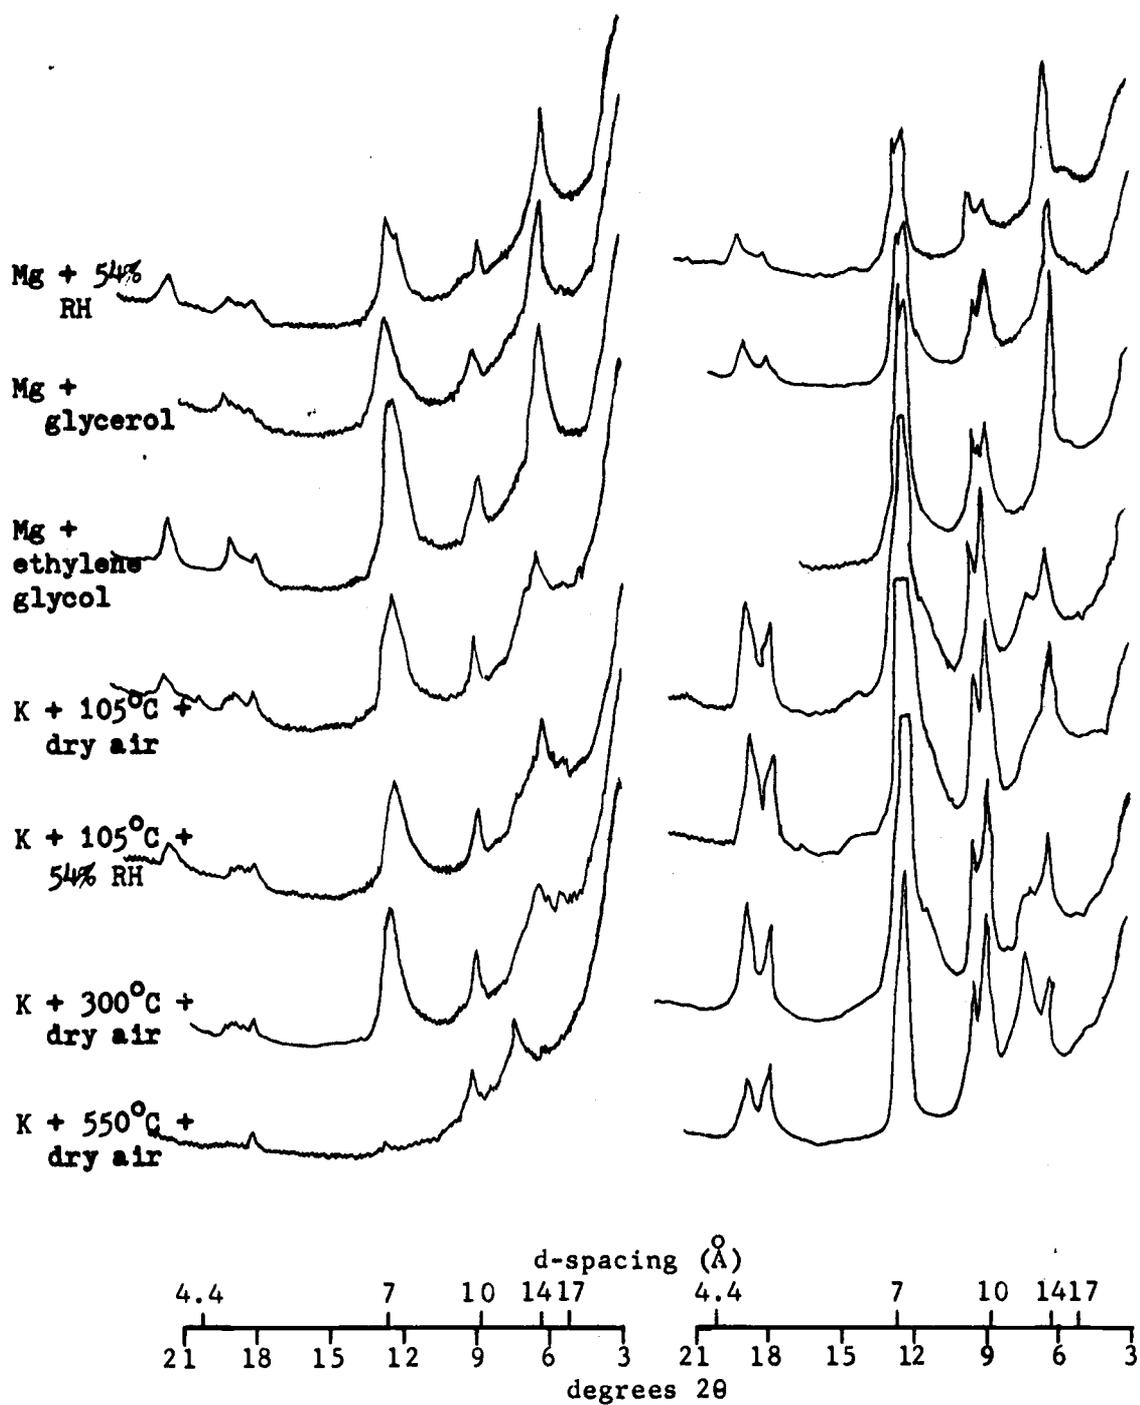
Figure 52. XRD patterns of clay in schistose material, site A-S-1a (left) and A-S-1b (right).

The XRD patterns of clay samples of this failure are quite complex (Figure 52). Sample a is from relatively stable material which is being rafted along within the large failure, and sample b is from the slip plane of one of the large toe slides at the creek. In both samples chlorite and mica are present as is probably vermiculite and kaolinite. Kaolinite typically is difficult to identify in the presence of chlorite due to possible confusion of the first order kaolinite line with that of second order chlorite (Brindley, 1961).

In this case, however, there is clearly a doublet (which is more obvious in the original patterns than in the reproductions) in the region of  $7.1 \text{ \AA}$  which very likely indicates the two components. In addition there is a doublet in the patterns of sample b in the region of  $10 \text{ \AA}$ , the lower spacing peak of which is interpreted as paragonite,

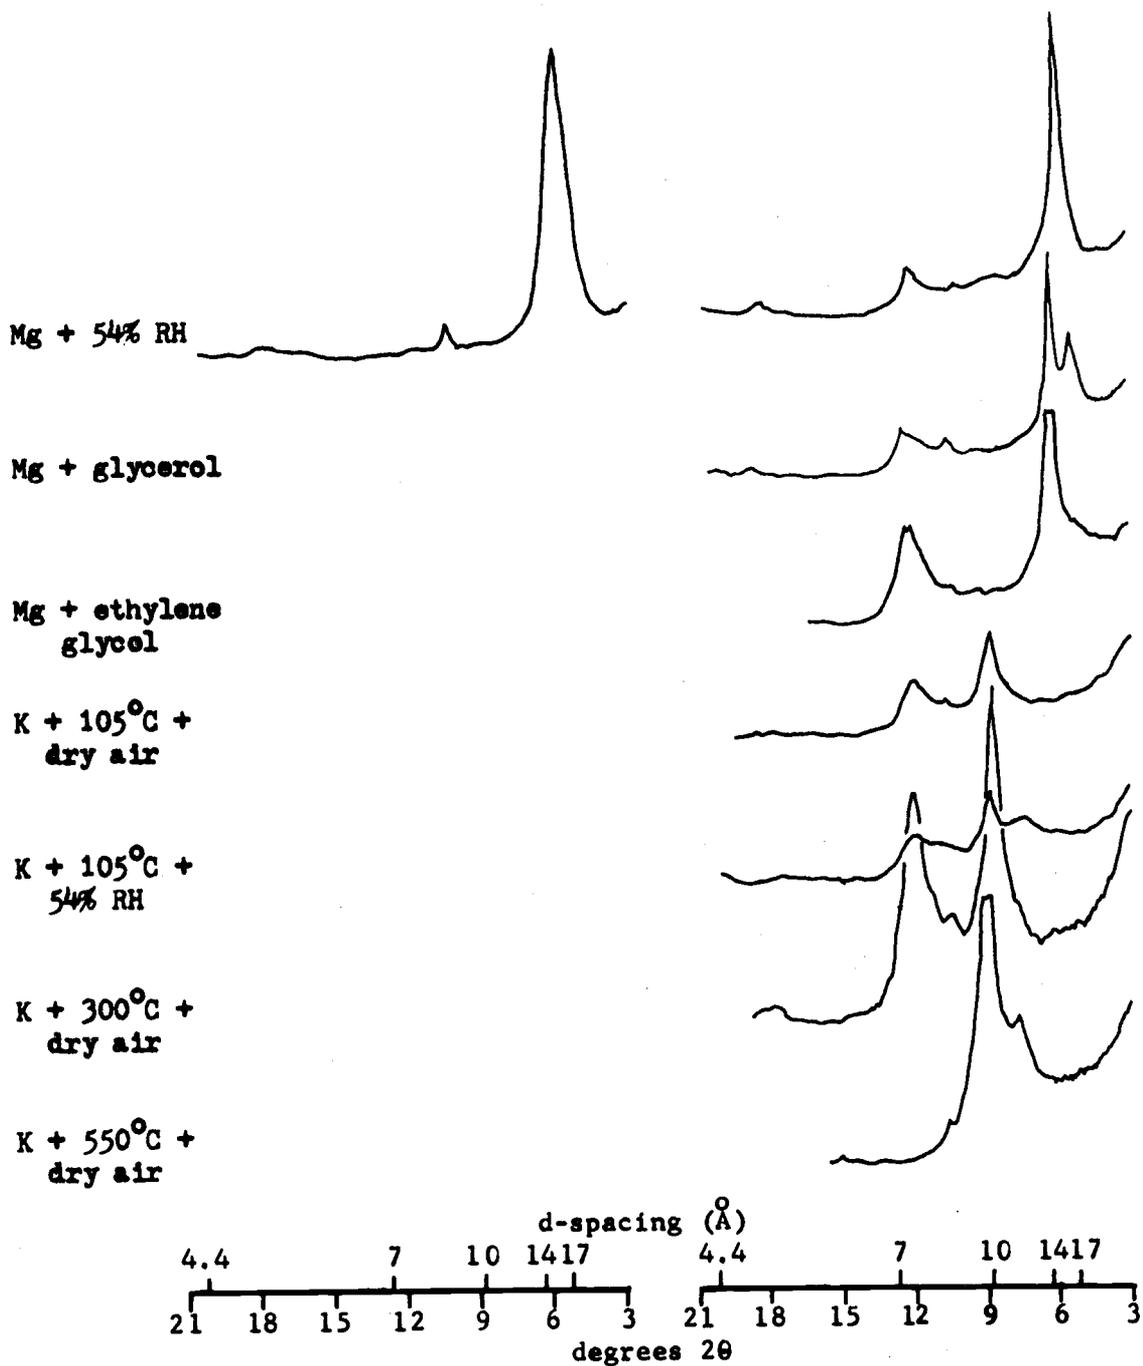
Figure 53. XRD patterns of greenish subsample c (left) and brown subsample d (right), site A-B-1.

A large failure in the Bigelow Creek drainage, site A-B-1, involved relatively complex and variable mineralogy. Samples c, d, e, and f are subsamples which represent materials of various colors at progressively greater depths within a  $3/4$  meter profile section of the failure surface; whereas sample b is a random sample of a nearby road cutbank. The XRD patterns indicate smectite (beidellite?), vermiculite, kaolin (disordered kaolinite?), mica, zeolite, some amorphous material, chloritic intergrade, and perhaps an interstratified component (Figures 53, 54, and 55). The complexity of the failure combined with the complexity and variability of the clays make it impossible to determine the relevance of the clay fraction to the failure process without further investigation. The main reason for presenting the data here is to point out the mineralogical variability of the area and to record the analyses for posterity.

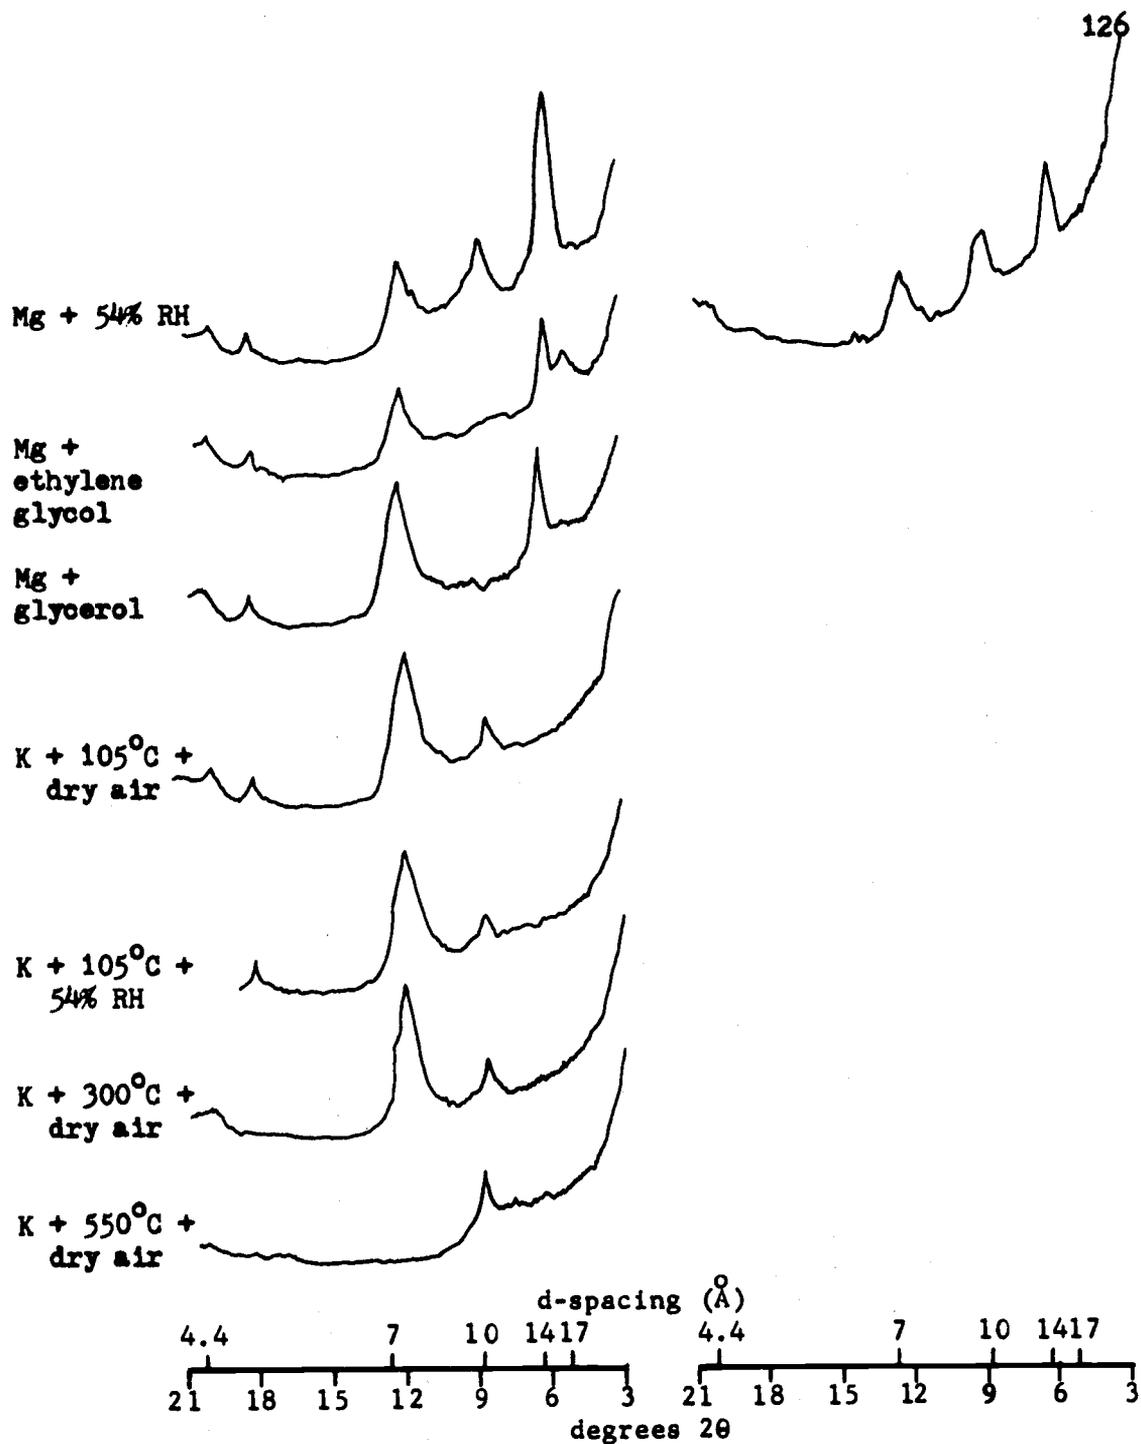
Figure 54. XRD patterns of orange-brown subsample e (left) and orange subsample f (right), site A-B-1.
