AN ABSTRACT OF THE THESIS OF

RONALD DAVID TASKEY for the DOCTOR OF PHILOSOPHY degree in SOIL SCIENCE presented on September 12, 1977

Title: RELATIONSHIPS OF CLAY MINERALOGY TO LANDSCAPE STABILITY IN WESTERN OREGON Redacted for Privacy

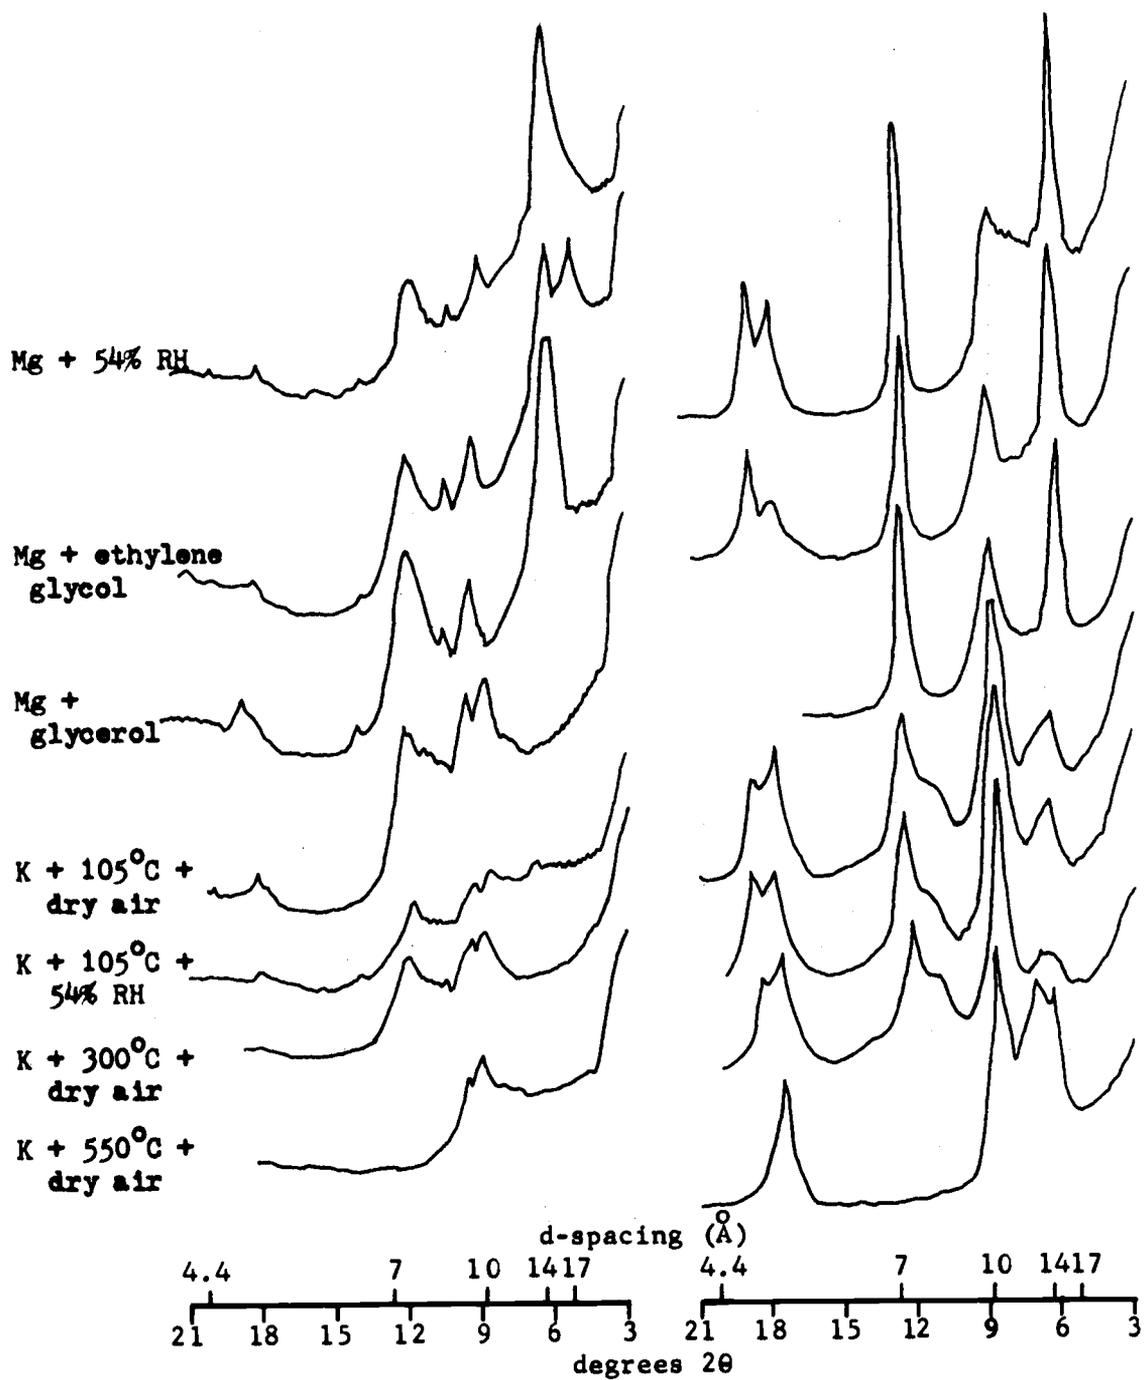
Figure 55. XRD patterns of clay sample A-B-1b (left) and R-WUR-1 (right).

A large failure in the Bigelow Creek drainage, site A-B-1, involved relatively complex and variable mineralogy. Samples c, d, e, and f are subsamples which represent materials of various colors at progressively greater depths within a  $3/4$  meter profile section of the failure surface; whereas sample b is a random sample of a nearby road cutbank. The XRD patterns indicate smectite (beidellite?), vermiculite, kaolin (disordered kaolinite?), mica, zeolite, some amorphous material, chloritic intergrade, and perhaps an interstratified component (Figures 53, 54, and 55). The complexity of the failure combined with the complexity and variability of the clays make it impossible to determine the relevance of the clay fraction to the failure process without further investigation. The main reason for presenting the data here is to point out the mineralogical variability of the area and to record the analyses for posterity.

Site R-WUR-1 is in an area of deep seated soil creep, rotational slumping and slow flowage in degraded schistose material with fragments of very hard argillite along the lower Rogue River. The soil's clay fraction, which is somewhat similar to that at Squaw Creek (A-S-1), consists of chlorite, mica, vermiculite, and a randomly interstratified component which is probably mica-vermiculite (Figure 55). Kaolinite may also be included, but its presence is unconfirmed.

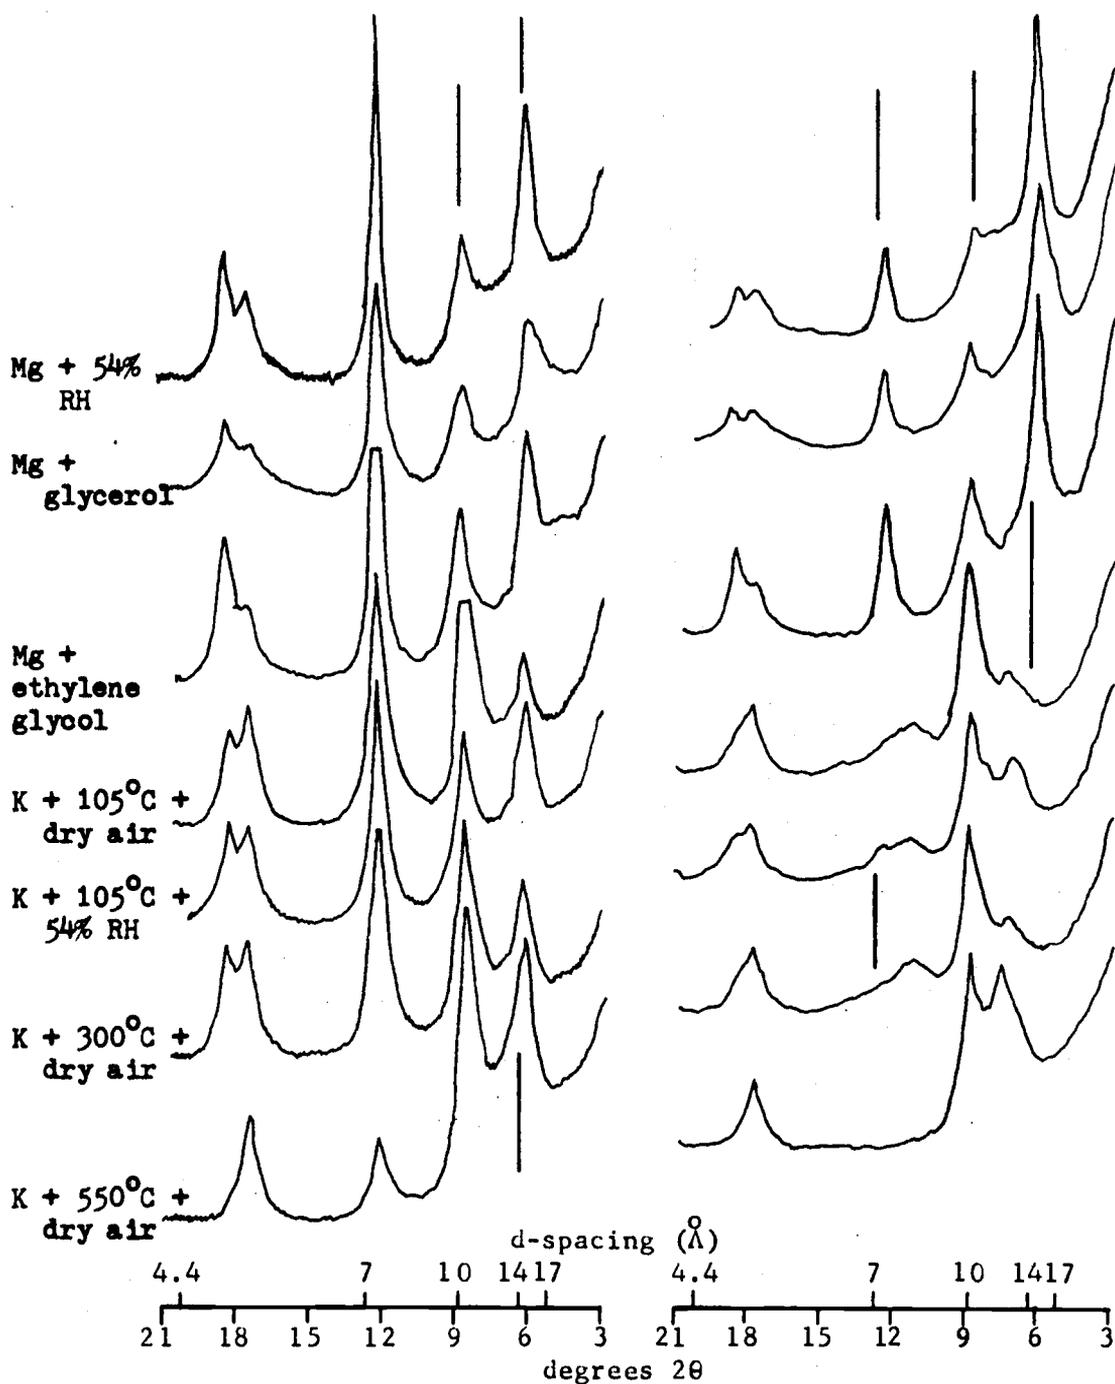
Figure 56. XRD patterns of failure material sample a (left) and failure surface sample b (right), site R-1.

Further down the Rogue, near Gold Beach, is an area of deep creep subject to slumping and earthflowing. The materials of the site, R-1, have undergone considerable mixing due to a long history of mass movement. The clays here are similar to those at site R-WUR-1 except for the presence of weakly displayed smectitic material (Figure 56). The samples were taken a few centimeters from each other in a moderate sized road bank failure; sample a represents the block of soil which has actually dropped away from the main bank, and sample b represents the soil of the bank failure surface. The patterns show much stronger  $7 \text{ \AA}$  peaks in sample a than sample b. (It is not known whether the  $7 \text{ \AA}$  peaks are due to kaolinite or second order chlorite.) They also show less evidence of chlorite in sample b than in a, and strong evidence of a randomly interstratified component in b. The significance, if any, that these differences may have to the stability of the site is undetermined.

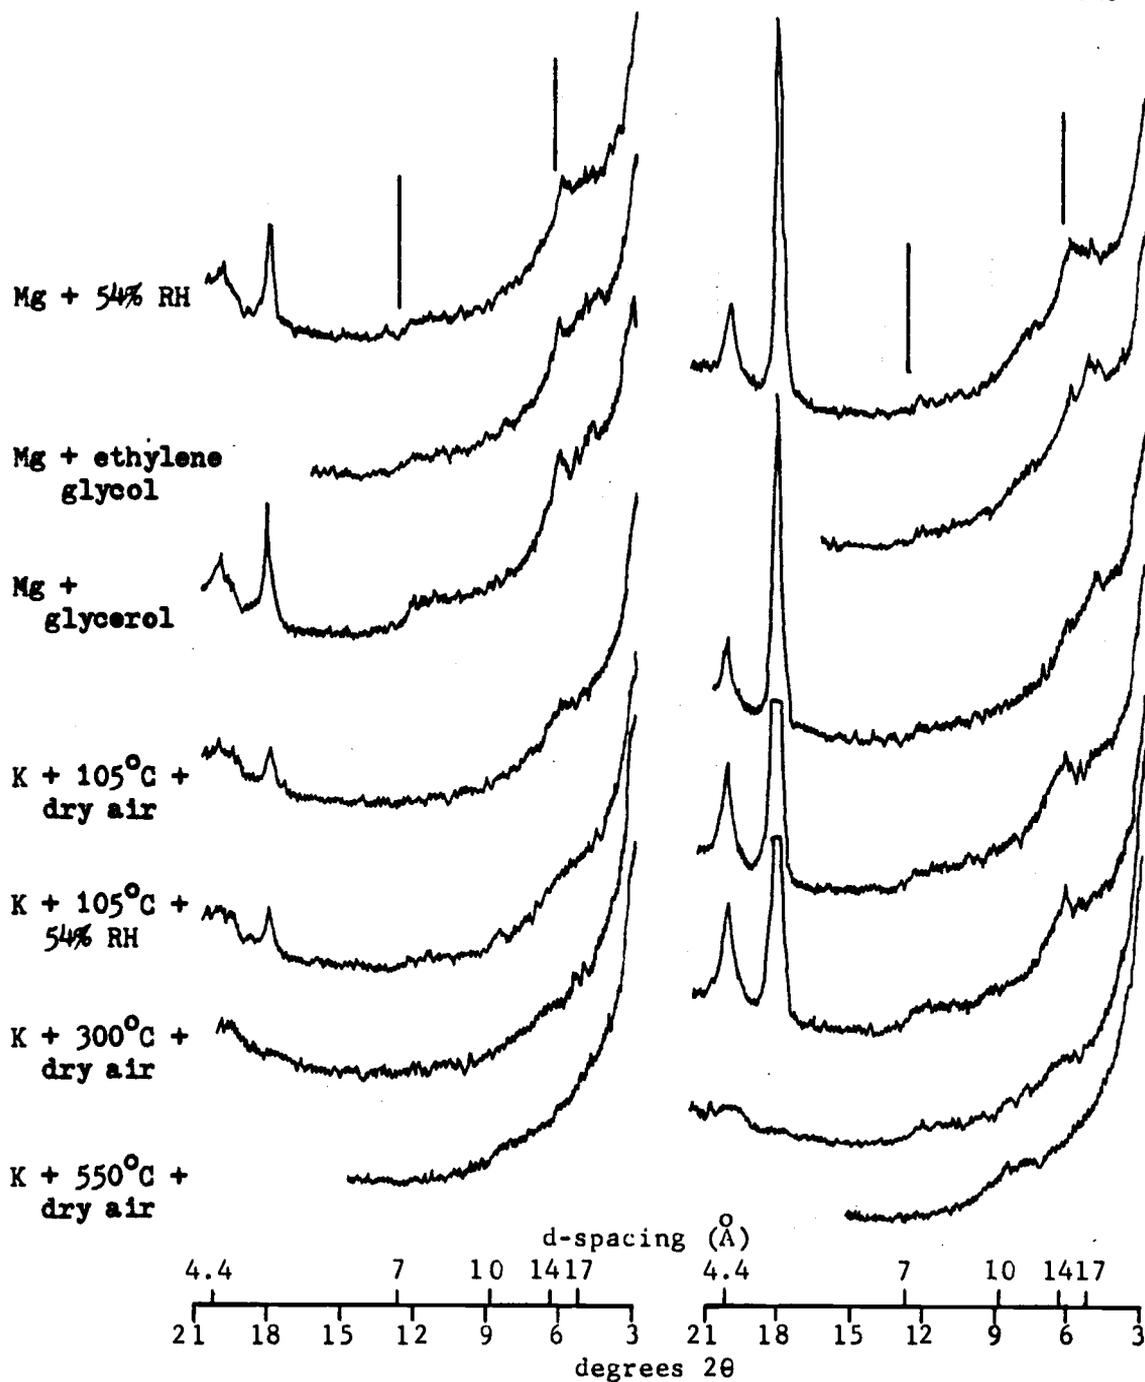
Figure 59. Site NS-BC-1 XRD patterns indicating amorphous material, gibbsite, chloritic intergrade and a trace of halloysite in samples a (left) and b (right).

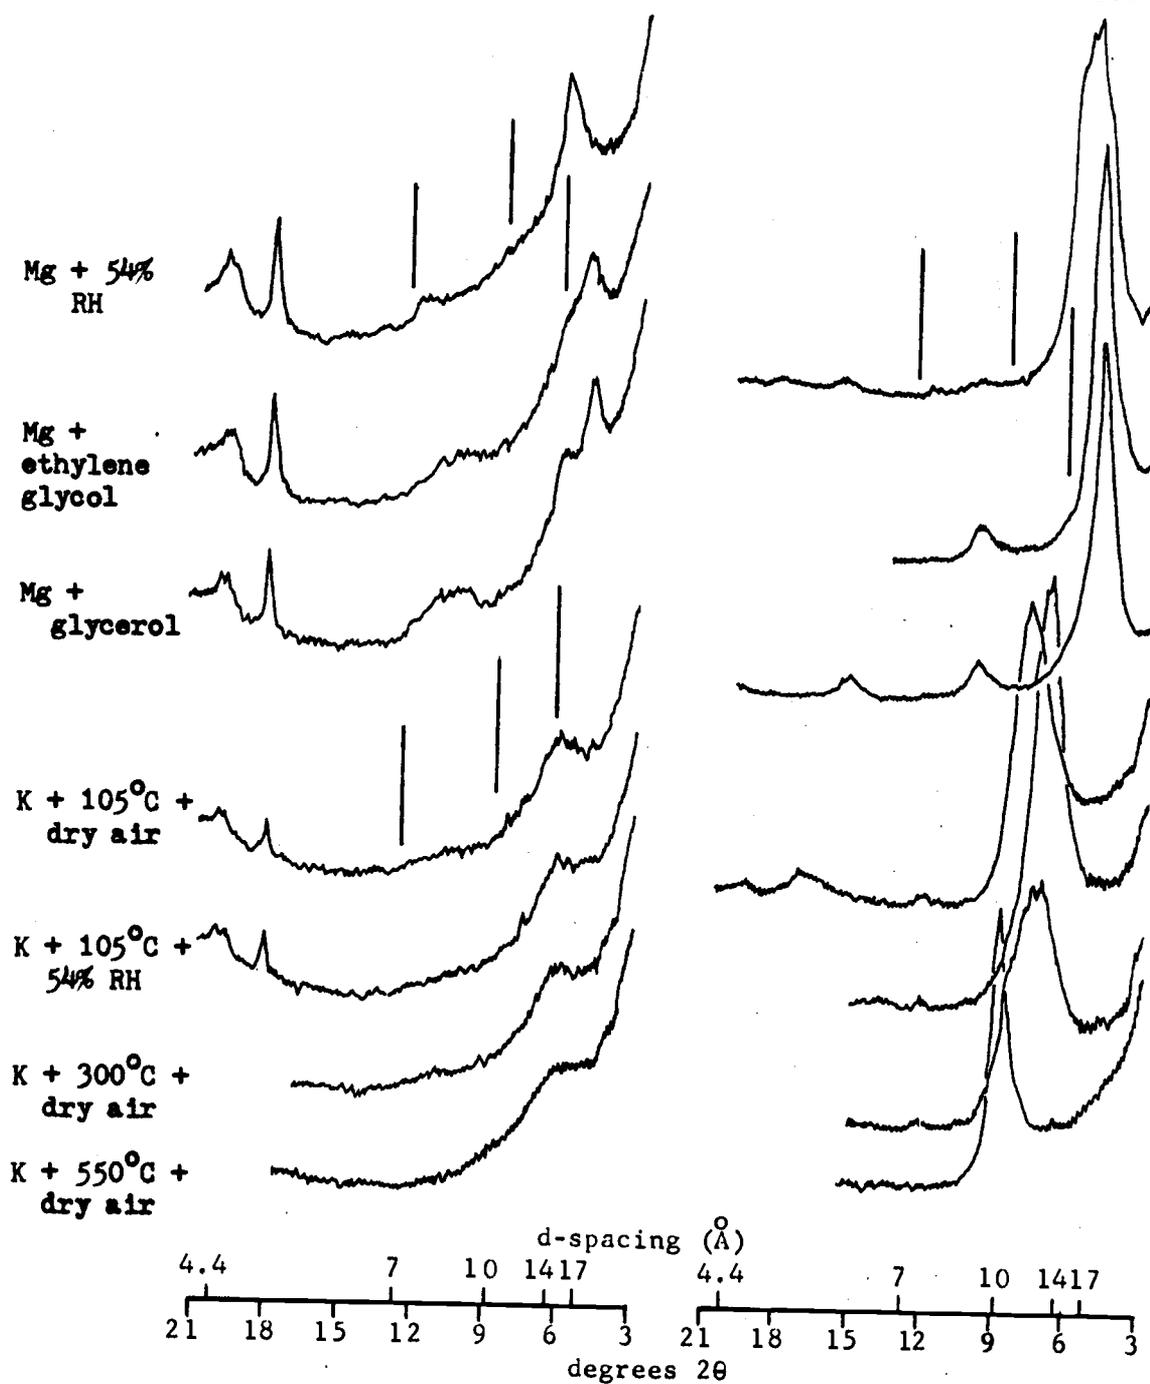
Figure 60. Site NS-BC-1 XRD patterns indicating chloritic intergrade, gibbsite, amorphous material and halloysite in sample c (left) and primarily montmorillonite in sample e (right).

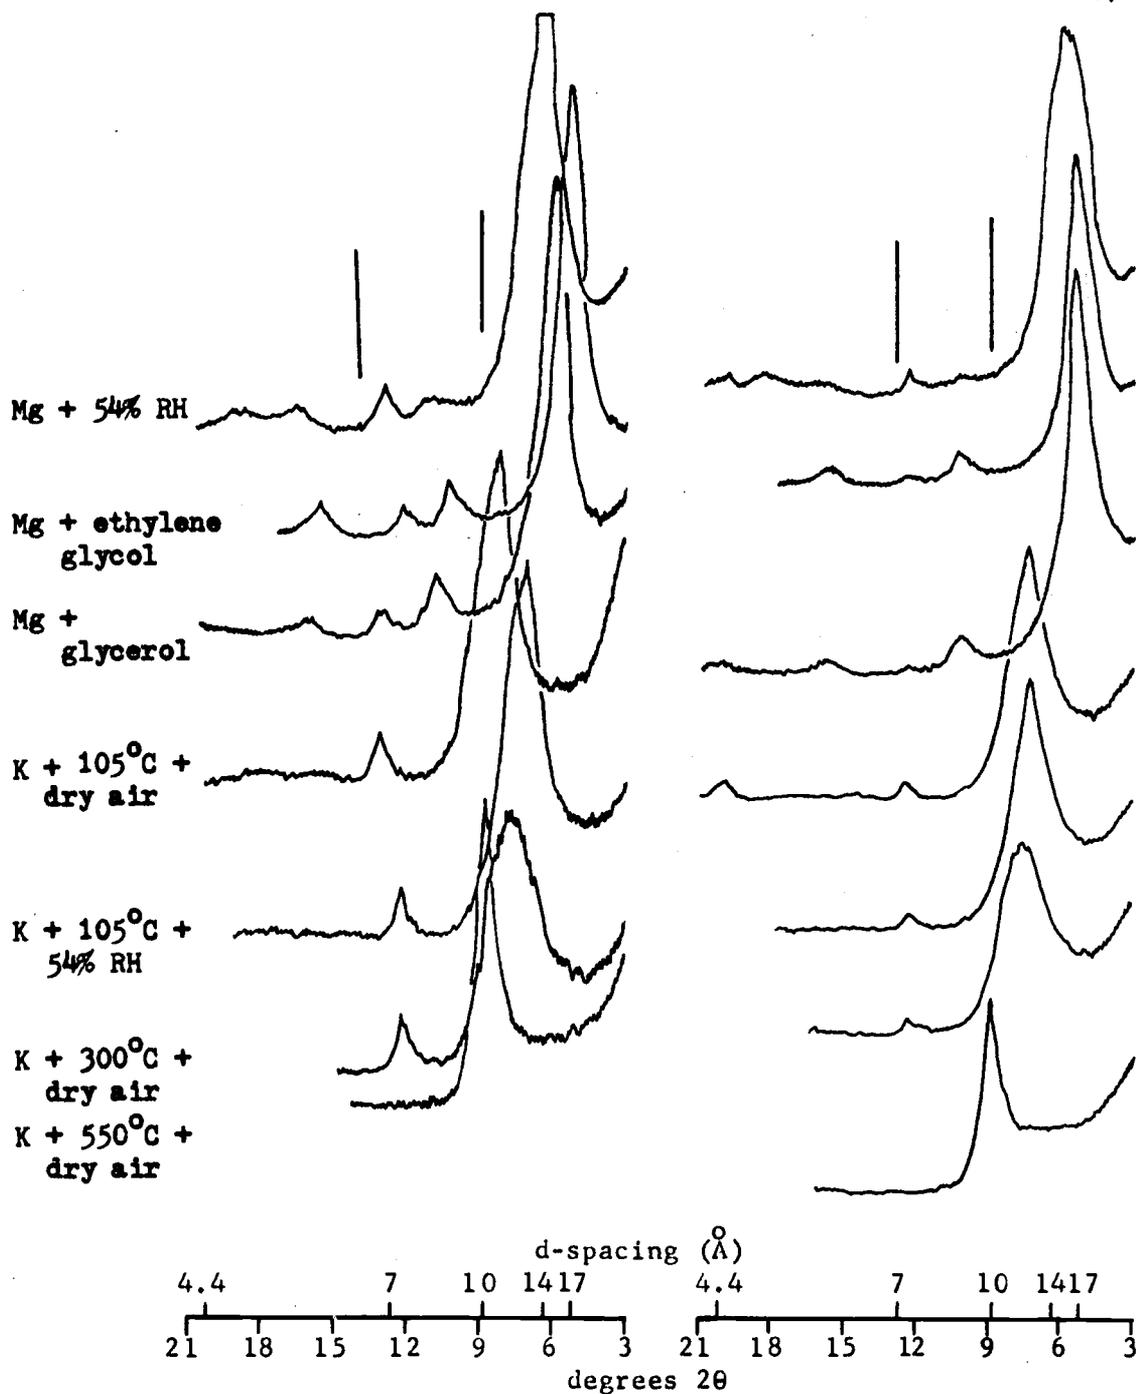
Figure 61. Site NS-BC-1 XRD patterns, indicating mentmorillonite in samples d (left) and f (right).

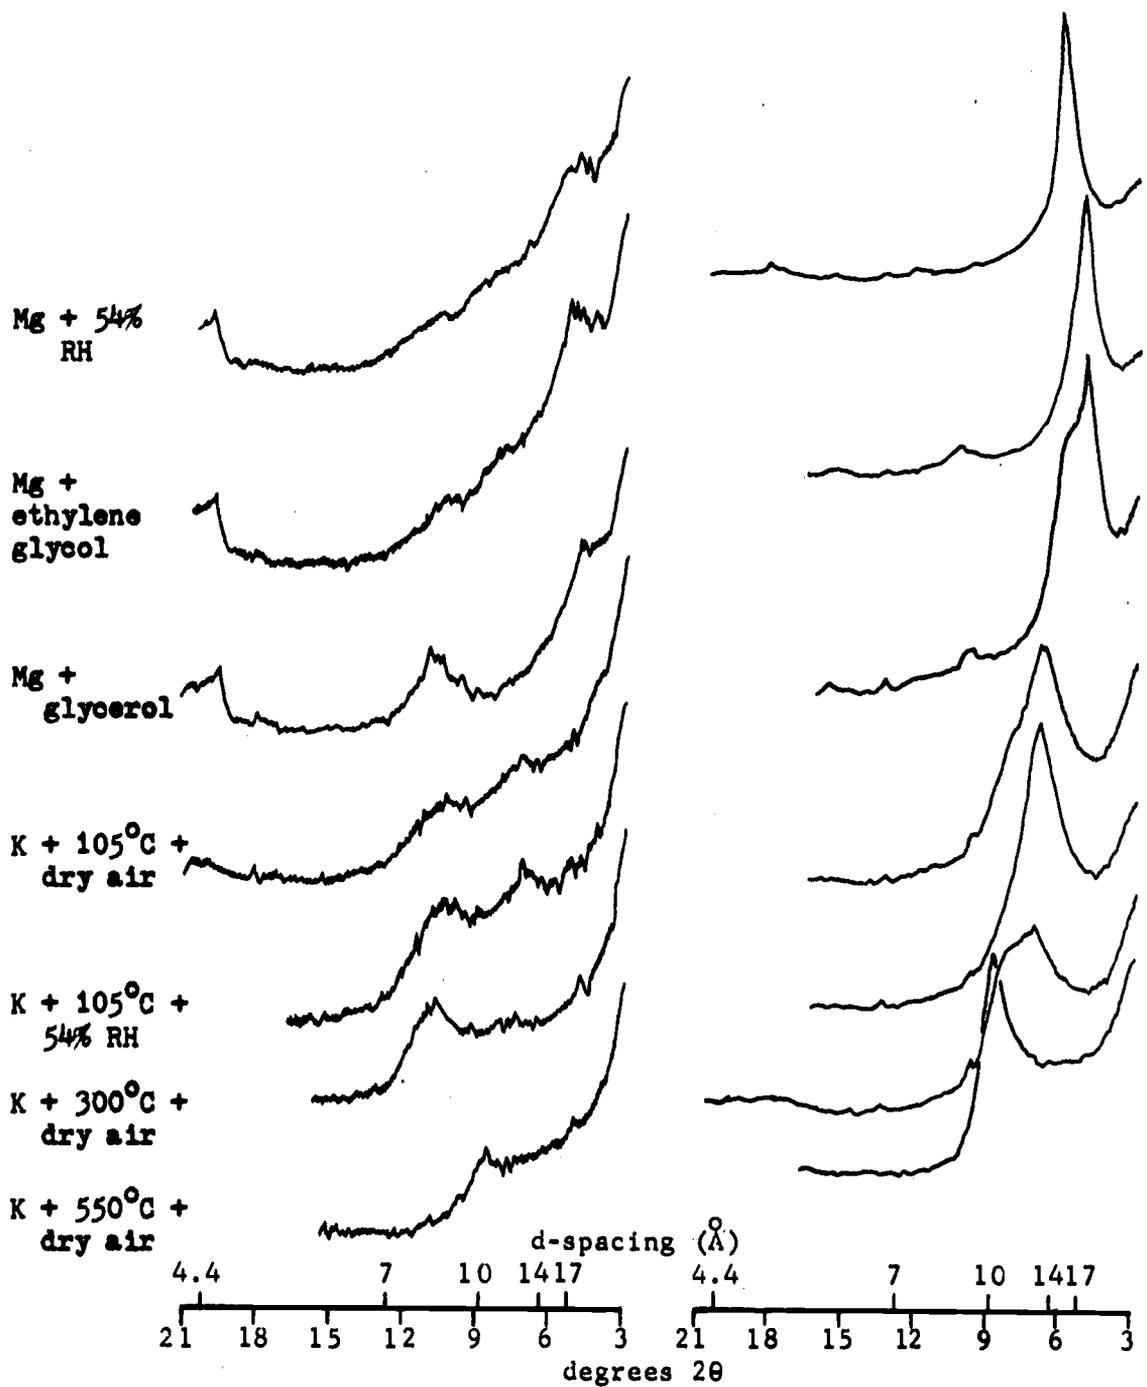
Figure 62. Site NS-BC-2 (left) debris flow soil and MS-D-1 (right) from Knob Rock scarp.

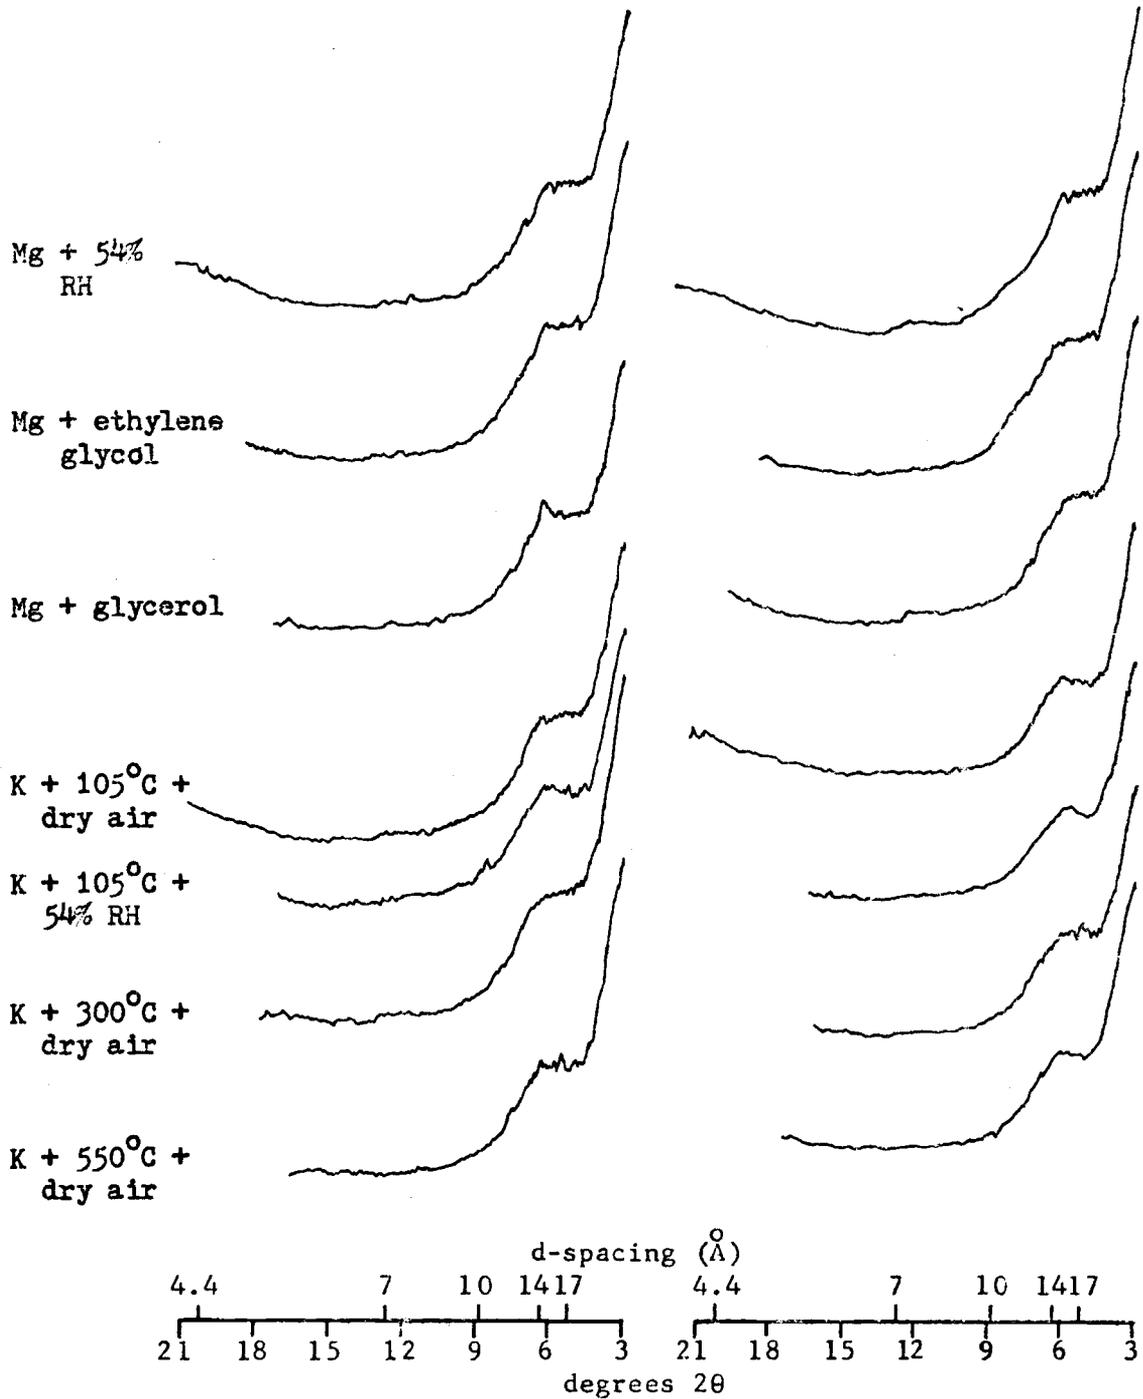
Figure 63. Site MS-P-1 XRD patterns indicating amorphous material, chloritic intergrade and a trace of halloysite in samples a (left) and b (right).

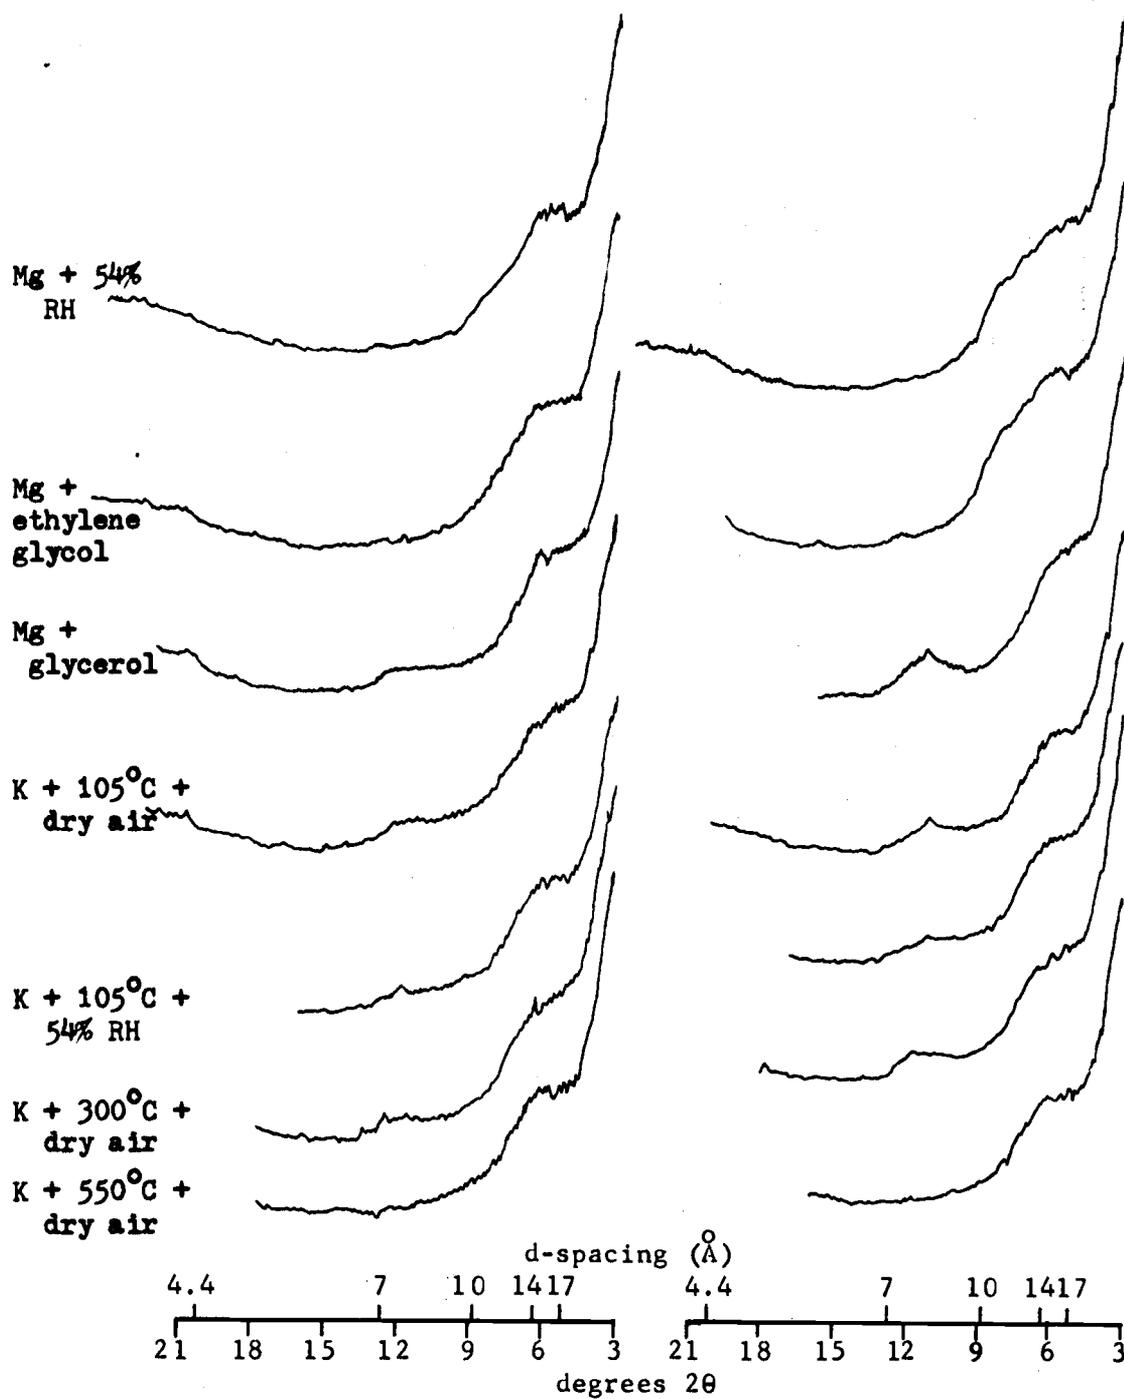
Figure 64. Site MS-P-1 XRD patterns, sample c (left) and sample d (right).

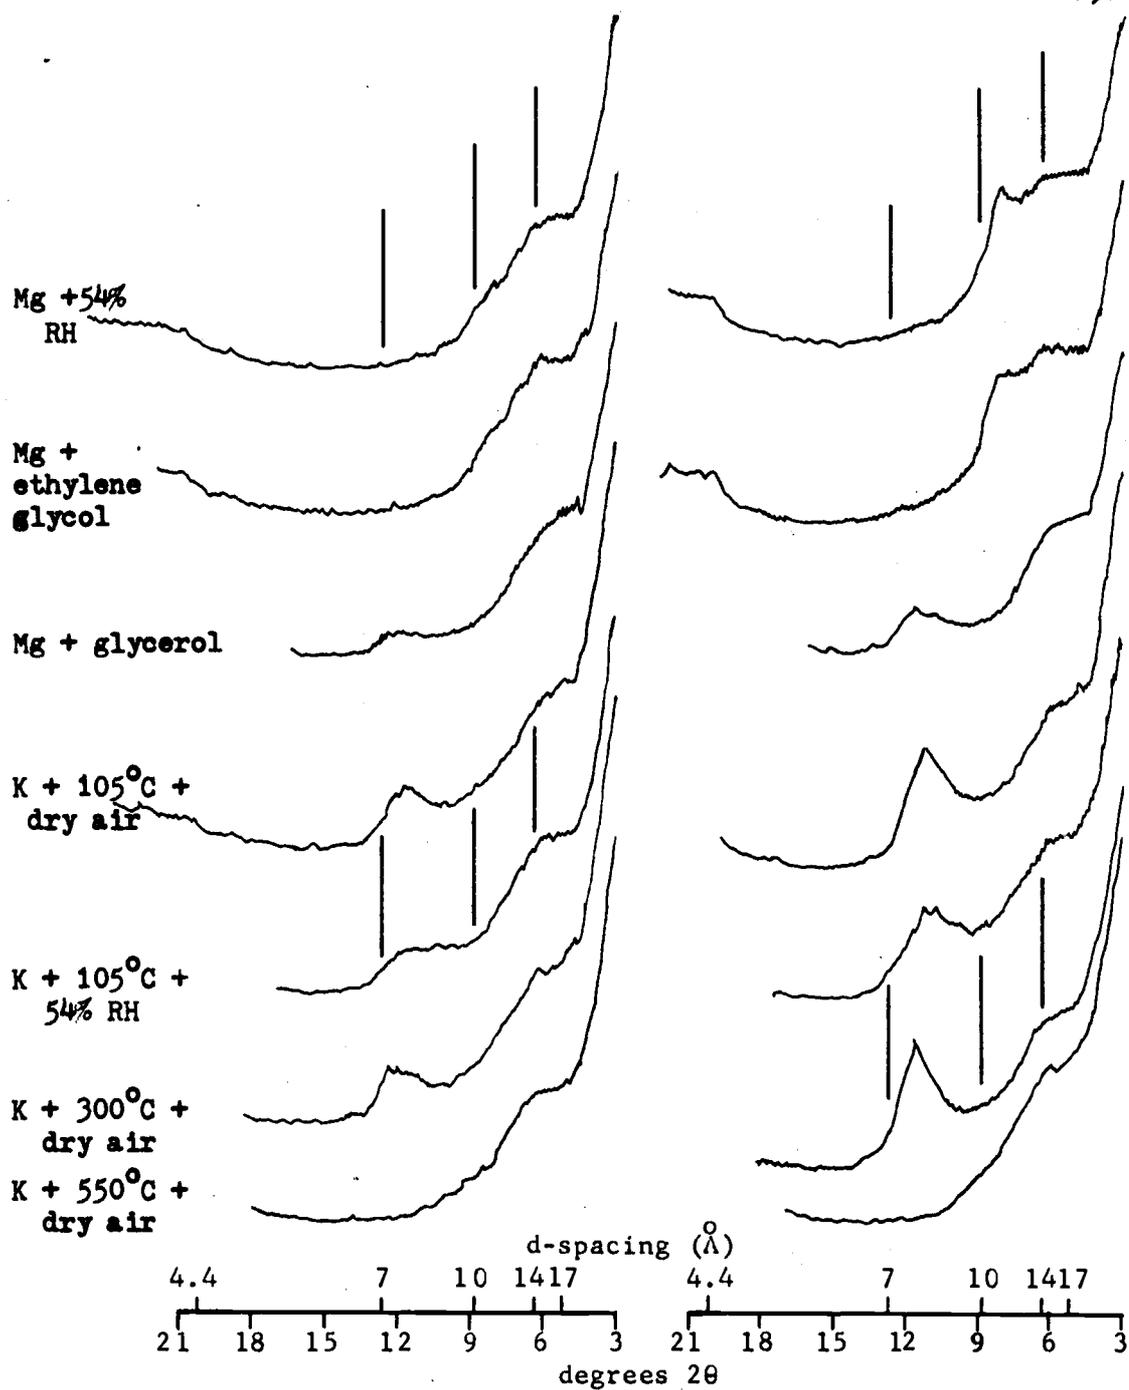
Figure 65. Site MS-P-1 XRD patterns, sample e (left) and sample f (right).

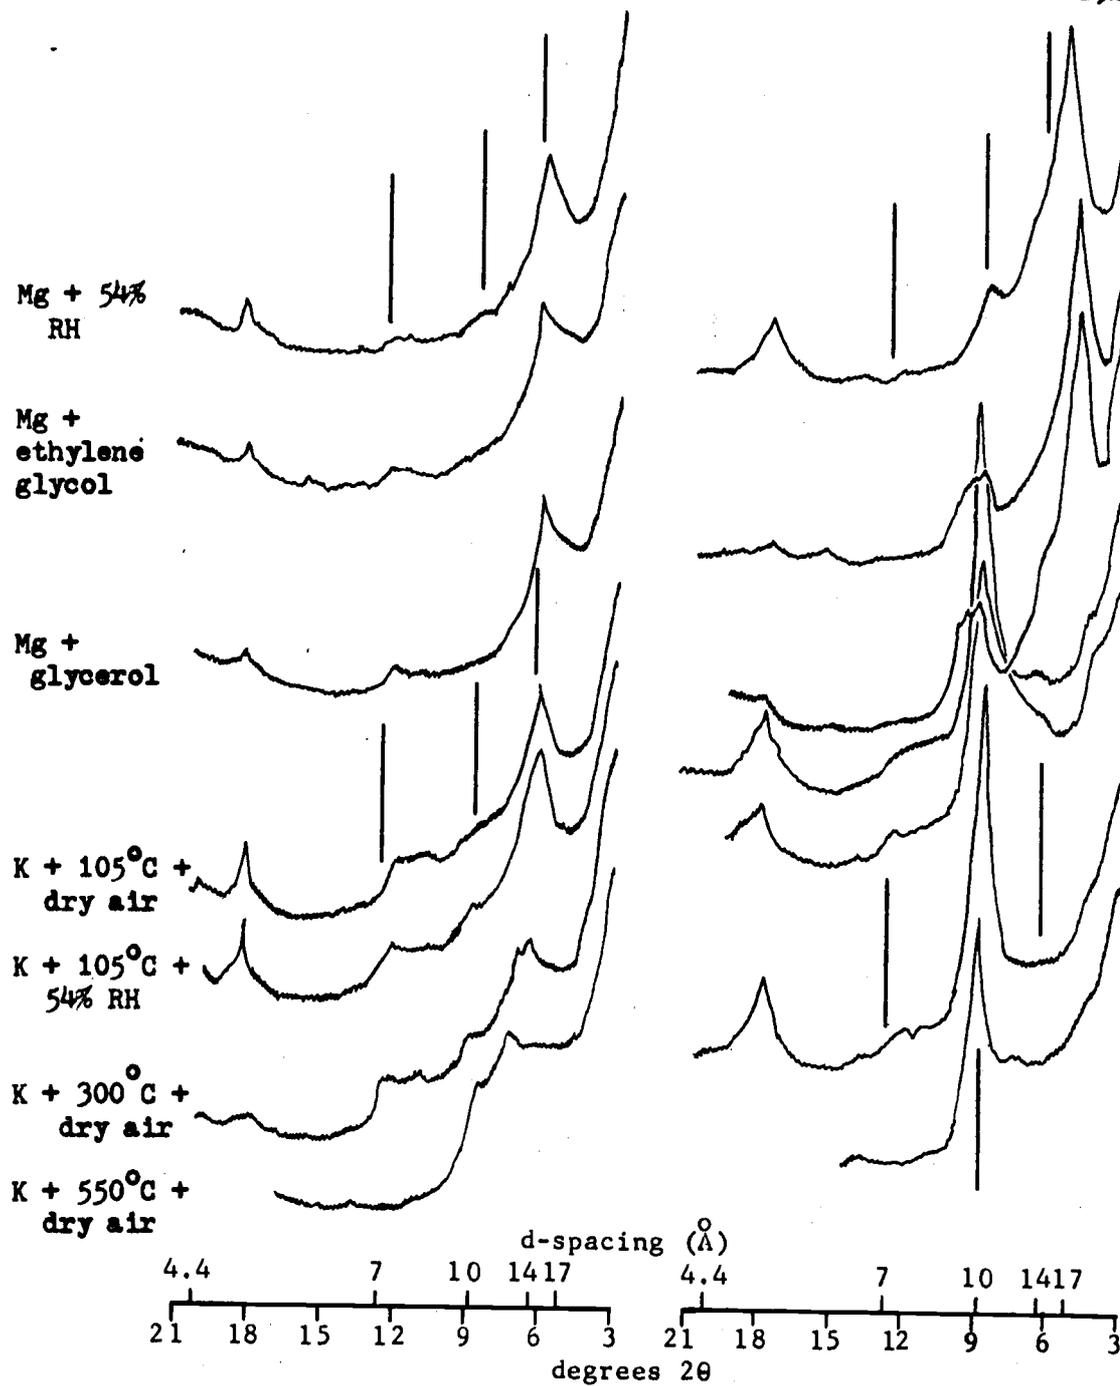
Figure 66. Site MS-J-1 XRD patterns, sample a (left) and sample b (right).

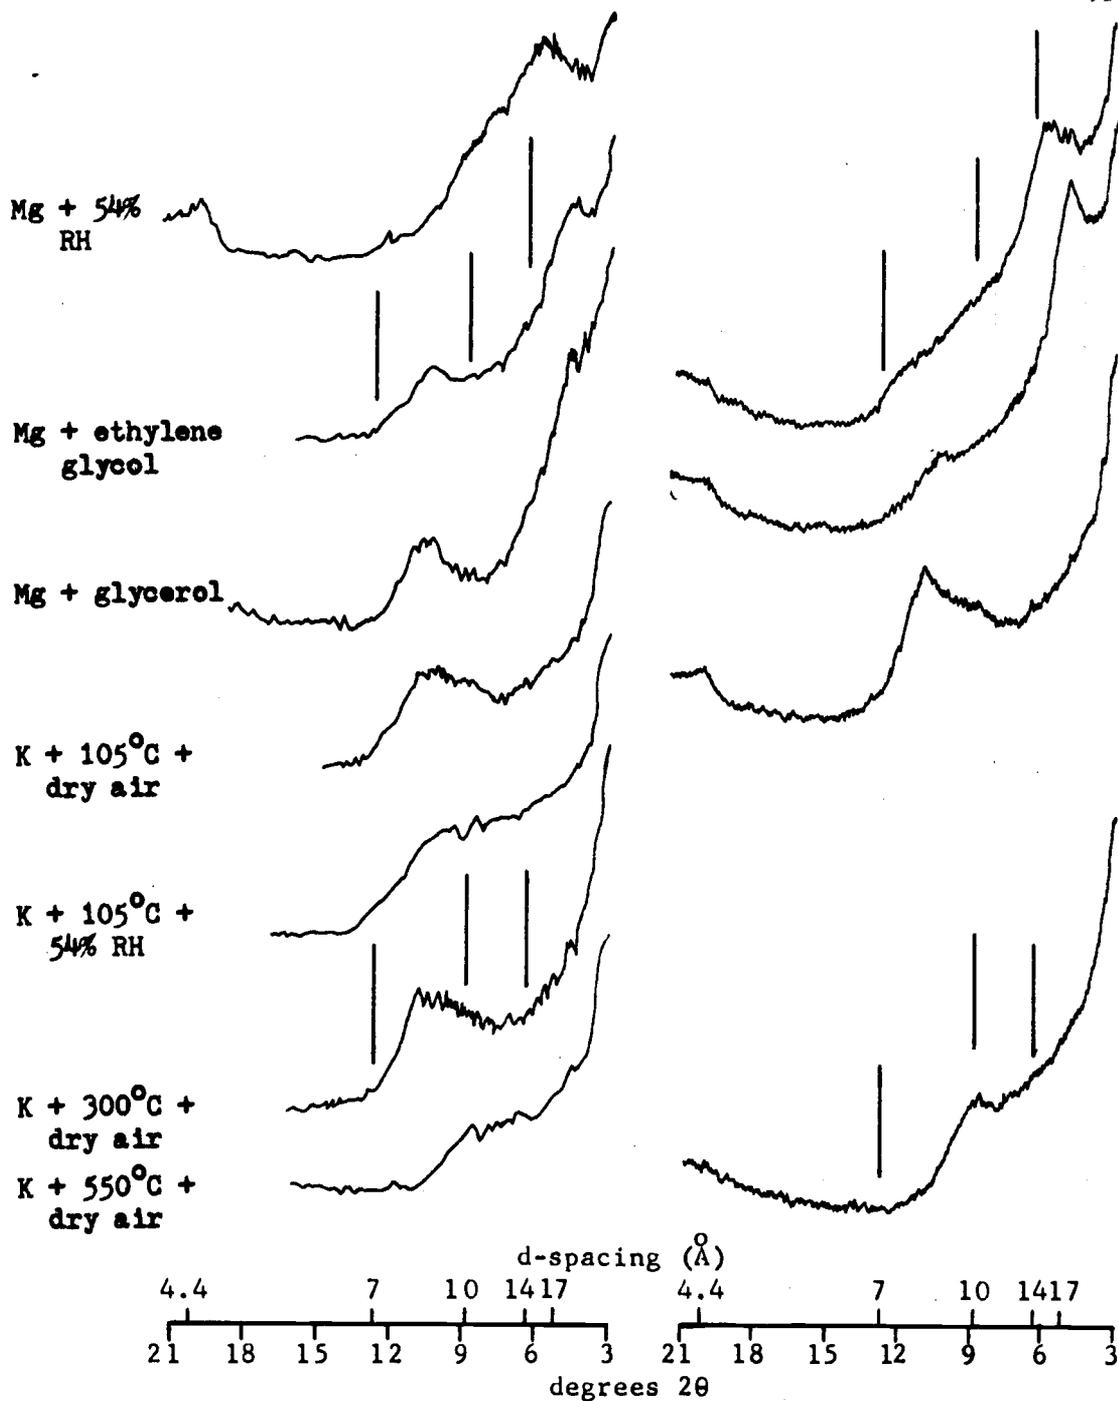
Figure 67. Site MS-3 XRD patterns of clay formed in reddish breccia, sample a (left) and sample b (right).

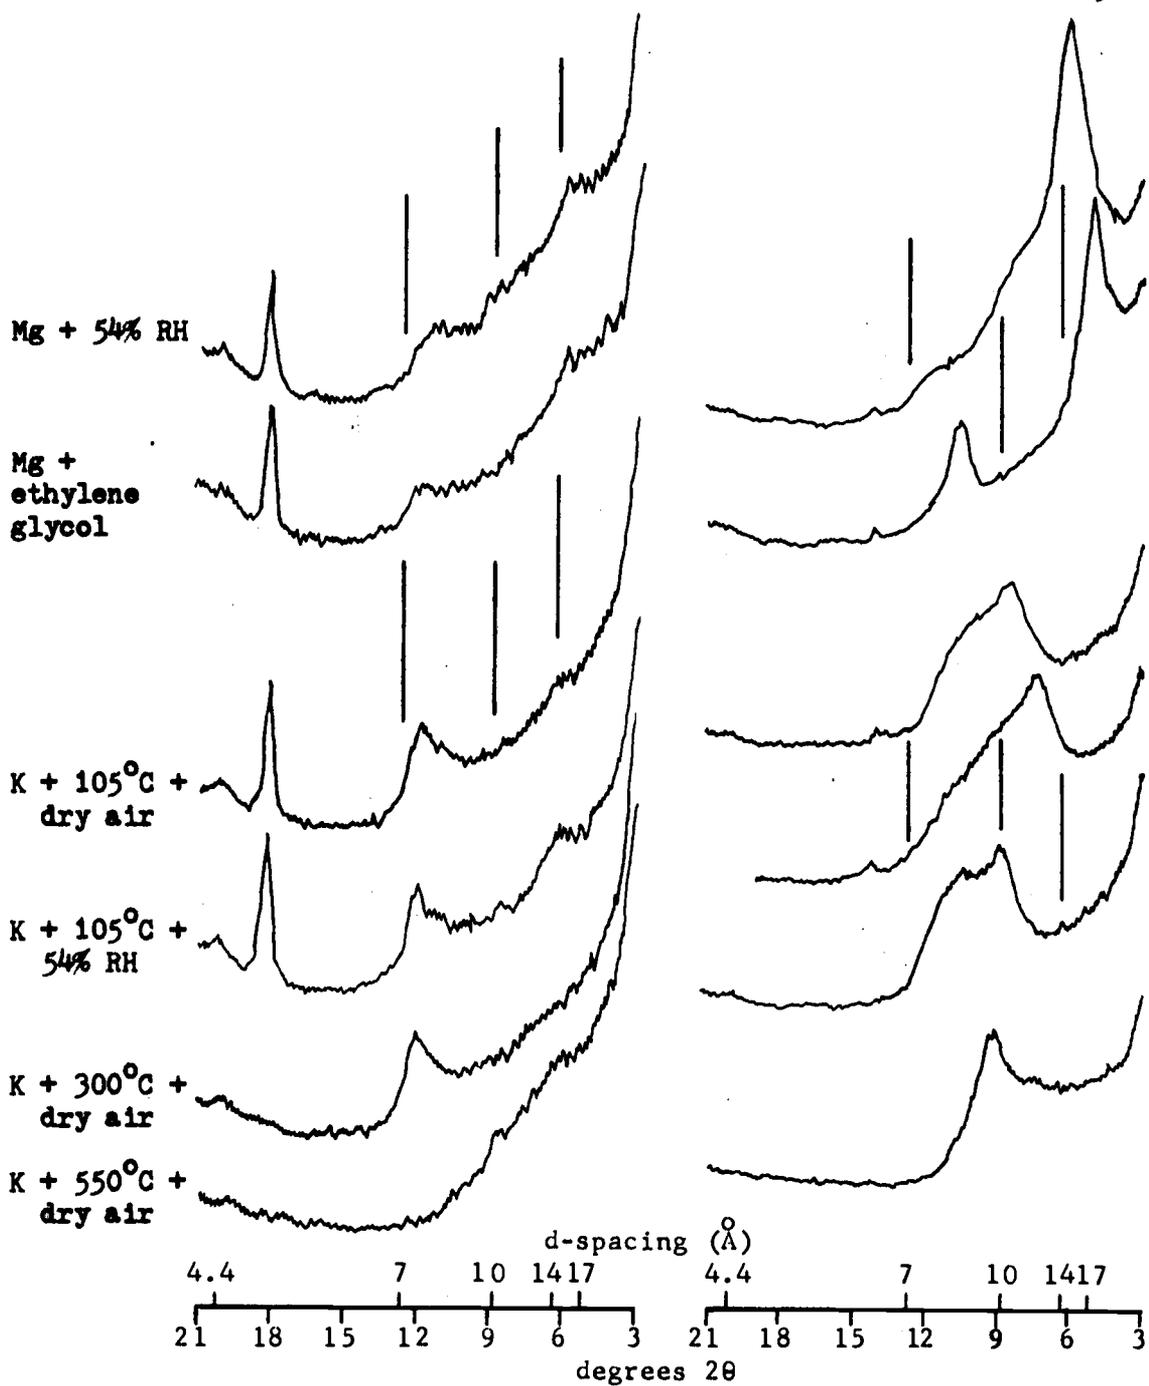
Figure 68. Site SS-SF-1 XRD patterns, sample a (left), sample b (right).

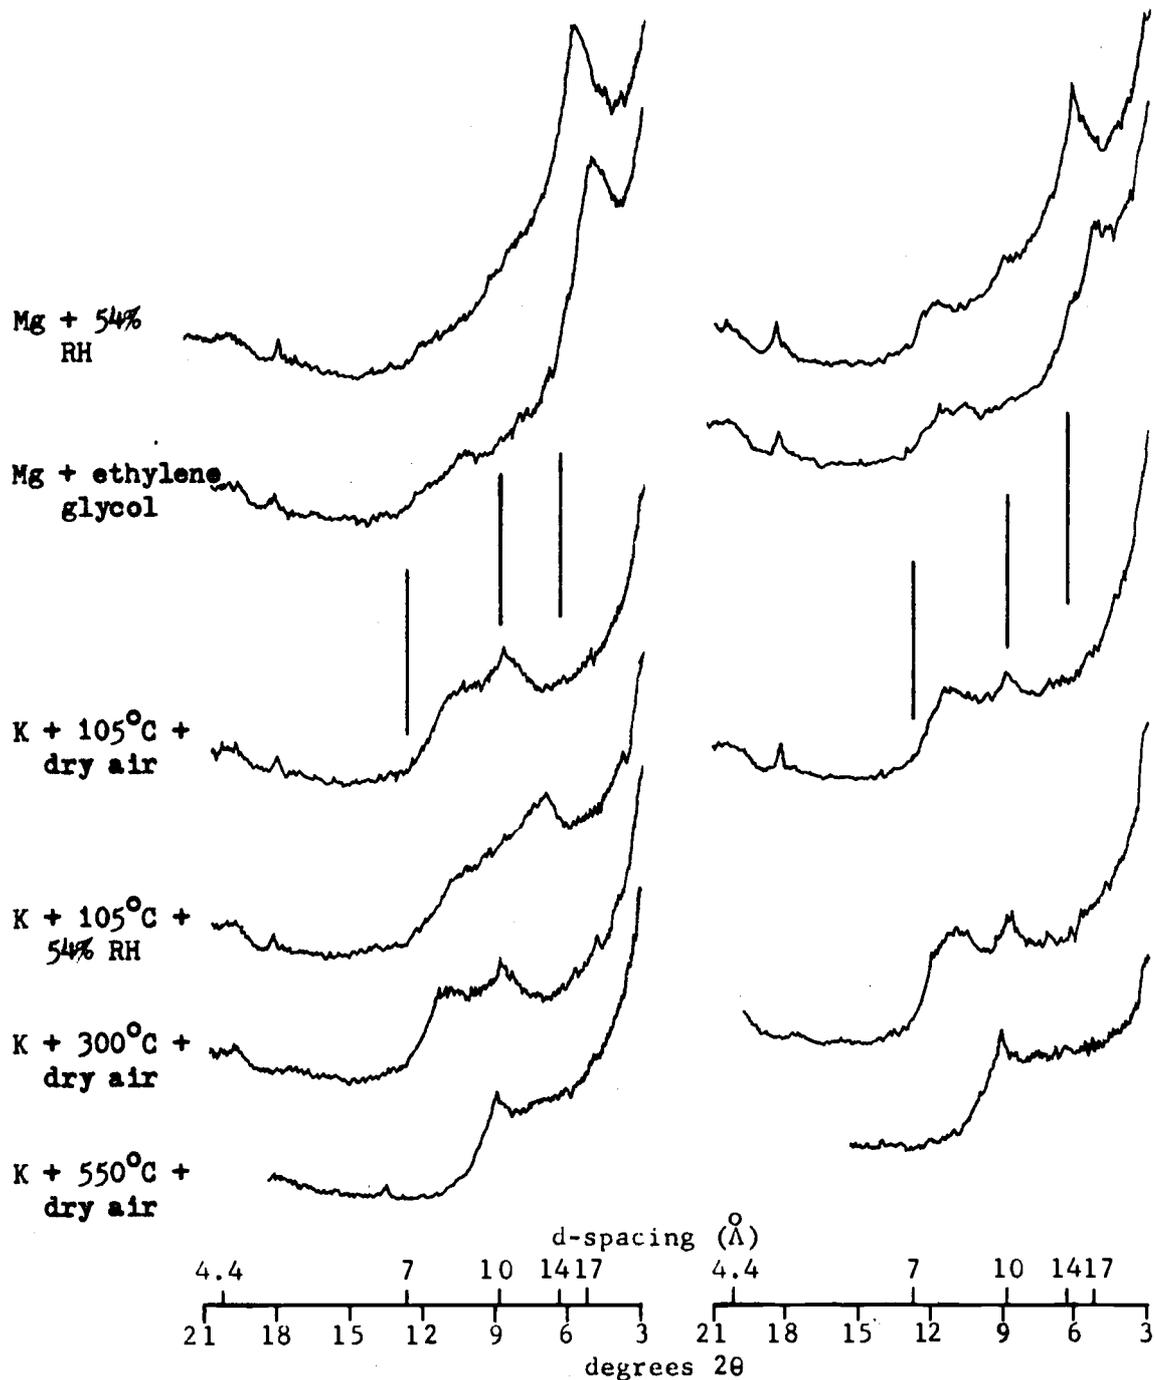
Figure 69. Site SS-SF-1 XRD patterns, sample c (left) and sample d (right).

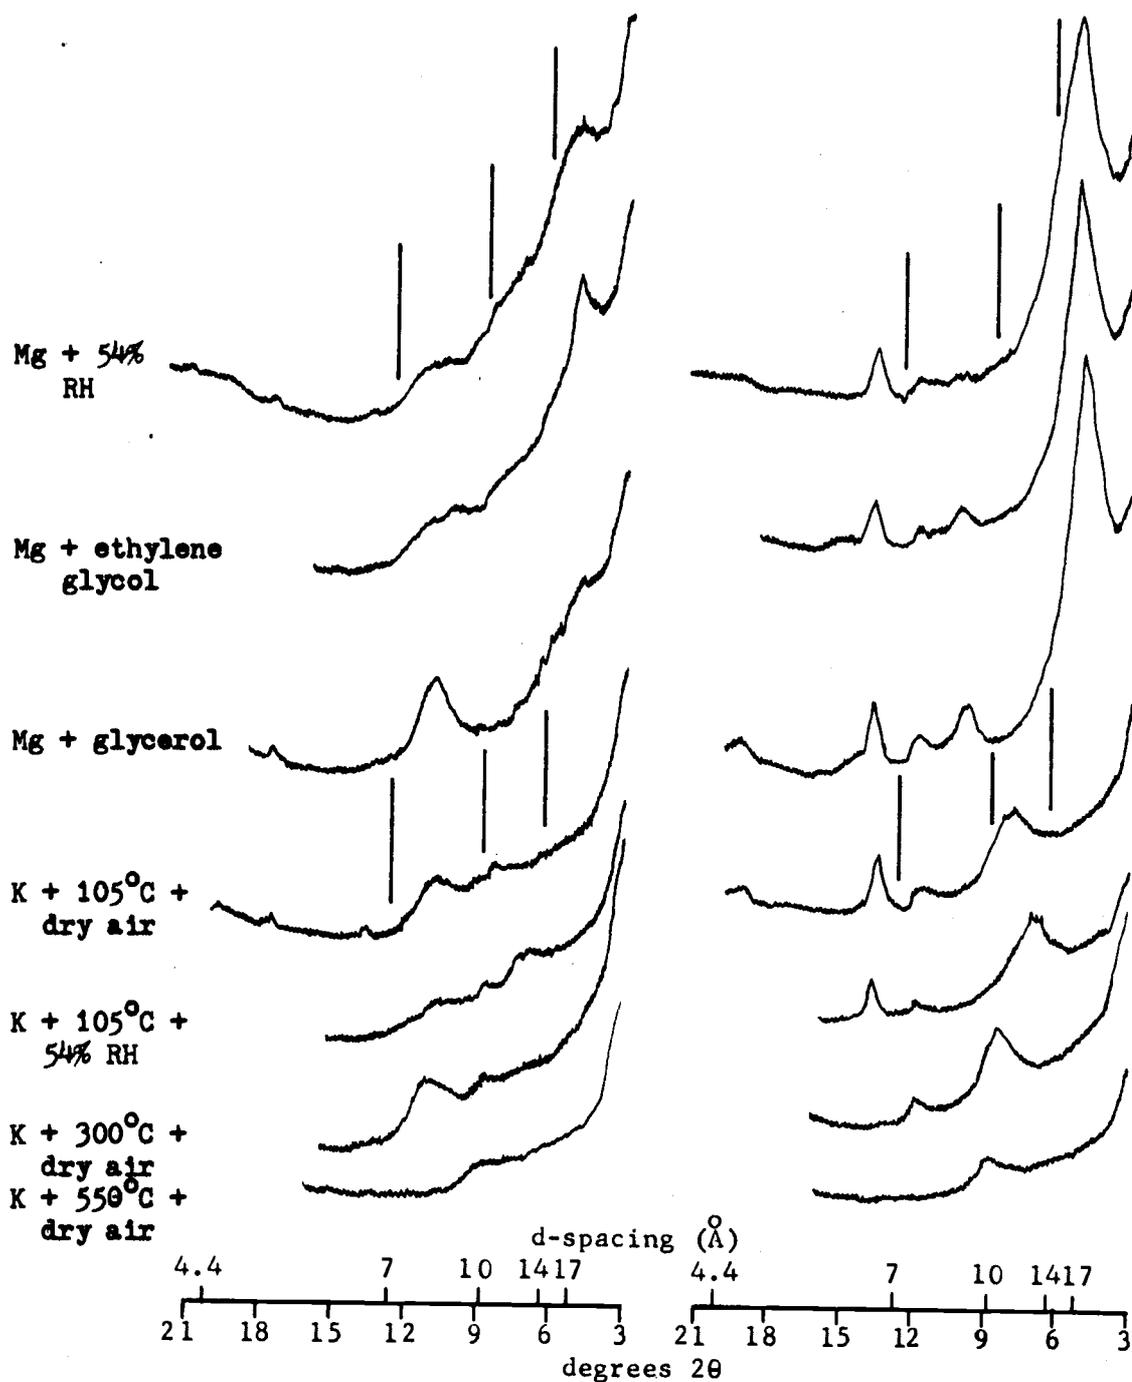
Figure 70. Site SS-SF-1 XRD patterns, sample f (left) and sample g (right).
