AN ABSTRACT OF THE THESIS OF

RONALD DAVID TASKEY for the DOCTOR OF PHILOSOPHY degree in SOIL SCIENCE presented on September 12, 1977

Title: RELATIONSHIPS OF CLAY MINERALOGY TO LANDSCAPE STABILITY IN WESTERN OREGON Redacted for Privacy

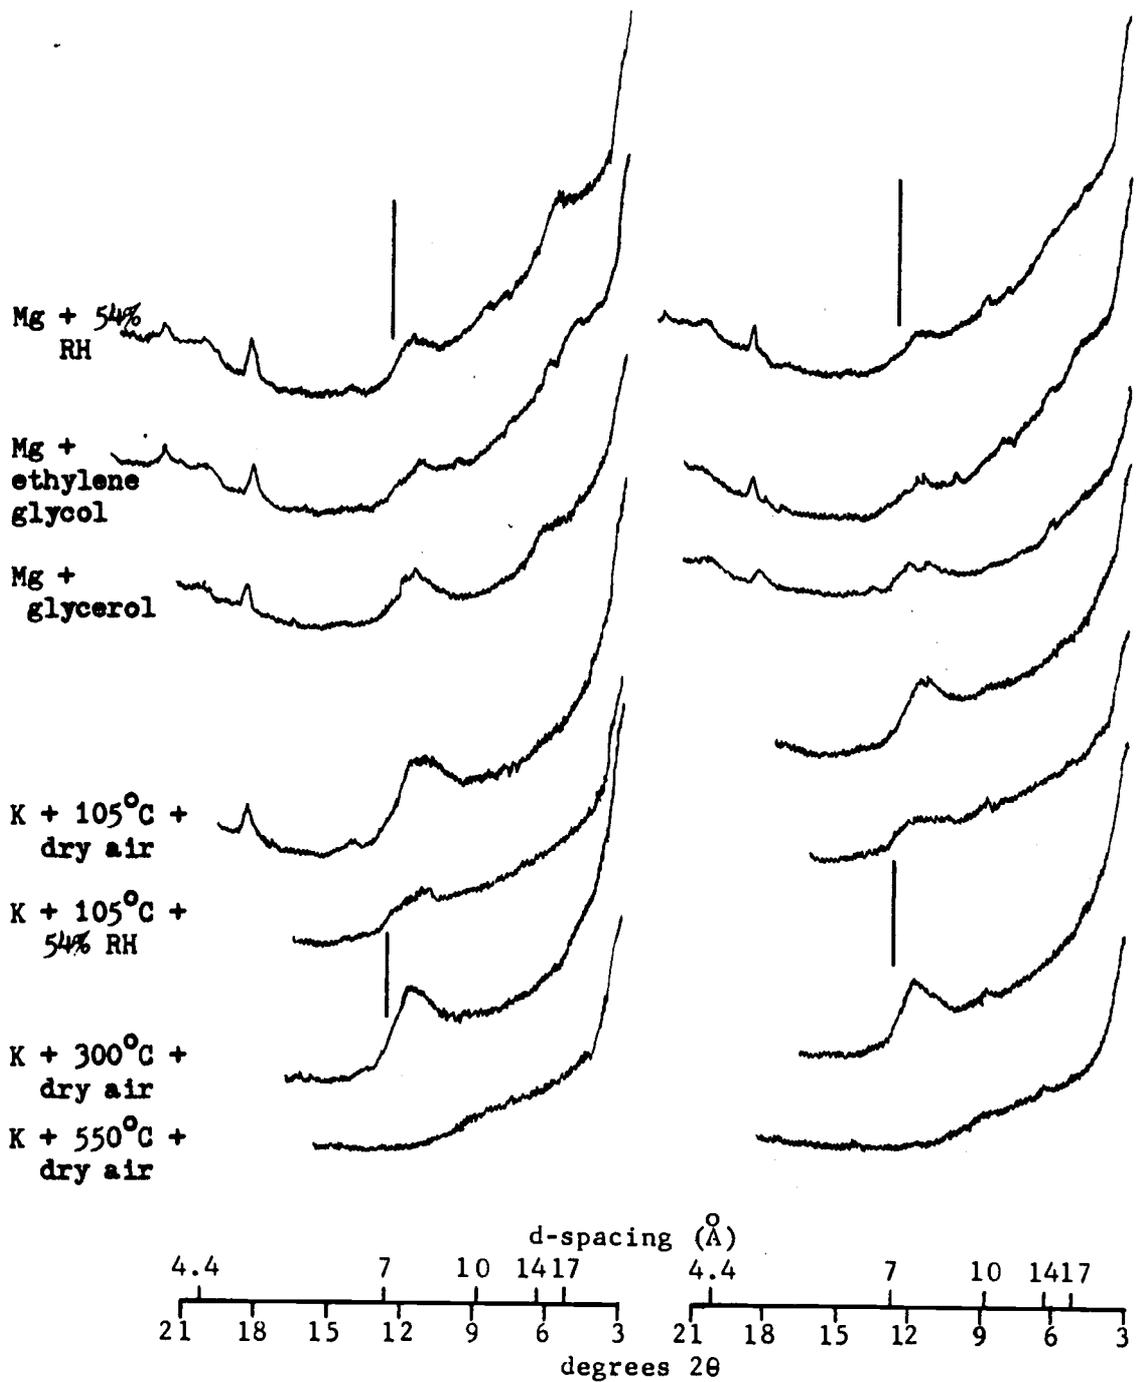
Figure 71. Site SS-SF-1 XRD patterns, sample i (left) and sample j (right).

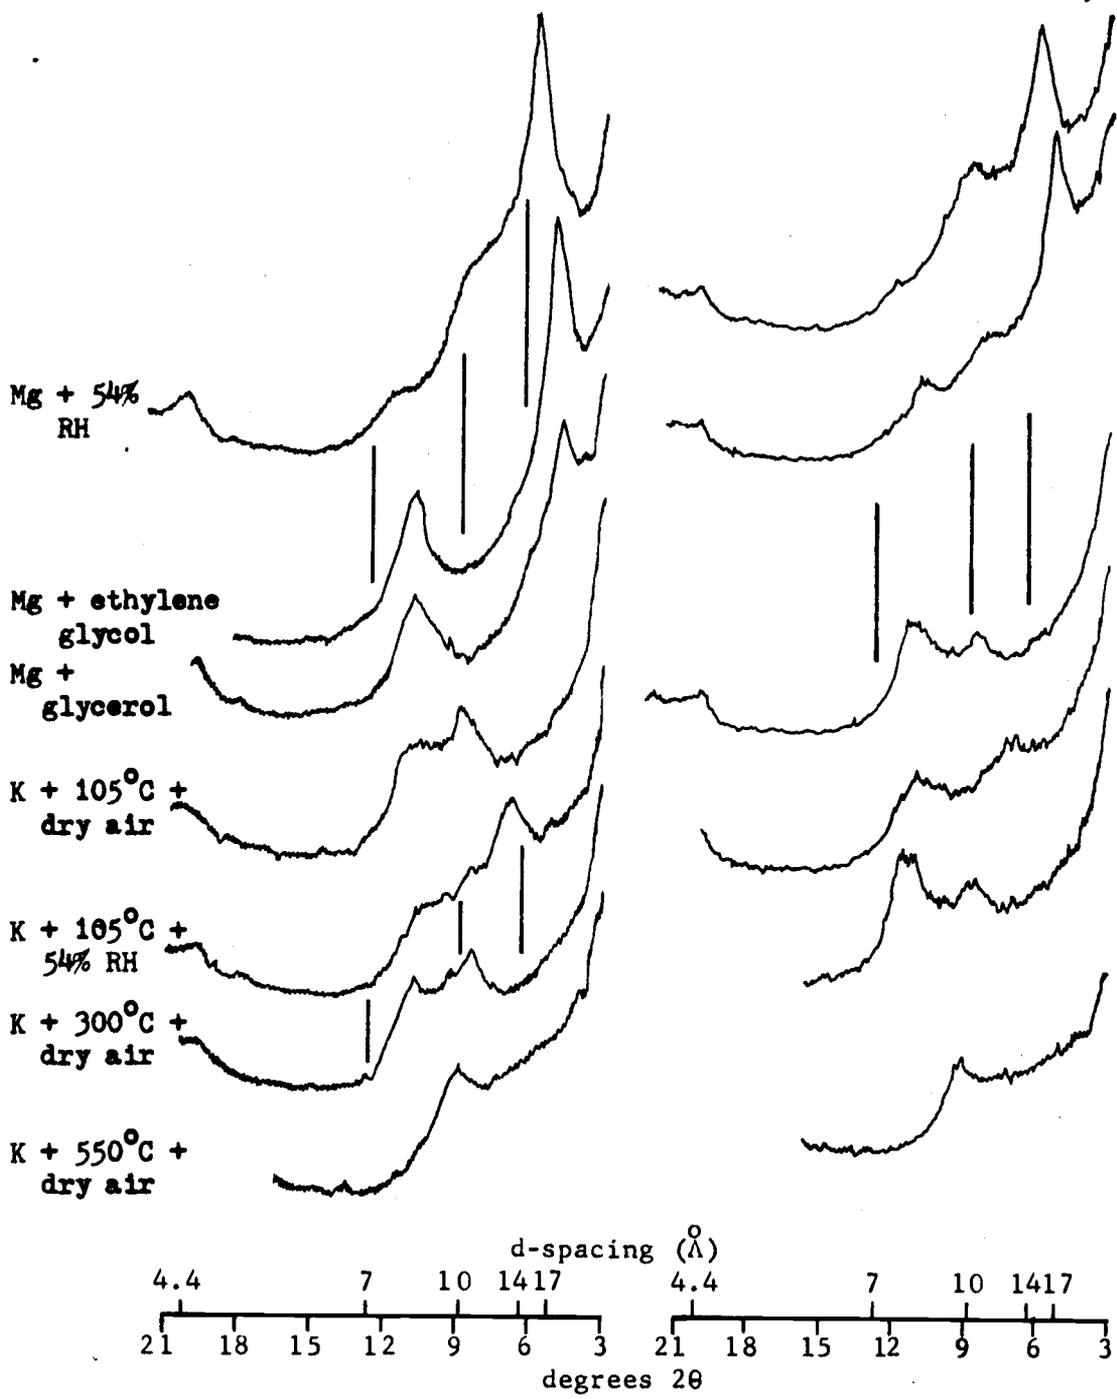
Figure 72. Sites SS-SF-2 (left) and SS-SF-11 (right), somewhat more stable soils in an overall unstable area.

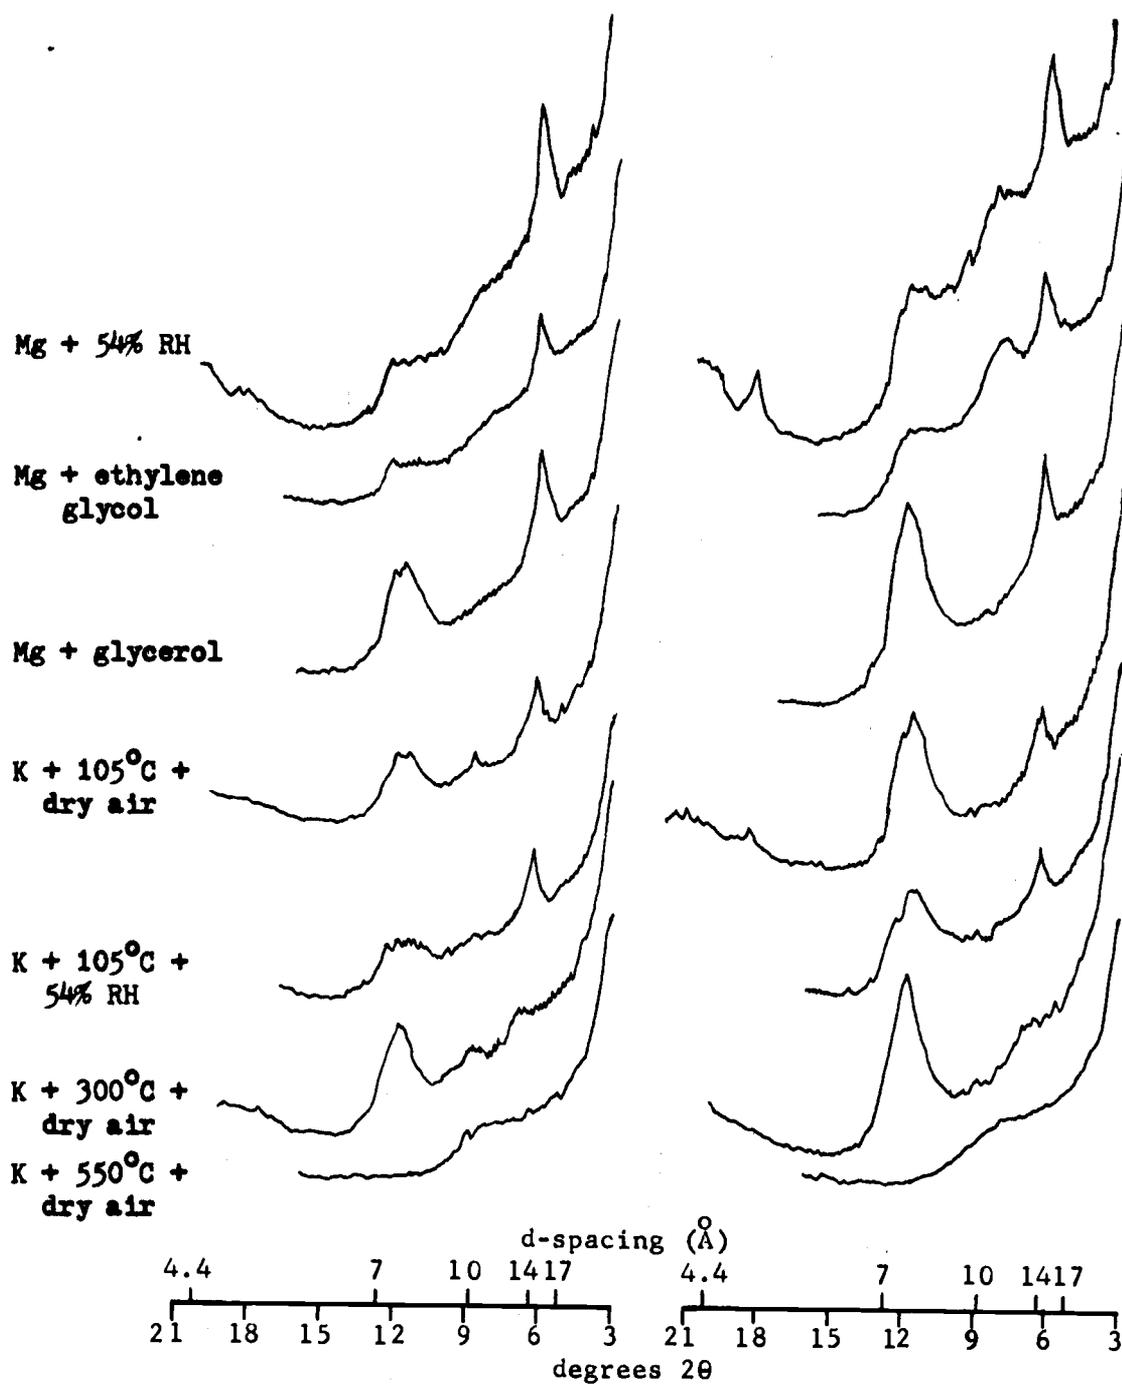
Figure 73. Site SS-SF-4 XRD patterns of soil block which split away (sample a, left) from scarp and of scarp wall (sample b, right).

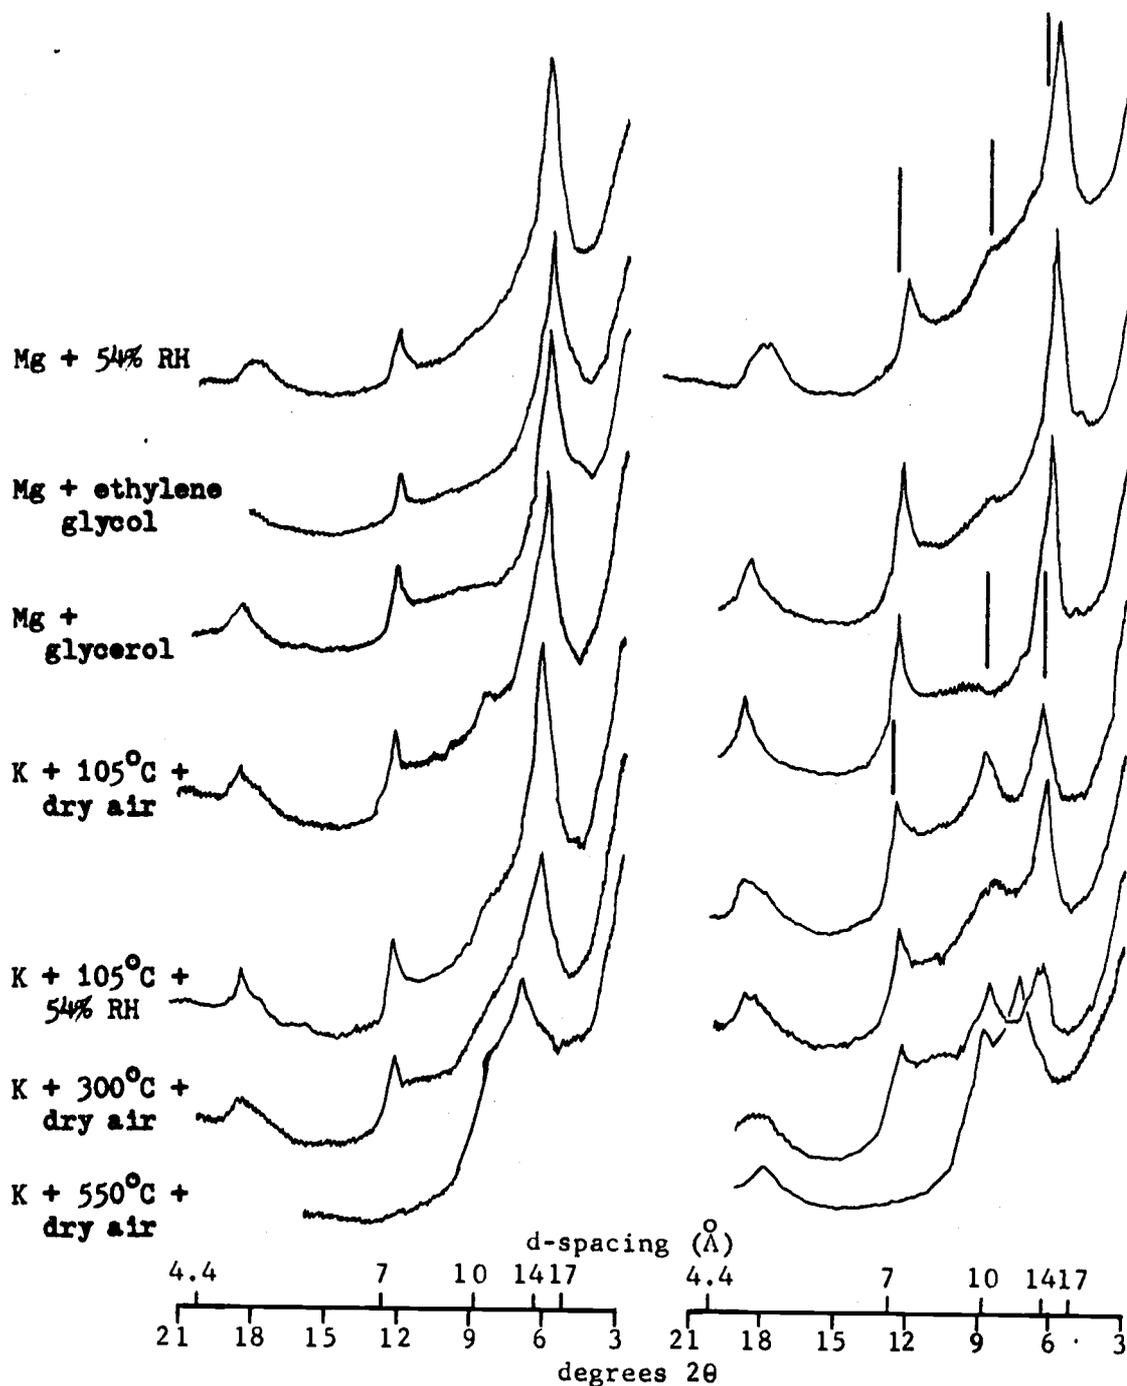
Figure 74. Debris avalanche site SS-SF-5 XRD patterns, sample a (left) and sample b (right).

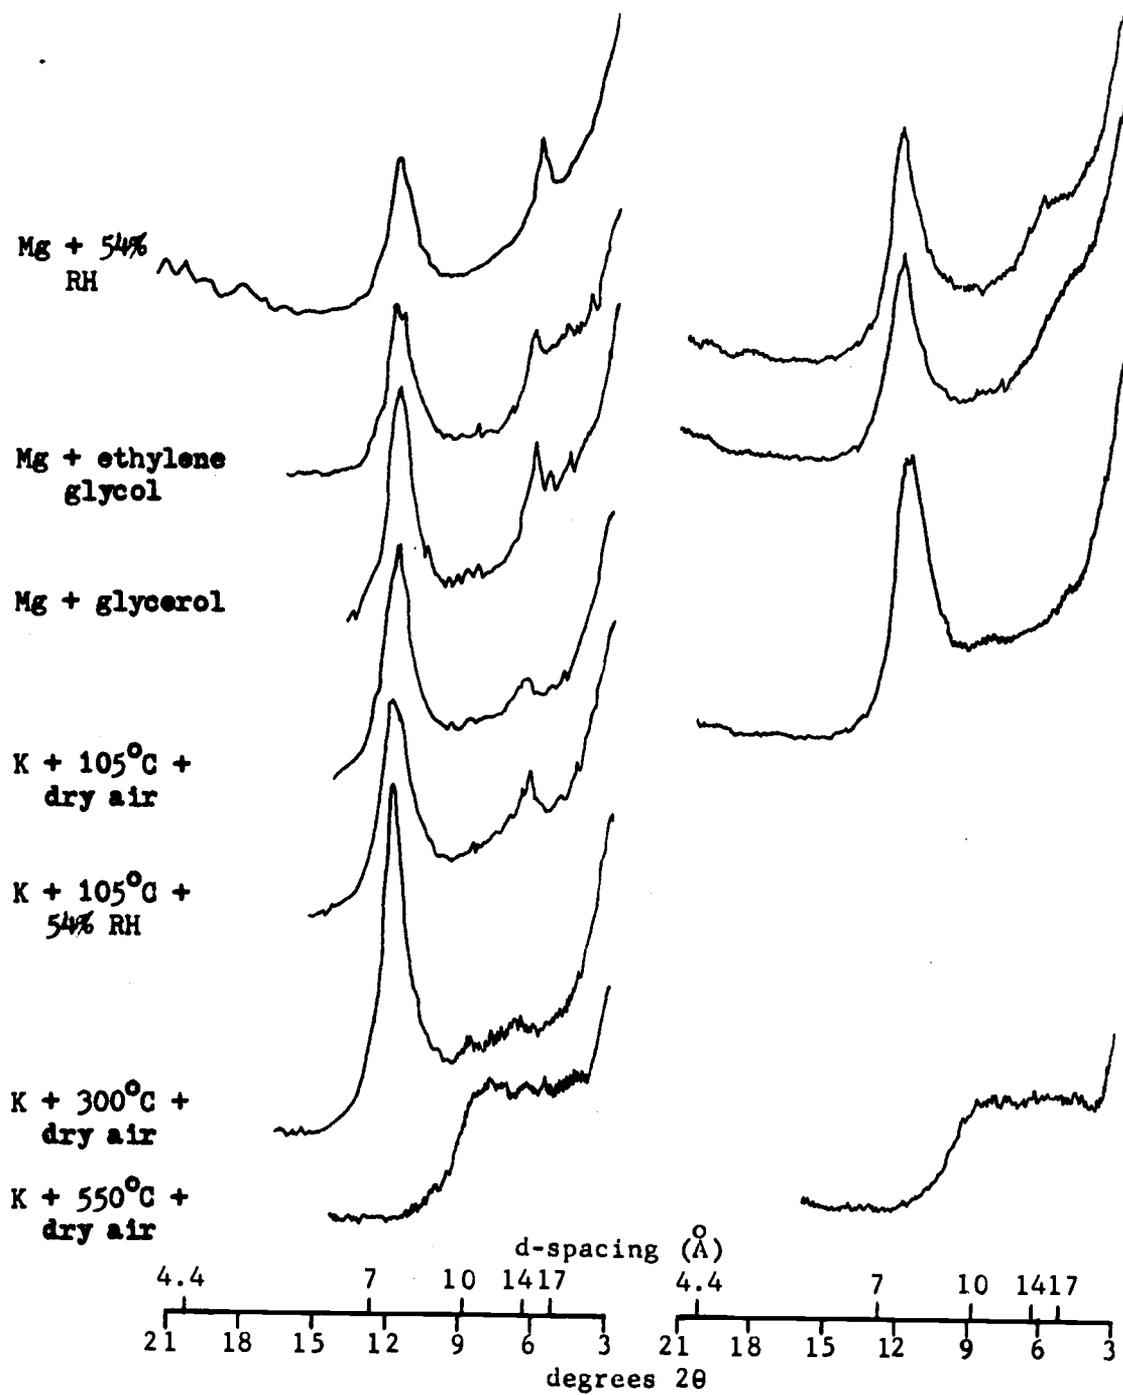
Figure 75. Site SS-2 at Foster scale station, sample a (left) and sample b (right).

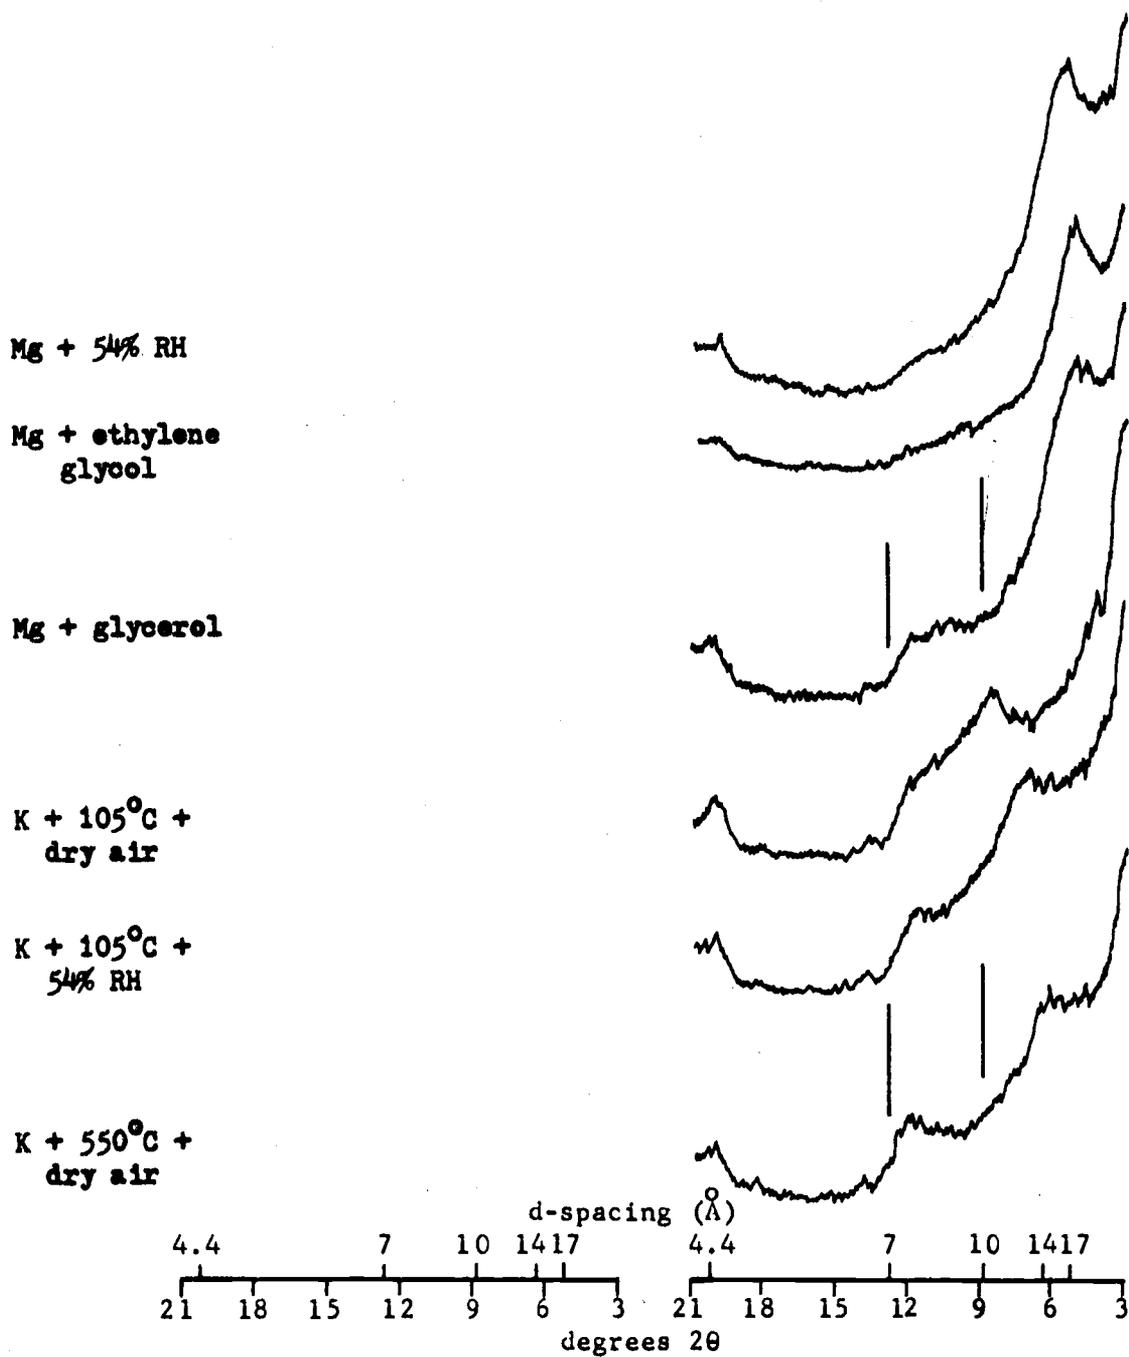
Figure 76. Site MK-D-2 XRD patterns indicating chloritic intergrade, amorphous material and halloysite which failed over smectite.

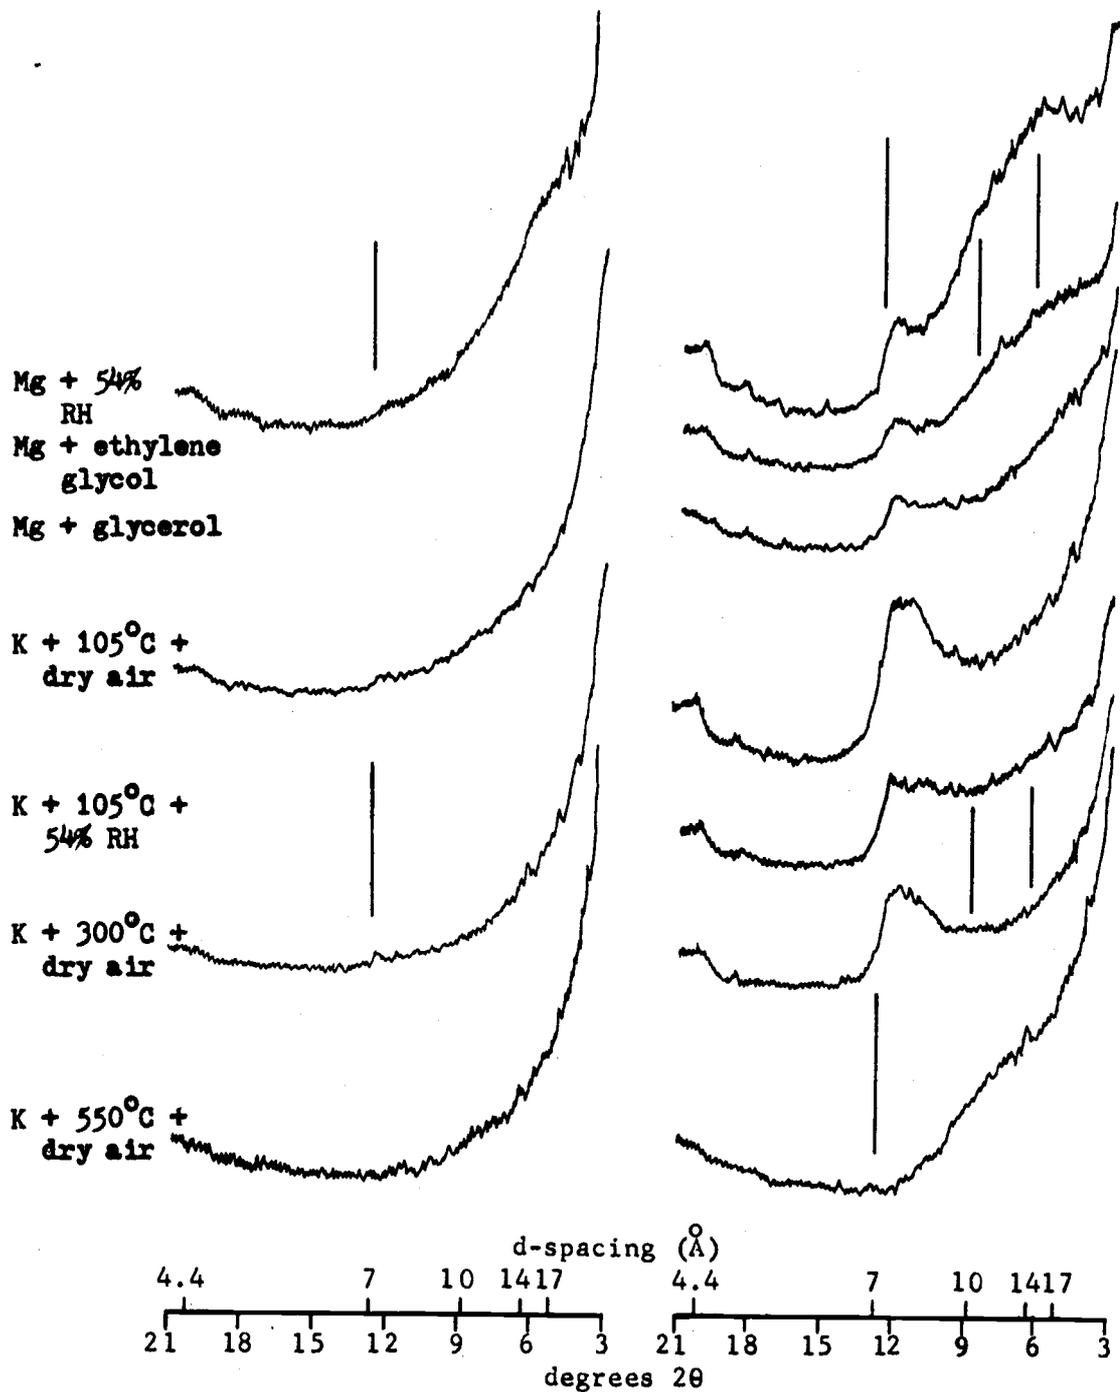
Figure 77. Site MK-L-1 (left) and MK-L-2a (right), stable and earth-flor soils, respectively.

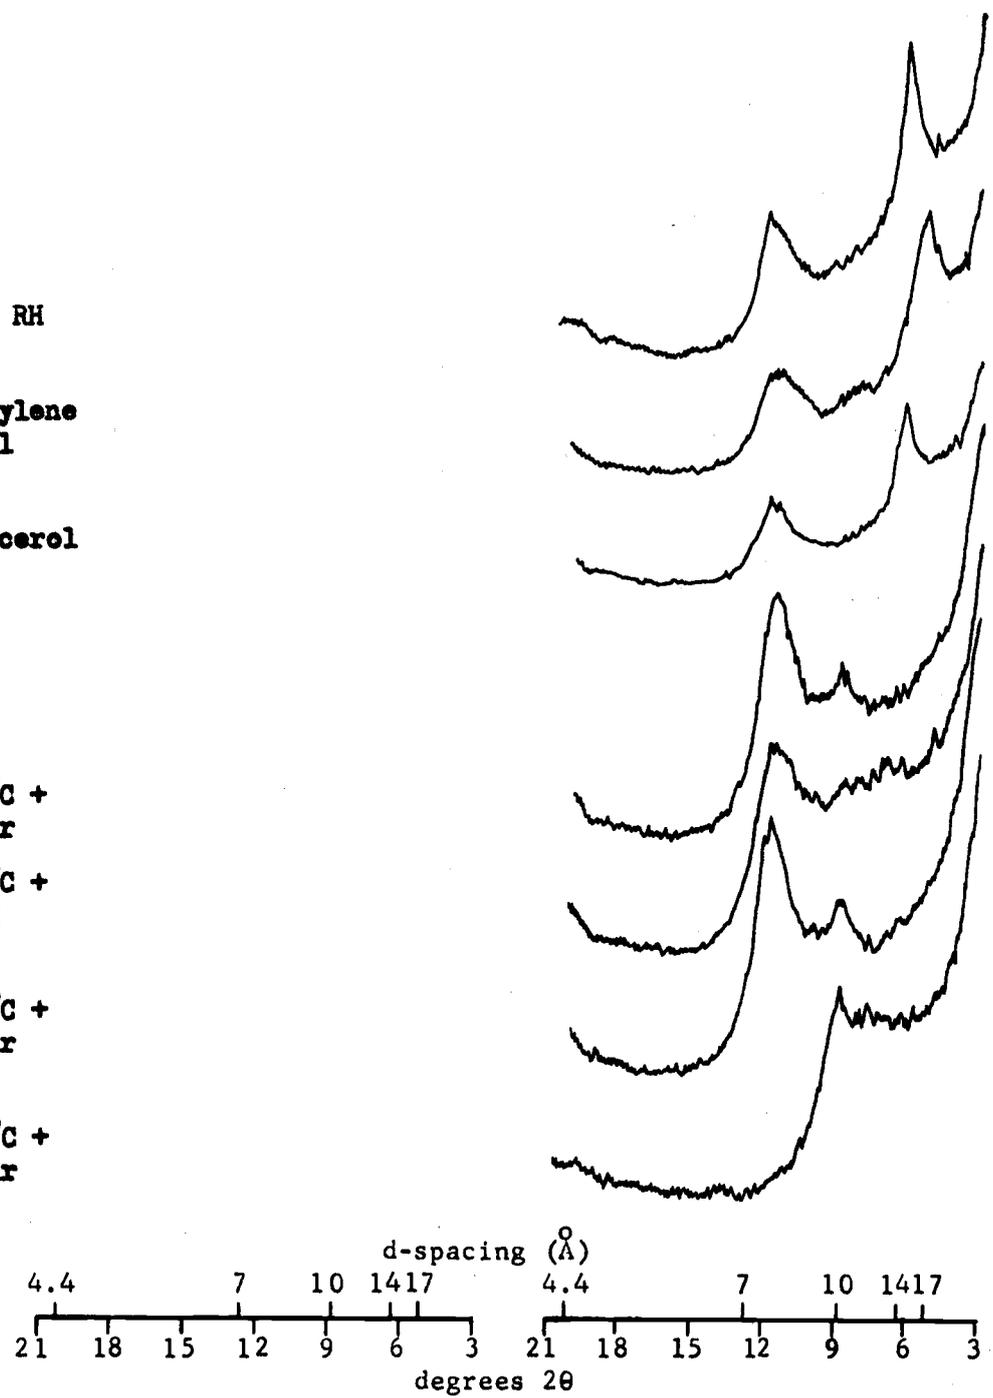
Figure 78. XRD patterns of the relatively stable site MFW-BW-1.

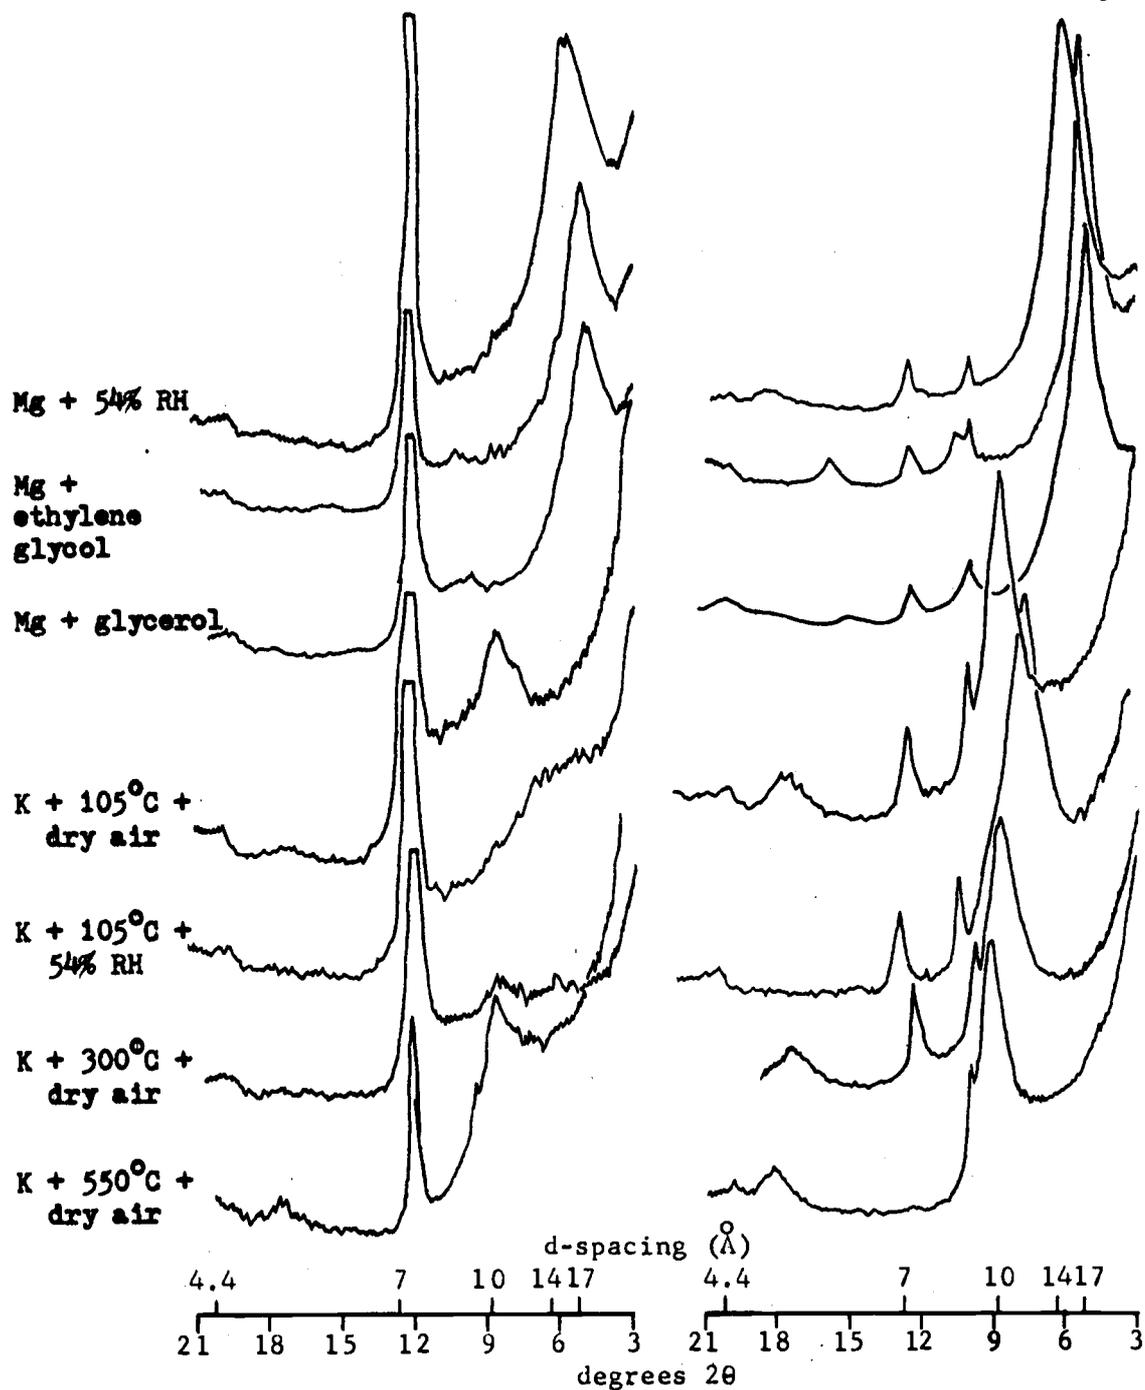
Figure 79. Site MFW-CP-1 XRD patterns, sample a (left) and sample b (right).

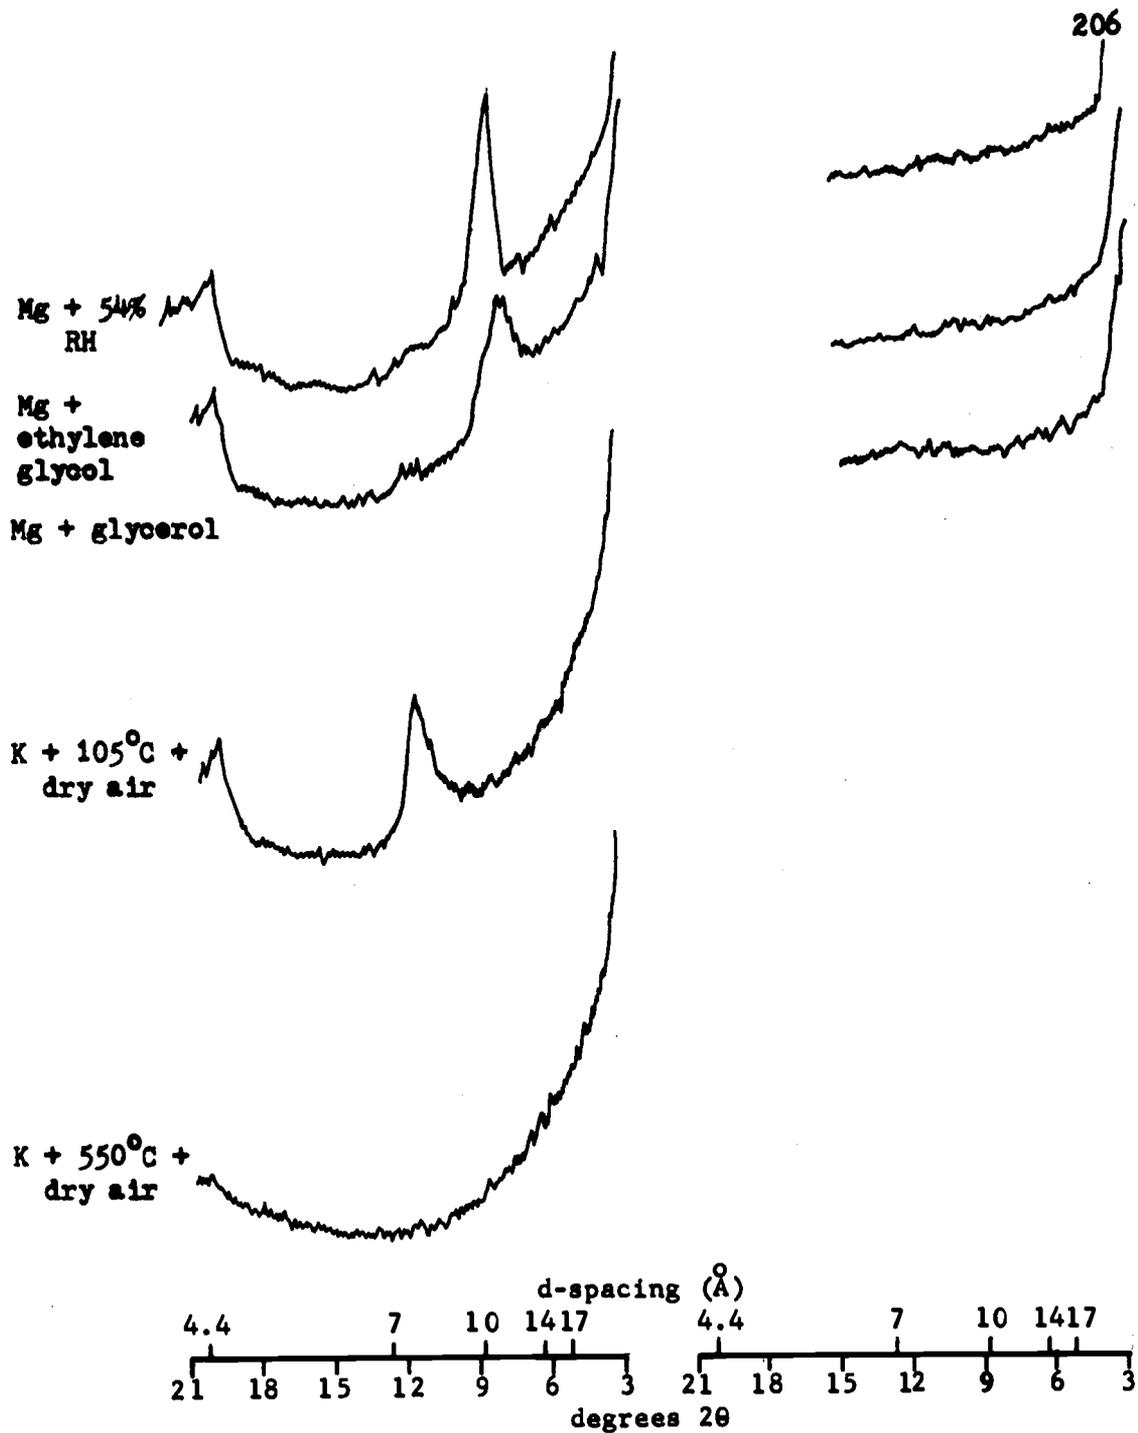
Figure 80. Site MFW-D-1c (left) and MFW-D-1 sample from Youngberg, et al. 1971, (right).

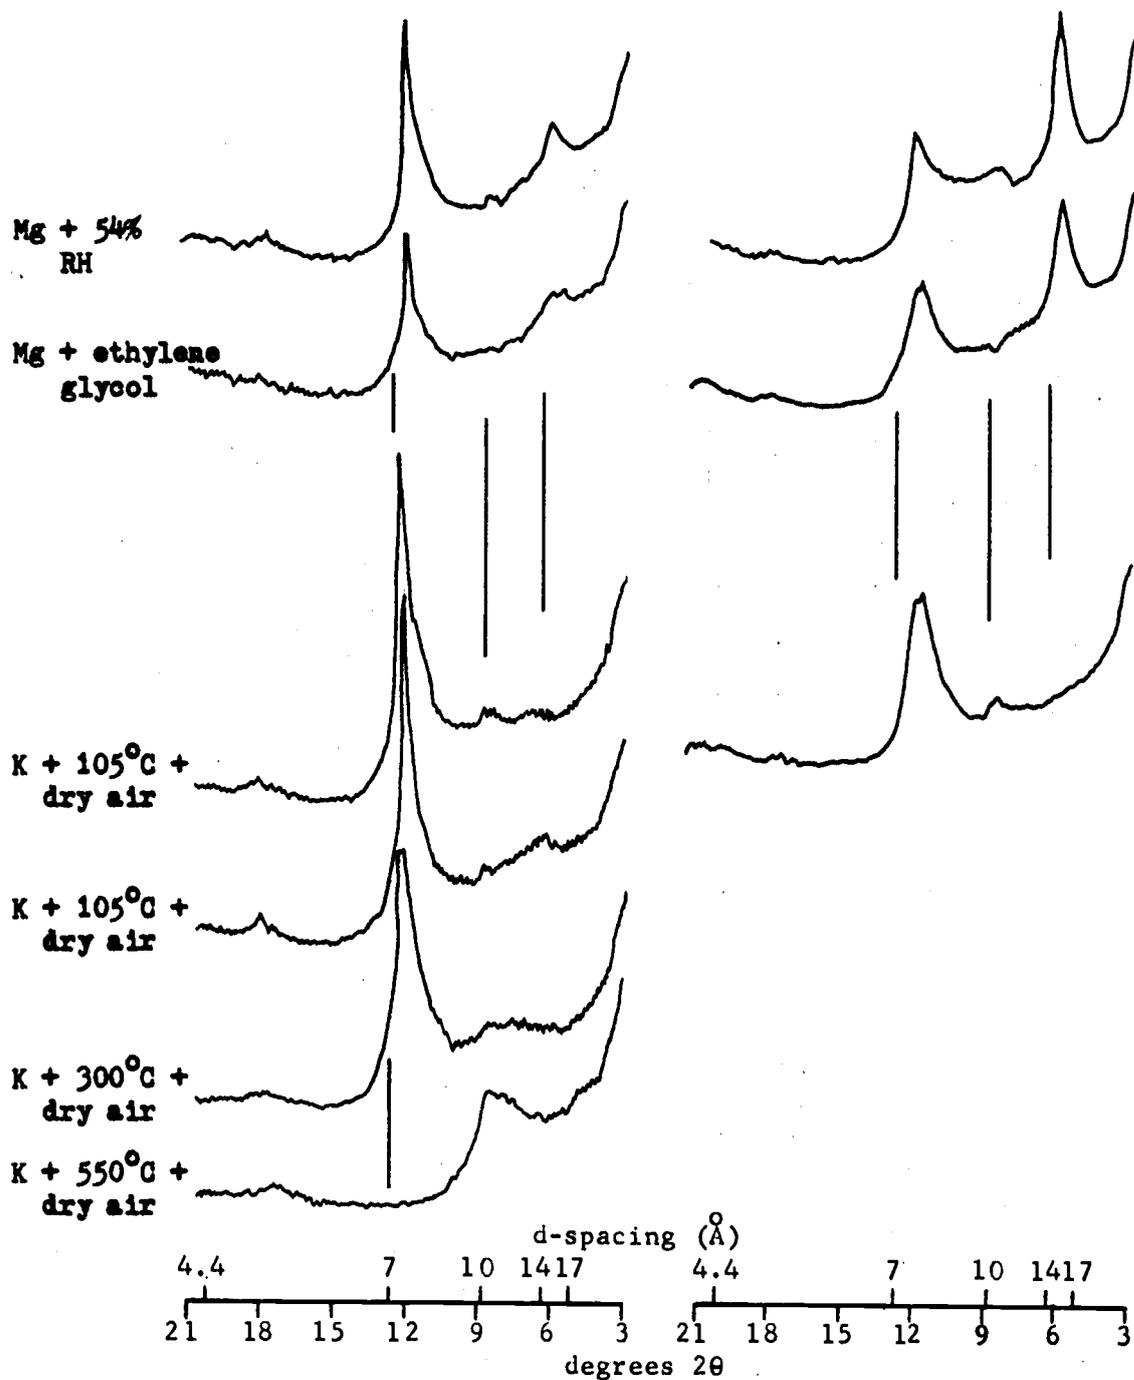
Figure 81. Site NU-LR-B-1 (left) and SU-S-1a (right), relatively stable soils.

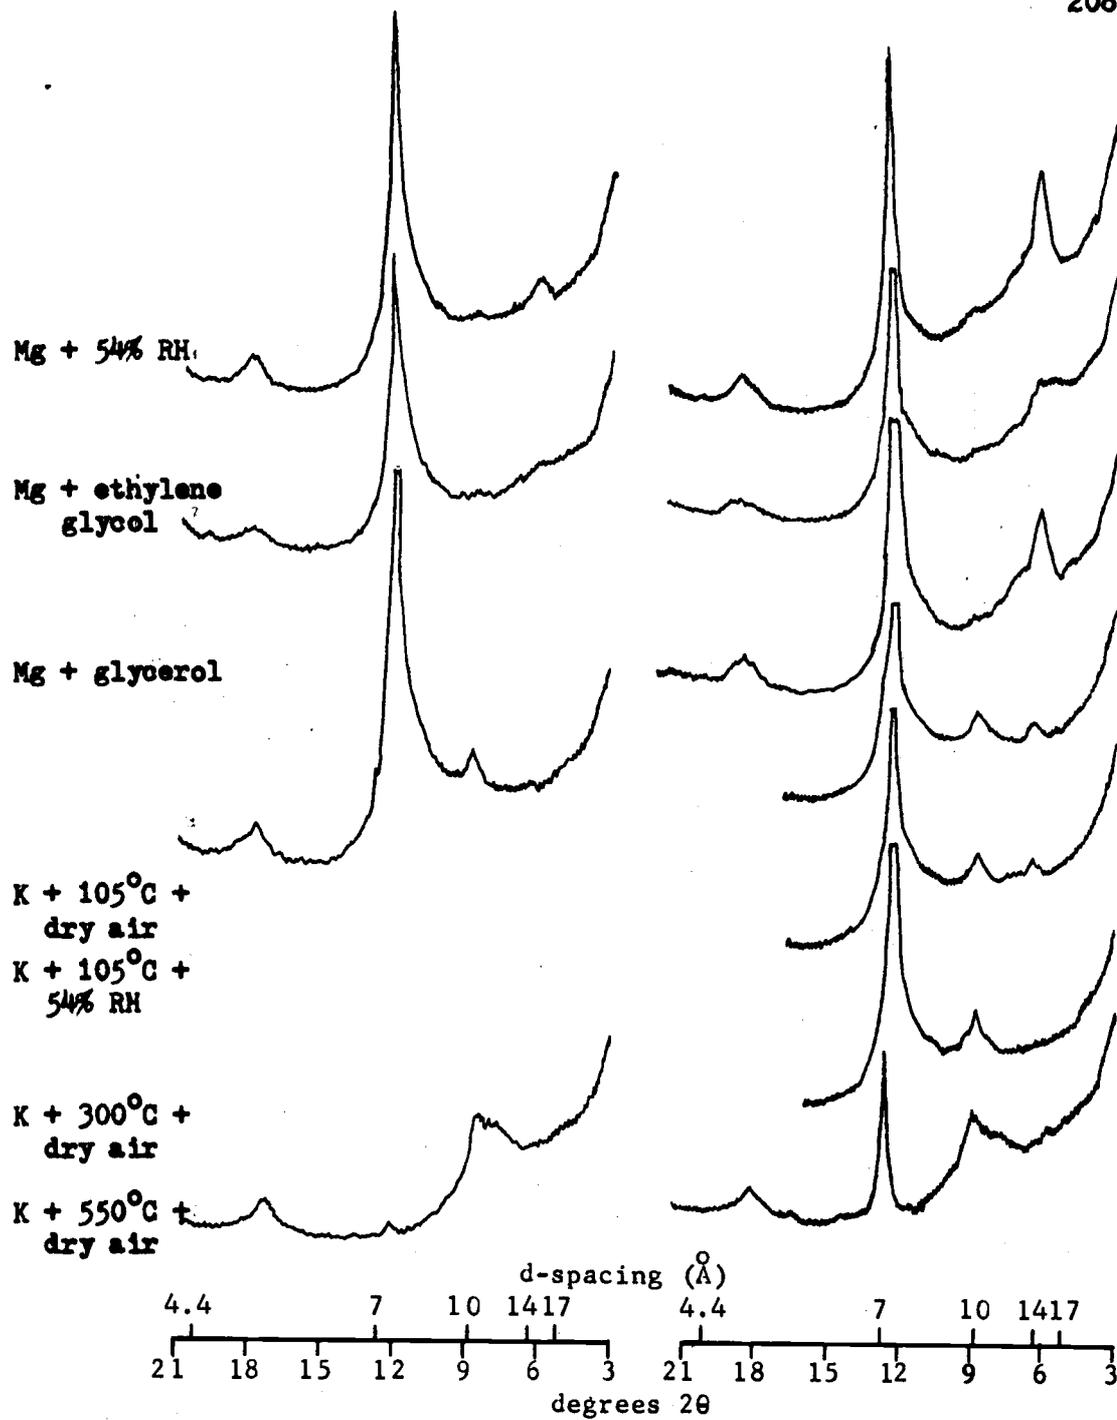
Figure 82. Site SU-1 XRD patterns, sample b (left) and sample a (right) indicating kaolinite as the dominant component in each.

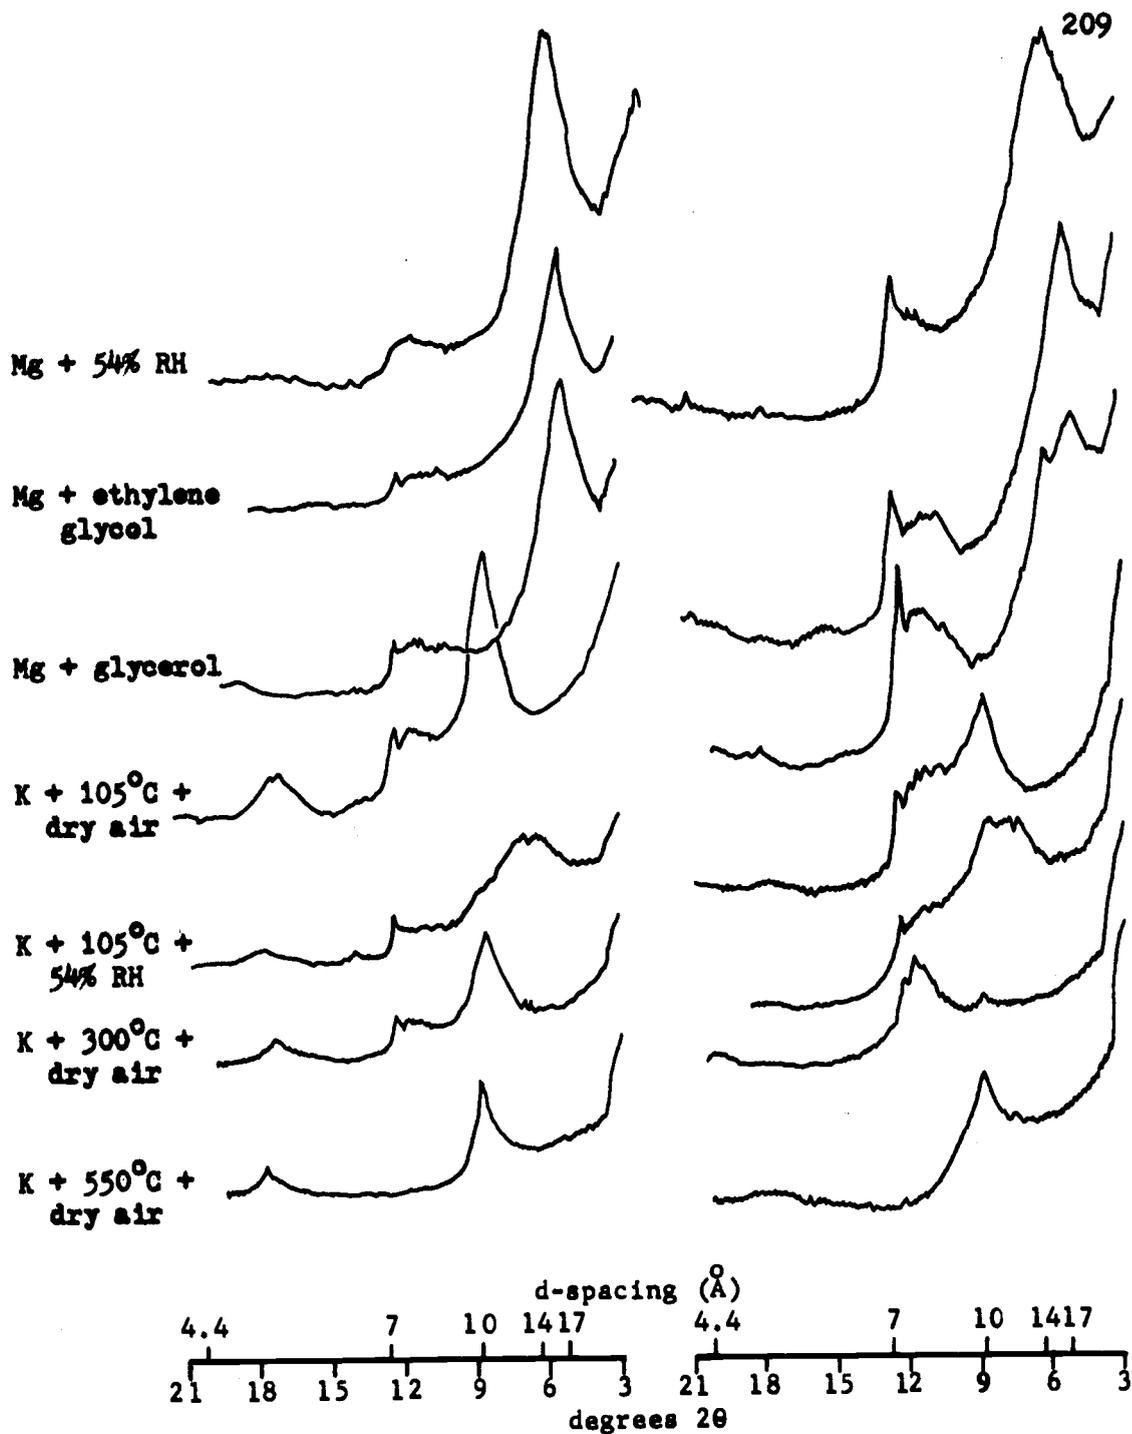
Figure 83. Site R-M-1 XRD patterns, sample c (left) and sample a (right).

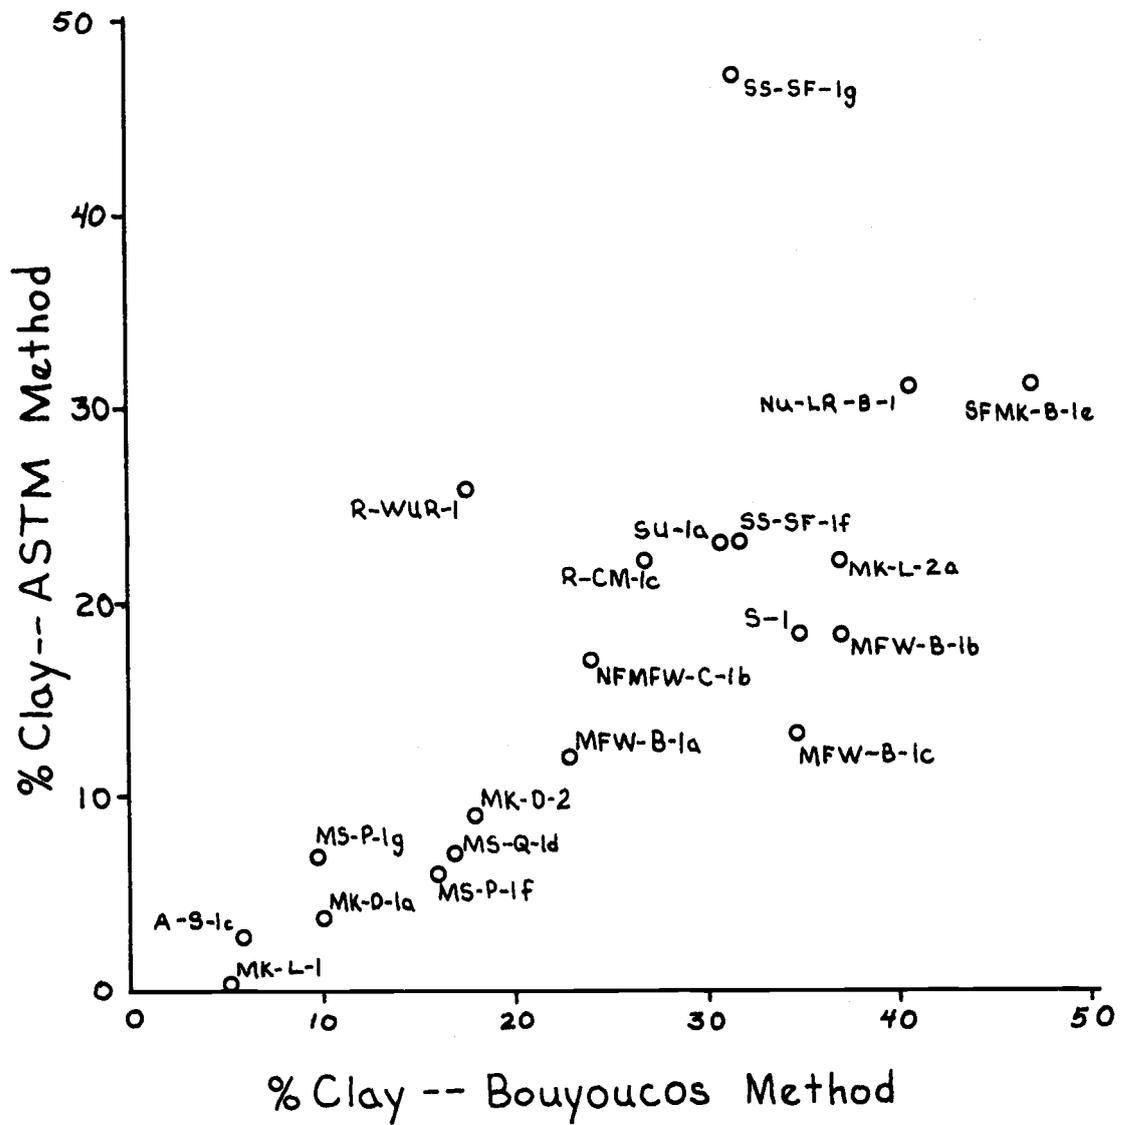
Figure 85. Comparison of clay percentages by ASTM and Bouyoucos hydrometer methods.

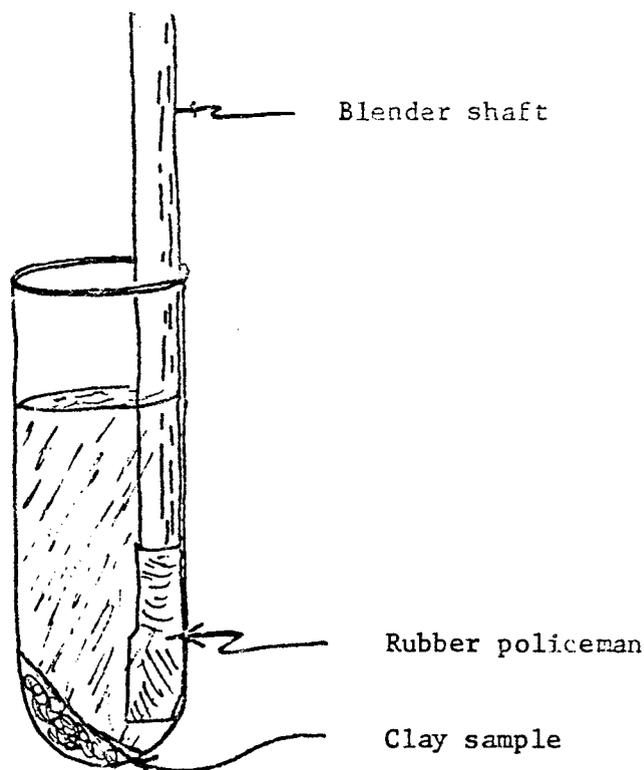
- c) Stir with a blender equipped with a rubber policeman. This can be done without losing a drop -- believe it or not! Hold the tube by its bottom and gently press the wall of the tube against the blending shaft with the shaft inserted nearly to the bottom of the tube. Operate the blender in short spurts while at the same time slowly rotating the tube. Note the diagram. Practice using a tube containing only water.
