Supplement to REPAIR OF AIRCRAFT SANDWICH CONSTRUCTIONS

REPAIR OF AIRCRAFT SANDWICH CONSTRUCTIONS 1, 2

A. A. MOHAUPT, Technologist and B. G. HEEBINK, Engineer

Forest Products Laboratory, Forest Service U. S. Department of Agriculture

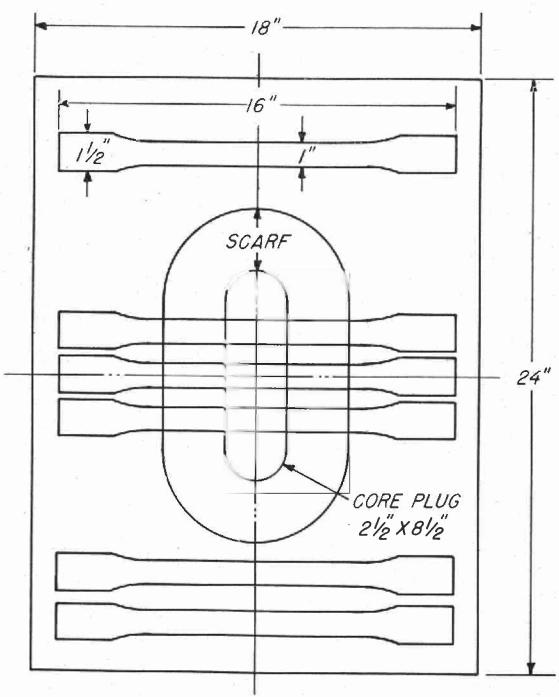
Figure 1.--Cutting diagram for test panels with glasscloth facings, showing location and shape of repair area and tension specimens.

The size of the repair area, which was oval in shape, was 2-1/2 by 8-1/2 inches and was the same for all panels (fig. 1). Preliminary preparation of the repair area consisted of cutting holes at the end of the oval

Three longitudinal-tension specimens were taken across the repair area, and three control tension specimens were cut from outside the repair area, as shown in figure 1. The tension specimens were 1-1/2 by 16 inches with the center portion tapered to 1 inch wide to reduce concentration of stresses near the grips. In order to prevent crushing of the ends held by the grips of the testing machine, the core was sawed out and a hard-maple block was inserted between the facings.
