Level Siding

COMMON LUMBER

Bulletin 5

Oregon Forest Products Laboratory

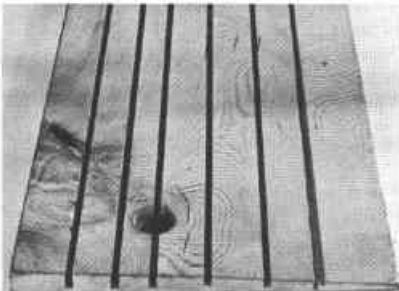
Figure 4. Siding had increased stability when back-grooved.

- . Conditioning or not conditioning the lumber core.
- . Back grooving the siding after bevel sawing (Figure 4).
- . Grooves sawed in each face of lumber core before assembly (Figure 5).
- . Spacing of grooves in lumber core--1 1/2 or 3 inches (Figure 2).
- . Water-repellent dip of siding pieces.
- . Aluminum paint on resawed surface.

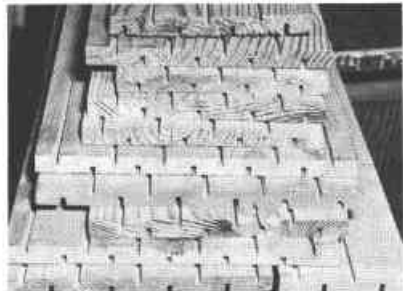
Figure 5. Lumber grooved on alternate sides before panel assembly.

Saw grooves in grooved cores were about $1/8$ inch wide, spaced 1 1/2 or

3 inches apart, and penetrated about half the thickness of the core (Figure 5).

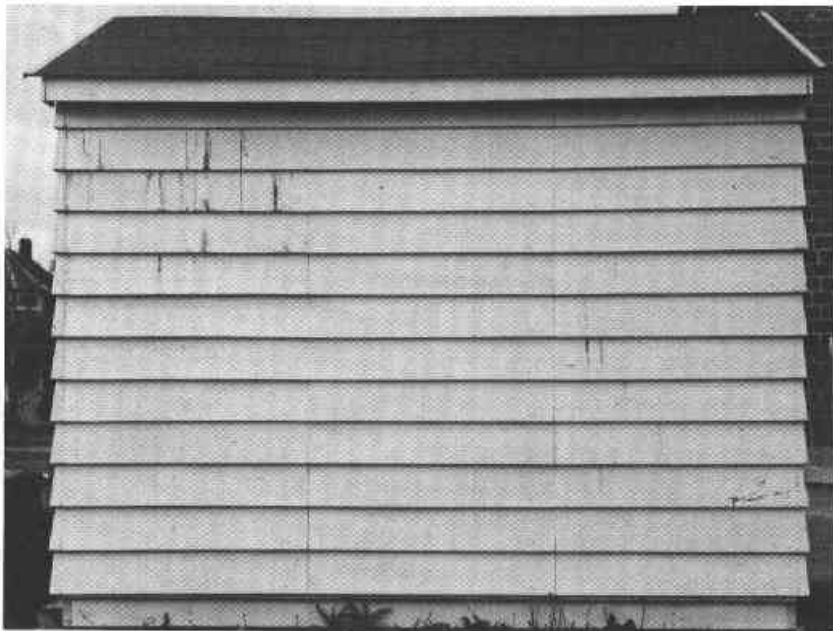
Figure 9. East wall of house covered with test sidings, after a year's exposure.

An 8- by 12-foot house was built in March 1956 to test various sidings under simulated severe use conditions (Figure 9). The house was built of standard frame construction, with a plywood floor and shiplap sheathing on the walls (Figure 10). The roof was sheathed with plywood with a vapor barrier on the inner surface. Instruments were installed to maintain

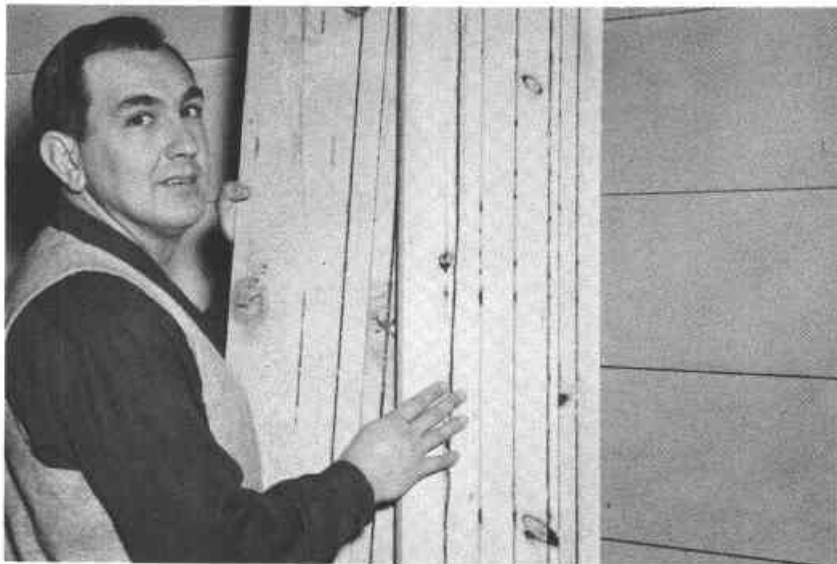
Figure 23. Low-grade lumber presented no serious problems in making the laminated siding, but its appearance might cause sales resistance.

Surface appearance of the laminated siding was attractive, but it is possible experience will show the advisability of choosing smooth-cut, edge-glued veneer for face ply, perhaps in a grade better than chosen for the present study (C repaired). Furthermore, the appearance of low-grade lumber in the siding base might constitute a sales problem that could be overcome by selecting a better grade of common lumber for the core than that in siding tested (Figure 23).
