LUMBER DRYING KILN ENERGY AUDIT WORKBOOK

Marty Ahad, P.Eng, Program Manager
BC Hydro Power Smart Industrial
Vancouver, BC

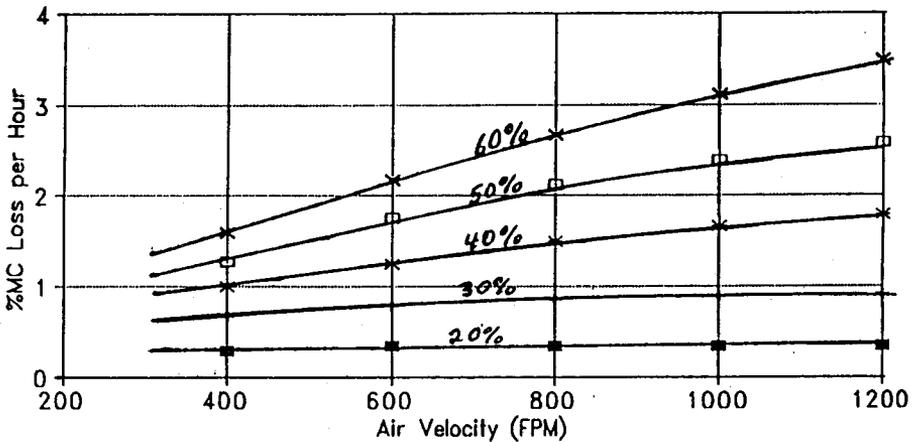
Figure 1. Effect of air velocity on drying rate at various moisture contents.

The drying rate depends less on airflow at low moisture contents than at high moisture contents. This is shown in Figure 1.
