AN ABSTRACT OF THE THESIS OF

Christina Lawrence for the degree of Master of Science in Wood Science presented on December 18, 2017.

Title: Utilization of Low-value Lumber from Small-diameter Timber Harvested in Pacific Northwest Forest Restoration Programs in Hybrid Cross Laminated Timber (CLT) Core Layers: Technical Feasibility

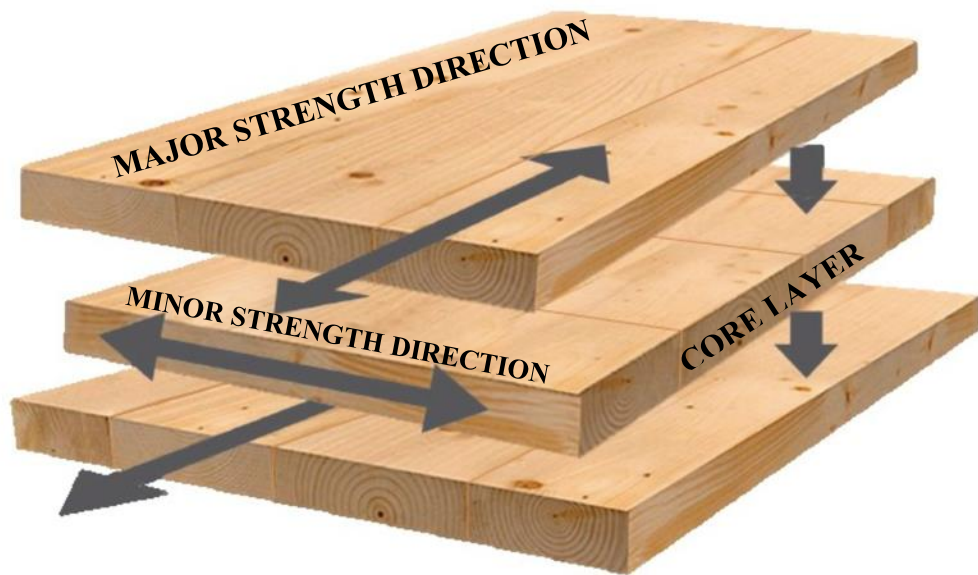
Figure 1: Example of the standard cross laminated timber lay-up. (Laguarda Mallo and Espinoza 2015)

CLT is a structural composite panel product usually consisting of 3 to 9 layers of dimension lumber arranged perpendicular to each other (Figure 1), much like layers of veneer in plywood, and can be used as a prefabricated wall, floor and roofing element in residential, public and commercial structures.

The CLT grade characteristics of interest for this project include: modulus of rupture ($f_{b,0}$), modulus of elasticity (E_0), and shear strength ($f_{v,0}$), where the major strength direction (subtext 0) refers to the general direction of the grain of the parallel layers and minor strength direction (subtext 90) refers to the direction perpendicular to the major strength direction of the panel (ANSI 2012) (Figure 1).

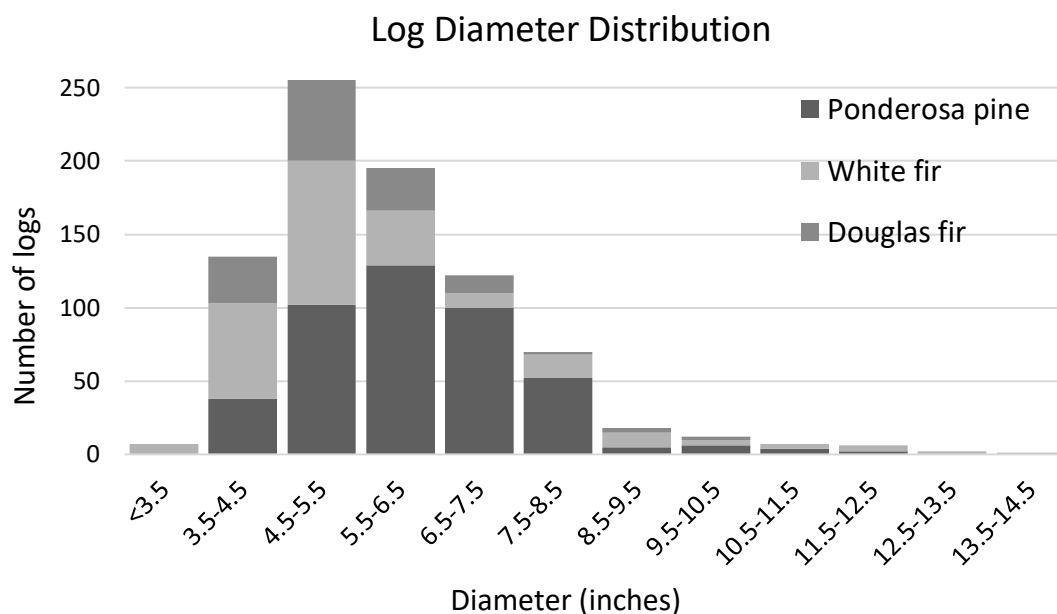
Figure 14: Summary of log diameters delivered to Idaho Forest Group by Iron Triangle.

The company's HewSaw is set up to cut a minimum of a 3.5-inch, on the small end, diameter log and derive a minimum lumber size of 3" x 3" piece; most of the project's logs of which were between 4.5 and 6.5 inches (Figure 14).

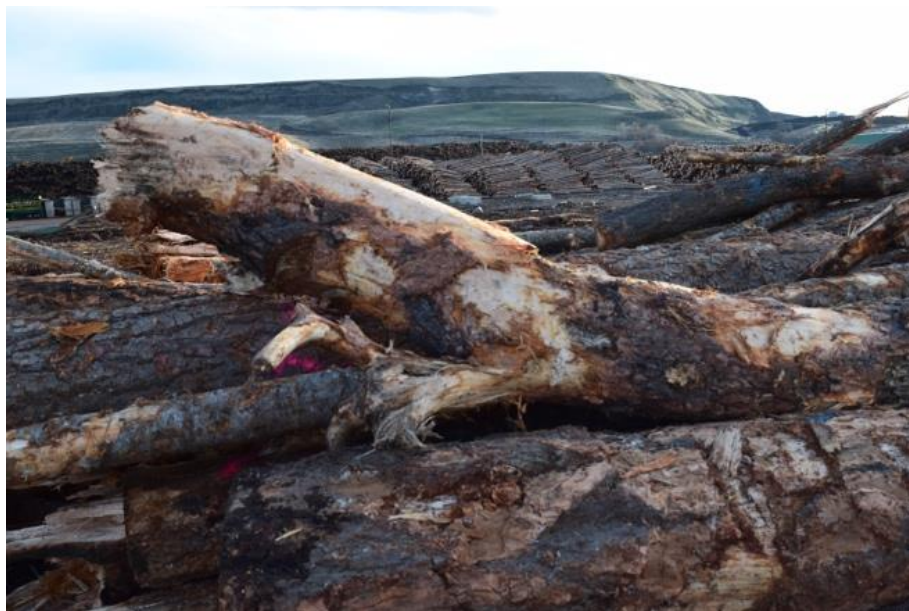
Figure 15: A delivered log to IFG that was rejected due to having too much sweep, or curvature to the log.

The merching process revealed a large amount of material that could not be processed (10%). Some logs had undetected rotten cores or too much sweep (Figure 15) to be processed by the HewSaw; the defects were detected when scanned by the HewSaw for lumber recovery optimization. Some of these defects can be seen in Figure 15, Figure 16, and Figure 17.

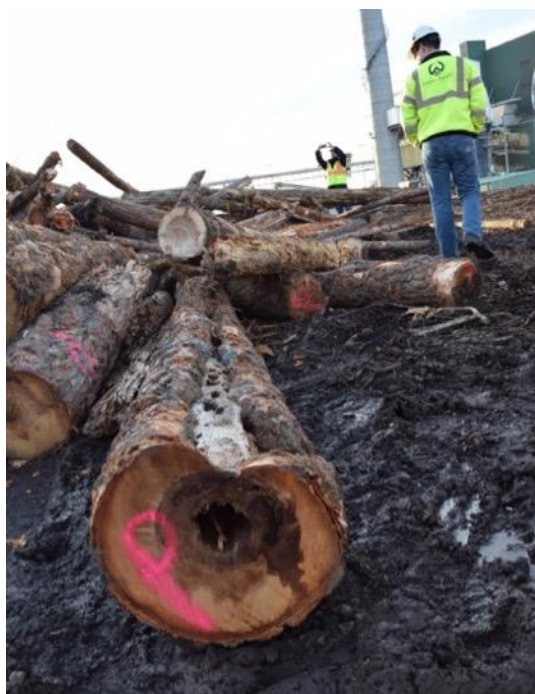
Figure 16: Rejected log at IFG during the merching process that contains rotted out core, bug defects, and exposed sap wood.

1. Additional time at merchandizing (material that should have been left at the thinning site to rot; seen in Figure 16, Figure 17, and Figure 15)
2. Repeated jams at the point where the transverse kicker was supposed to kick logs out of the belt sideways towards a transvers conveyor. These required personnel with a hook and/or chainsaw to unclog (substantial stoppage, Figure 18).
3. Log had no cut solution, so log was removed.
4. The log was bucked (cut) to short, causing the log to be removed.
5. Several pieces jammed in the HewSaw gang saw section (Figure 19).
6. And, at least in one case, a sawn piece still traveling together, past the first gang saw unit, got jammed on the conveyor (Figure 20).

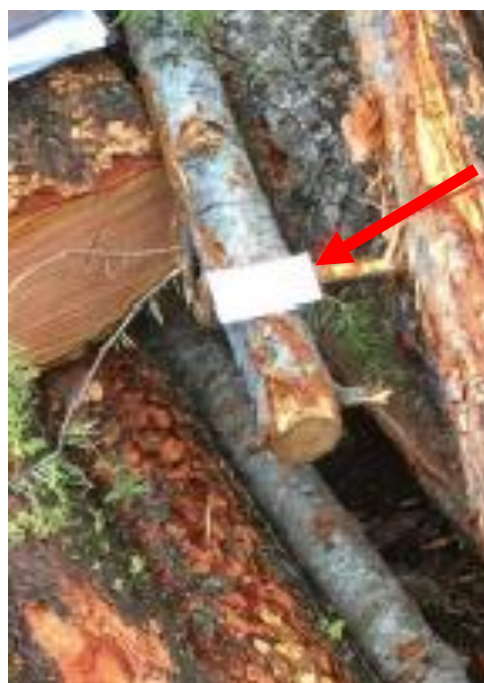
Figure 17: A log that was delivered, but is unable to be processed at IFG due to its very small diameter. An idea of the diameter can be seen by the business card held up, which is 3.5 inches in length.

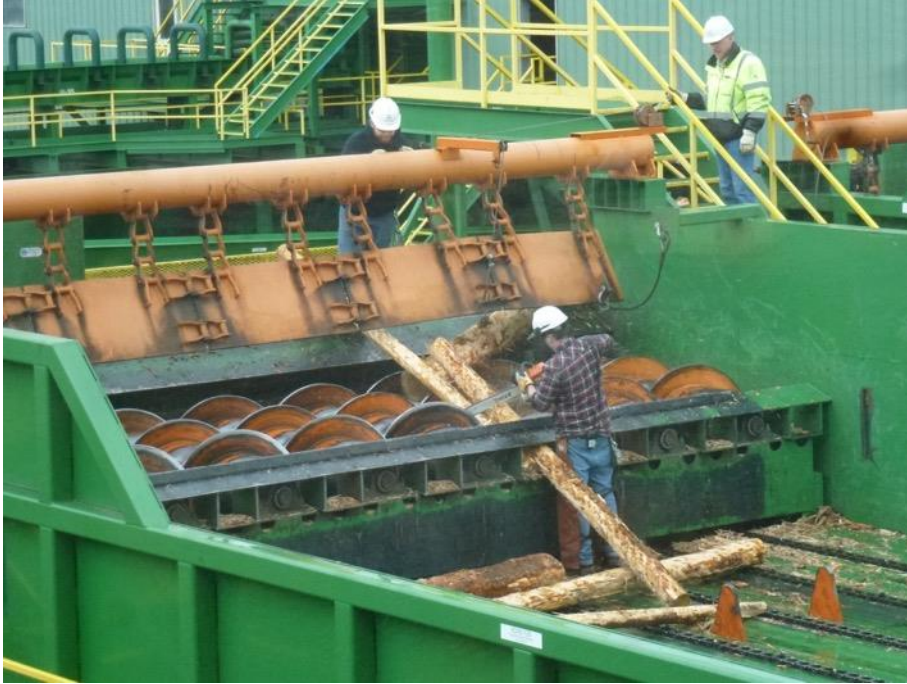
Figure 18: Difficulties during the breakdown process. During the processing the material was rotated, causing it to get caught in the machinery and needing it to be removed. This occurred multiple times.

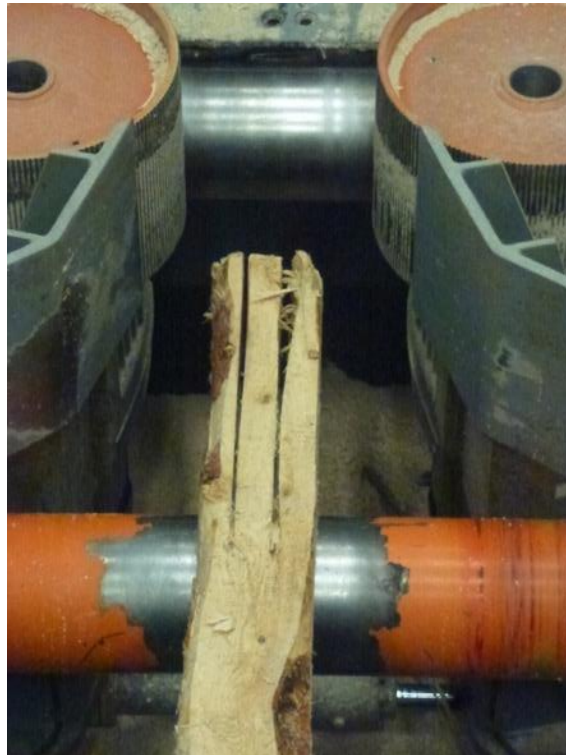
Figure 19: The HewSaw breakdown process began and was unable to continue through the saw, as the piece got jammed on the conveyor.

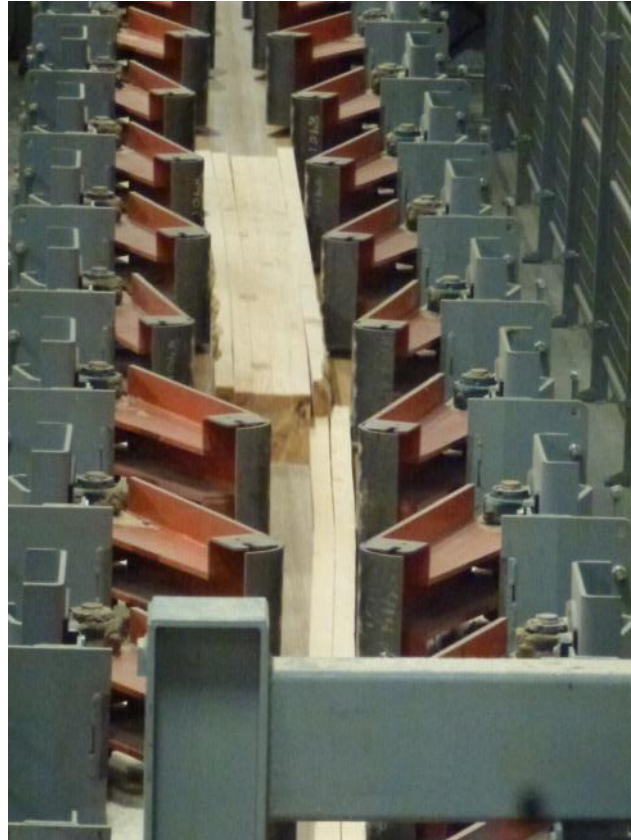
Figure 20: A sawn pieces still traveling together, past the first gang saw unit, got jammed on the conveyor.

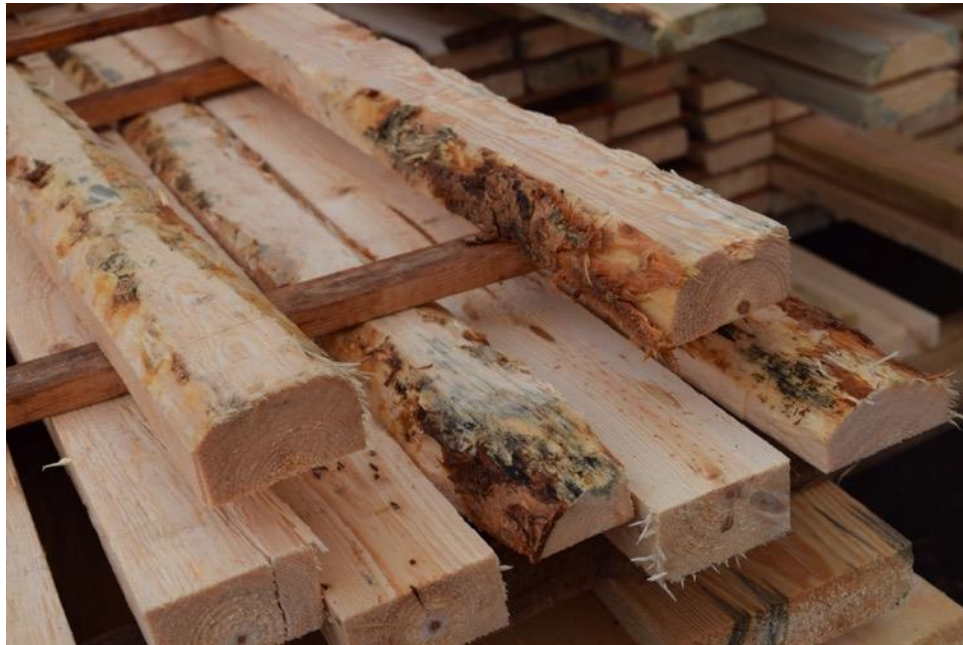
Figure 24: An example of the amount of wane that was present throughout the processed material; this was compatible with the No.2 visual grade.

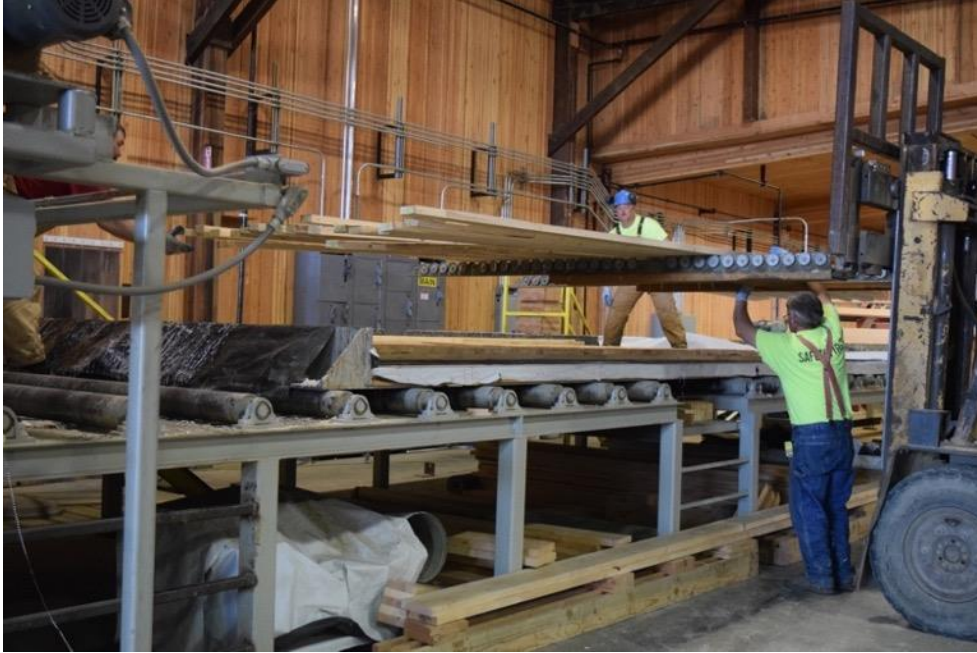
Figure 26: Layup of the major strength direction of the panels. One ply of lumber is laid-up on the forks of the forklift, which have wheels to roll the lumber off. The linemen simply need to ensure that the lumber is laid-up tightly.

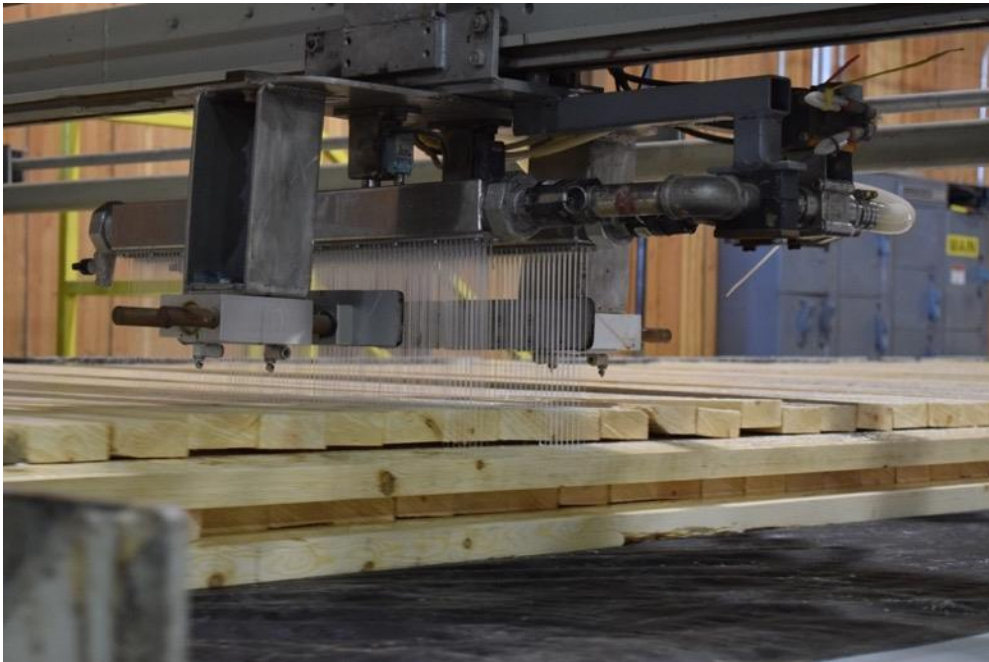
Figure 27: Panel glue spread setup. The glue head moves along the minor direction of the panels lay-up, while the table, on which the panels are laid-up, moves in the major direction. The hardener and MF glue are kept separately and roll together when placed under pressure in the press.

The glue used for the panels was a two-part melamine formaldehyde (MF) manufactured by AkzoNobel, with spread rates between 73-100 lbs/Mft² (Table 2). This glue is sensitive to environmental and lumber temperatures, performing optimally between 70-75°F for the lumber (Lawrence and Brock 2017, Casco Adhesives 2009). The hardener and resin are kept separately (Figure 27) and are applied individually as parallel beads on the panels lay-up, combining only when the panel is pressed and the two parts spread and merge together. Ensuring that the resin is cured according to manufacturer's specs, each panel is pressed for an average of two hours with a 105 psi (Table 2). The press time and the ratio between the resin and the harder is adjusted if the environment or lumber is different than the optimal 70-75 °F range. The CLT panels with Iron Triangle, LLC material were produced within the week of June 1, 2016. The panels produced from Collins Co. lumber were pressed between January 18-20, 2017.

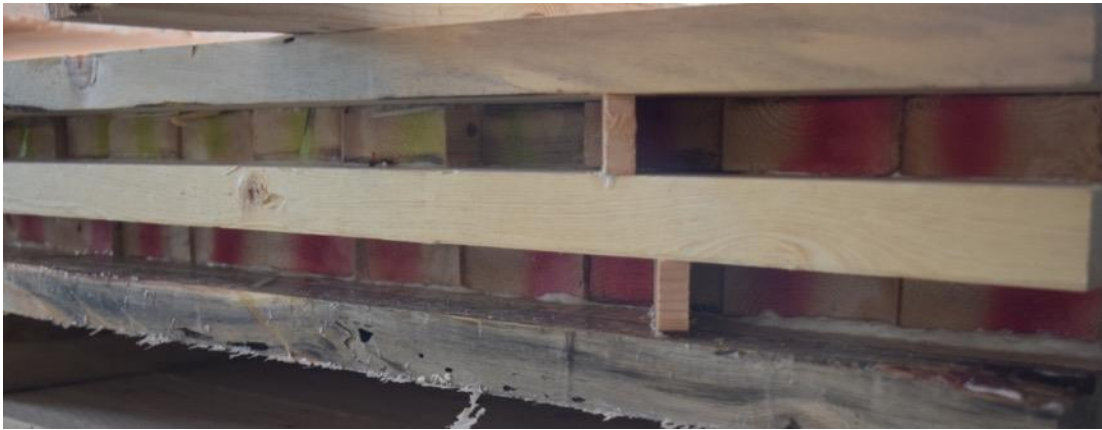
Figure 29: Example of the overhang designed to ensure a tight layup.

The company designs layups with an overhang on the edges of the panels to allow the in-plane pressure and ensure a tight layup and press of the panels (Figure 29).

and block shear specimens were cut with an additional inch of width when cut on the edge of the panel to prevent an incomplete sample, as the edges of the panel had overhang (as seen in Figure 29).

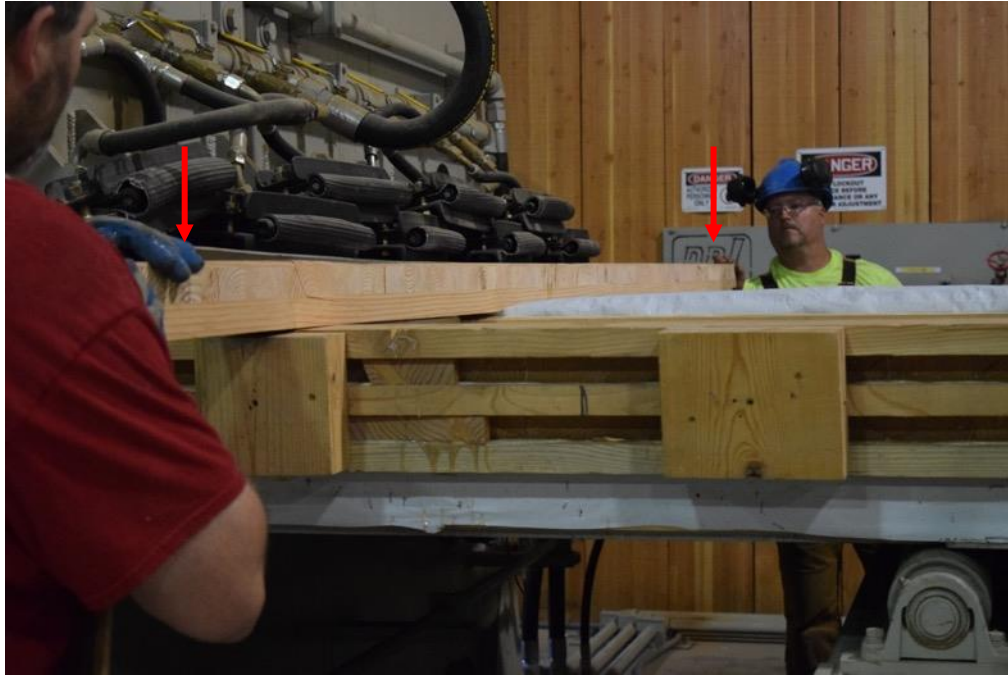
Figure 31: Because of warping, the panels had to be manually pressed down when loaded into the pneumatic press. The arrows indicating the pressure points on the board helping to squeeze the laid-up panel in the press.

Due to the substantial presence of twist, the panels had to be manually pressed down to be loaded into the pneumatic press (Figure 31). According to the CLT line team this, difficulty in loading the press was not typical. The twist was present only in the

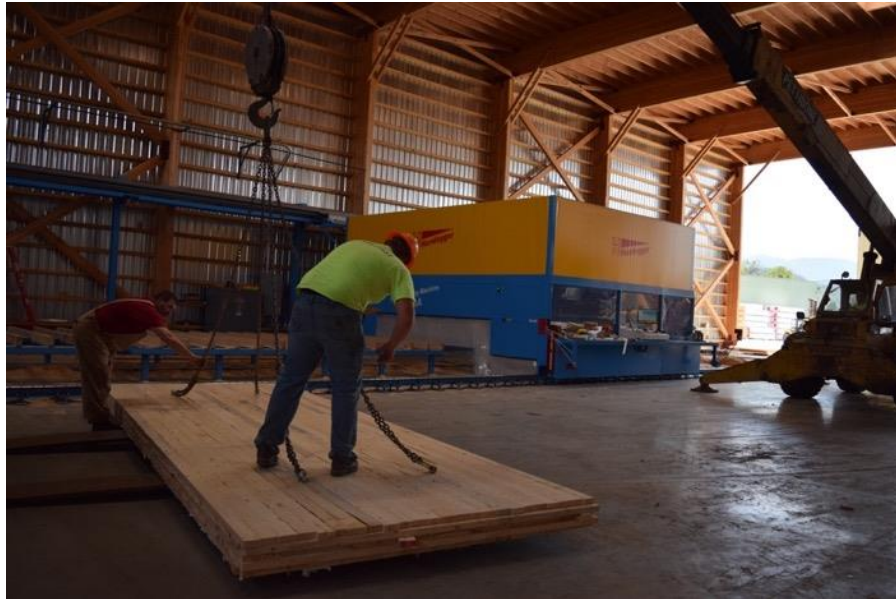
Figure 32: The labor-intensive method used by D.R. Johnson to move the produced panel from the press to their CNC. The panel must be rotated, screws inserted, and the chains adjusted for stability.

After the panels were removed from the press they were moved to the Hundegger PBA Computer Numerical Control (CNC) machine to make the specified cuts. Panels from the press are moved to the CNC by a crane (Figure 32). Once the panel is placed on the stands for the CNC, the cut pattern is uploaded. The corner from which the cut pattern will be based is then selected to ensure a square cut. Before the Hundegger PBA, D.R. Johnson's CNC machine, was installed the company was using hand tools, such as skill saws and panels saws, for finishing cutouts to panels.

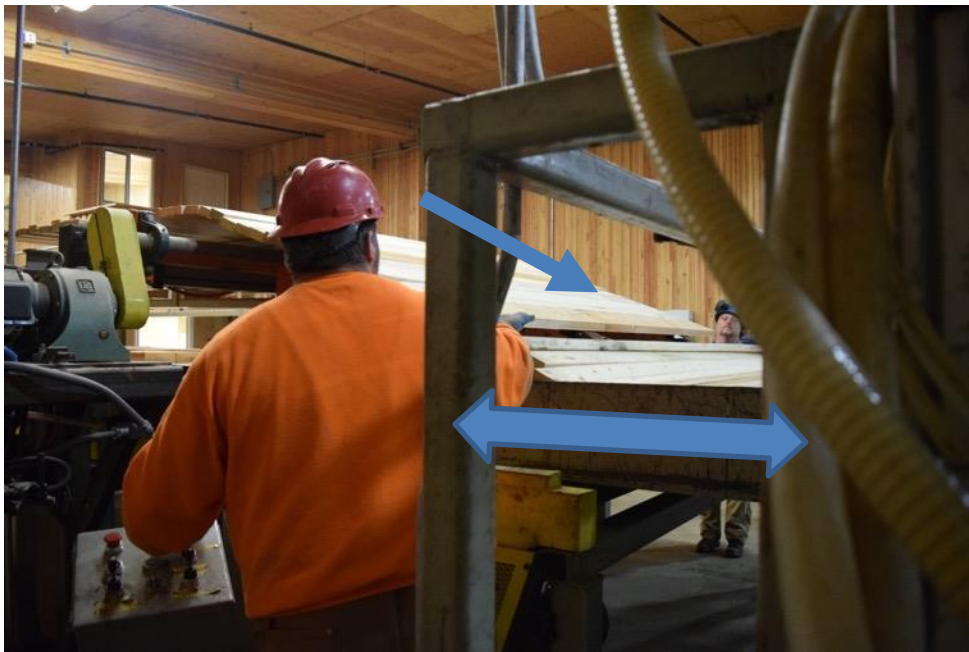
Figure 33: The additional machine that D.R. Johnson used for assistance in the minor direction. This allowed for the lumber to be rolled on top of the previous layer as the staging area for the panel moved back and forth for a quicker and easier layup to help reduce open times.

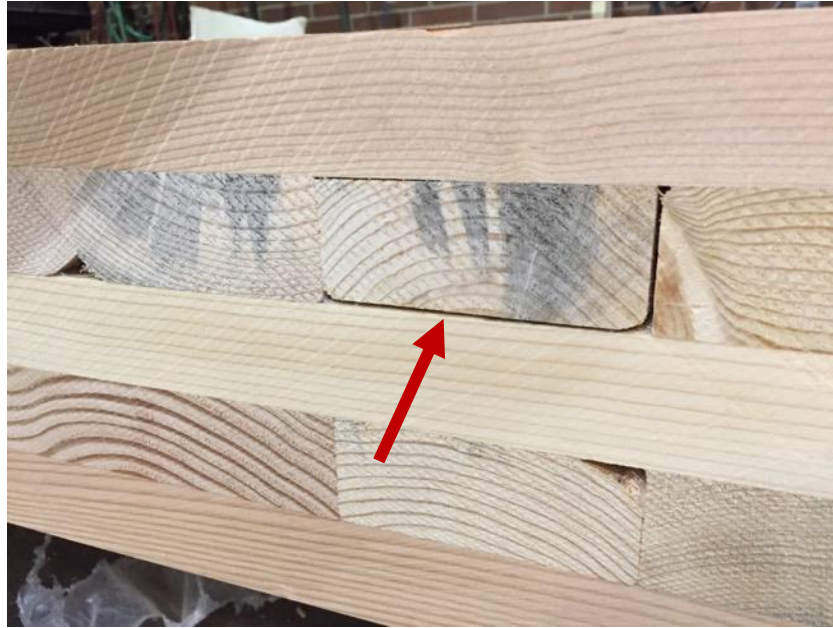
Figure 34: Due to bow and twist, when sent through the planer, the lumber becomes too thin for panel production and/or a sufficient bondline.

Due to the presence of twist some pieces of lumber could not be properly flattened in the planner and thus was not consistently planed (Figure 34). This means that some pieces of lumber were planed thinner than the target. The effect of loose thickness tolerances due to planing overly twisted pieces was explained in section 1.8.5

Thickness Tolerance and can be seen in Figure 34 where a piece of lumber was planed too thin causing a gap within the core of the panel. This is a major issue because the adhesive line in this spot (and possibly along the lamination) was not pressed properly.

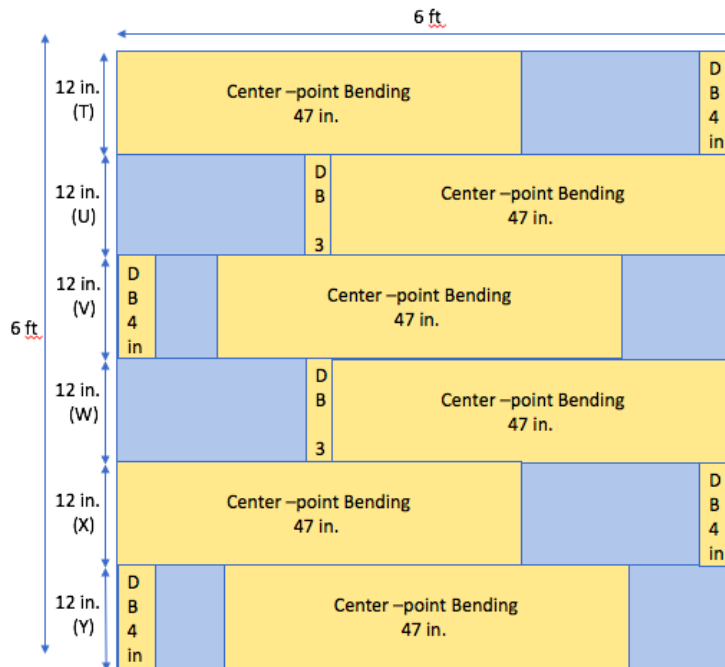
(a)

(b)

Figure 35: The cut pattern for a 3- (a) and 5-ply (b) single species panel. Where “DB” refers to strip of material that was cut for further breakdown in the cyclic delamination and block shear specimens. The DB (4”) cuts are to ensure the sample is not effected by any inconsistencies that occurred along the edge of the panel.

The specimens were pre-cut at D.R Johnson on their Hundegger PBA CNC. The use of the new CNC machine sped up the cutting process. All cut patterns for the panels, with dimensions, can be seen in Figure 35 and Figure 36. The 3rd-point bending specimens and the center-point specimens were instantly tested when delivered to OSU as not additional prep work needed to be done before testing. The block shear and delamination samples were stored in an ASTM standard conditioning room. The project's cut pattern would have required a full (8-hour) day per panel before the Hundegger PBA CNC was added to the production line, but only equated to roughly 30-45 minutes (dependent upon the panel depth) afterwards at D.R. Johnson. Then each piece of the

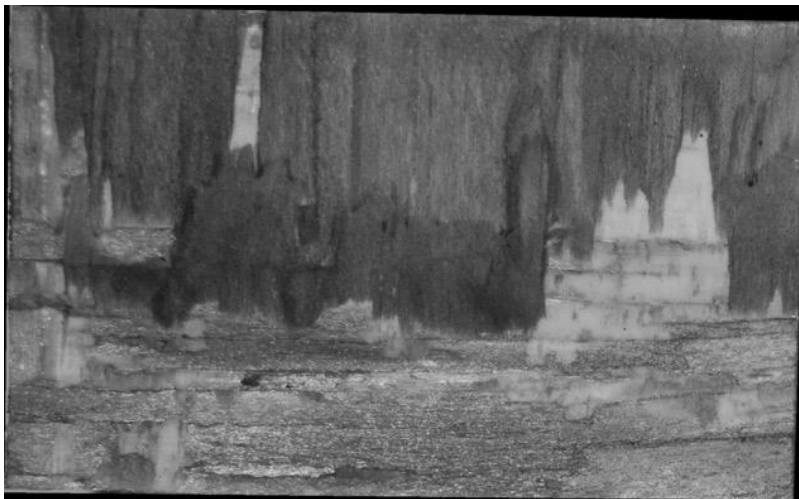
(a) After the sample is stained and photographed, such as Figure 46. The image is then selected in ImageJ and selected side of the bondline is cropped.

(b) Once the image is cropped, it is set to gray scale with an adjustable scale to adjust if appropriate.

(c) The program will then give the results, similar to those seen to the left. The amount of resin and wood failure are upfront and clear, indicated with the red circle.

Figure 47: The process of image analysis that was done on the shear samples after testing, with correlating descriptions (a), (b), (c).

(Nikon 2015). The images were then processed with an imageJ software package (IJ 1.46r) by the National Institutes of Health (Ferreira and Rasband 2012) using a script created specifically for this purpose (Sept 2015). The program converts the color bondline image pixels in to greyscale and then counts the darkest pixels, which are representative of wood failure (Figure 47).

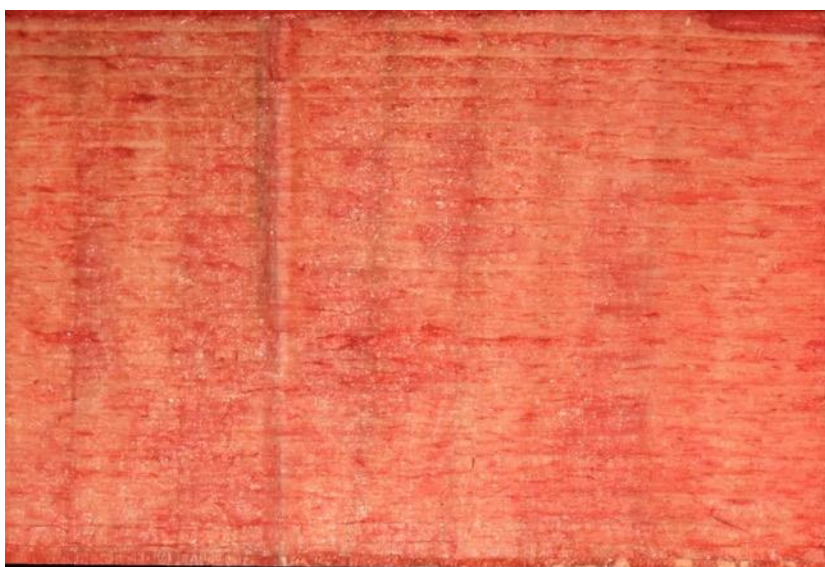
Figure 48: Example of some of the difficulty with safranin stain; where wood failure is present but minor, making it difficult to distinguish from the resin failure.

While safranin stain did work well for most specimens, some issues were experienced when individual cells attached to the adhesive surface making it difficult to determine whether a sample passes the qualification criteria. It is sometimes difficult to properly qualify the failure automatically without a microscopic inspection of the surface. An example of when using the safranin stain could be difficult is with small transitions between the wood and glue failures, as seen in Figure 48.

In Figure 48, there was minimal wood failure according to the ImageJ script used, but in reality, there was a higher level of wood failure. The grain orientation in Figure 49 resulted in the same miss-interpretation of the WF% from the images. Grain orientation of the area being stained affects the adsorption or stain intensity, which can register as resin failure even when the visual inspection would reveal only wood failure. This problem can be seen in Figure 49, highlighted with the blue circle. While the programming script was used to analyze the samples, it can be manually adjusted for specimens that were difficult to interpret.

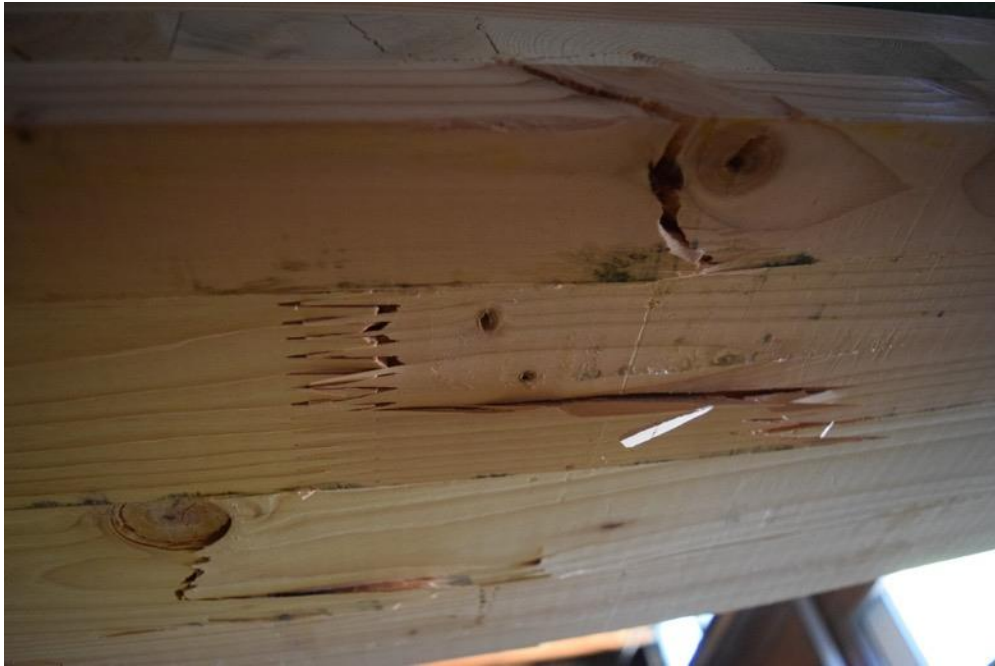
Figure 53: Failure of a 5-ply third-point test specimen at finger joints and knots.

The long span beams mainly failed at finger joints and knots on the tensile side (Figure 53 and Figure 54). Test results by panel construction type are summarized in Table 6. Specimens made with No.2 Douglas-fir face and thinning core lumber exceeded benchmark characteristic set by the PRG 320-2012 for E3 CLT grade. The benchmark characteristic values were calculated based on the stiffness valued listed for the E3 CLT grade in Table A2 in PRG 320-2012. Both the mixed core and mixed species sample groups exceeded the characteristic values MOR (f_b) and E_f benchmarks for the E3 preset grade.

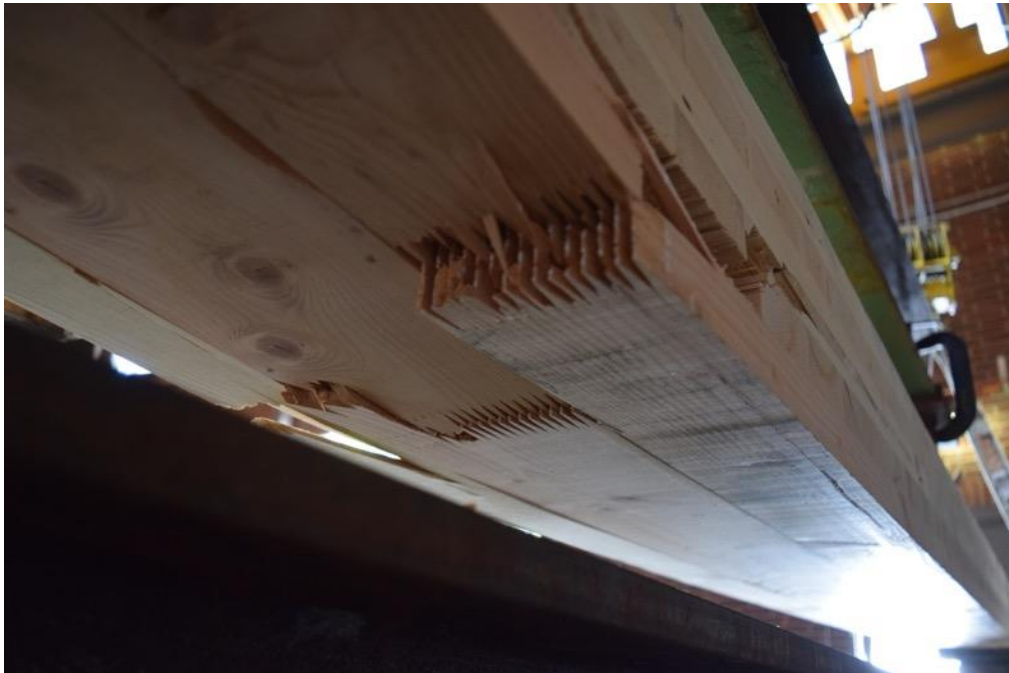
Figure 54: Failure of a 5-ply third-point test specimen at two finger joints, which were close together.

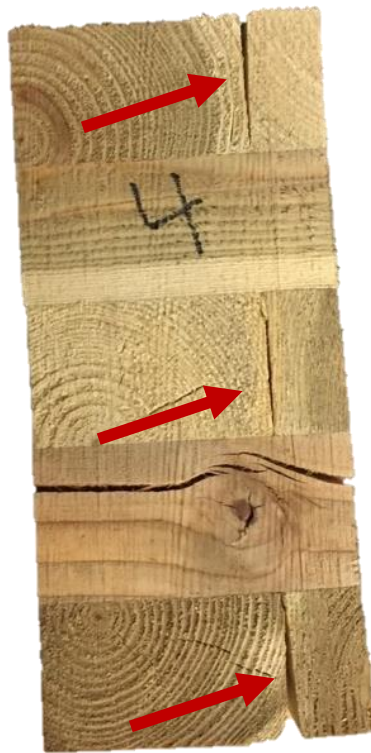
Figure 65: Cyclic delamination sample showing un-bonded edges that caused very little to no delamination on the bonded faces.

The corners of the specimens where two pieces (Figure 65) of lumber met with unbonded narrow edges were initially a concern, but no excessive amount of failure at those locations was found.

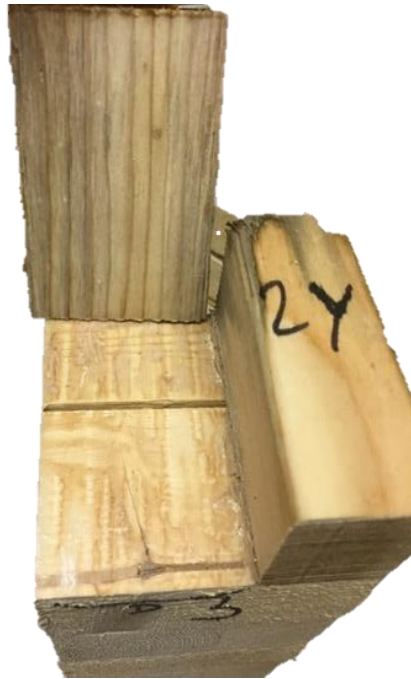
Figure 66: A mixed species sample that resulted in high delamination.

There were specimens that clearly failed in delamination, as seen in Figure 66.

Causes of failure for these specimens could have been due to: lumber being planed too thin causing inconsistent pressure, allowing the adhesive to cure but no bond to be formed. Another possible reason may be the incompatibility with the adhesive system formulated for Douglas-fir used in the test with other species. Incompatibility of the adhesive system with the species included in the mix may have contributed to the

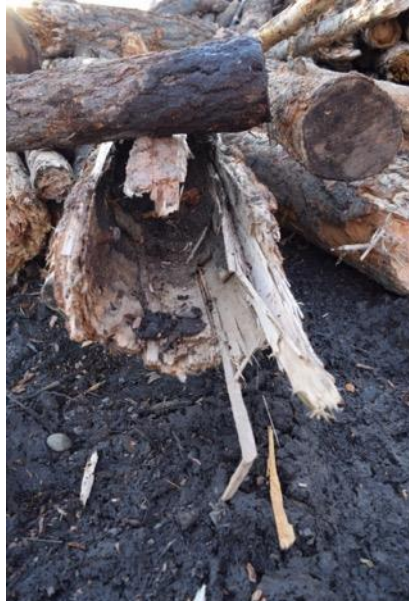
Figure 72 Log defects causing them to be removed.

The above figures show some of the defects the rejected timber contained. Other features included rot and significant curvature in the log, making it impossible to send through the HewSaw.

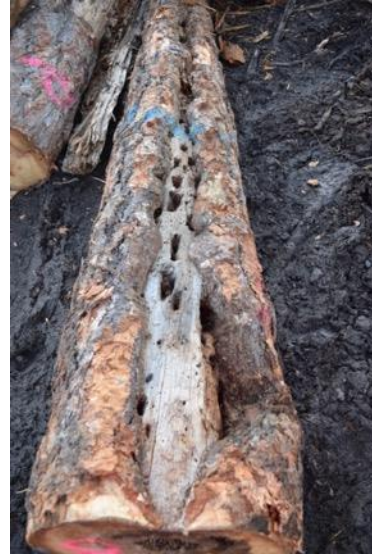
Figure 71: Animal defects of removed timber.

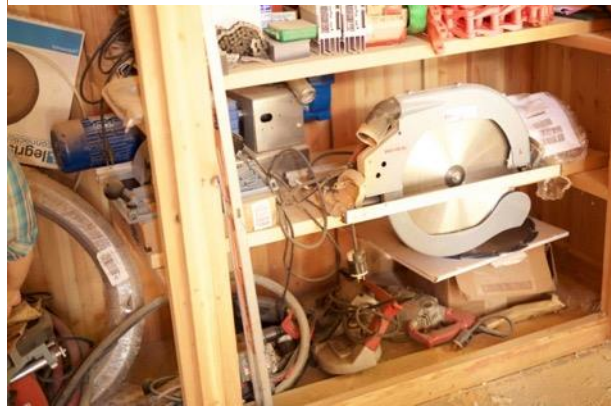
Figure 73: Finishing equipment for CLT panels at D.R. Johnson.

done in order for maximum efficiency when putting the building together. They are currently using hand tools, such as the ones that can be seen in Figure 73 and Figure 74. Due to the use of these machines, it causes the company to have a limited amount

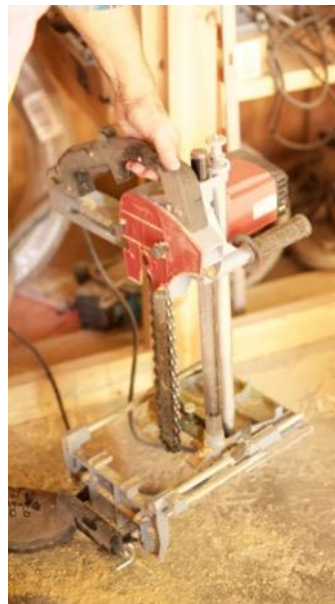
Figure 74: D.R. Johnson used a chainsaw to make the needed cuts on the panels.

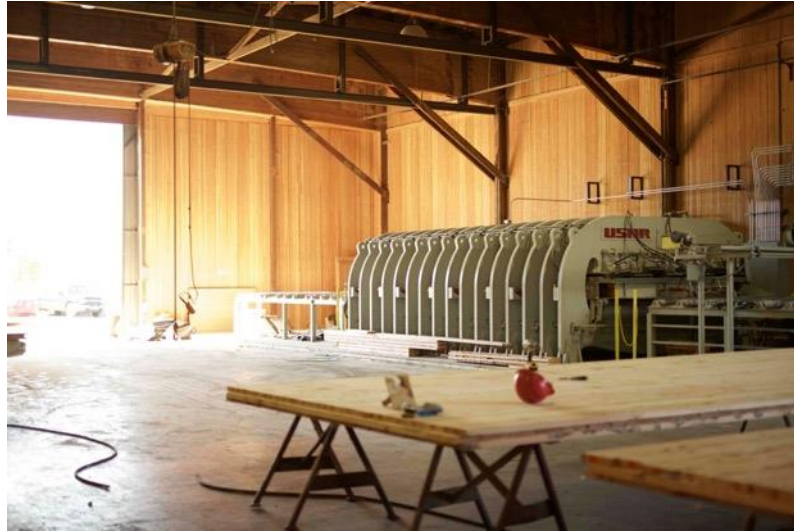
Figure 75: The custom press produced by USNR.

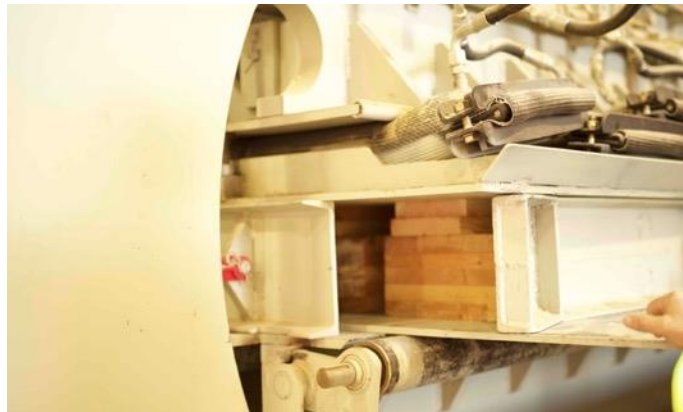
Figure 76: Closeup of the press closing.
