U. S. Department of Agriculture, Forest Service
FOREST PRODUCTS LABORATORY

**HOUSE FRAMING LUMBER
SHOULD BE KILN DRIED**

By L. V. TEESDALE
Senior Engineer

Published in
SOUTHERN LUMBERMAN
July, 1933

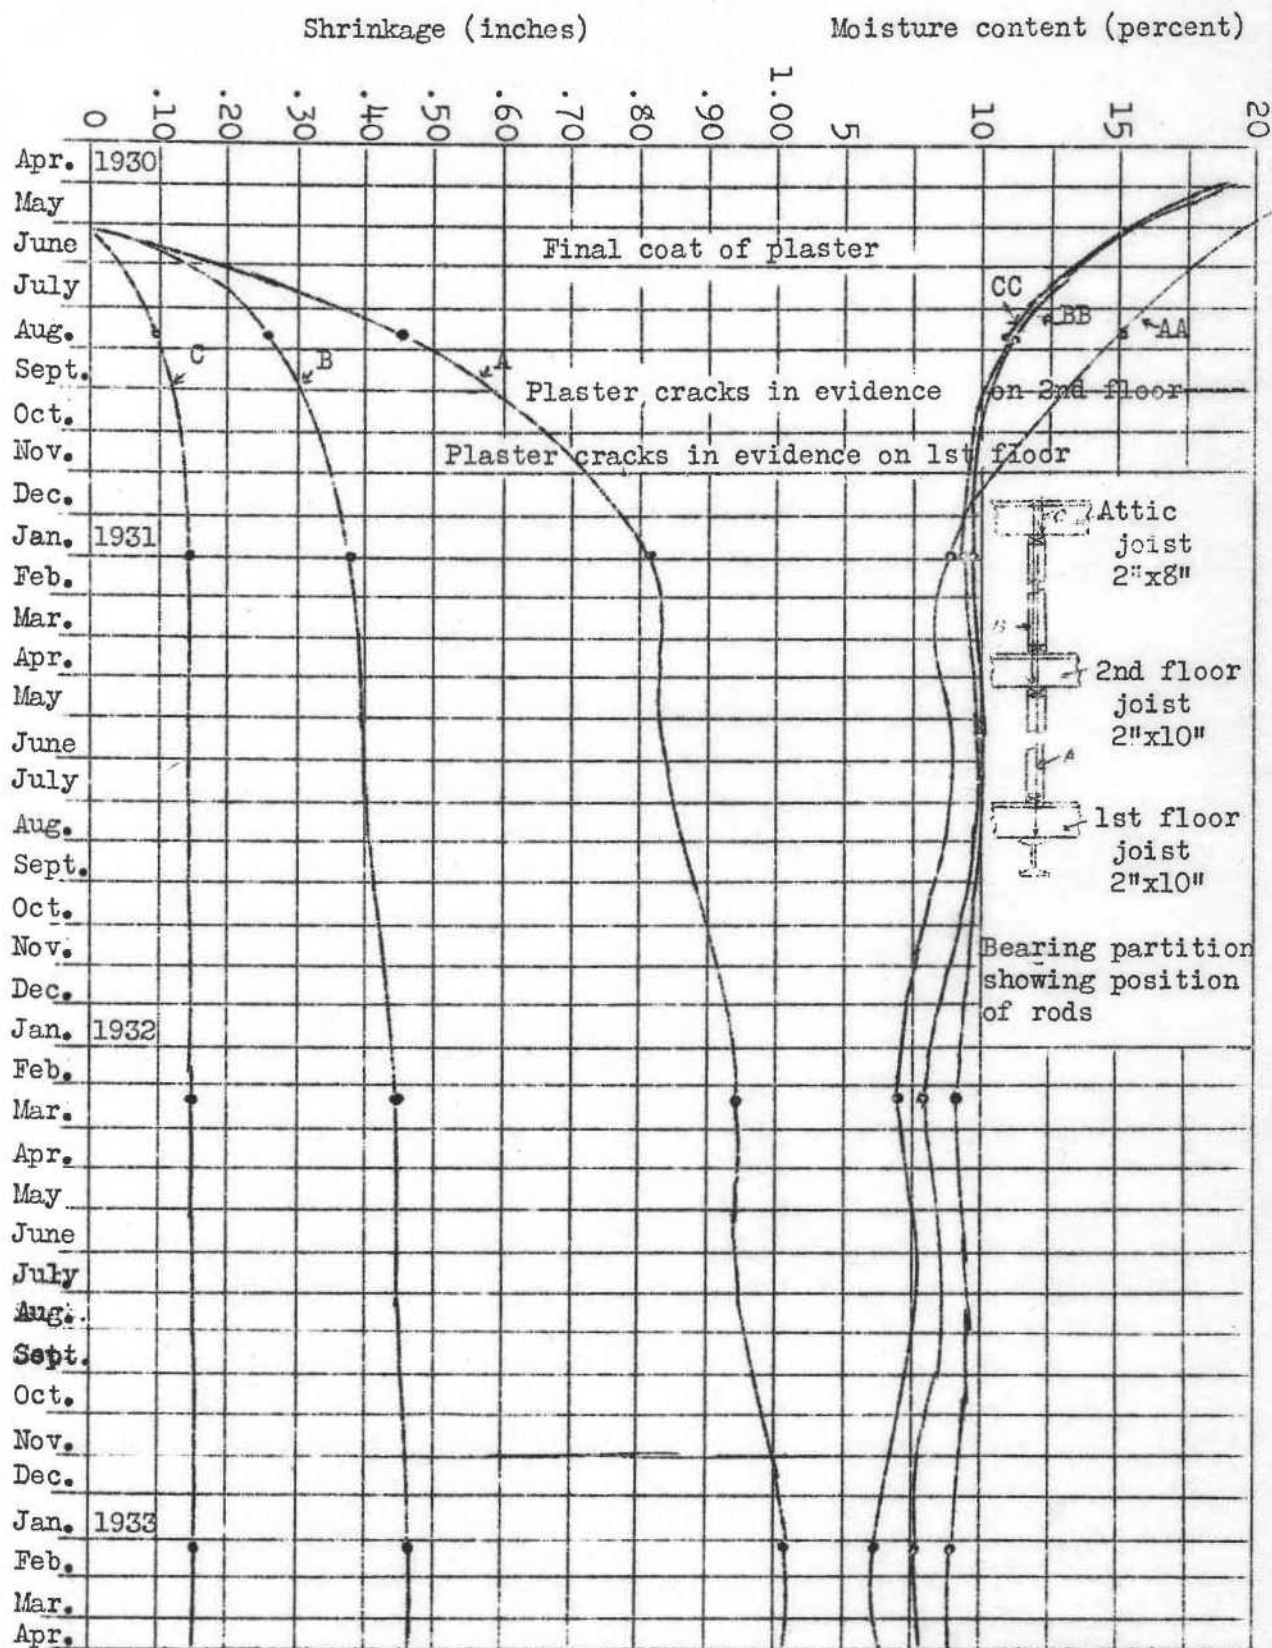
Figure 1.--Curves showing shrinkage (a) between basement girders and attic floor; (b) between first floor partition cap and attic floor; (c) between second floor partition cap and attic floor. The average moisture content of the wood represented in the first floor, second floor and attic units is also shown.

Plaster cracks in the house appeared first in cross walls on the second floor and later some minor cracks developed in the bearing wall and around the fireplace on the first floor. A fair proportion of the shrinkage had taken place before cracks developed as may be noted on Figures 1 and 2. This may be explained by the fact that under ordinary use conditions some shrinkage in the structural frame can take place without producing plaster cracks, or in other words there is a certain amount of "take up" or slack between the frame and the plaster. Tests have shown that the grounds, studs, door and window jams pick up moisture from fresh plaster, and expand slightly. Subsequently after redrying they shrink away from the plaster and leave a space even though very small that will permit some movement of the plaster sheet before contact is reestablished. After the take up or slack was absorbed in the house under consideration further shrinkage caused the cracks to extend in proportion to the shrinkage. In spite of the amount of shrinkage found in this house the effect of shrinkage in terms of plaster cracks and other defects has not been important on the first floor. On the second floor some unsightly cracks have developed and, because of distortion in the frames of two doors in cross walls, adjustment of the hardware has been necessary so that the doors would latch.

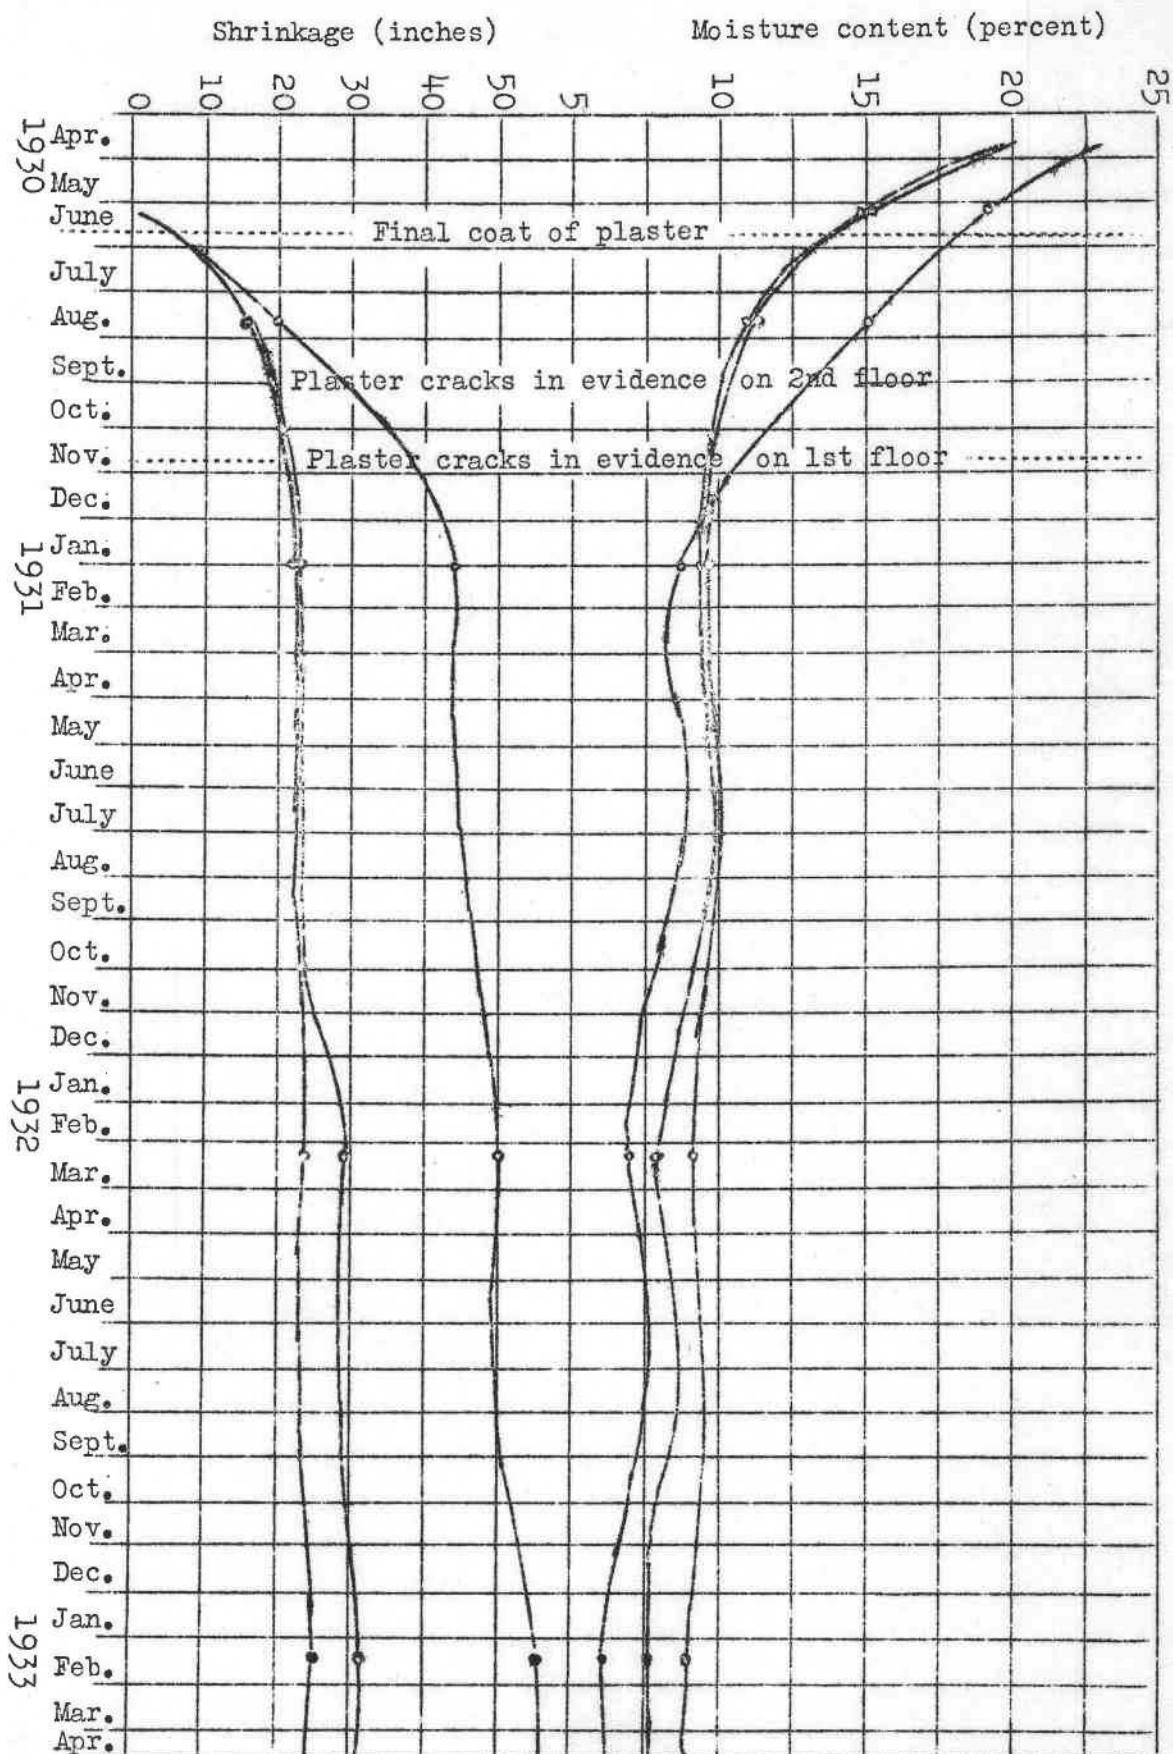
Figure 2.--Curves showing shrinkage (a) between top of basement girder and top of first floor partition cap; (b) between top of first floor partition cap and top of second floor partition cap; (c) between top of second floor partition cap and attic floor. The average moisture content of each unit is also shown.
