Floor Tile

CORK

Forest Products Research Center

Information Circular 13

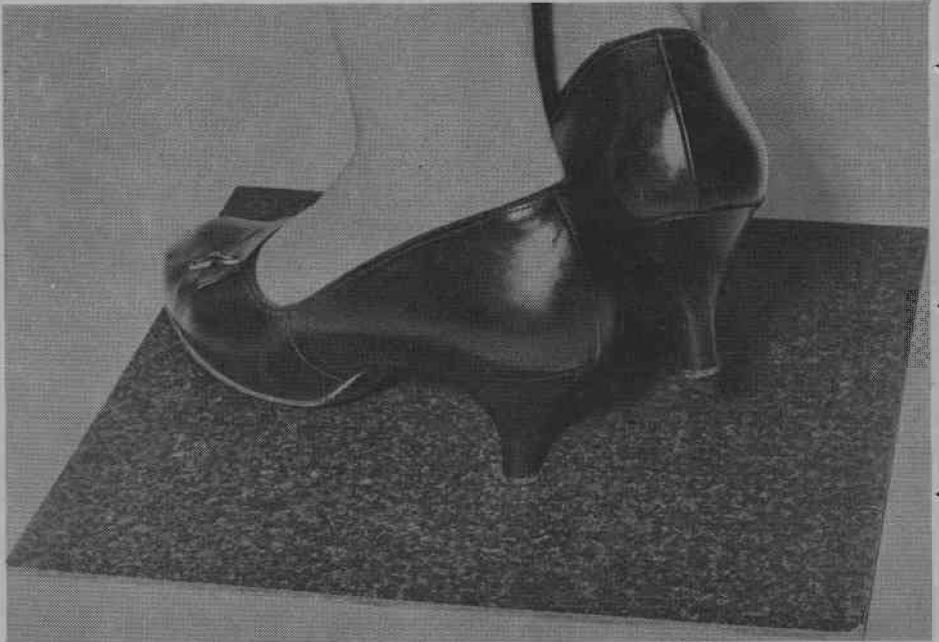
CUSHIONING EFFECT of Douglas fir floor tile was coupled with quick recovery from indentation.
