EFFECT OF WETTING ON PERFORMANCE OF SMALL-SCALE SHEAR WALLS

Abstract. Wood shear walls are the main lateral force-resisting system for wood-frame construction. Water intrusion and subsequent decay around connections can significantly impact shear wall behavior, but these problems are seldom studied. In this study, effects of water intrusion and fungal attack on shear wall capacity were examined using small-scale (610- × 610-mm) shear walls that were monitored with time using destructive monotonic tests. Results were compared with tests of dry and water control samples. Although fungal colonization was not successful under the conditions tested, wetting (with or without fungal inoculation) produced interesting effects on shear wall capacity. Wetting alone initially increased shear wall capacity, possibly because of fastener corrosion. Observations and digital image correlation data suggest that tensile forces in the uplift corner of the shear walls governed failure modes, which were primarily nail withdrawal, nail pull-through, flake debonding, and cross-grain tension. Wetting affected rigidity of oriented strandboard and led to more frequent nail pull-through. Although failure loa

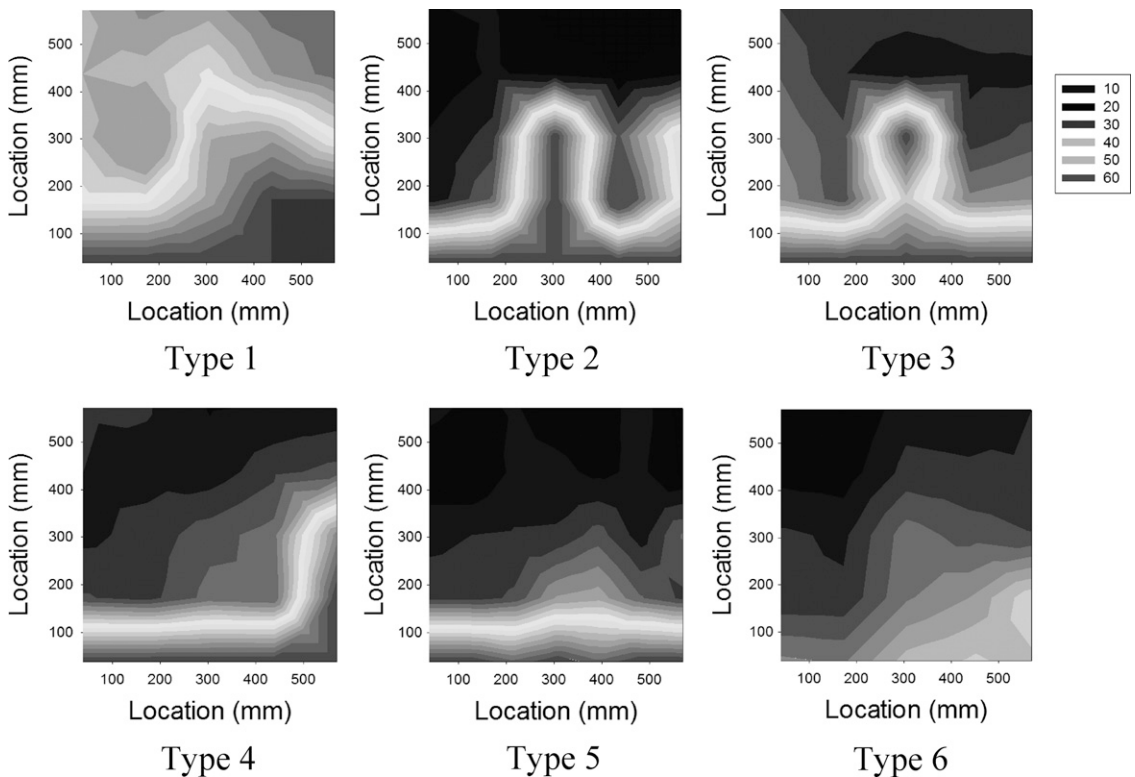
Figure 3. Examples of moisture distribution patterns in shear wall assemblies subjected to regular wetting in the uplift corner (lower right on each diagram) in which lighter colors signify higher moisture levels.

Moisture levels in the assemblies, as determined by mass gain, increased by 12–17% overall, but nearly all of this increase occurred in the uplift corners resulting in moisture contents in this region between 52 and 71%. These values closely corresponded to those found using the moisture meter and suggest that the panels were well above the FSP in the uplift zone (Fig 3).

As noted, wetting tended to be concentrated in the uplift corner, reflecting the tendency of the irrigation system to direct water into this region. The bottom of the OSB adjacent to the bottom plate achieved the highest moisture levels, but there were some variations in wetting patterns (Fig 3). Six different wetting patterns occurred (Fig 3) and were arbitrarily called type 1 to type 6.
