METHODS FOR TESTING AND EVALUATING CARGO FLOORING FOR TRANSPORT AIRCRAFT

No. 1550

UNITED STATES DEPARTMENT OF AGRICULTURE FOREST SERVICE FOREST PRODUCTS LABORATORY Madison 5, Wisconsin In Cooperation with the University of Wisconsin

M. P. BROKAW, Engineer

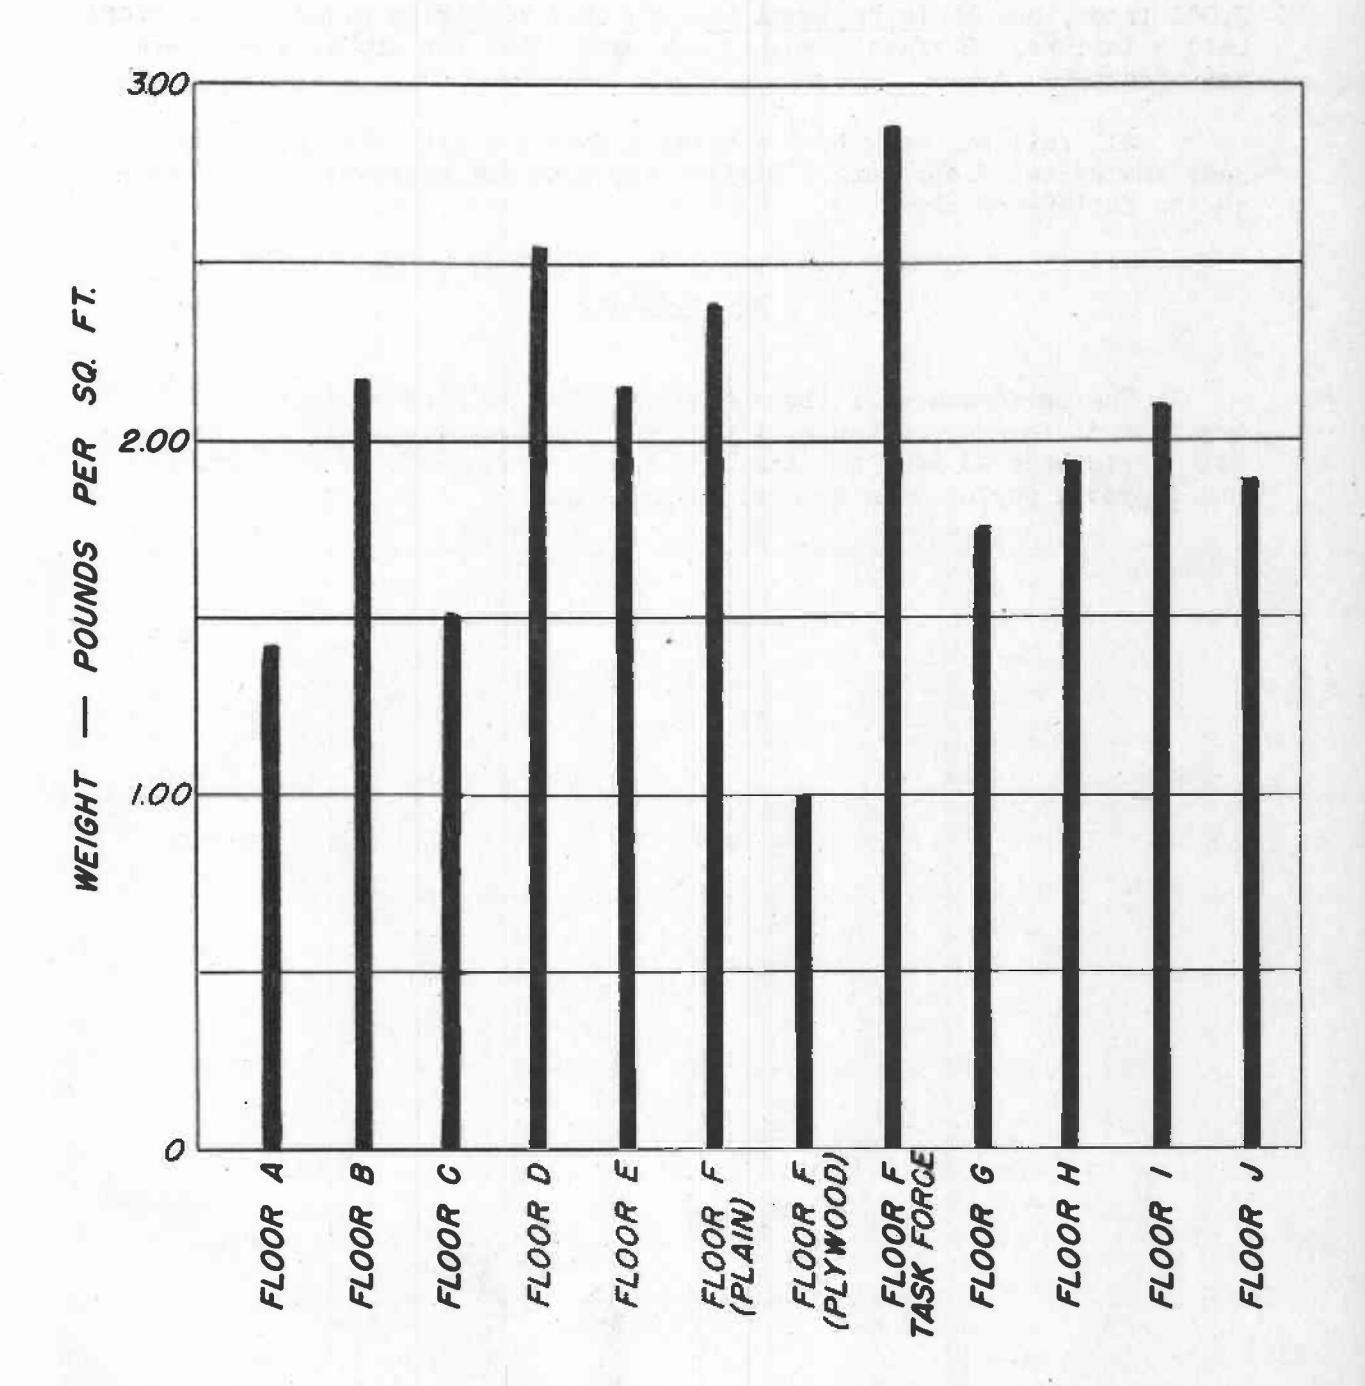
Figure 1.--Weight per square foot of the flooring as received. Floor D has tie-down rings attached. Floor J is equipped with skid strips on 10-inch centers. The weight of floor F as installed is the sum of ordinates marked (plain) and (plywood). The additional weight marked (task force) applies only to areas so protected.
Z M 61390 F

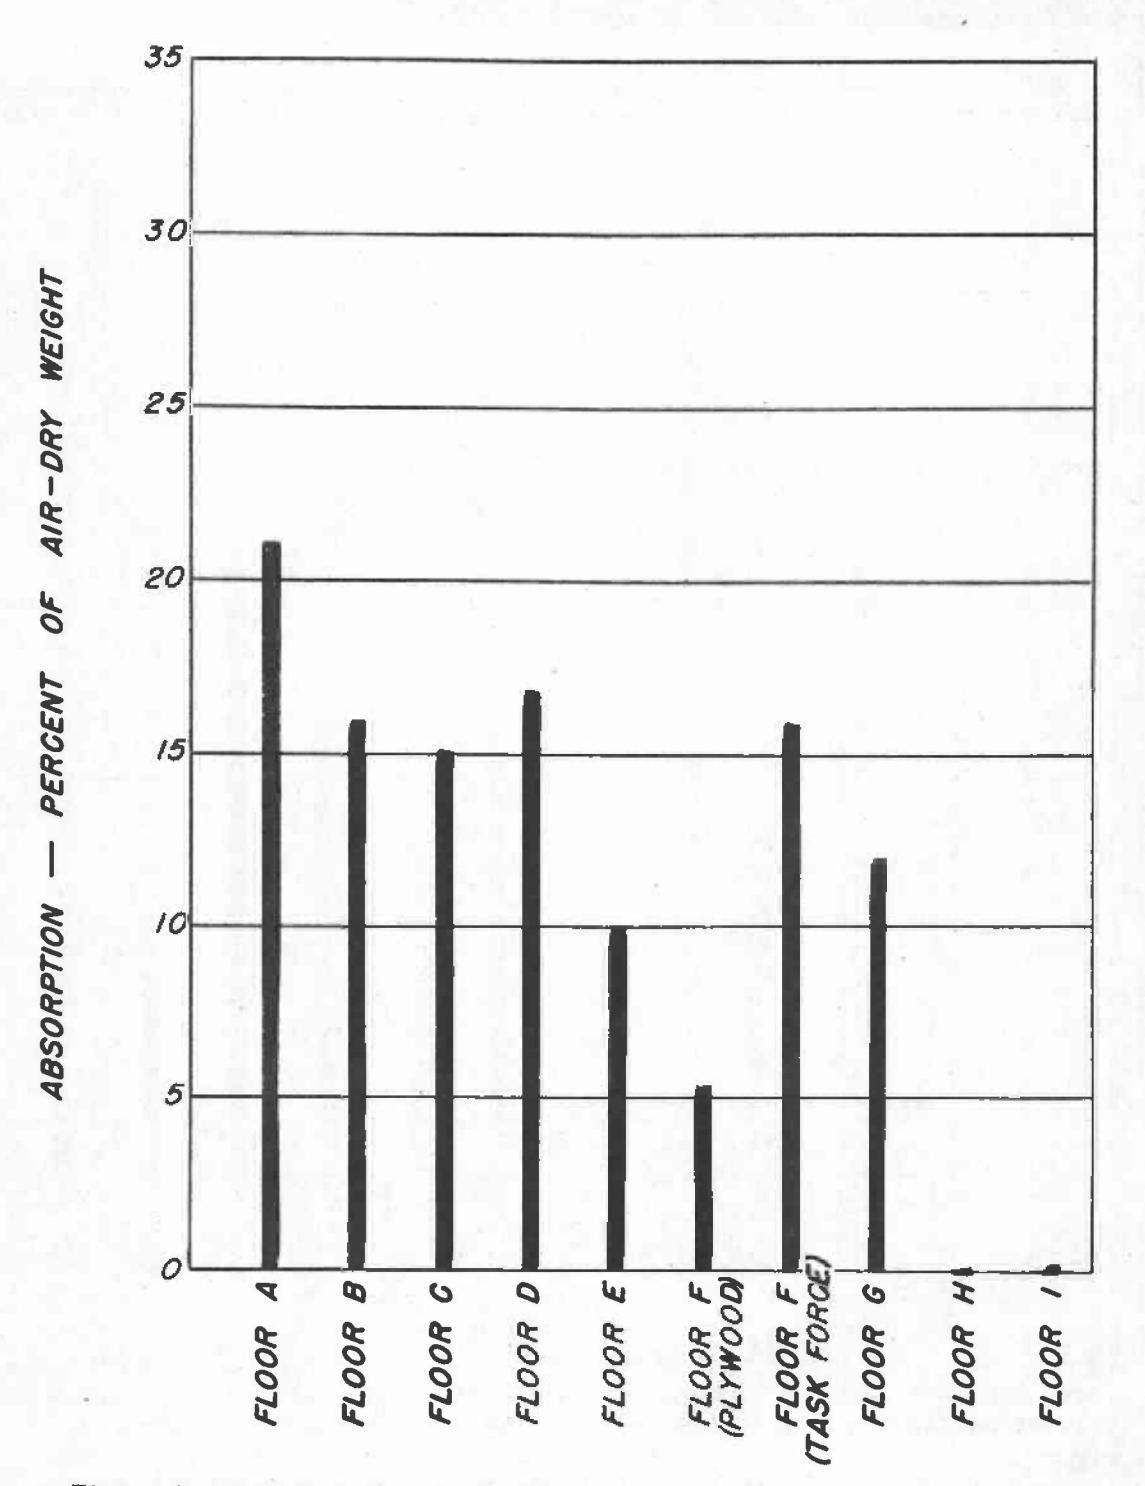
Figure 2.--Results of tests to determine absorption during immersion in water for a period of 48 hours. Specimens were 18 inches wide and 32 inches long. Absorption for floors E and F was based on the weight when air dry of the protective plywood cover or task force treadboards. Z M 61391 F

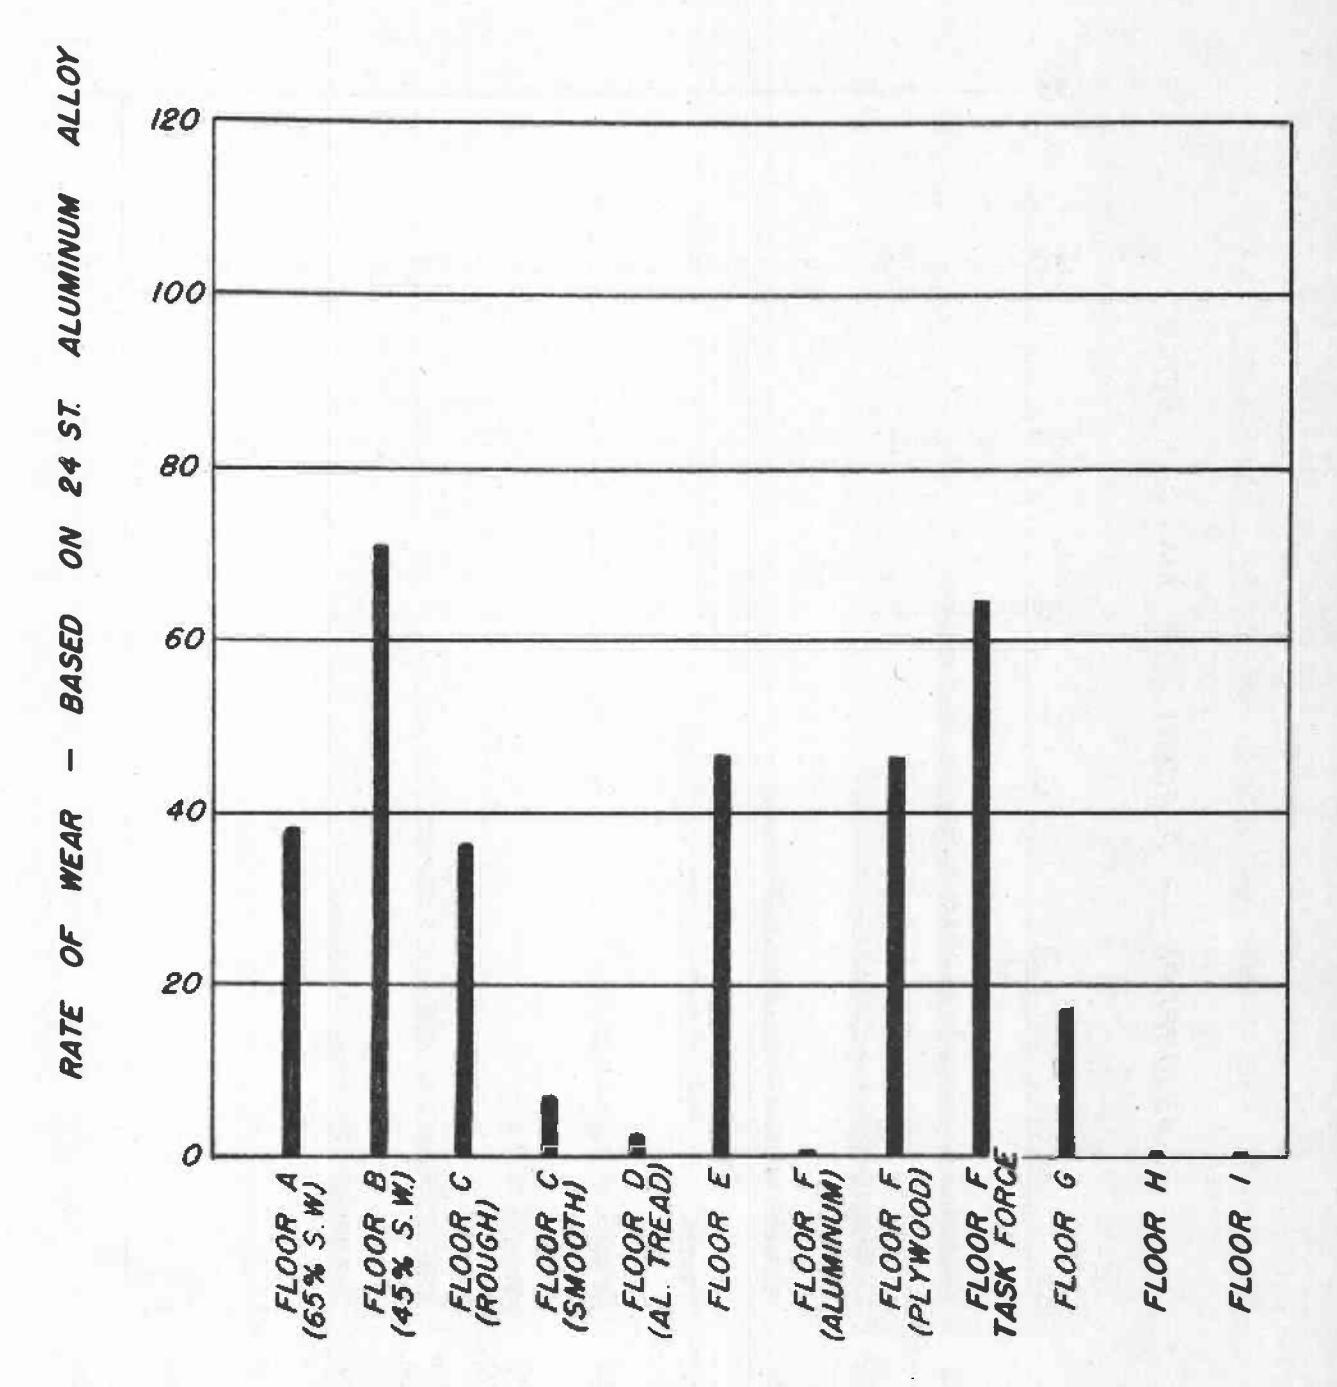
Figure 3.--Ratio of thickness loss of floorings to thickness loss of 24 ST aluminum under abrasion tests on air-dry specimens. The surfaces of floors A and B had 65 percent and 45 percent, respectively, of the area composed of summerwood. 2 x 61392 F

Floor A and floor B show widely divergent values of surface wear when tested in the air-dry condition. The difference in results can be explained when the relative amounts of summerwood are considered. The sample for floor A had about 65 percent of the exposed area composed of summerwood, while floor B had only 45 percent. Since summerwood is more dense and harder than springwood, the material having most summerwood content would be expected to show the best resistance to wear and abrasion. Tests on a wet surface, however, indicated that the difference in

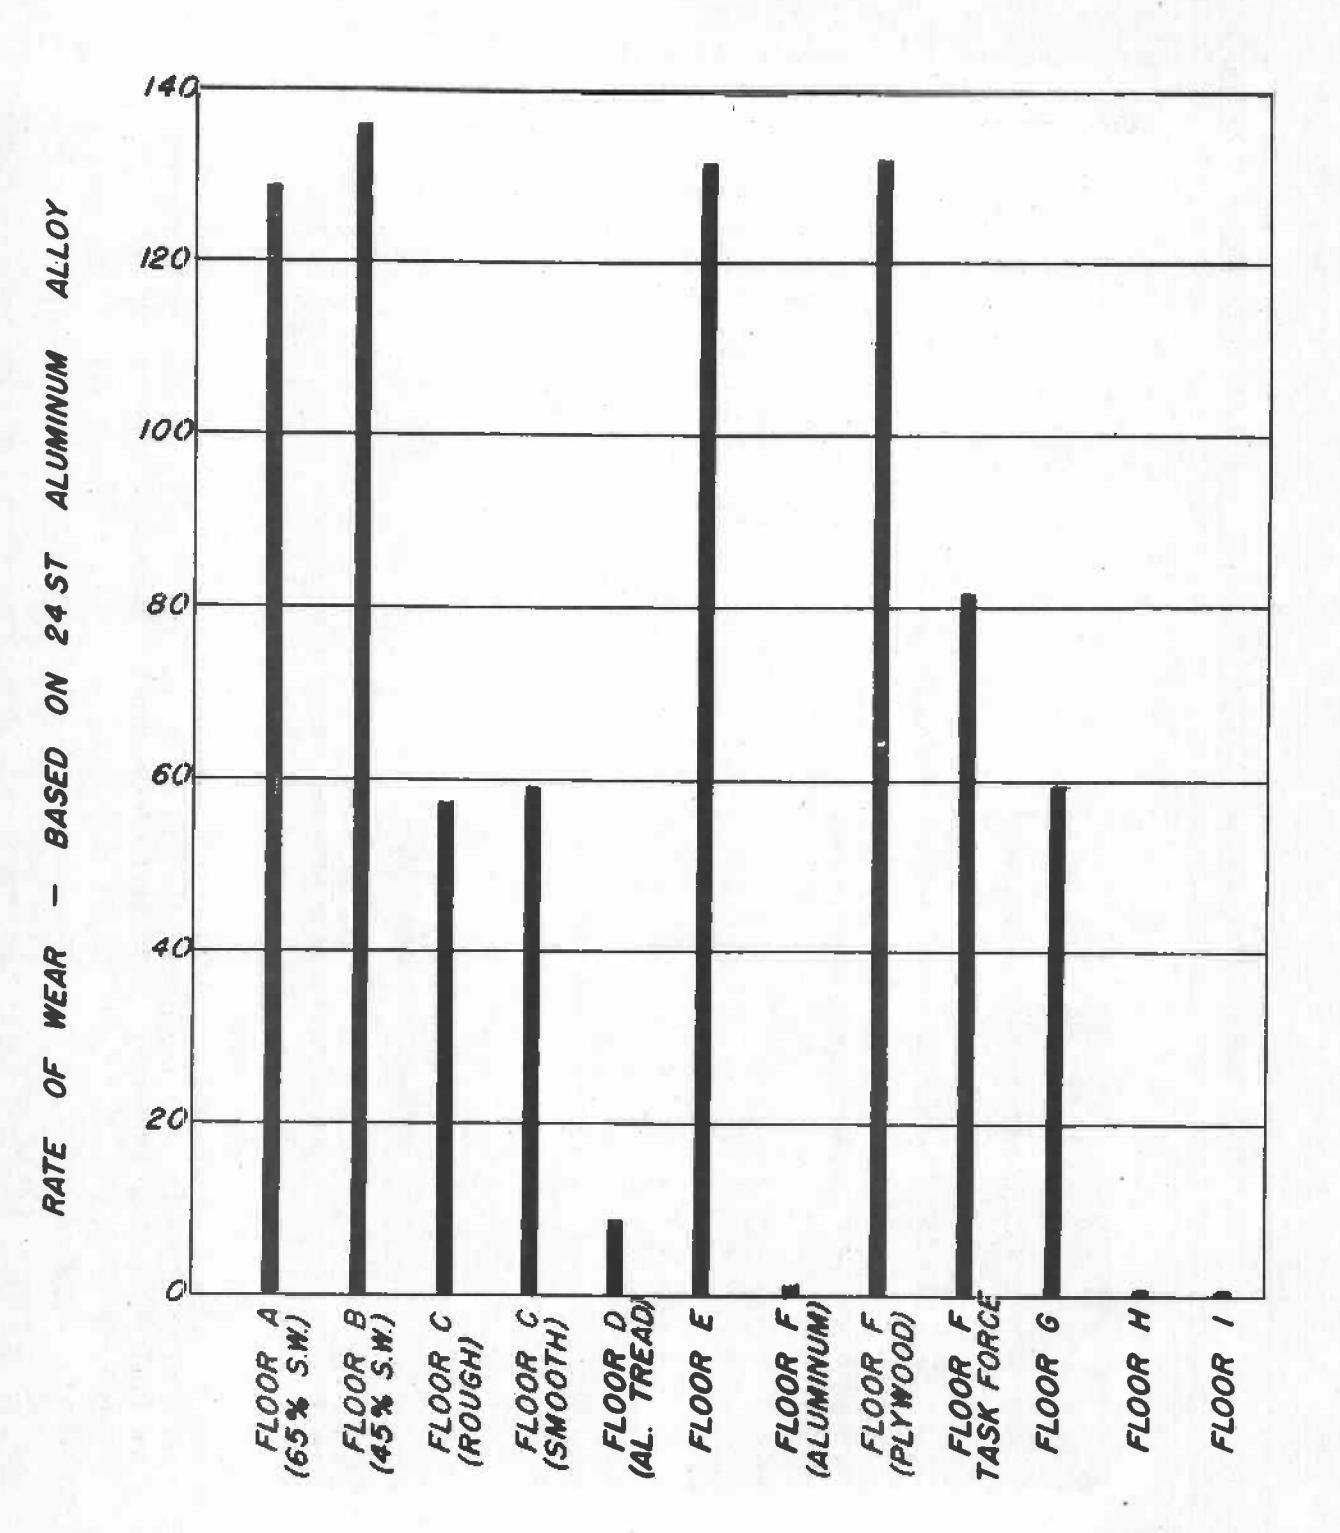
Figure 4.--Ratio of thickness loss of floorings to thickness loss of 24 ST aluminum under abrasion tests on specimens immersed in water. The effect of summerwood on rate of wear for floors A and B is not as apparent in the wet test as it is when tested dry. 2 M 61393 F

wear owing to summerwood is not critical. In this instance, the direction of motion of the abrading agent in reference to direction of grain is more important. The mean wear values for floors A and B are about equal when wet, but the rate of wear is greater when the abrasion is along the grain than when it is across the grain.

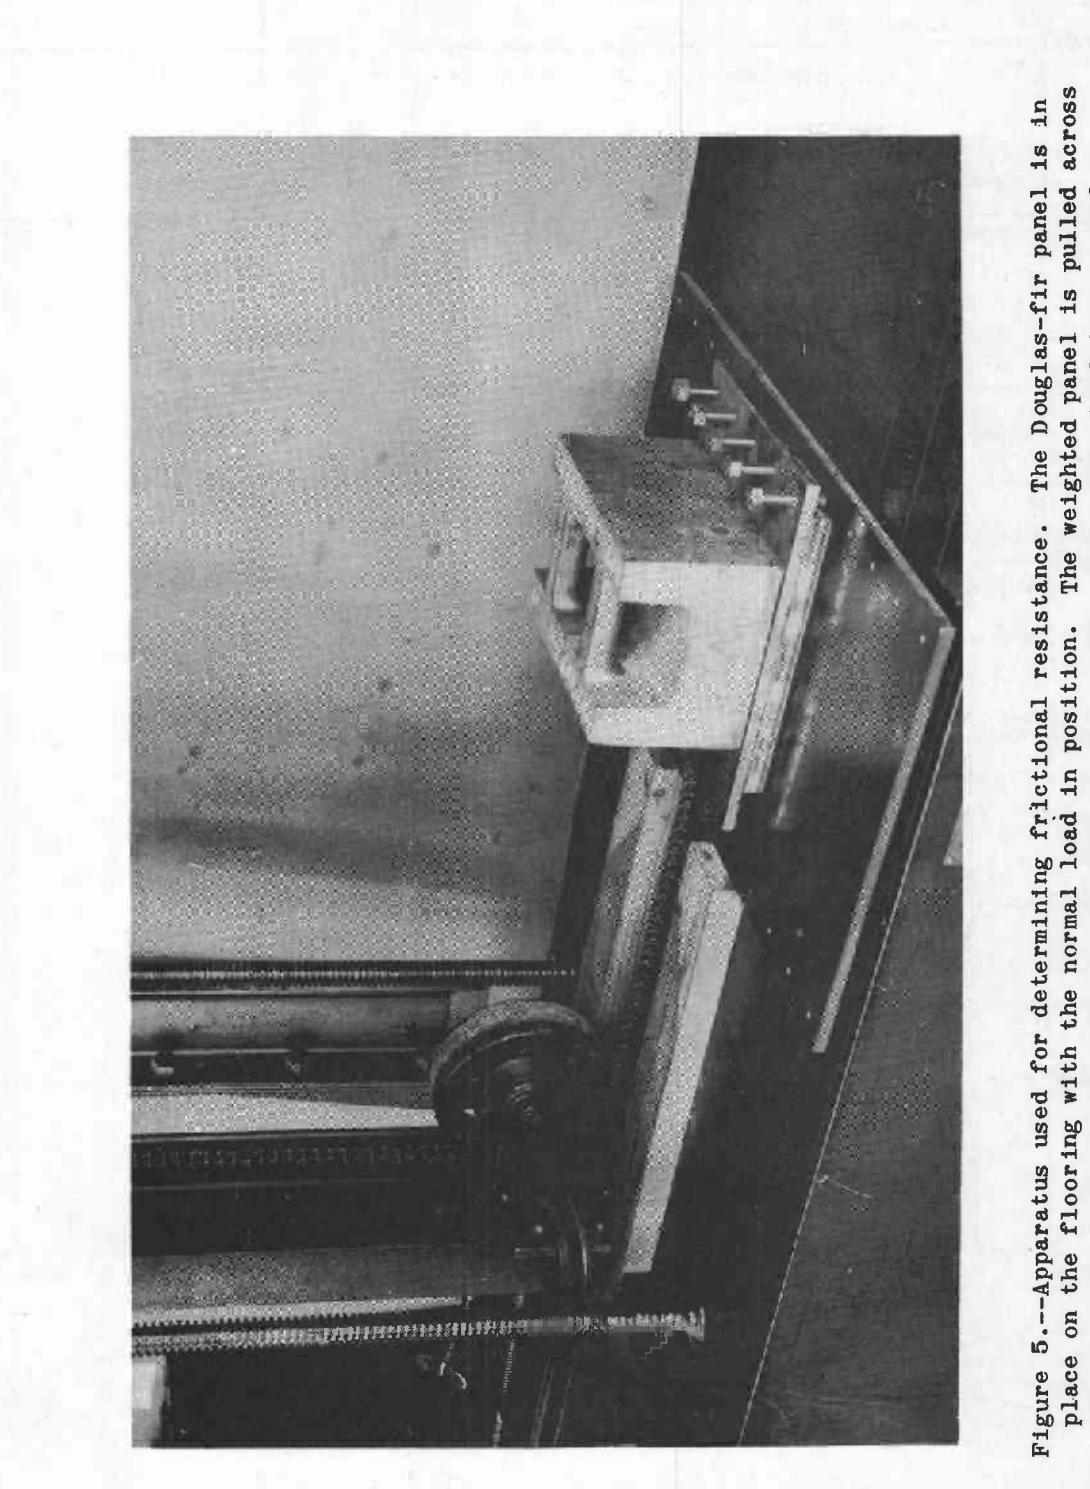
Tangential load is measured the floor by a chain appearing at the left of the panel. through the upper head of the testing machine.

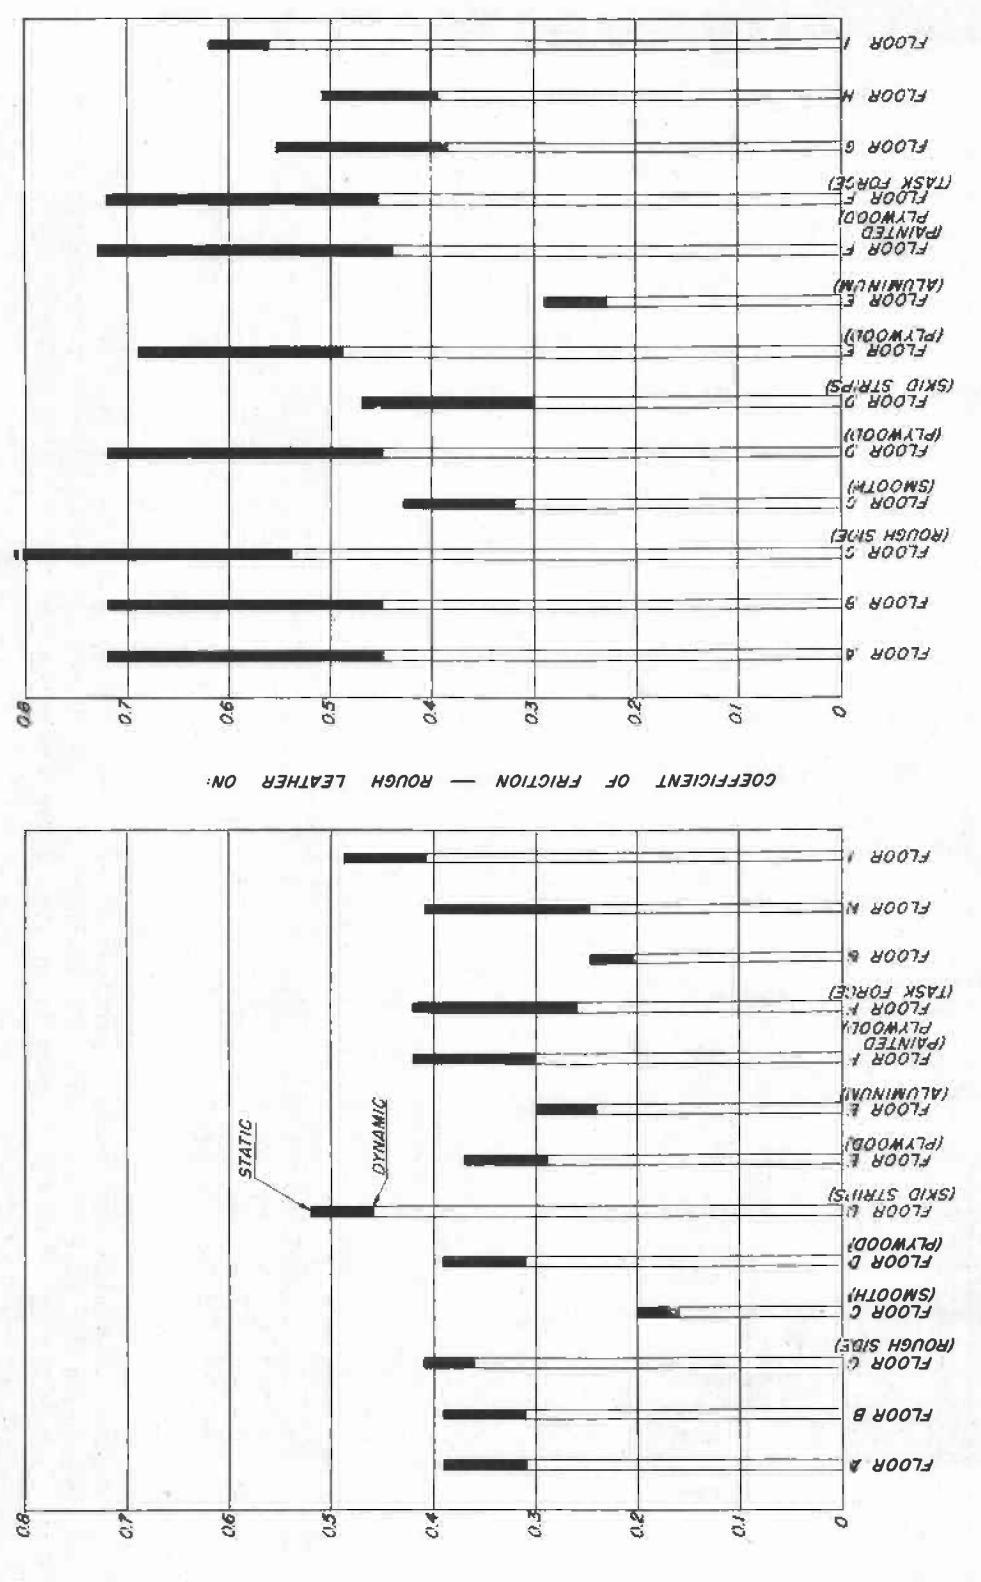
dynamic coefficients of friction between various types of flooring and Douglas-fir plywood or rough sole leather. The surfaces in contact were in the air-dry pounds was 200 1 square foot area of Normal load on an Figure 6.--Static and condition. £. 61395

Tests in the air-dry condition were made on material stored in air having a relative humidity of 65 percent and a temperature of 74° F. Tests in the wet condition were made on flooring specimens and Douglasfir plywood or rough sole leather that had been submerged in water for a period of 48 hours. Free water was placed on the surface of the flooring prior to each test. Tests of the effect of SAE 30 oil on the coefficients were made on material in the air-dry condition. A sufficient quantity of oil was brushed on each surface to satisfy the demand of absorption, and prior to test a quantity of free oil was placed on the flooring before assembly of the apparatus. The results of the tests for coefficient of friction obtained under these conditions are shown in figures 6, 7, and 8.

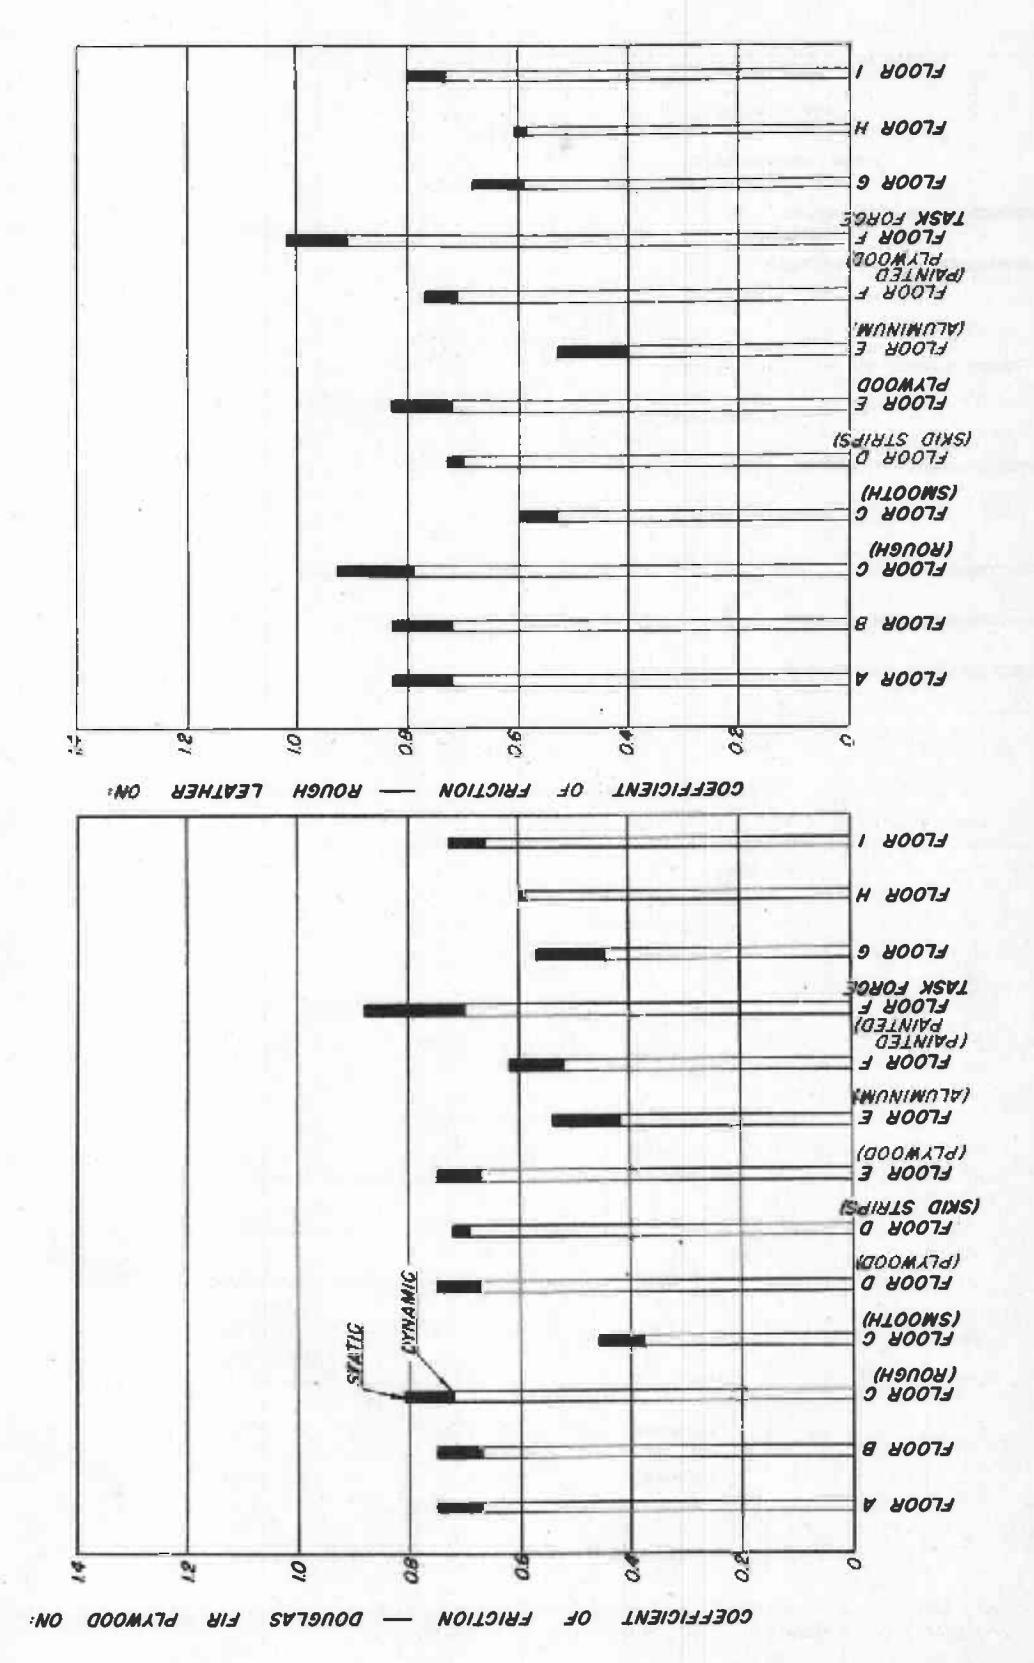
and The surfaces in contact had been immersed in was placed on the flooring before test. Figure 7.--Static and dynamic coefficients of friction between various types of flooring of free water or rough sole leather. a quantity water for 48 hours and Douglas-fir plywood -

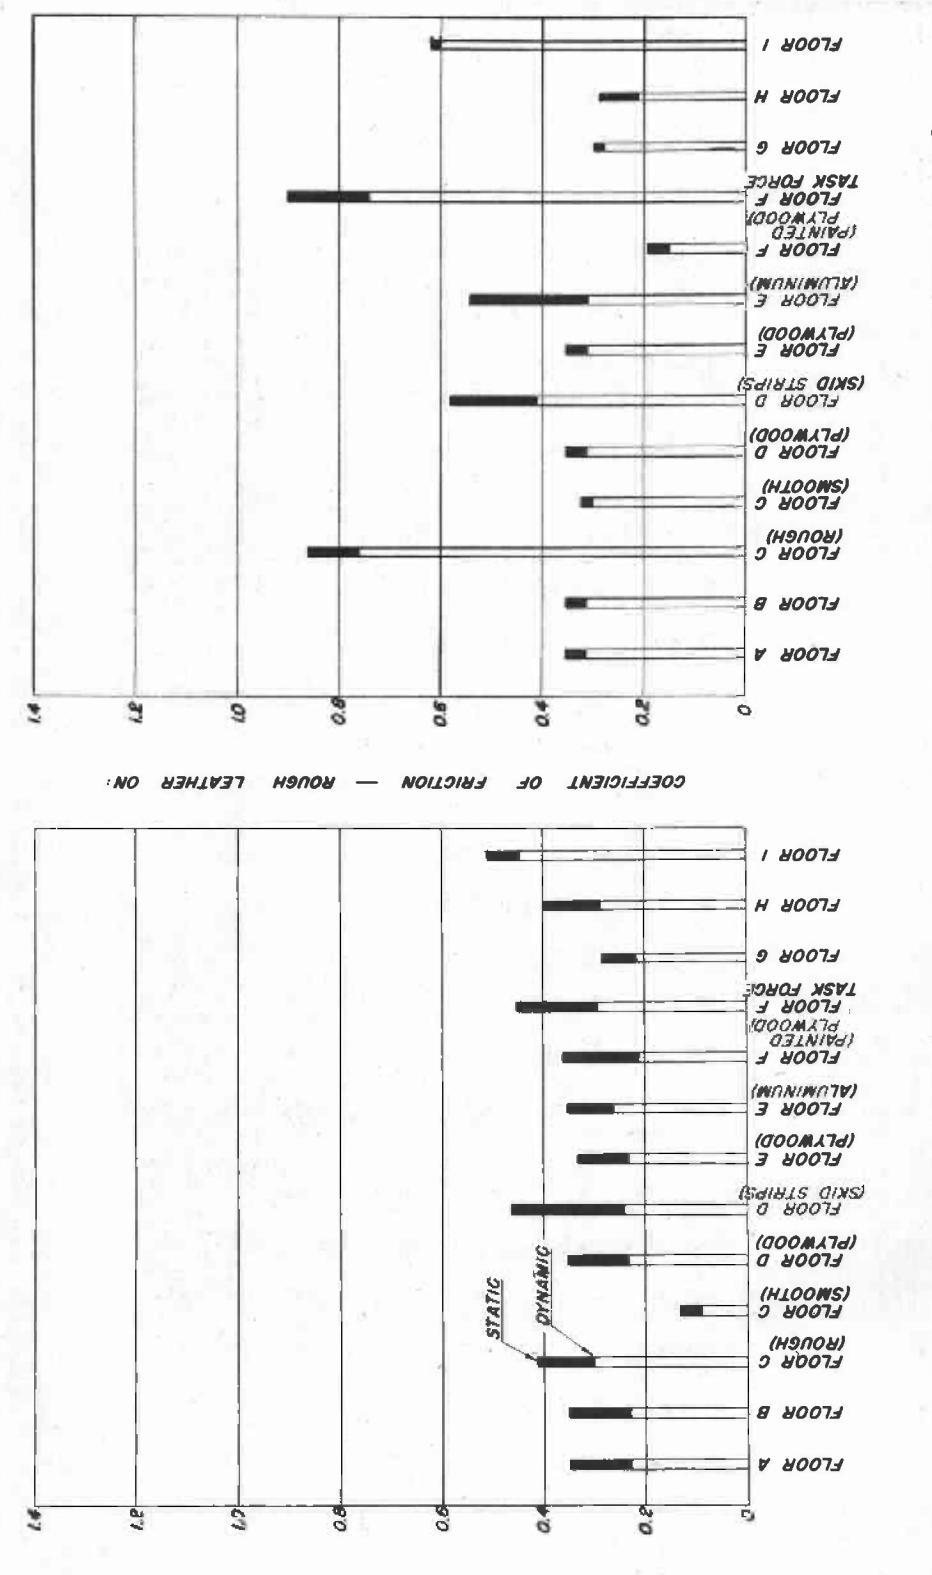
dynamic coefficients of friction between various types of flooring and ൽ The surfaces in contact were treated with test. or rough sole leather. of SAE 30 oil prior to Douglas-fir plywood Figure 8. -- Static and liberal application

Tests made on an oily surface of air-dry material showed the effect of a good lubricant on the coefficient of friction. A marked decrease in the values for all materials except floor C and floor F (task force) was noted. In these instances, the rough surface finish was sufficient to offset the lubricating effect of SAE 30 oil. The results of tests with oil were variable. The thickness of the oil film greatly influenced the magnitude of the coefficients, and the results are open to question from the standpoint of dependable reproduction.

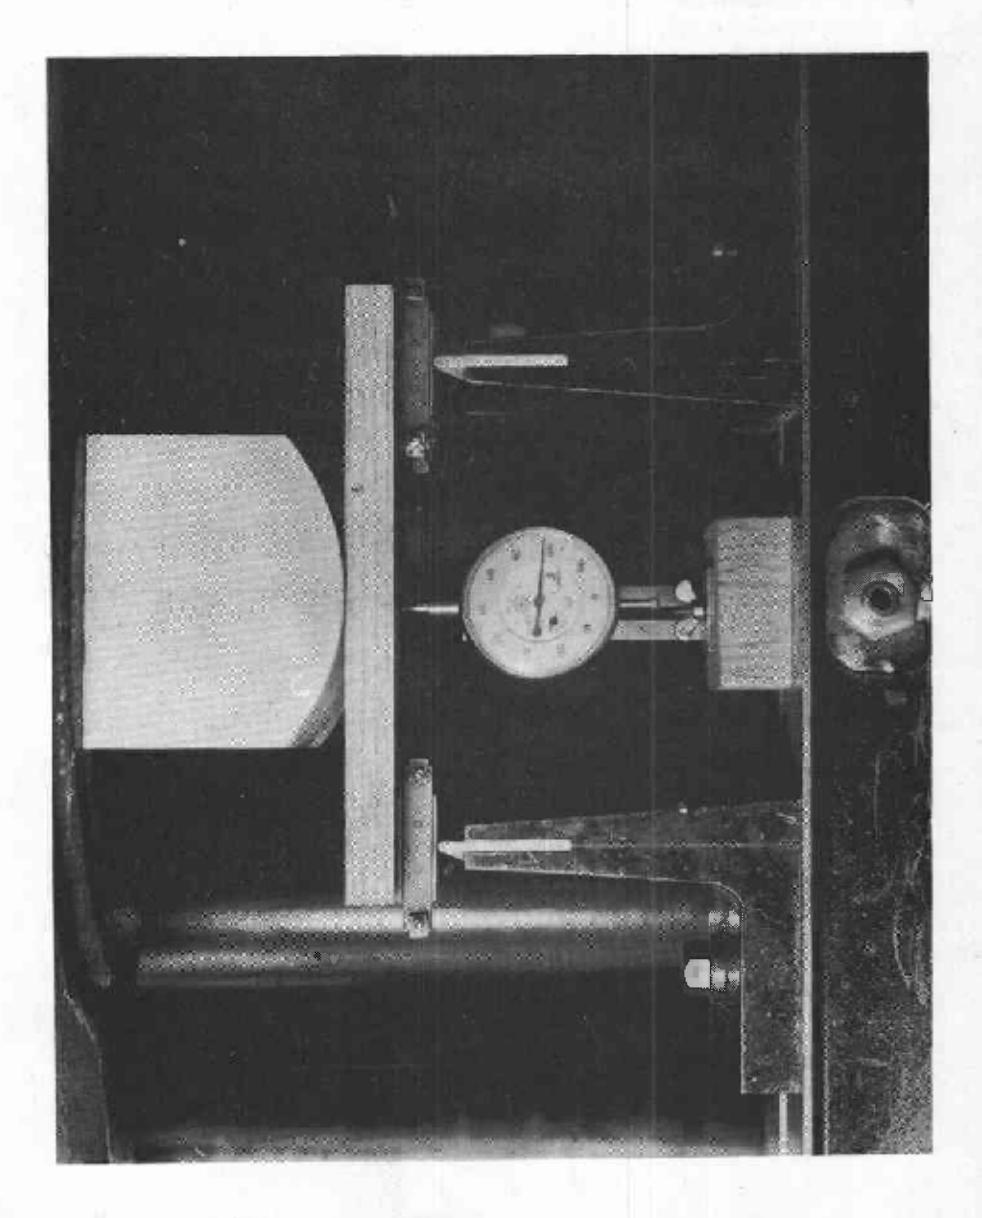
8-inch span. Load is applied by a 4-inch radius maple block bearing on the specimen, which is, 8 inches wide. Deflection at the center of the span is measured by a dial Figure 9.--Equipment used to test the static bending strength of cargo flooring. The specimen is supported on knife-edges and roller bearings placed to provide an indicator graduated to 0.001 inch.

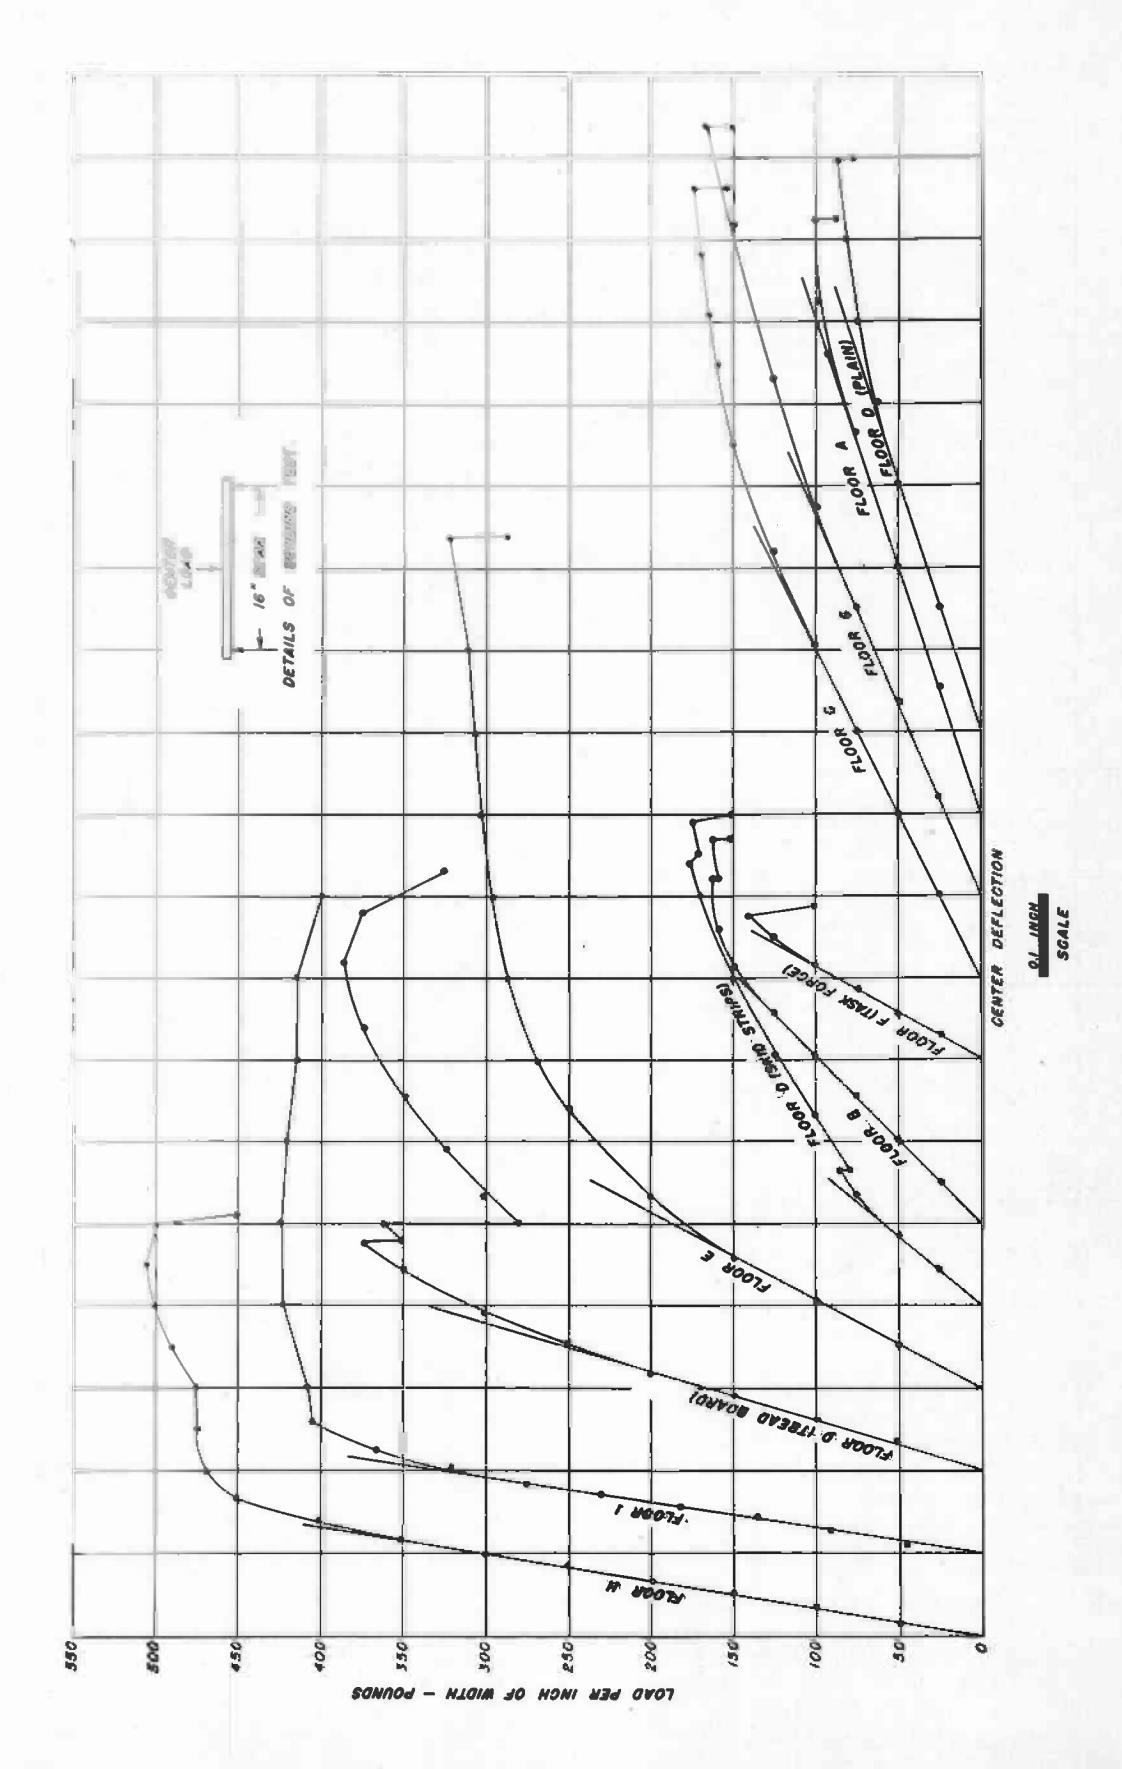
Figure 13.--Typical load-deflection curves from static-bending tests of specimens having a 16-inch span.

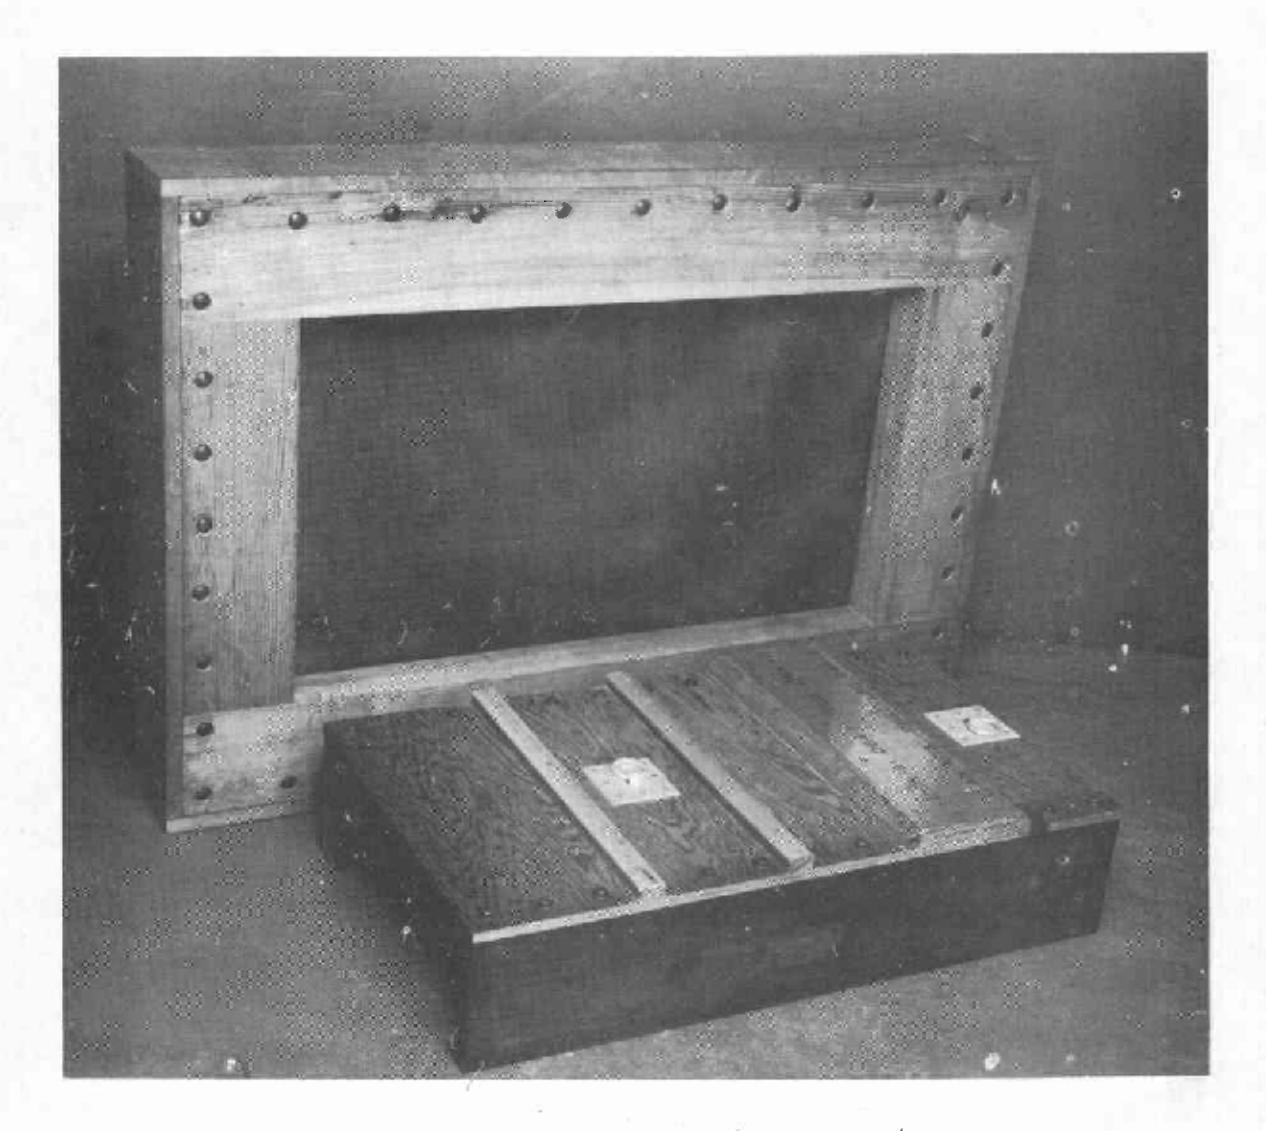
Figure 14.--Details of equipment used in tests of cargo flooring under uniform load. A floor panel attached to the steel fixture is shown in the foreground. The wood case containing a rubber bag for applying load by compressed air appears in position for assembly over the floor panel.

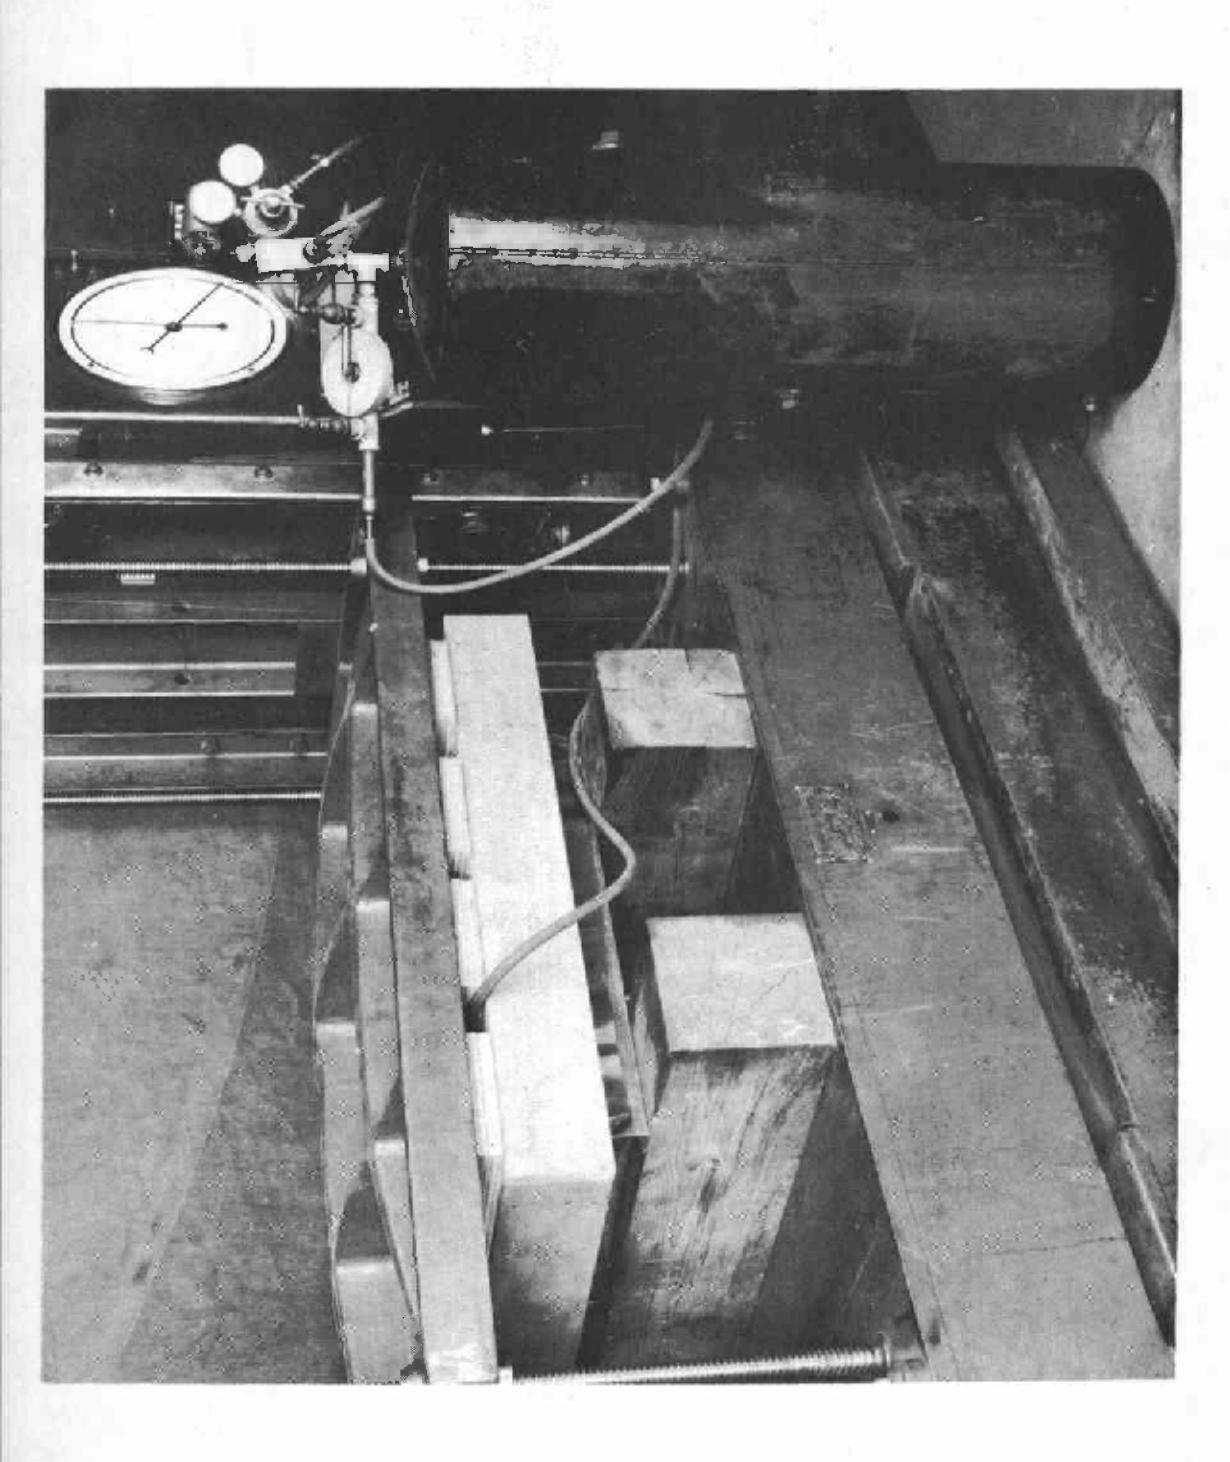
Figure 16 .-- Equipment used for testing flooring under uniform load. The specimen is mounted on a center of the panel is measured by a dial indicator touching the bottom or tension face of the into the bag from the tank and regulator shown at the right. The load applied to the panel is measured by the testing machine, which supports the fixture and wood case. Deflection at the steel fixture and covered by a wood case containing am inelastic rubber bag. Air is passed flooring.
