METHODS FOR TESTING AND EVALUATING CARGO FLOORING FOR TRANSPORT AIRCRAFT

No. 1550

UNITED STATES DEPARTMENT OF AGRICULTURE FOREST SERVICE FOREST PRODUCTS LABORATORY Madison 5, Wisconsin In Cooperation with the University of Wisconsin

M. P. BROKAW, Engineer

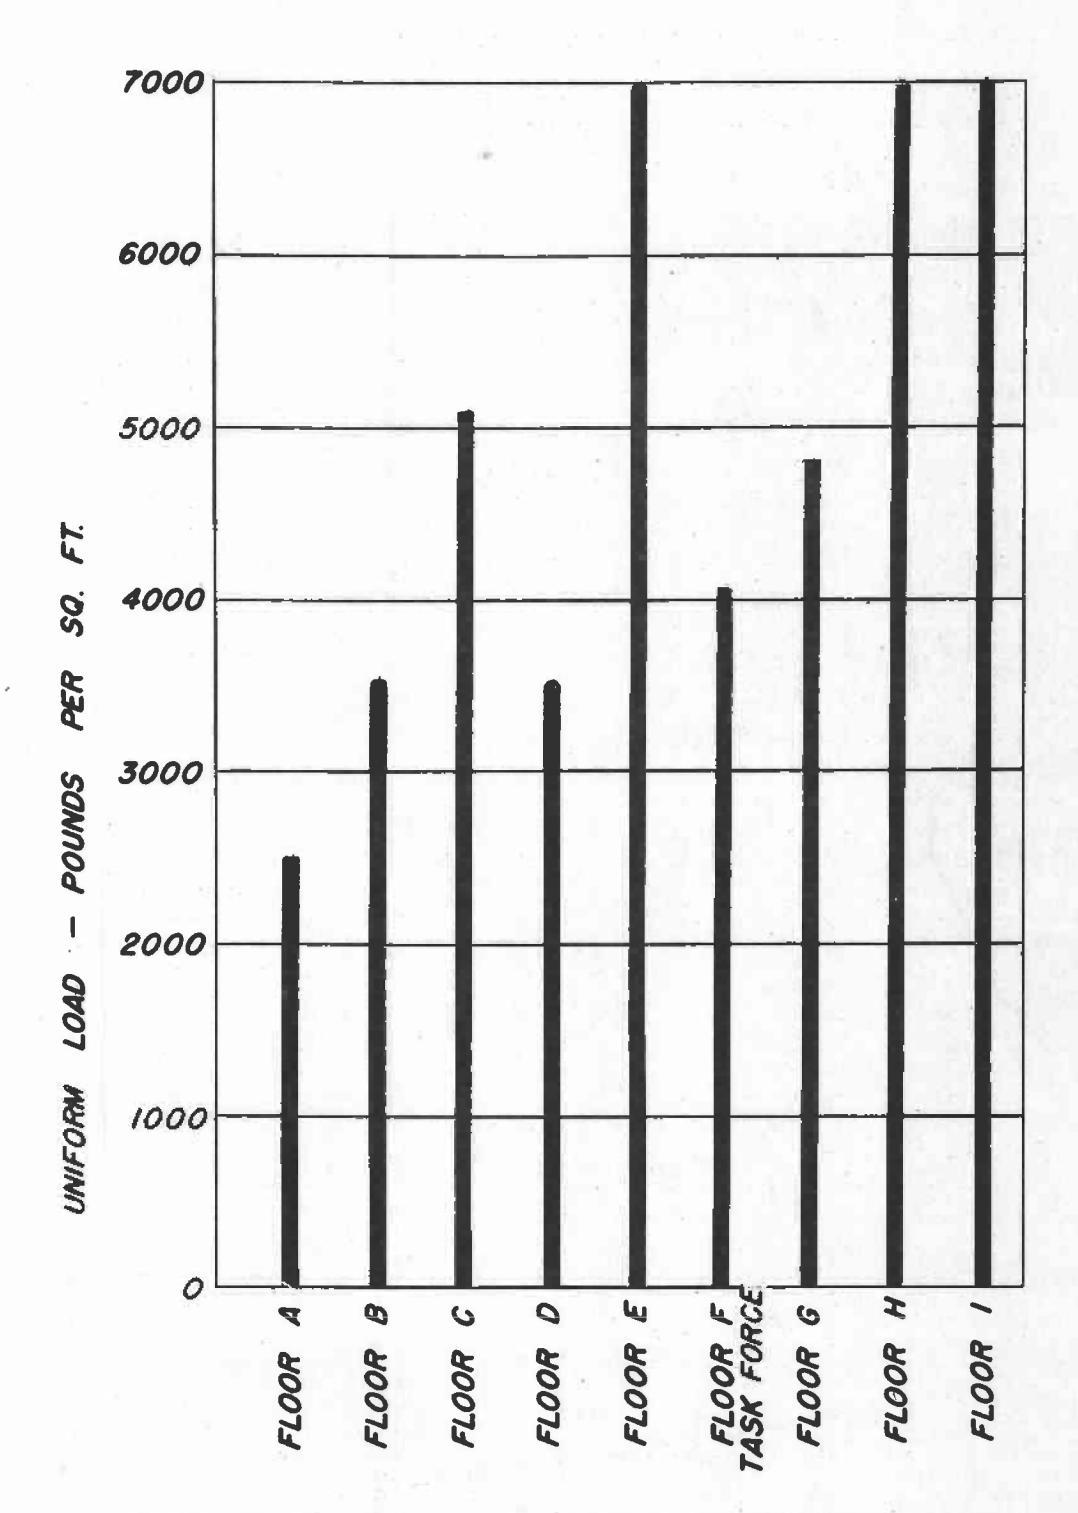
Figure 17.--Results of tests of the bending strength of 18by 32-inch panels under uniform load. Floors E, H, and I did not fail under a load of 7,000 pounds per square foot. Floor F was not tested under uniform load as it could not be prepared for support on the standard test fixture.

The results of tests for ultimate uniform load appearing in figure 17 indicate that all these types of flooring are satisfactory insofar as ability to withstand uniform load is concerned. The ultimate strengths of all floors greatly exceeded any requirement that has been considered for uniform loading. Floors E, H, and I were loaded to 7,000 pounds per square foot without visible damage. The tests were discontinued at that load.

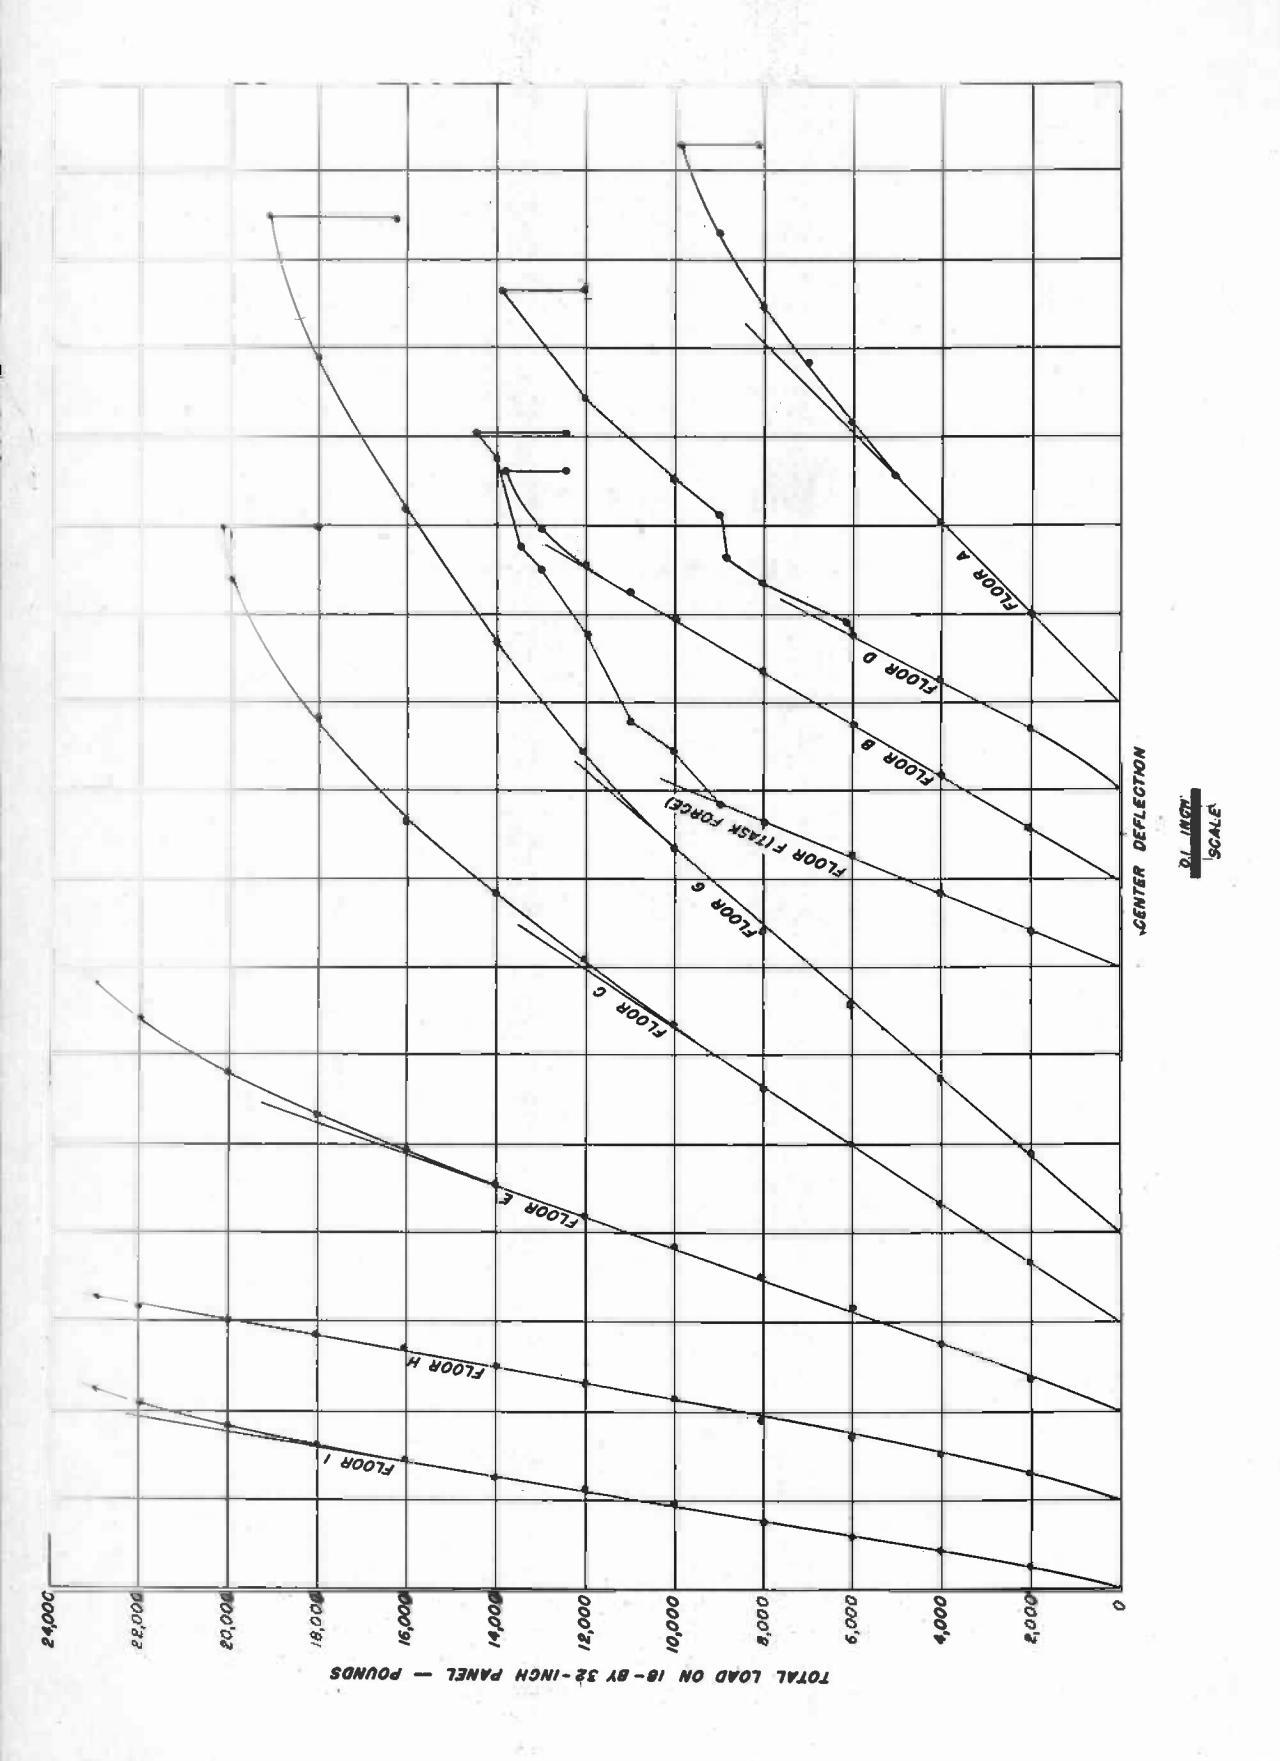
Floors E, H, and I were Figure 18.--Typical load-deflection curves from uniform load tests. not tested to failure.

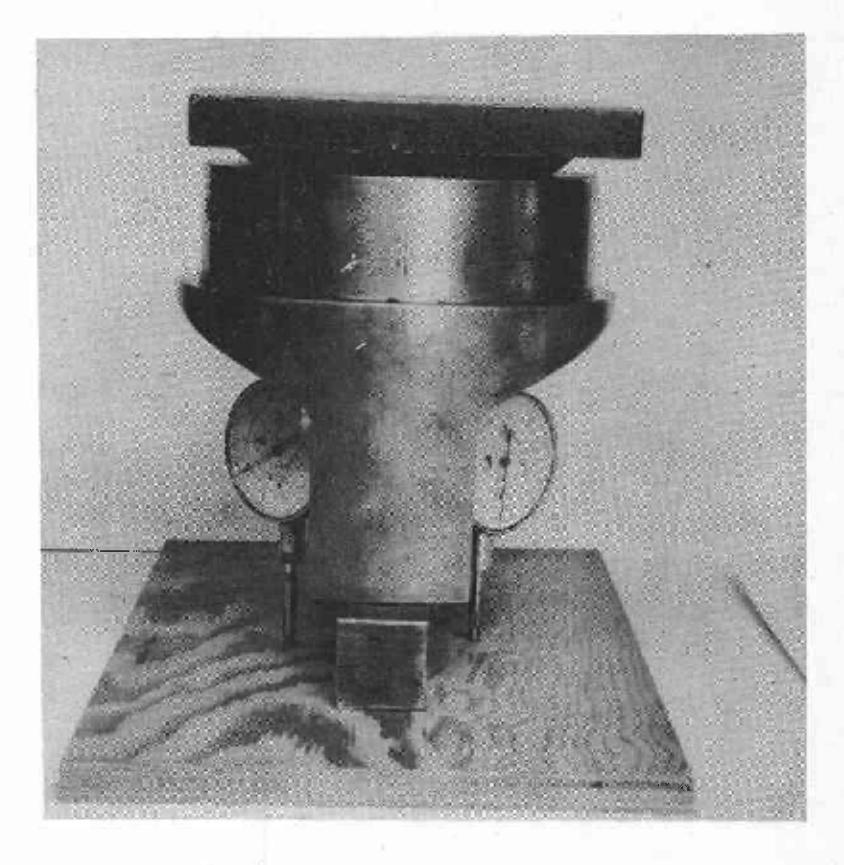
Figure 19.--Equipment used to test the crushing strength of cargo flooring under strip loading simulating the action of floor beams. The loaded strip is 1-1/4 inches wide and 9 inches long. Deformation is measured by the dial gages mounted on the loading head. The assembly shown is placed in a testing machine for application of load. 2 M 61405 F

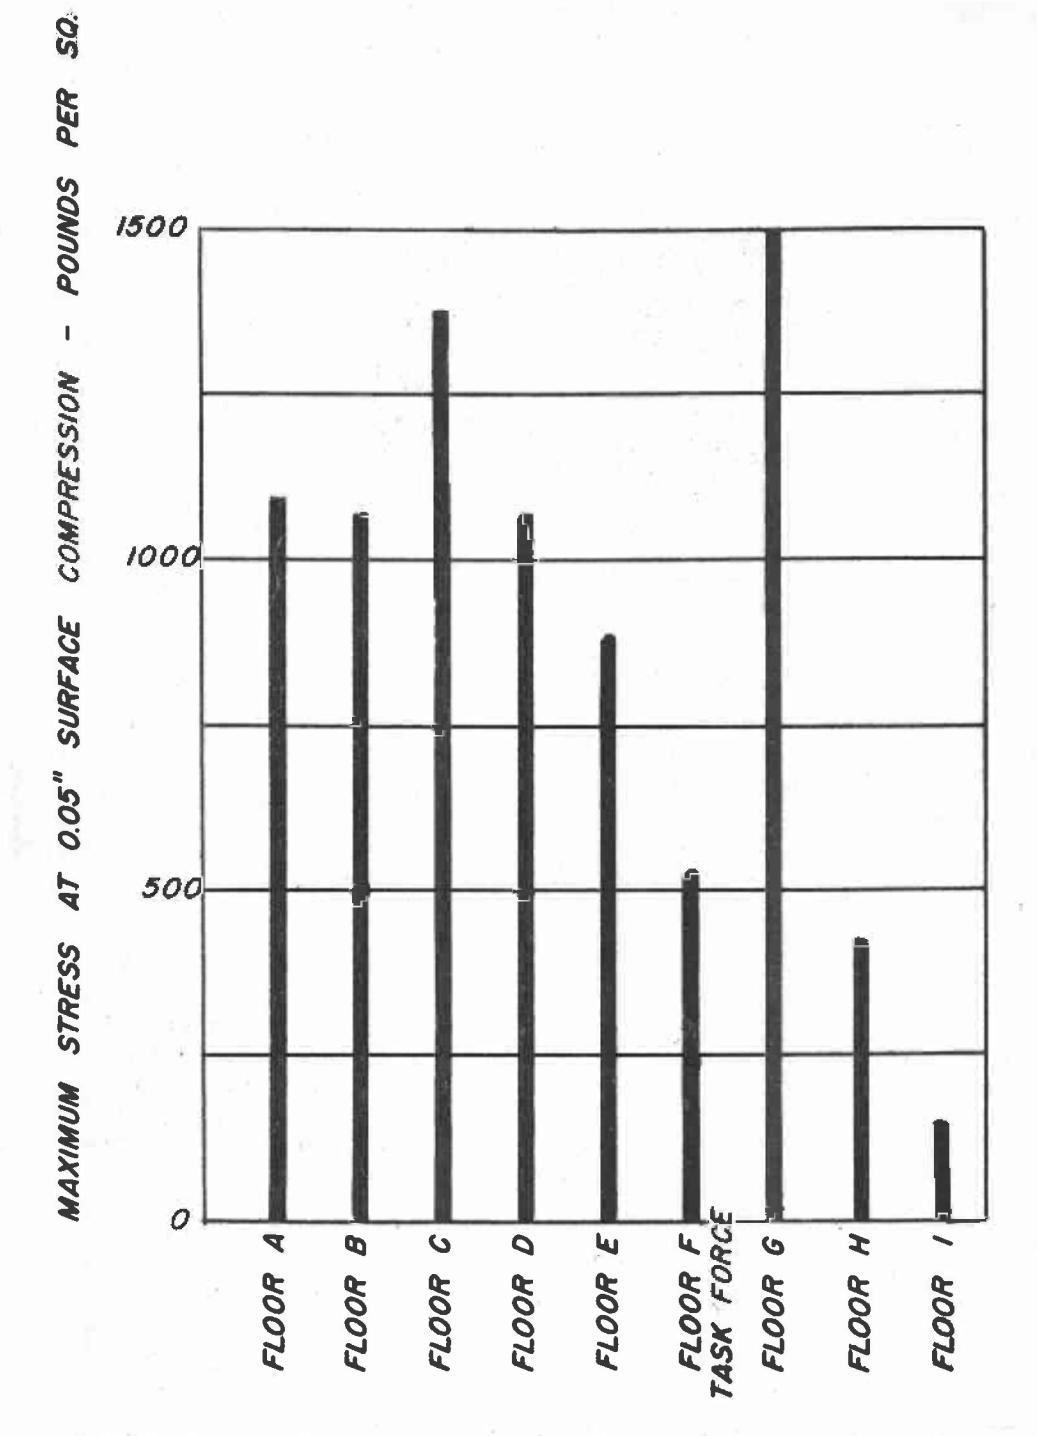
Figure 20.--Results of tests of flooring under strip loading simulating the effect of crushing over floor beams. Maximum stress corresponding to a deformation of 0.05 inch is shown for each floor except F which could not be adapted to this method of test.

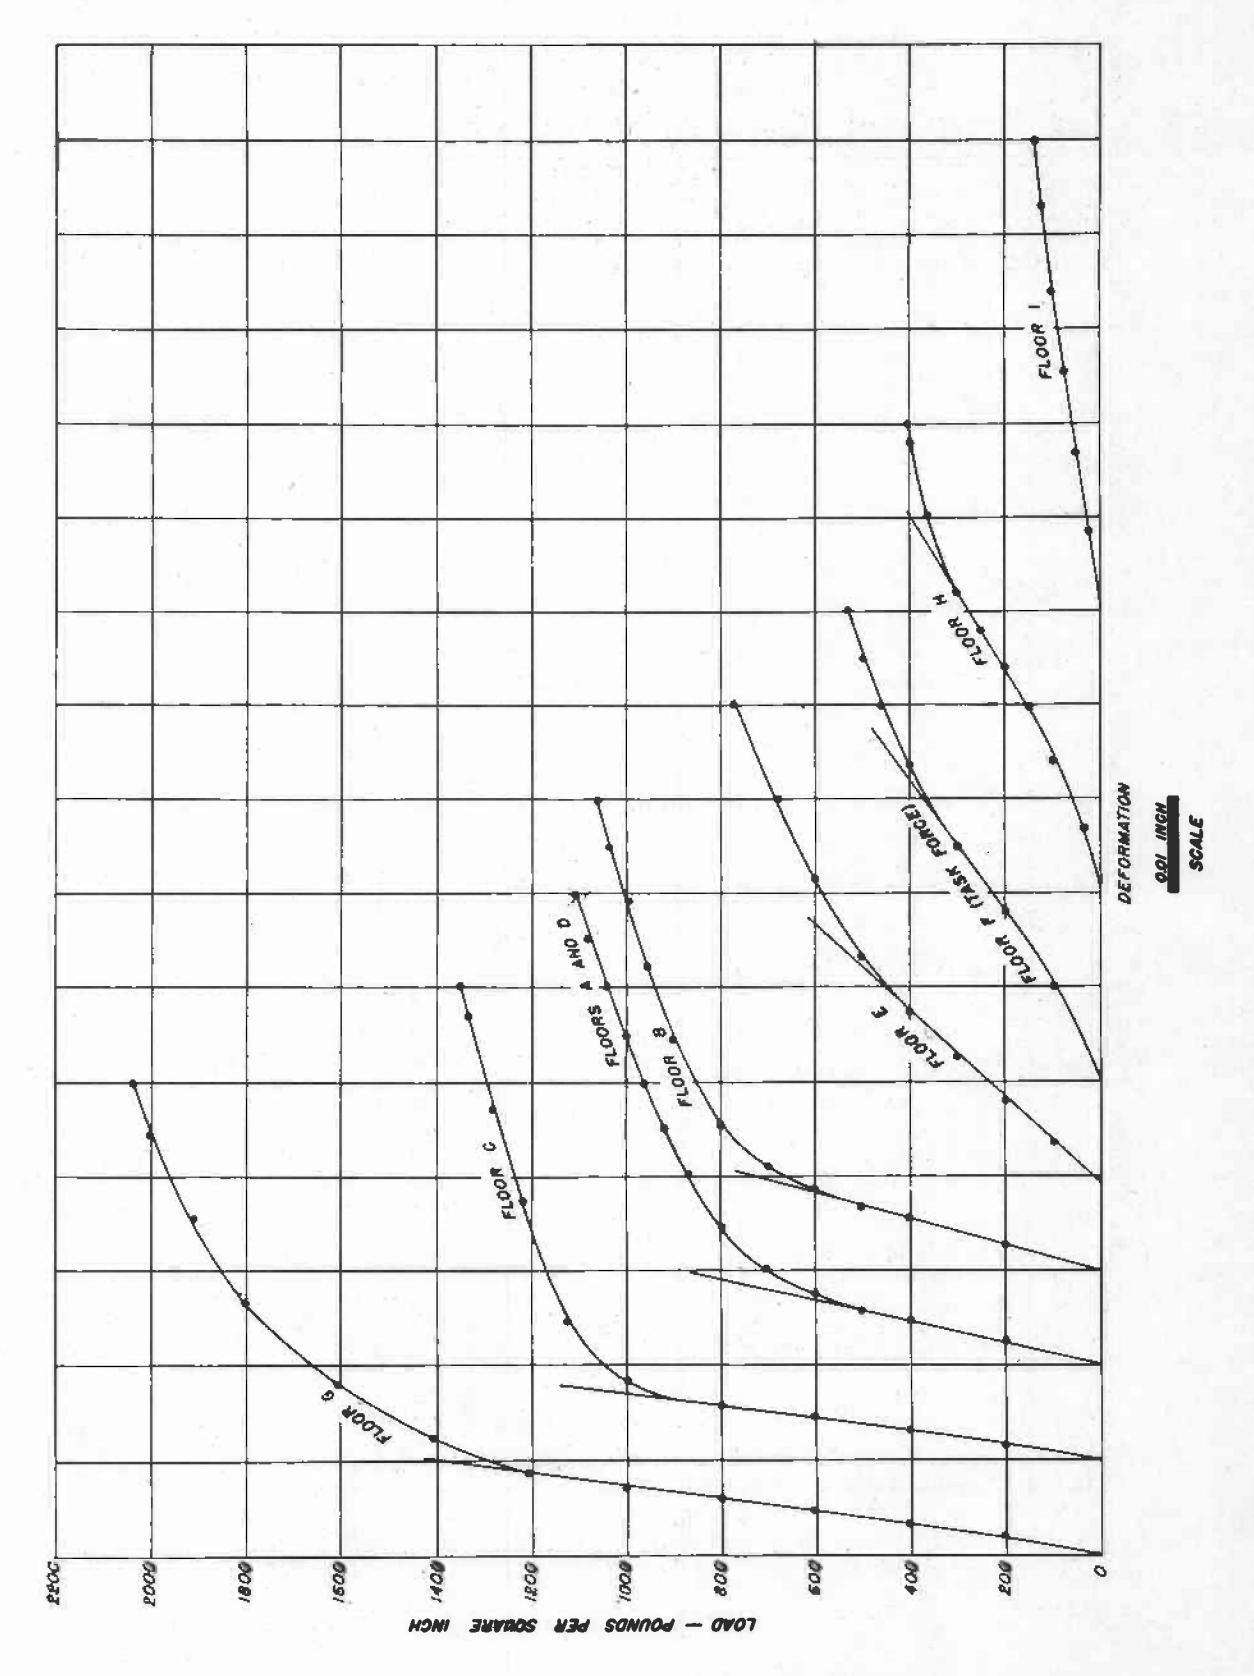
Figure 21.--Typical load-deformation curves from compression tests simulating the crushing effect of floor beams.

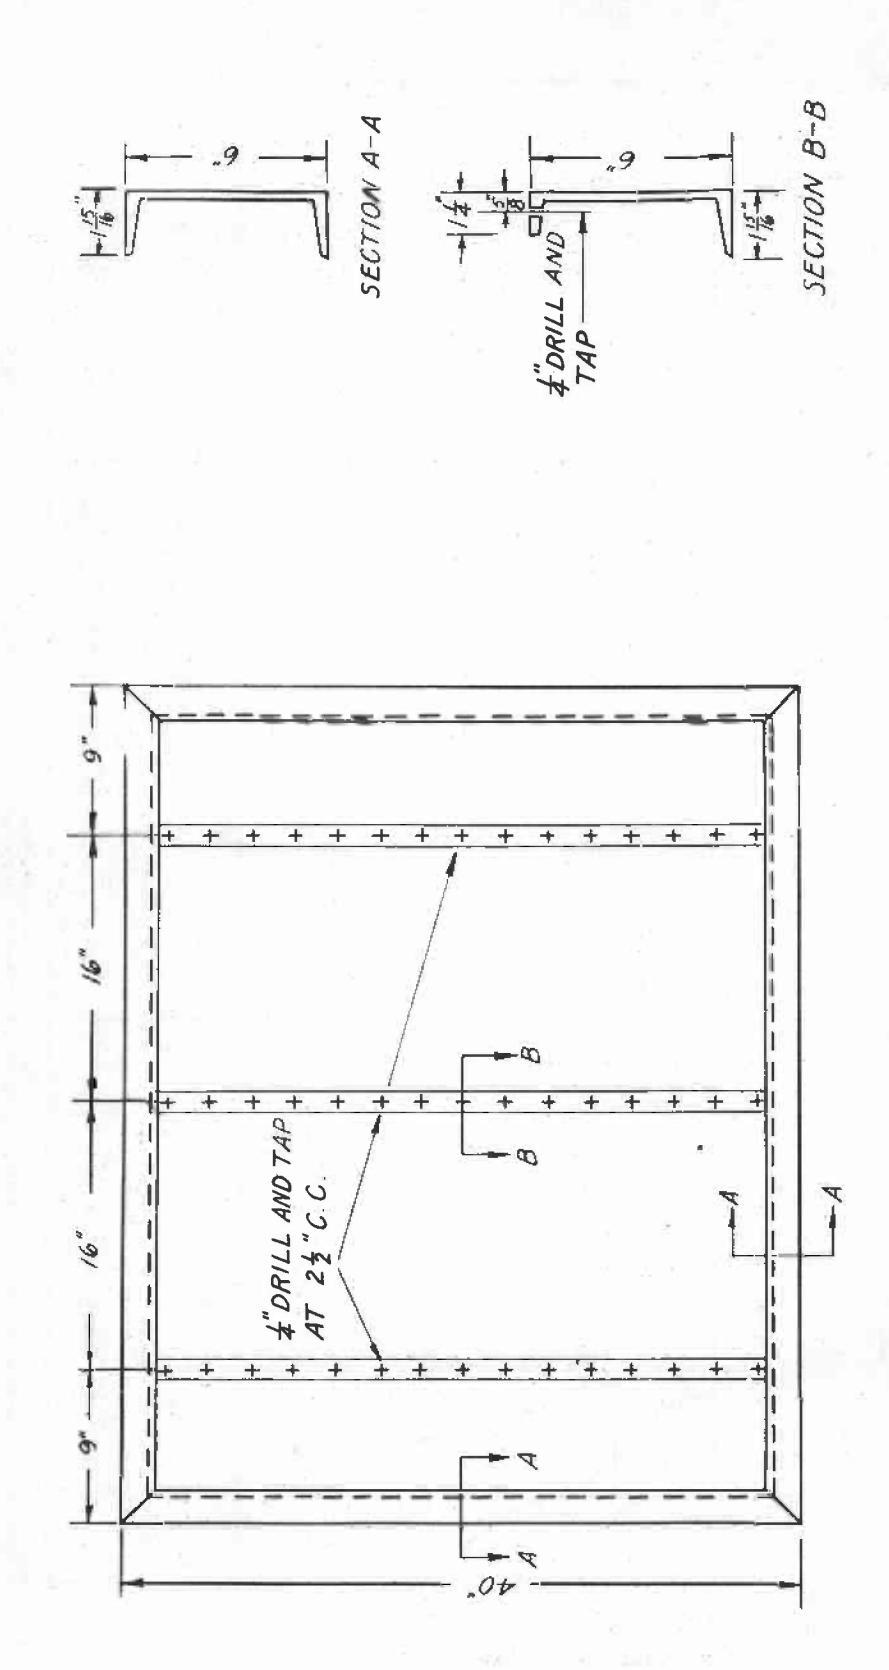
Figure 22 .-- Details of construction for steel fixture used to support air cargo flooring during concentrated, impact, and rolling-load tests. The spacing of the 0.25-inch tapped holes should conform to the requirements for corrugated types of flooring.

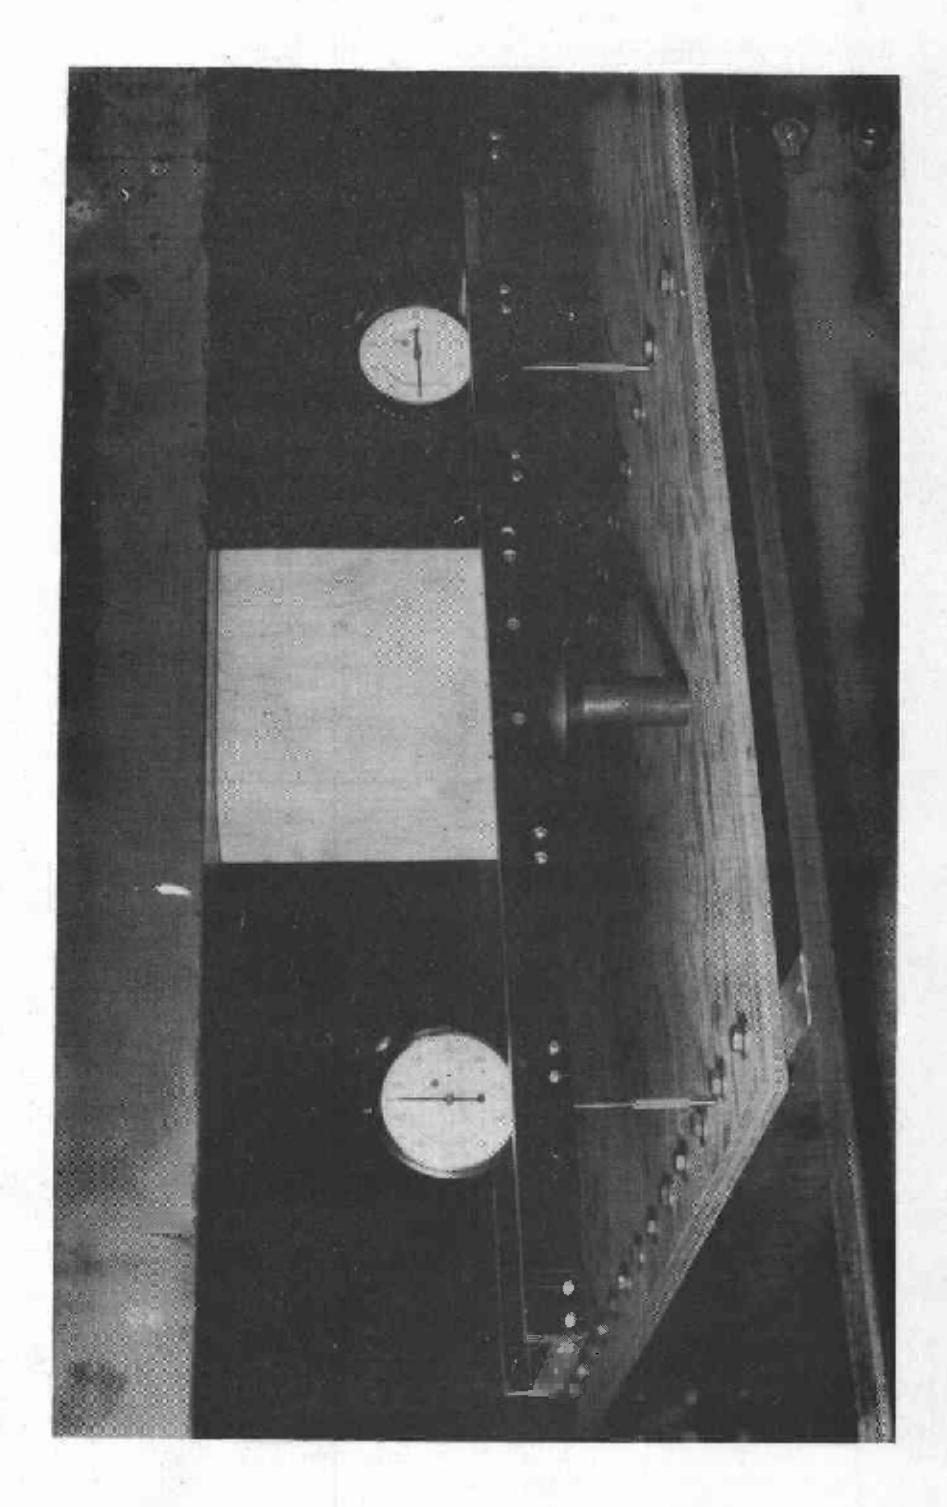
Figure 23.--Method of applying a concentrated load by a 1-inch cylindrical steel bar. Deflection under the bar is measured by a deflectometer composed of two dial gages supported in position over the floor beams. The gages are graduated to 0.001 inch. Z.M 61412 F

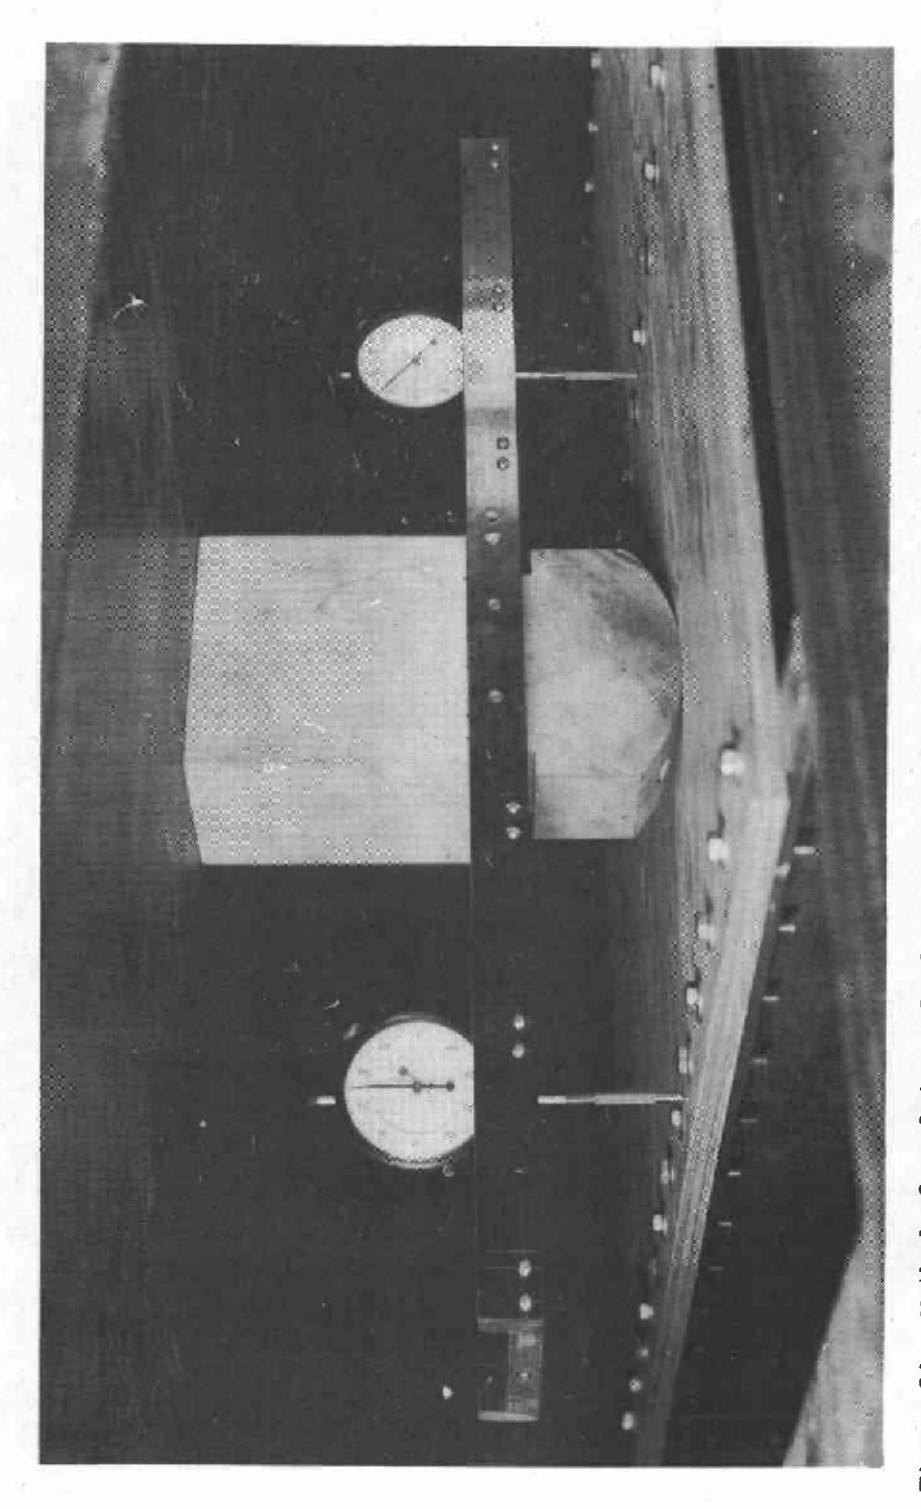
Figure 24.--Method of applying a load simulating an engine cradle wheel. A maple block 2-1/2 inches wide and having a 4-inch radius is used as a loading device. Deflection under the block is measured by a deflectometer composed of two dial gages supported in position over the floor beams. The block is oriented to simulate travel along the span. A ETHTO M Z

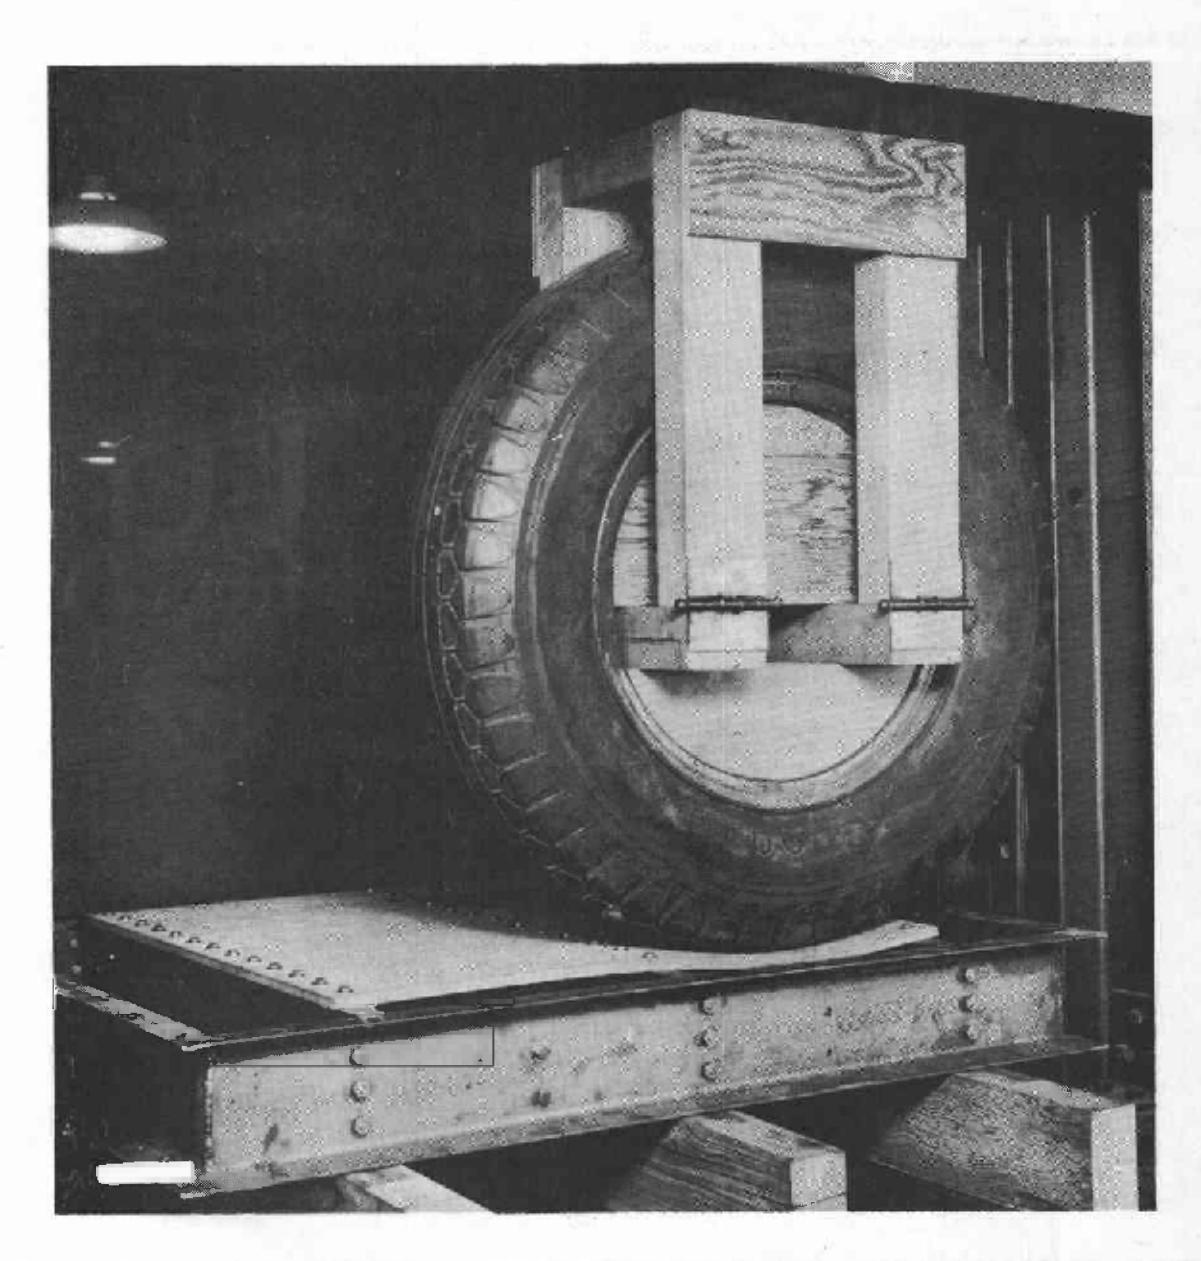
Figure 25.--Method of testing cargo flooring under load applied by an 8.25- by 20inch ten-ply truck tire inflated to 90 pounds per square inch. Deflection of the panel is measured at midspan by a dial gage placed below the panel and touching the tension face. The gage is graduated to 0.001 inch.

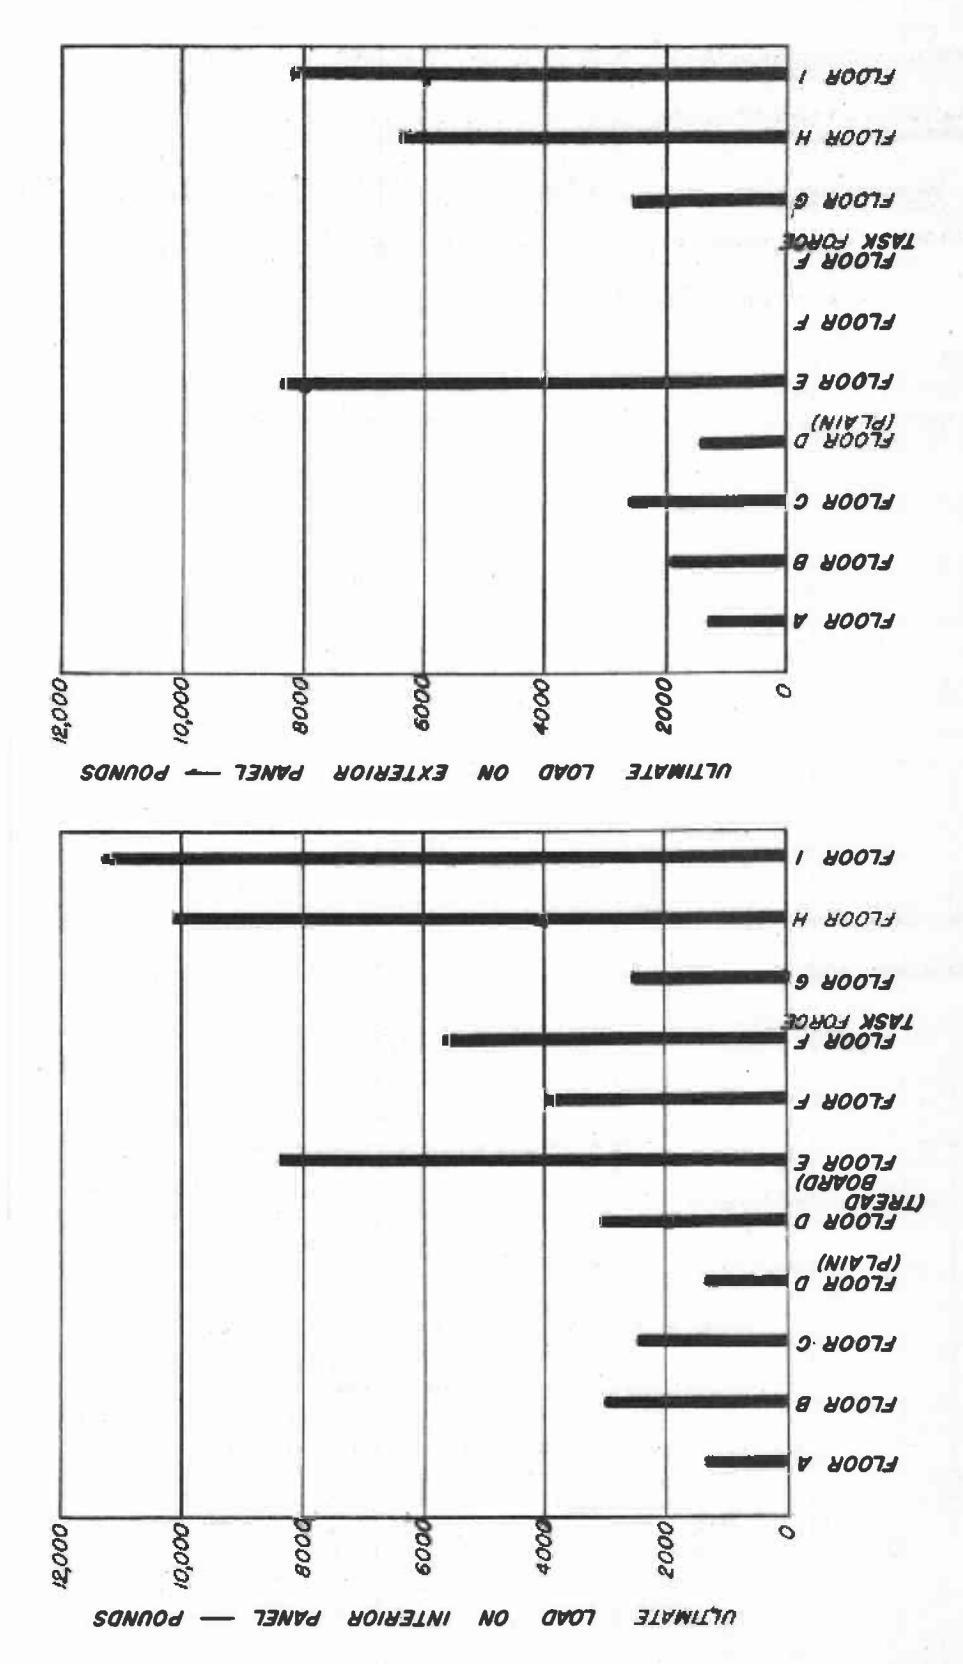
and at an exterior position within 4 inches of an unsupported edge. Load was applied by a maple block 2-1/2 inches wide and curved to a 4-inch radius. Floor F and floor F (task force) Figure 27.--Ultimate strength of one of two equal and continuous 16- by 32-inch panels of cargo flooring tested at midspan. Ultimate load was measured at an interior position on the panel were tested on floor beams that form an integral part of the airplane.

Tests of strength under loads applied through an engine-cradle wheel are presented in figure 27. The wheel was placed at midspan and was oriented for travel in a direction along the span or across the panel. It was found that the differences in ultimate load between the two directions were not significant, so the results were pooled in computing the average strengths. Floors D and F were tested at locations free from the supporting action of the tread strips, as well as on the treadboard provided to accommodate engine-cradle wheels. Tests at the 4-inch point were not made on floors F and F (task force) for reasons stated previously.

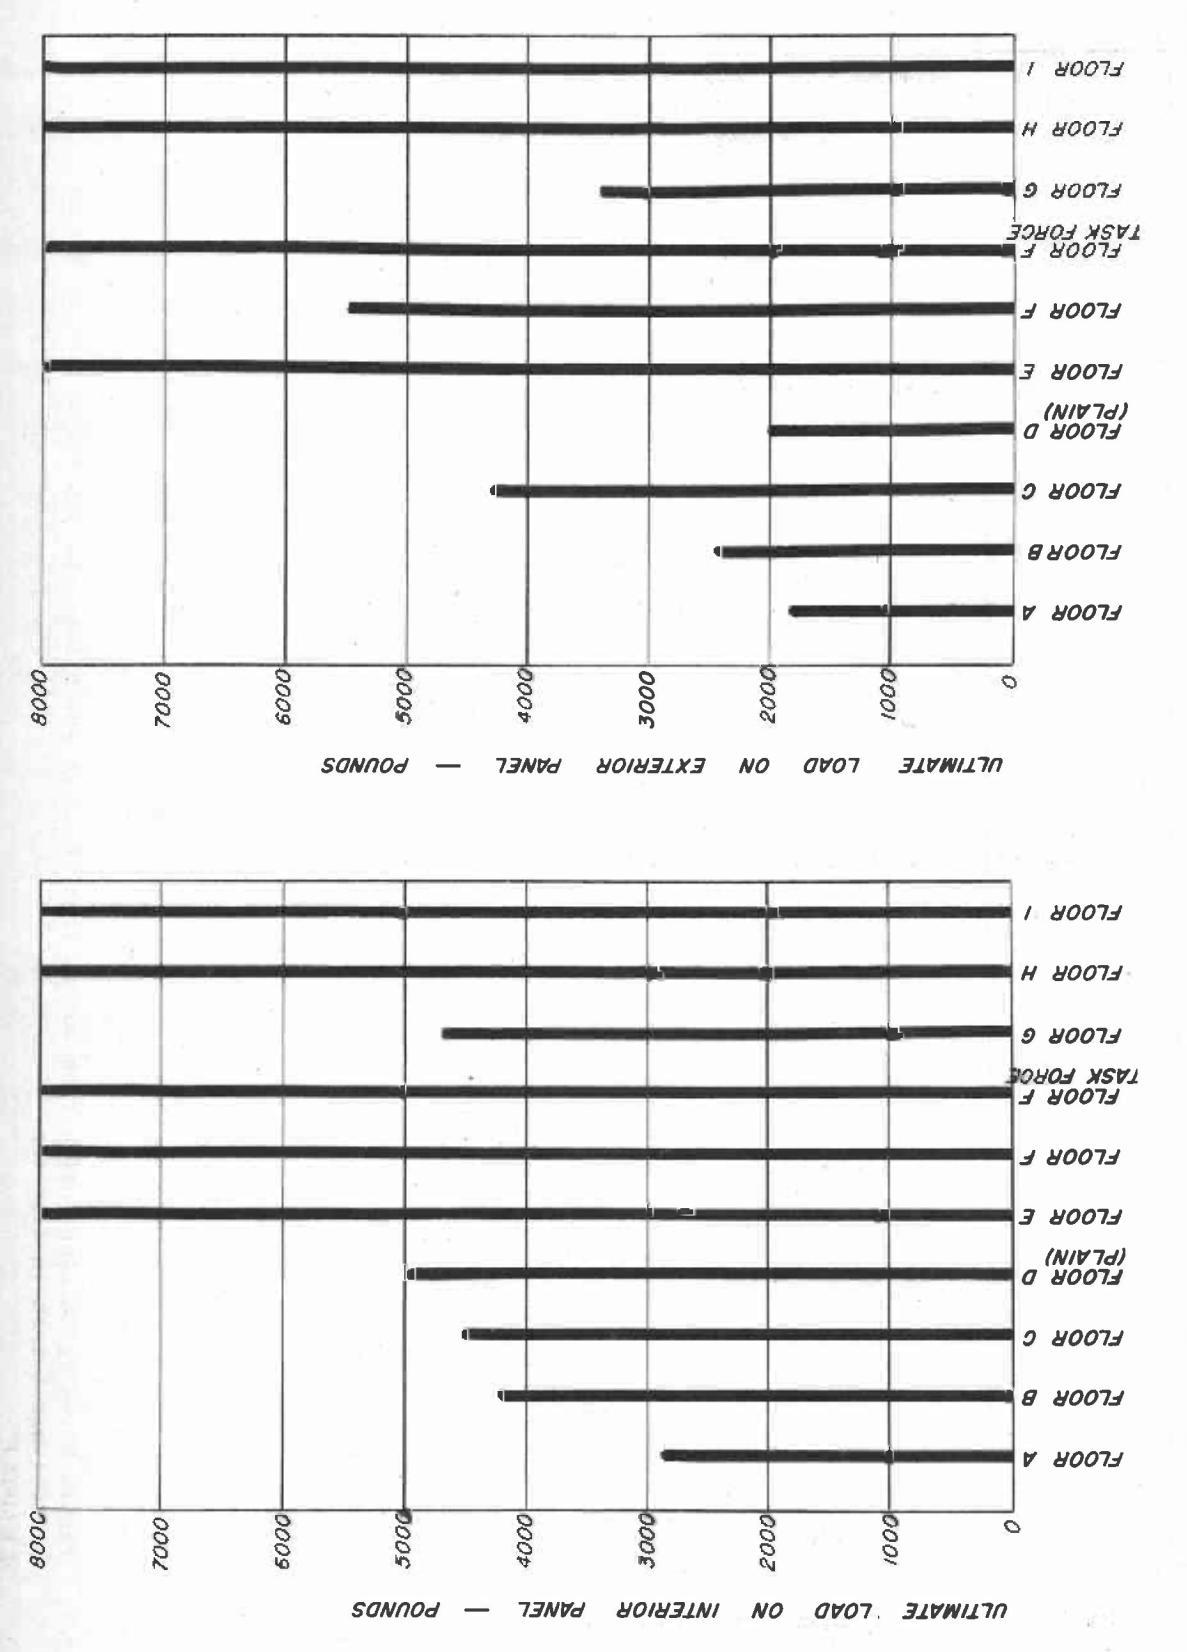
The chart at the left shows results Figure 28 .-- Ultimate strength of cargo flooring tested by an 8.25- by 20-inch, ten-ply heavy-F (task force), H, and I were tested to a load of 8,000 pounds which did not cause ultimate on of from tests on an interior portion of the panel, and the chart at the right is for tests an exterior portion within 4 inches of an unsupported edge. Tests were made at midspan one of two equal and continuous 16- by 32-inch panels except for floor F. Floors E, F, duty truck tire inflated to 90 pounds per square inch. fat lure.

The ultimate loads obtained from tests by a heavy-duty truck tire are shown in figure 28. Floor D was loaded adjacent to skid strips or treadboards. Floors E, F, F (task force), H, and I did not fail at a load of 8,000 pounds, and the tests were discontinued at this value.

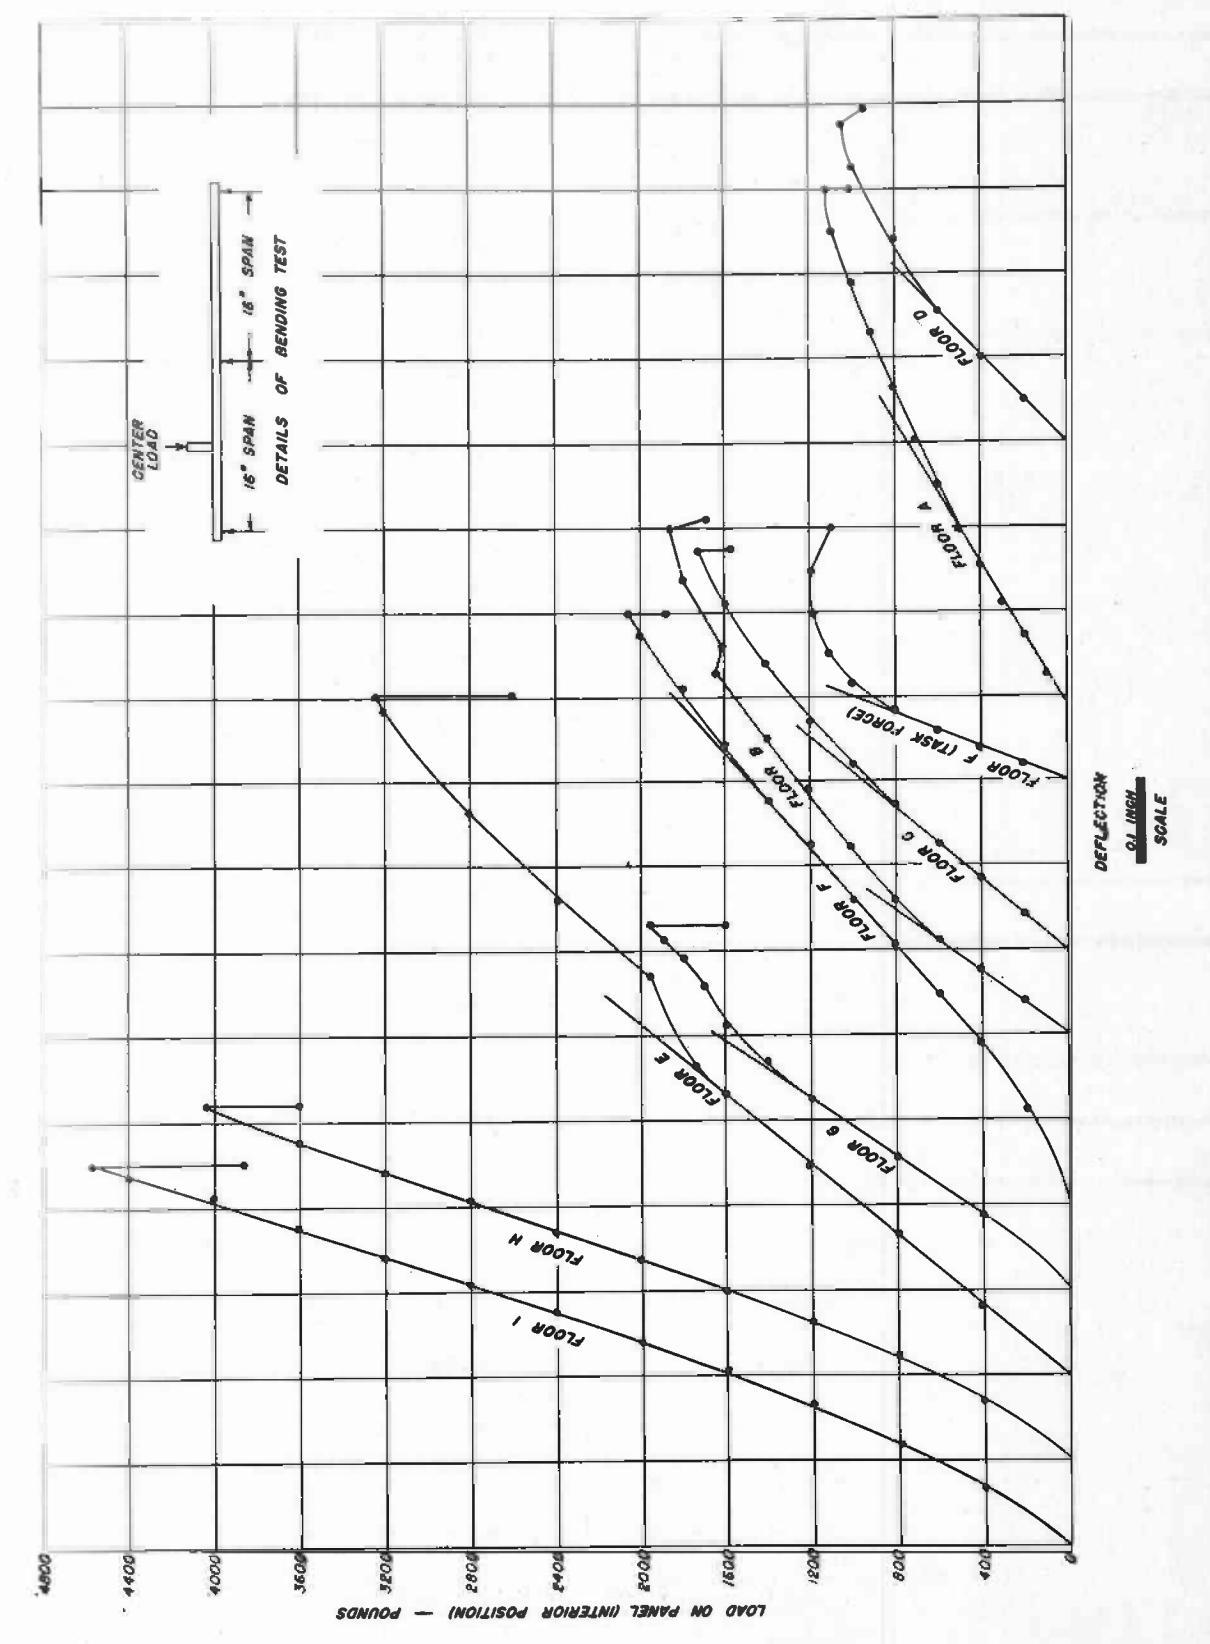
Figure 29 .-- Typical load-deflection curves from tests in which load was applied by a cylindrical steel bar 1 inch in diameter.

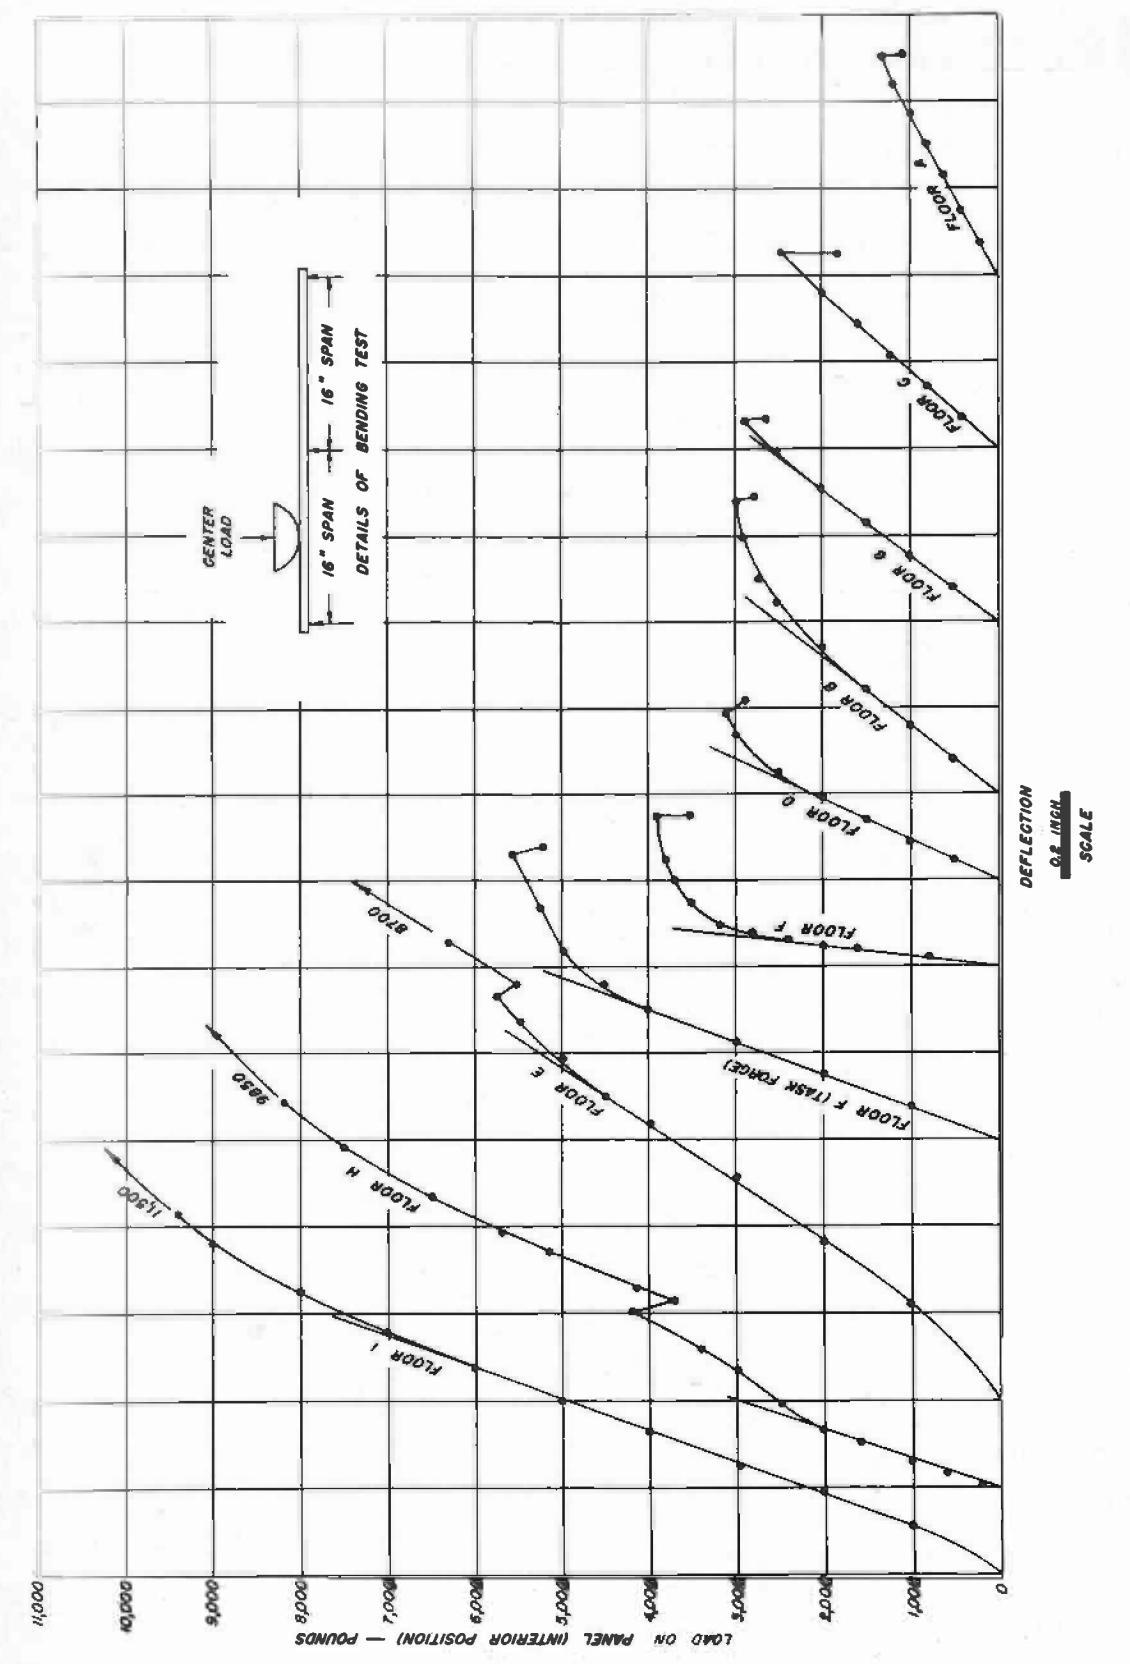
Figure 30.--Typical load-deflection curves from tests in which load was applied by a wood block 2.5 inches wide and shaped to a 4-inch radius. Z M 61419 F
