METHODS FOR TESTING AND EVALUATING CARGO FLOORING FOR TRANSPORT AIRCRAFT

No. 1550

UNITED STATES DEPARTMENT OF AGRICULTURE FOREST SERVICE FOREST PRODUCTS LABORATORY Madison 5, Wisconsin In Cooperation with the University of Wisconsin

M. P. BROKAW, Engineer

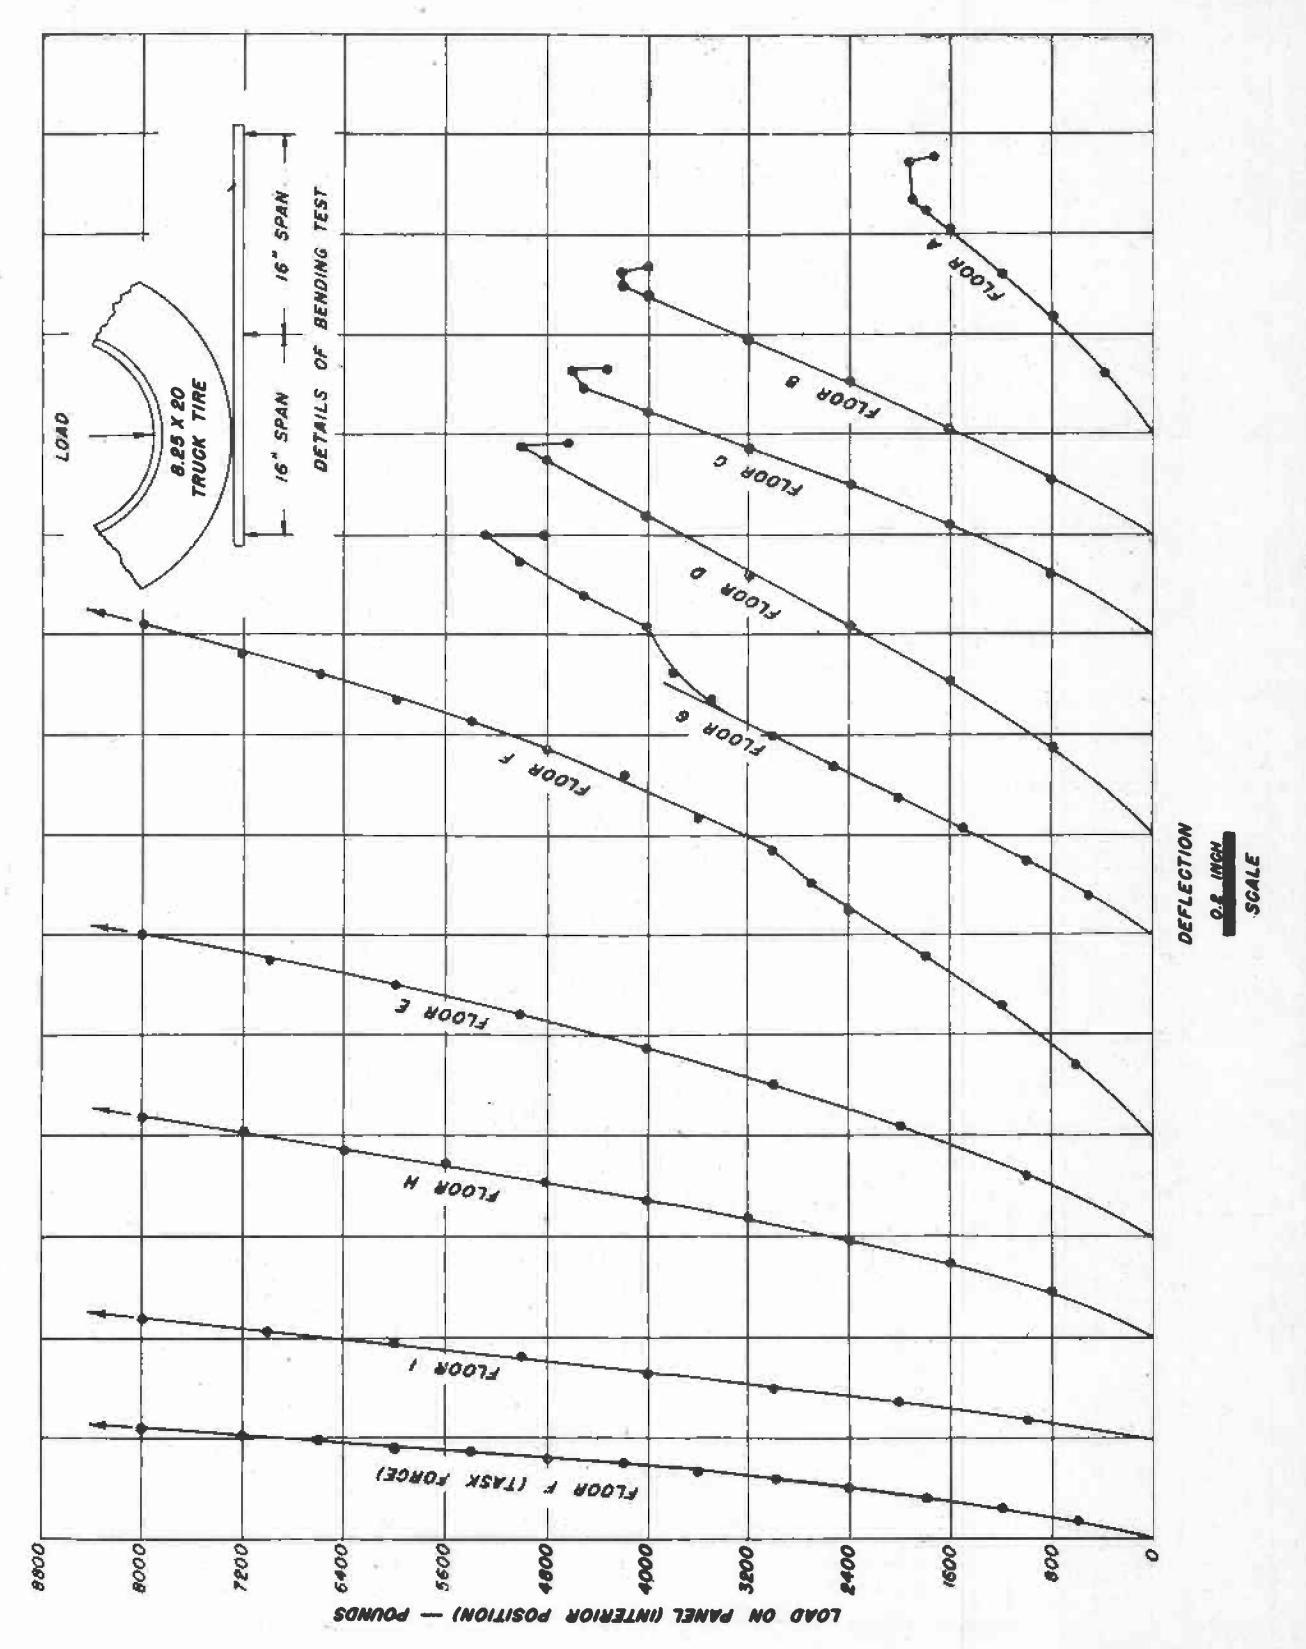
Figure 31.--Typical load-deflection curves from tests in which load was applied by an 8.25- by 20-inch truck tire inflated to a pressure of 90 pounds per square inch.

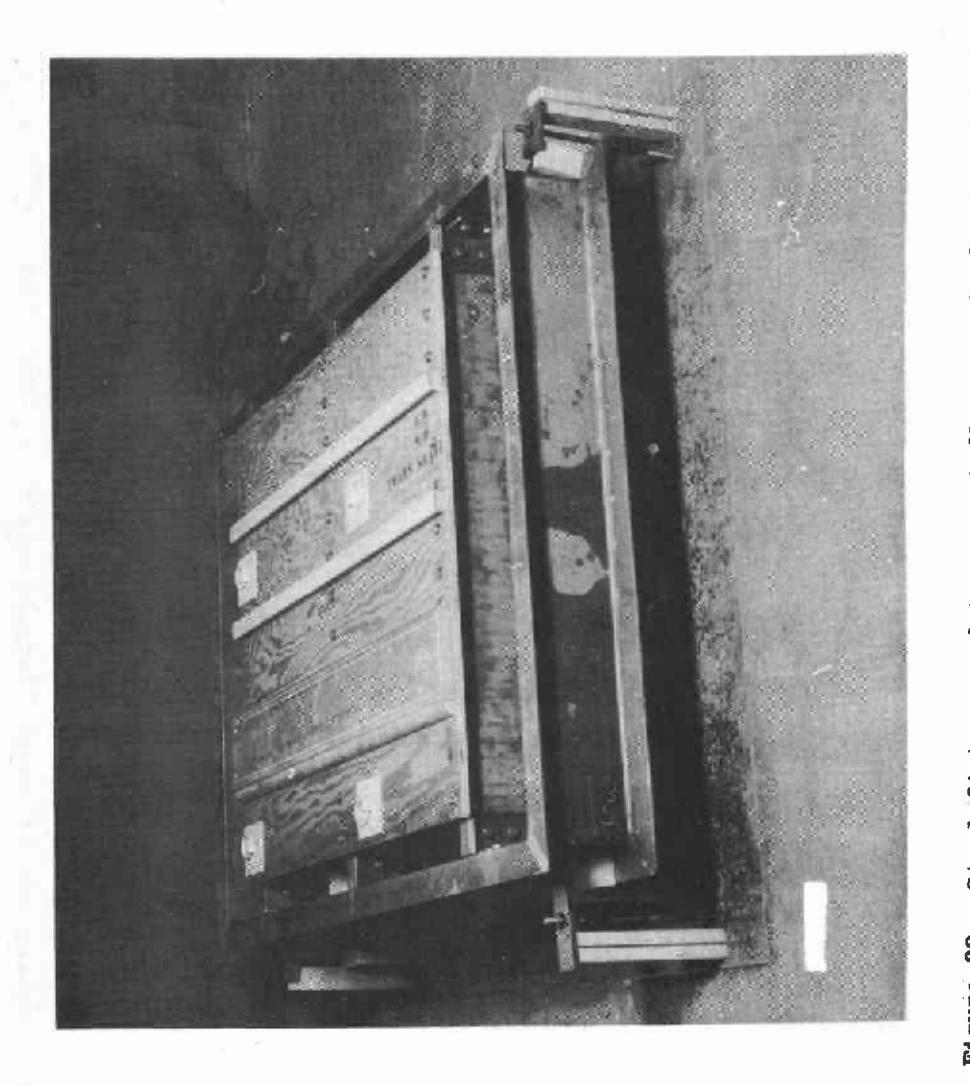
Figure 32 .-- Steel fixture used to support floor panels for impact tests.

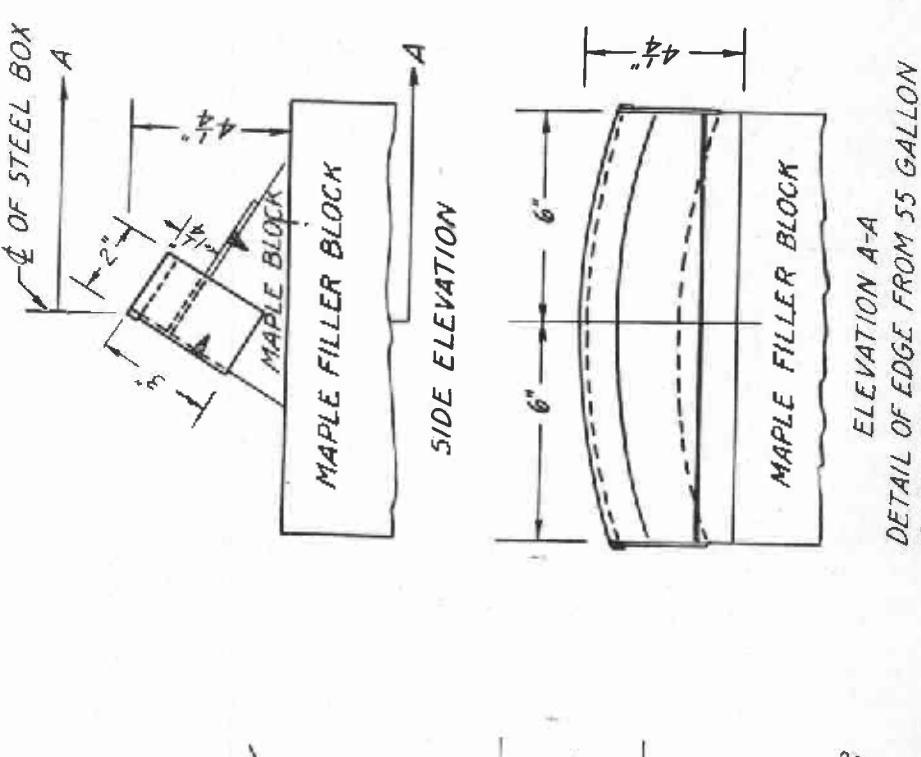
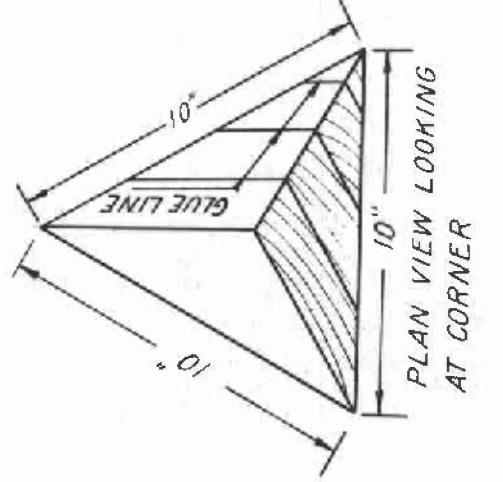
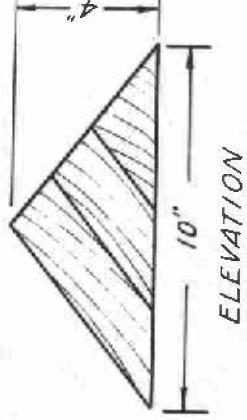
Figure 35.-+Details of construction for simulated soft pine box corner and edge of 55-gallon gasoline drum.

ELEVATION A-A DETAIL OF EDGE FROM 55 GALLON GASOLINE-DRUM.CUT DRUM 50 LINE THROUGH & OF STEEL BOX PASSES THROUGH CENTER OF GRAVITY OF DRUM.

DETAILS OF CORNER SAWN FROM SOFT PINE BLOCK FABRICATED FROM 2"LUMBER

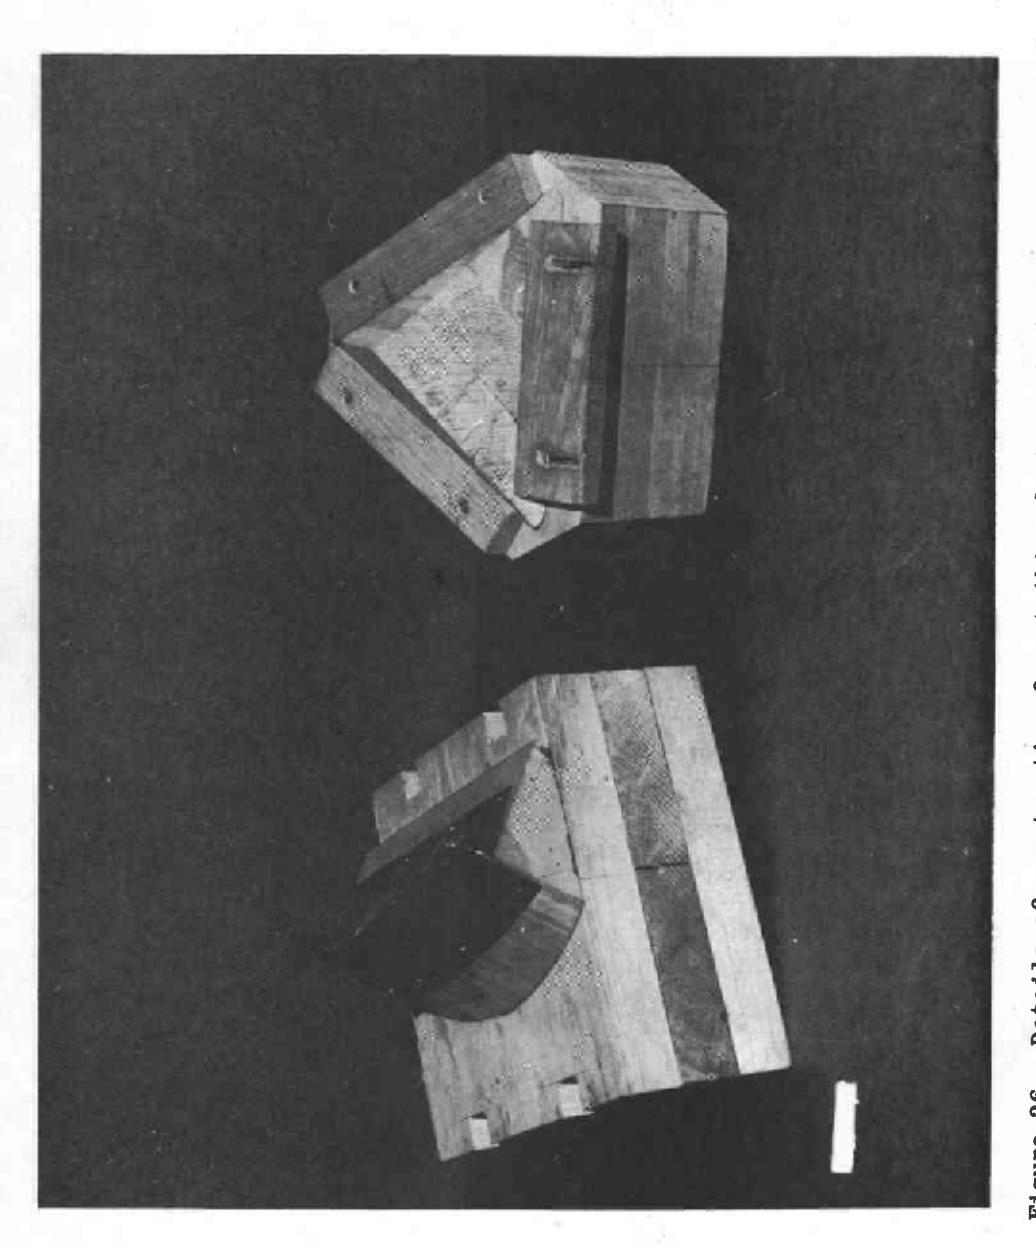
- Figure 36.--Details of construction for striking devices simulating the edge of a gasoline drum or the corner of a soft pine box. The box corners are readily removed and replaced by demounting one cleat.
 - Z M 61425 F

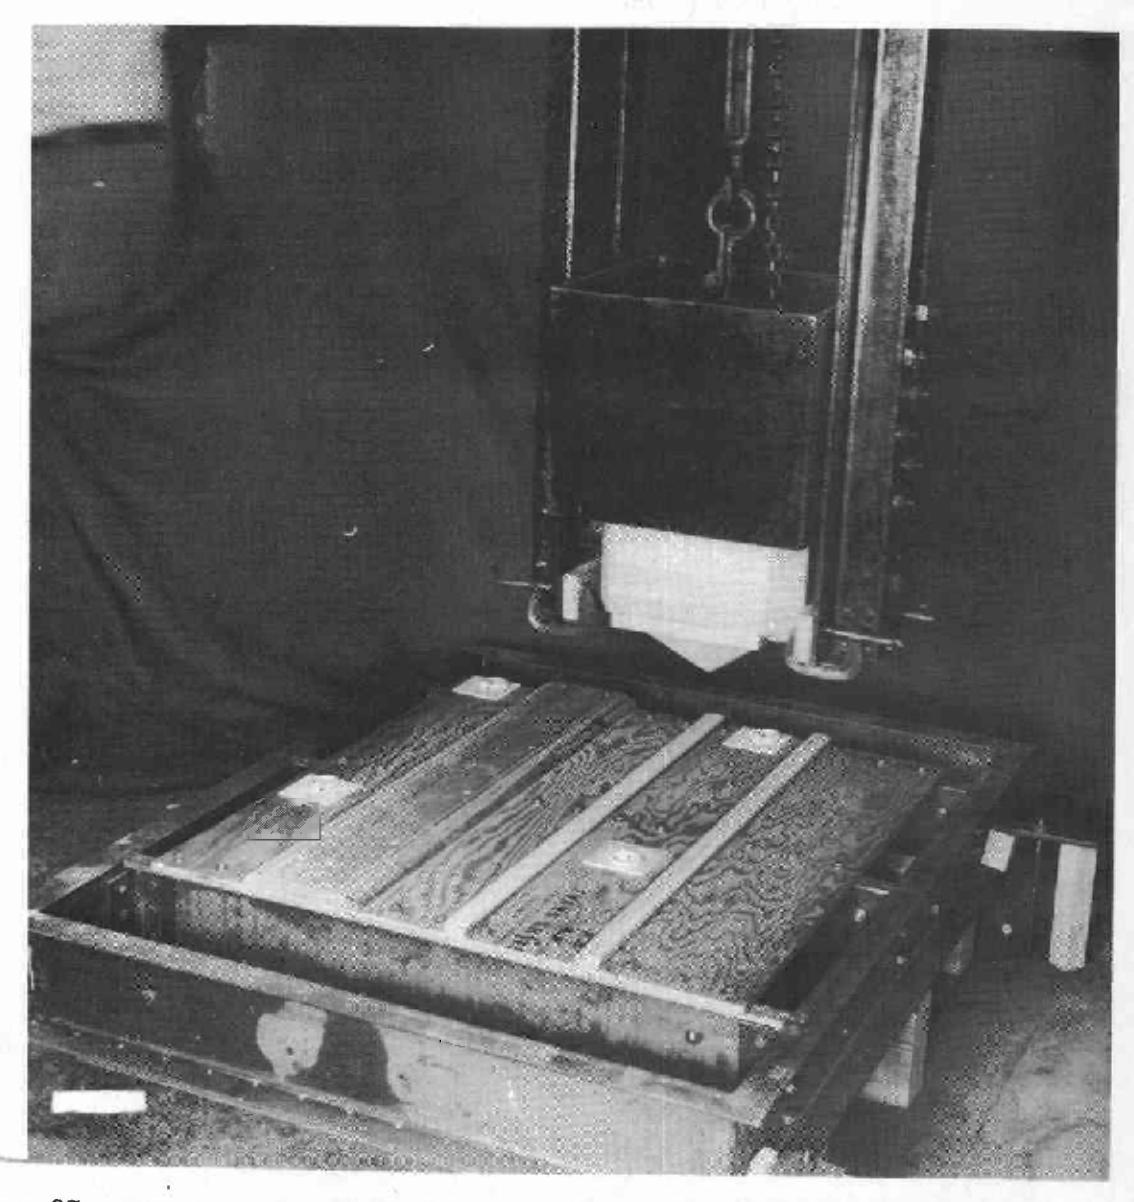
Figure 37.--Equipment for test of floor under impact of 200-pound box. The impact apparatus is shown before lowering into position for desired height of drop.

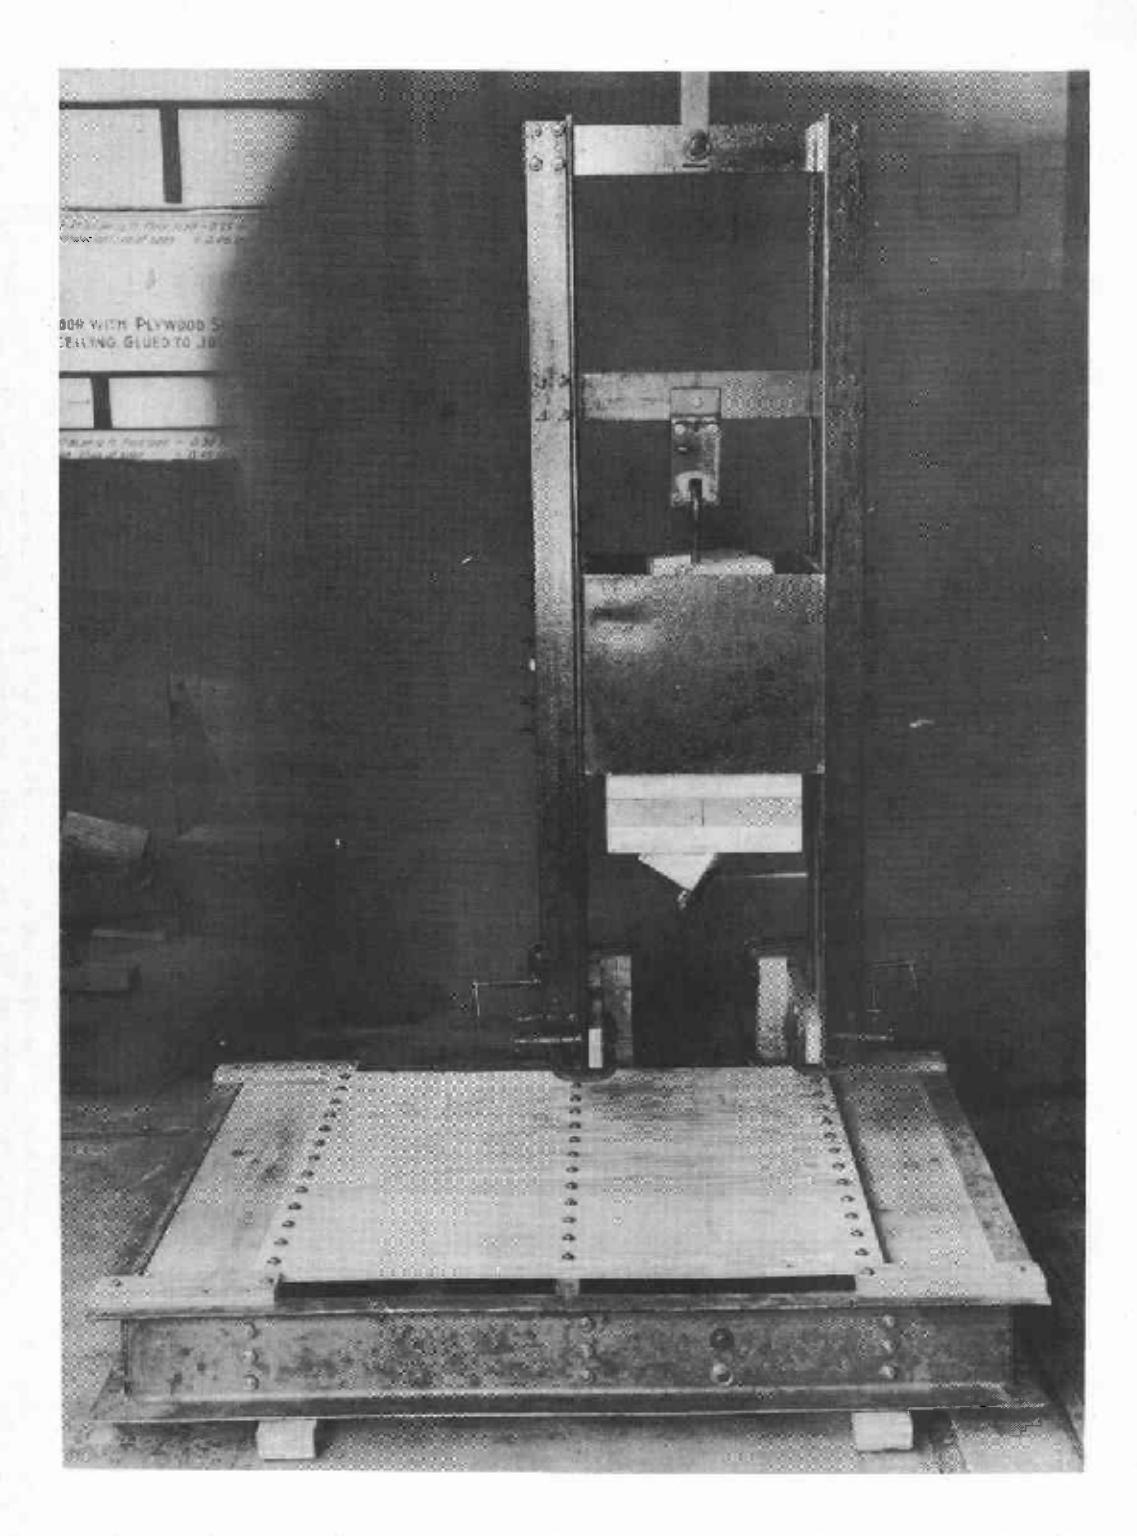
Figure 38.--Impact apparatus in position for test using the edge of a gasoline drum.

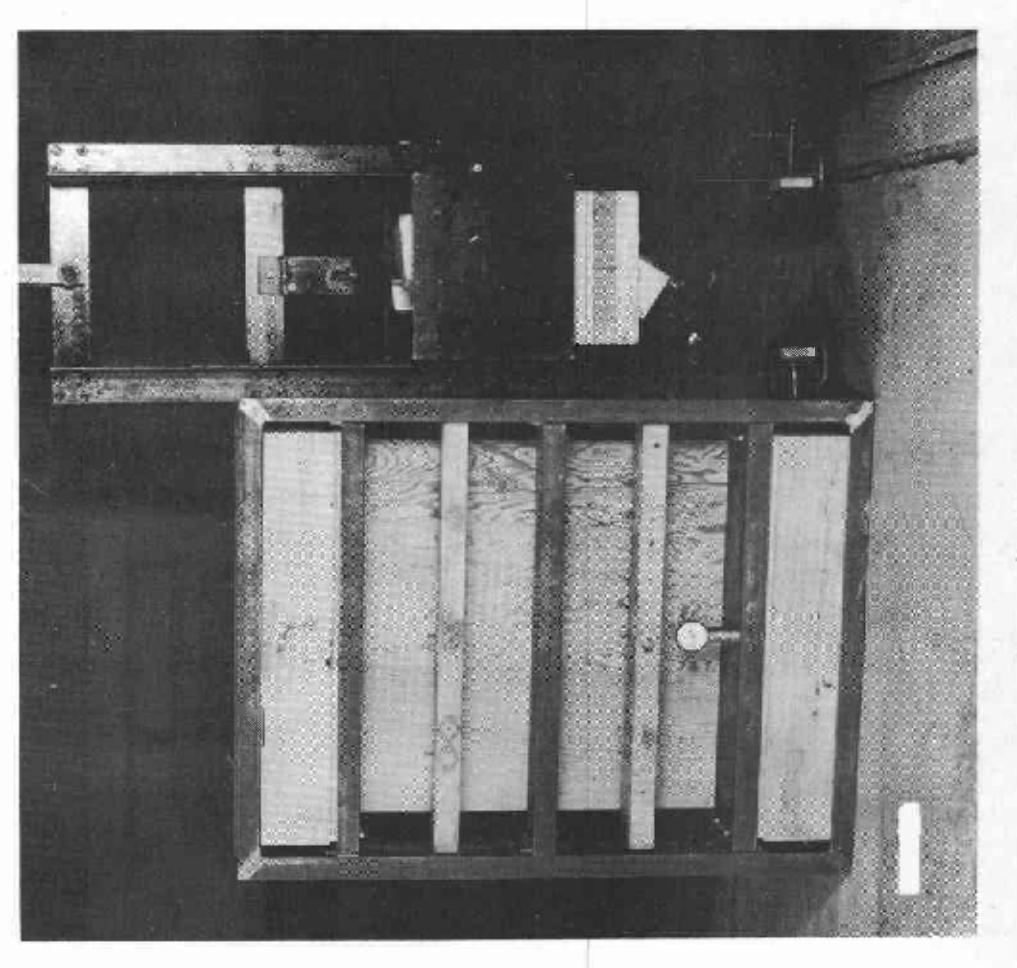
Figure 39 .-- General view of impact apparatus. The lower side of the appearing at midspan of each panel. A dial gage attached to a hollow cylinder as used to measure movements of the pins has been steel floor fixture is shown with the beam and pin deflectometer placed on the lower floor beam.

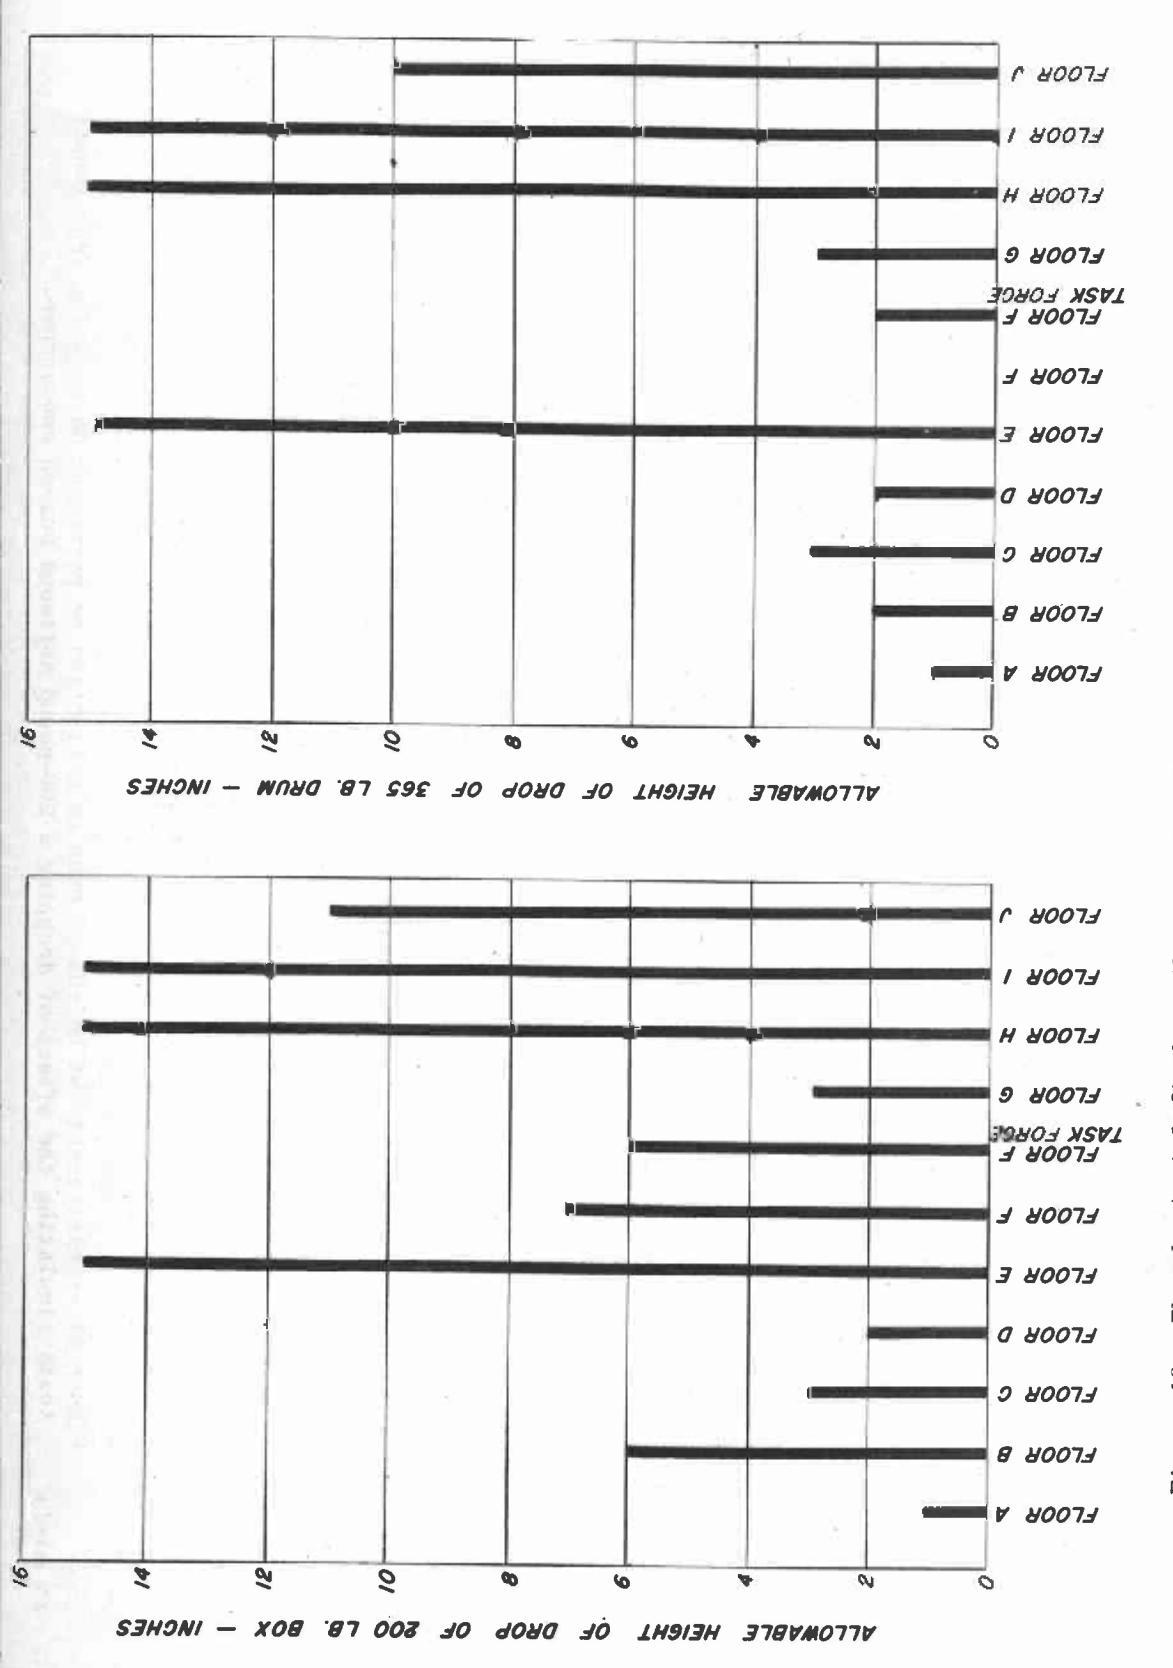
The results shown than floors E, H, and I sustained the load imposed by a drop from 15 inches without serious damage the chart at right the allowable heights of drop for a 365-pound steel drum which the several Figure 40.--The chart at left shows the allowable heights of drop for a 200-pound wood box and (task Under both types of test The allowable height for tests between stiffeners is less Floor F was not tested by the .365-pound drum owing to insufficient material. Floor F force) was tested by striking over the interior stiffeners or between them. floors will sustain without damage of a nature requiring repair. are for the former condition. 1 inch.

Interpretation of the results of impact tests, shown in figure 40, was made by consideration of head-deflection curves, head-deformation curves, and visual examination of the test specimens. The values of critical height of drop chosen are such that serious damage will result if these values are exceeded.

The height of drop shown for floors E, H, and I does not represent the maximum value that could be sustained. The equipment used in these tests limited the available head to 15 inches, which was not sufficient to cause serious damage to floors E, H, or I.

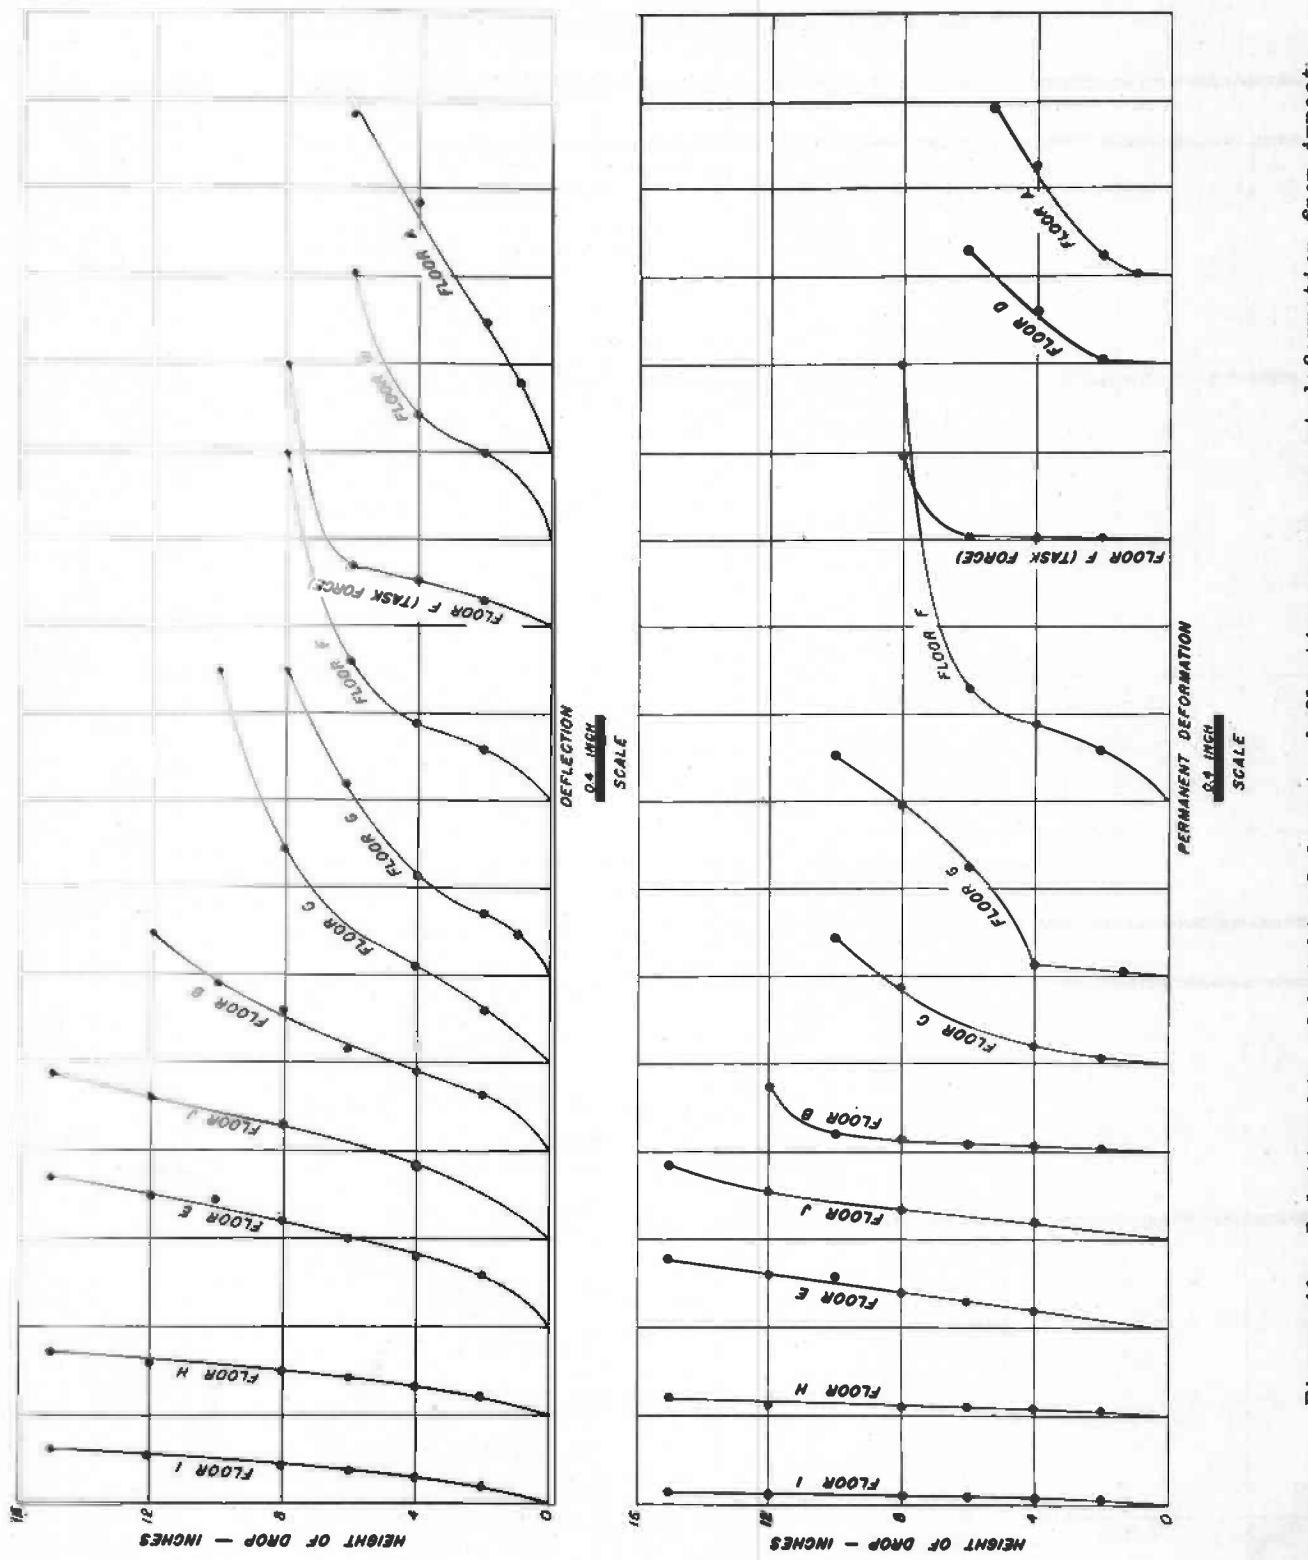
Figure 41.--Relationship of height of drop to deflection or permanent deformation from impact tests simulating the effect of dropping a 200-pound softwood box on one corner.

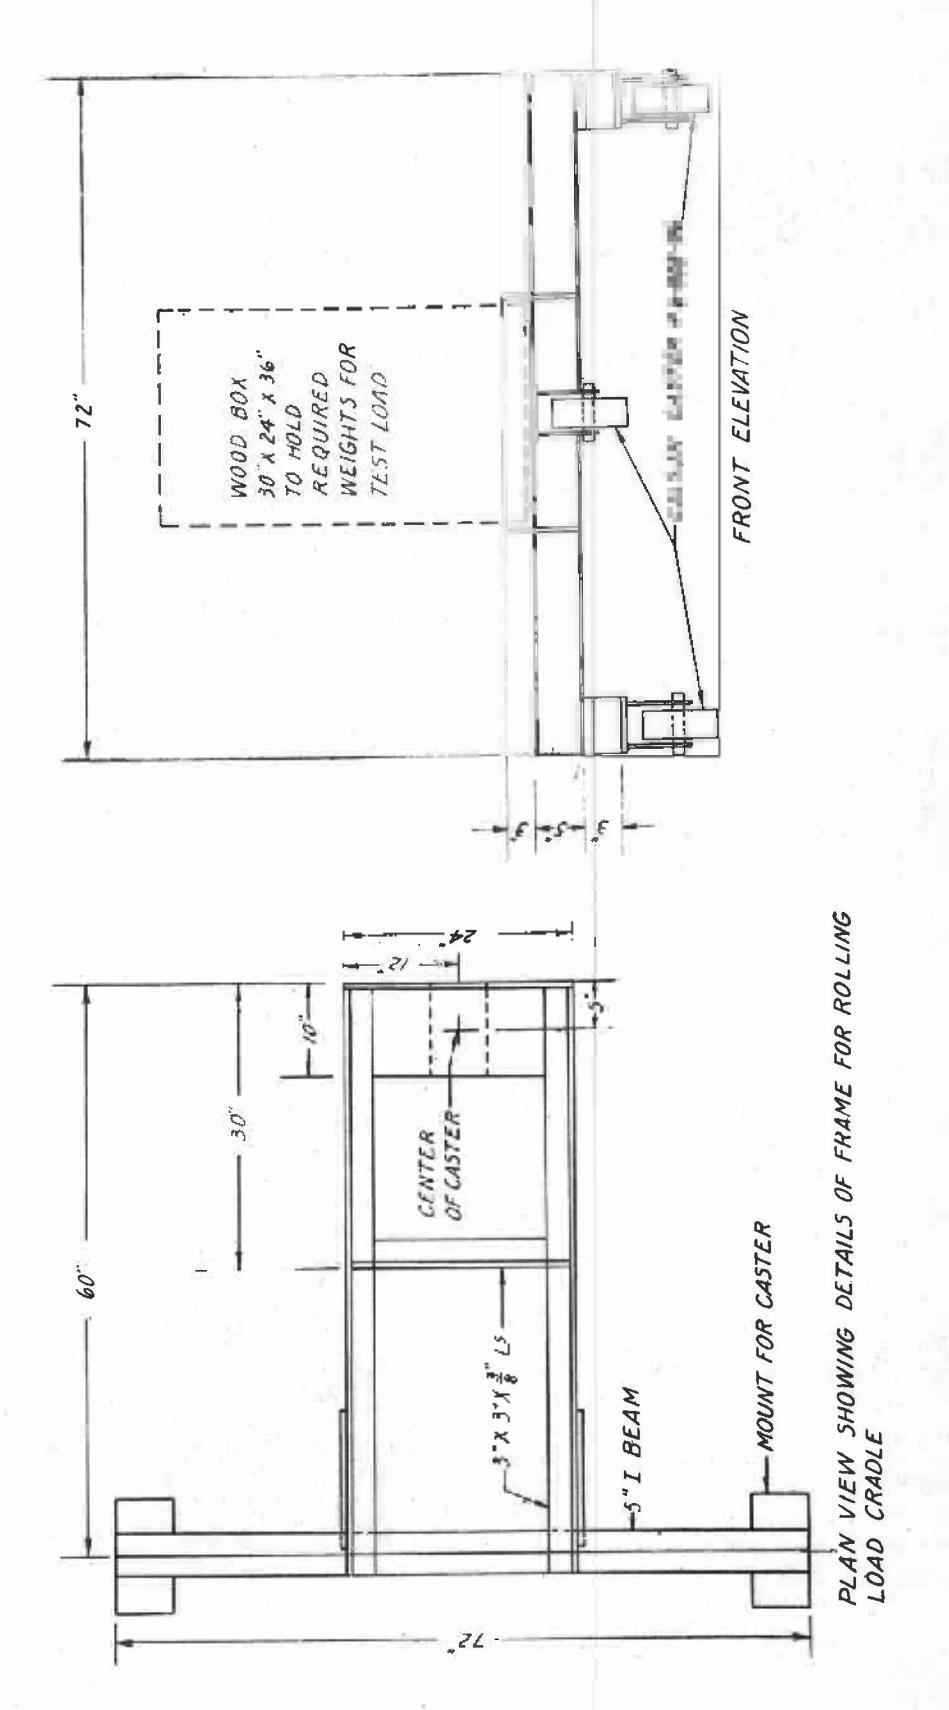
Figure 43.--Details of construction for steel cradle used to apply rolling-load tests to air cargo flooring. Z M 61432 F

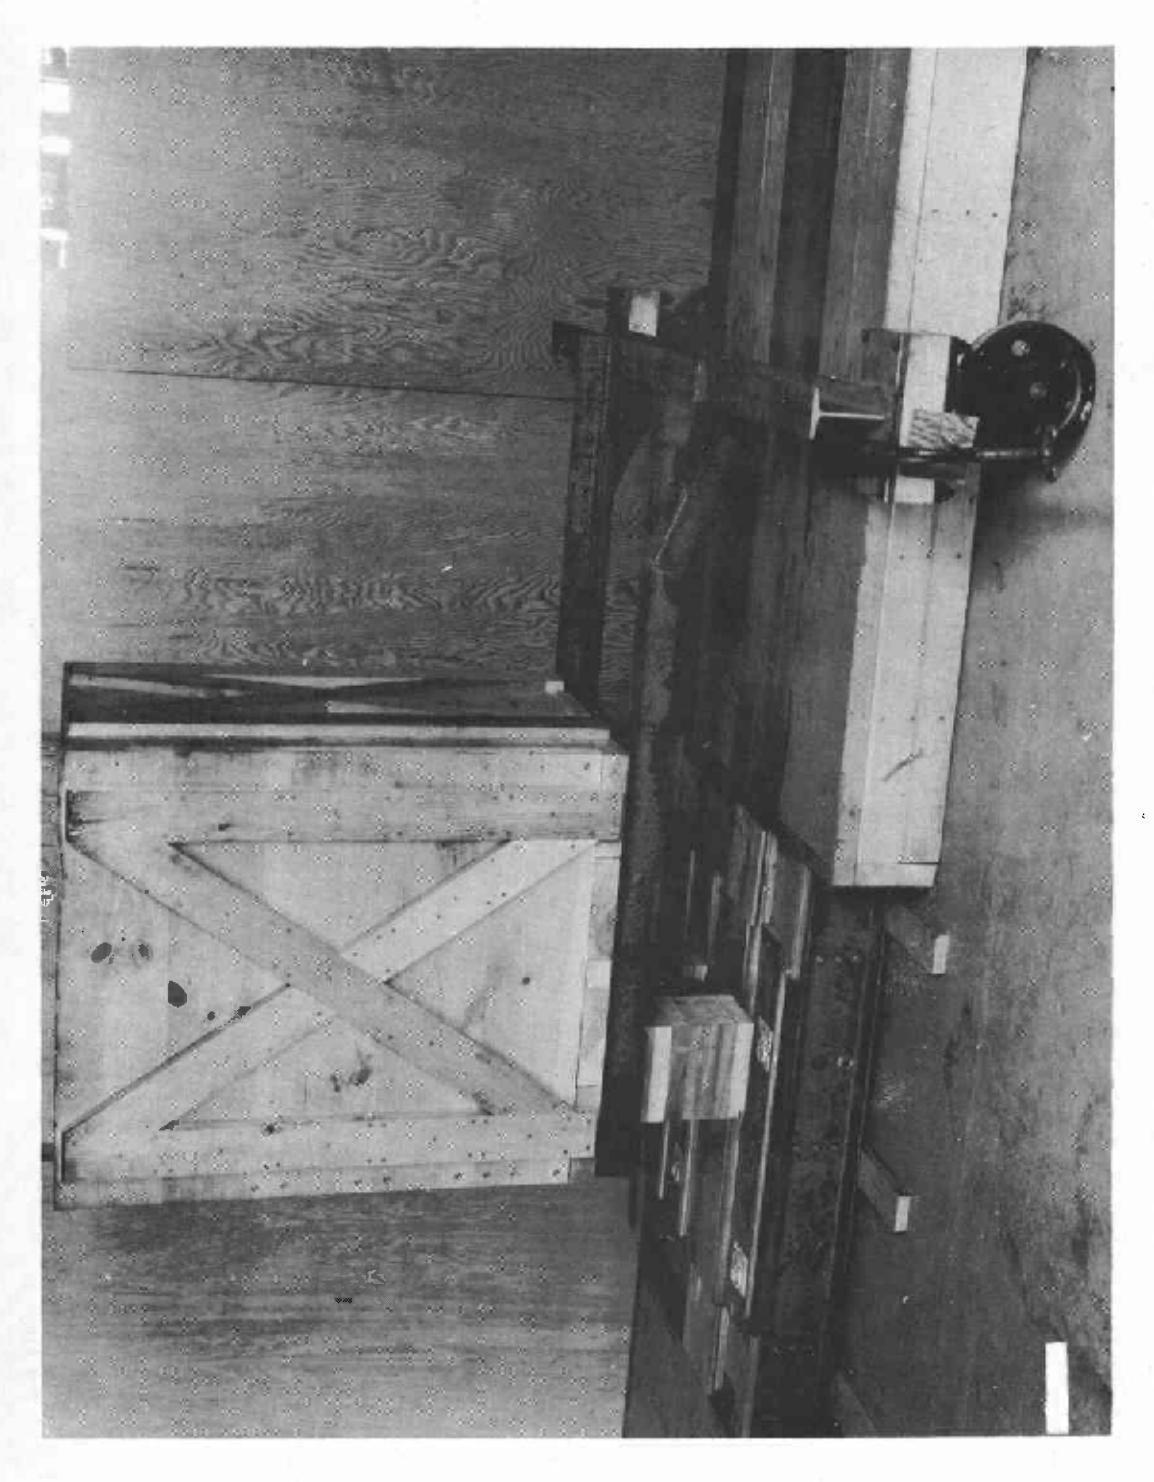
to the panel but not on it. The wood blocks on each side of the center wheel prevent the loaded cradle from falling completely through the cargo flooring when failure takes place. The imposed cradle wheel. The center wheel is in place on the panel, and the outside wheels travel adjacent Figure 44. ---Equipment used to test flooring under rolling load simulating the effect of an engine load is obtained by placing the necessary weight in the wood box mounted on the cradle.

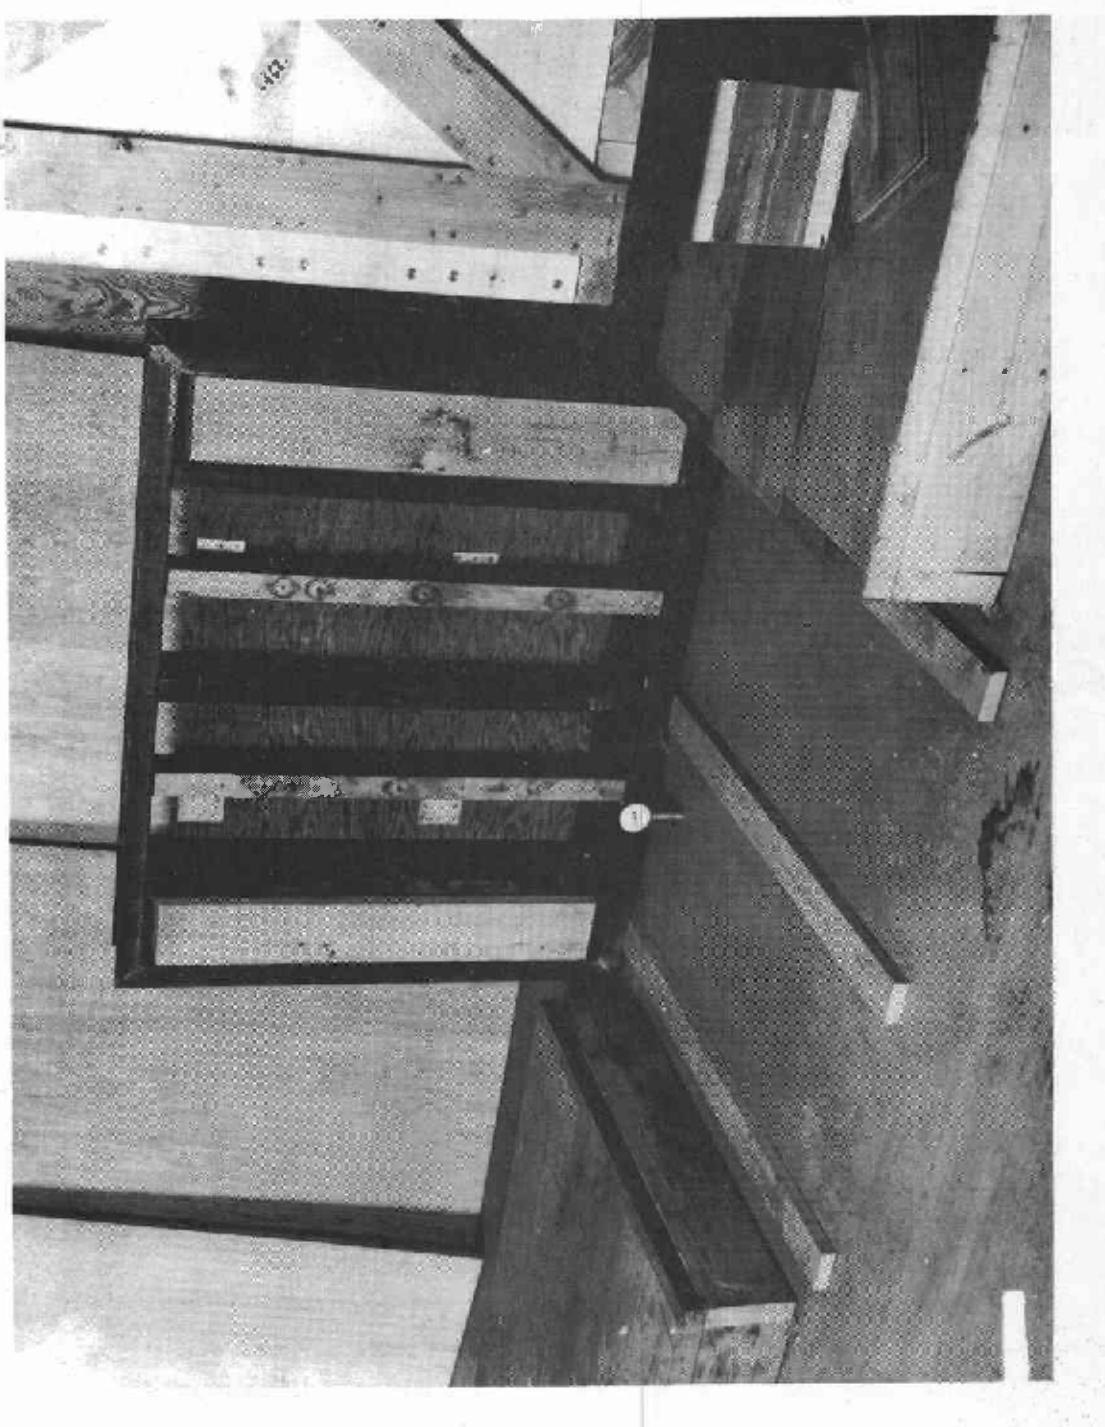
Figure 45.--Method of mounting a floor on the steel fixture. The beam and pin deflectometers are installed at midspan of each panel.

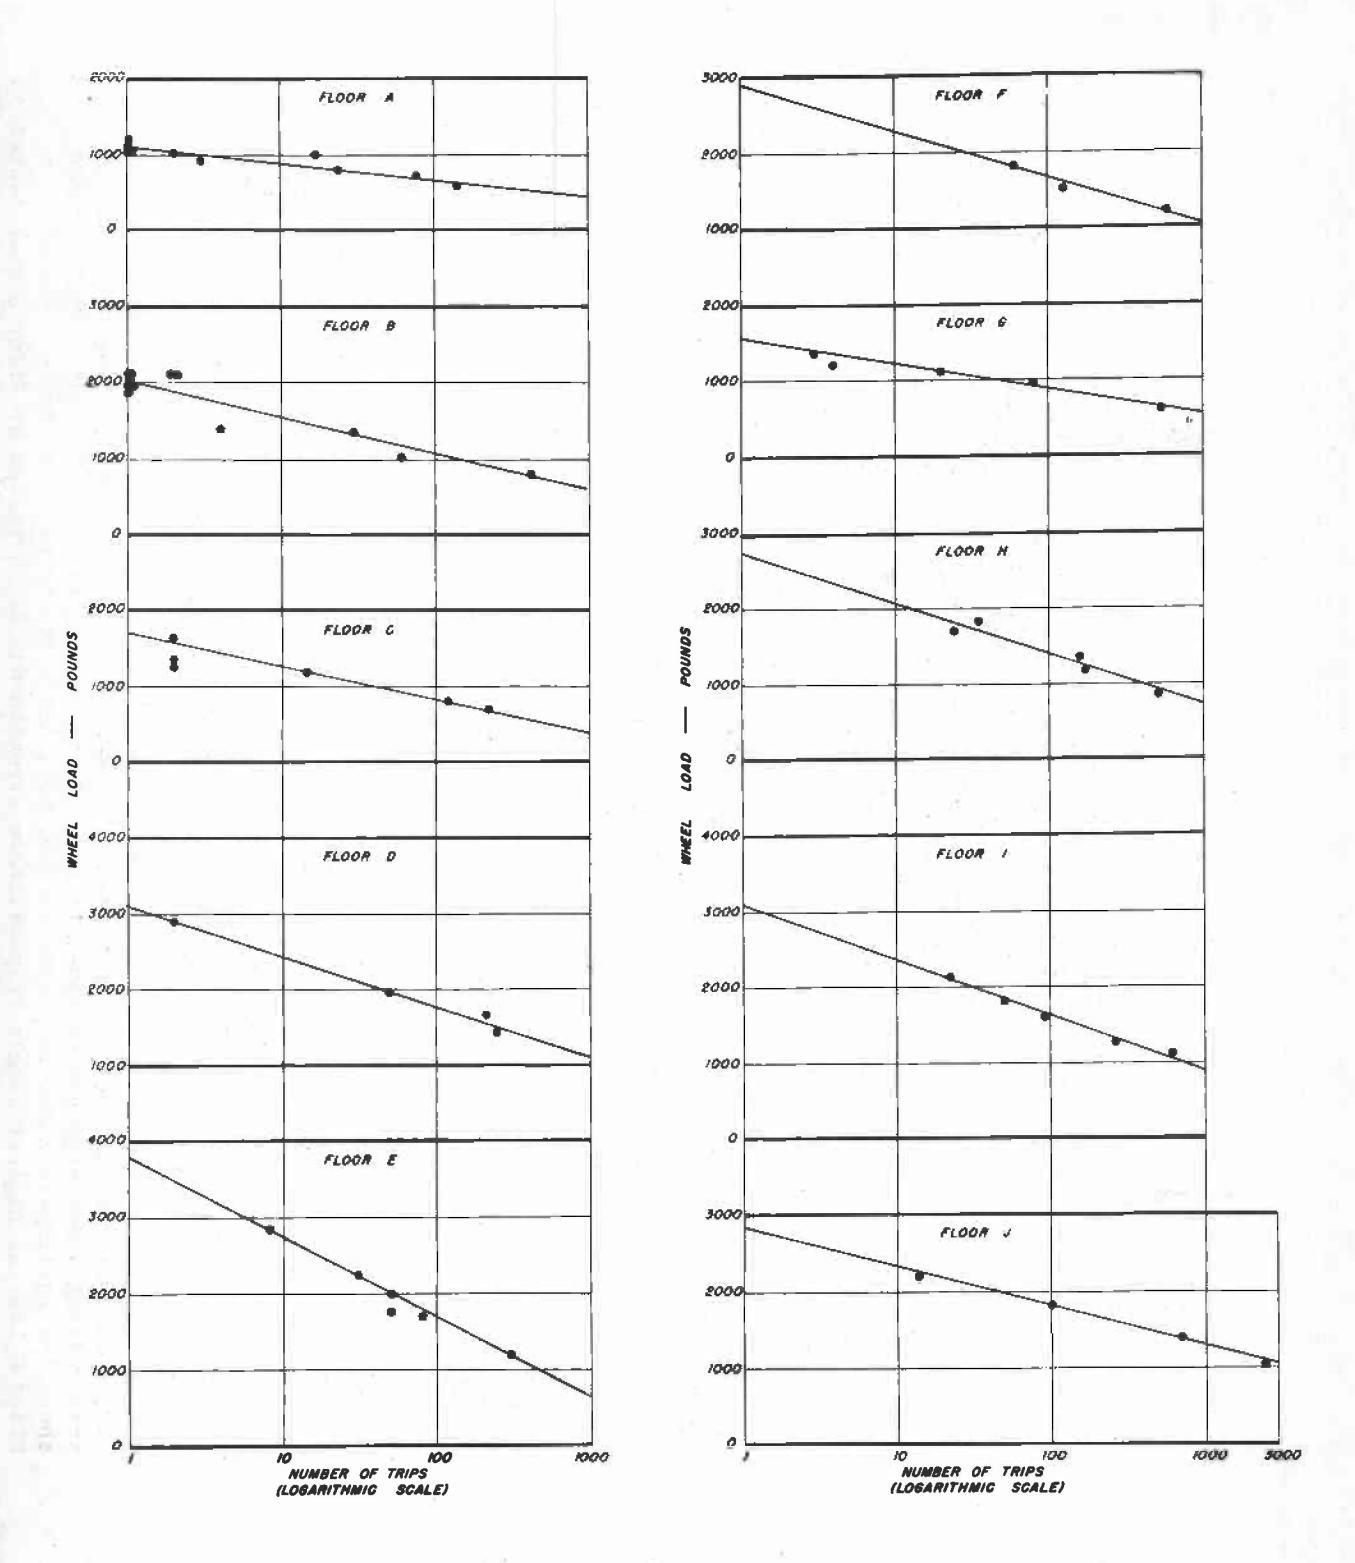
Figure 46.--Fatigue curves constructed with data from enginecradle rolling-load tests.

Wheel loads of several intensities were applied, and the number of repetitions of load, or trips, required to cause failure was recorded. These data were plotted on semilogarithmic paper with load intensity plotted on the arithmetic scale. Fatigue curves were drawn on the data from which the life expectancy corresponding to a given cradle-wheel load could be determined.
