METHODS FOR TESTING AND EVALUATING CARGO FLOORING FOR TRANSPORT AIRCRAFT

No. 1550

UNITED STATES DEPARTMENT OF AGRICULTURE FOREST SERVICE FOREST PRODUCTS LABORATORY Madison 5, Wisconsin In Cooperation with the University of Wisconsin

M. P. BROKAW, Engineer

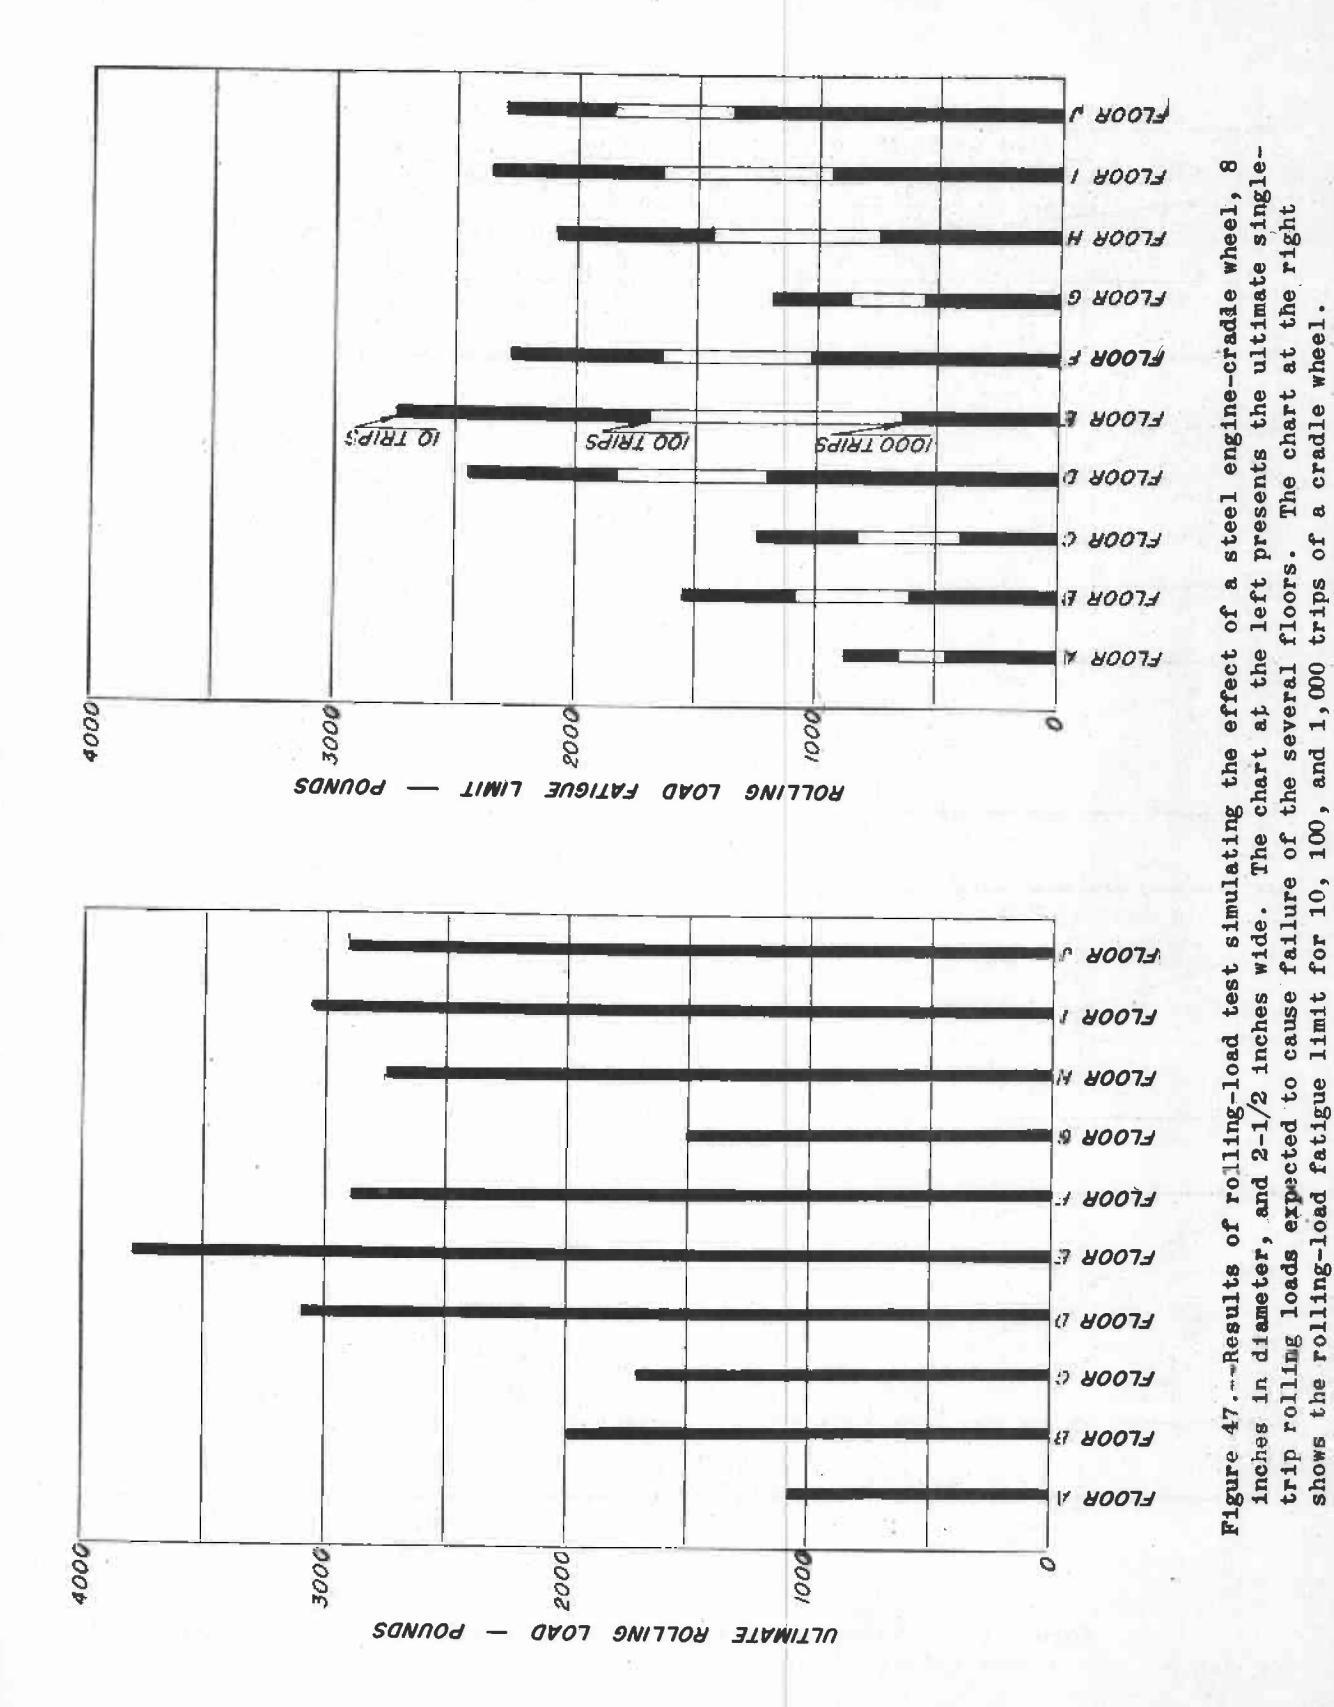
Floor E has the highest single-trip ultimate strength but is surpassed by floor J when tested by fatigue loading.

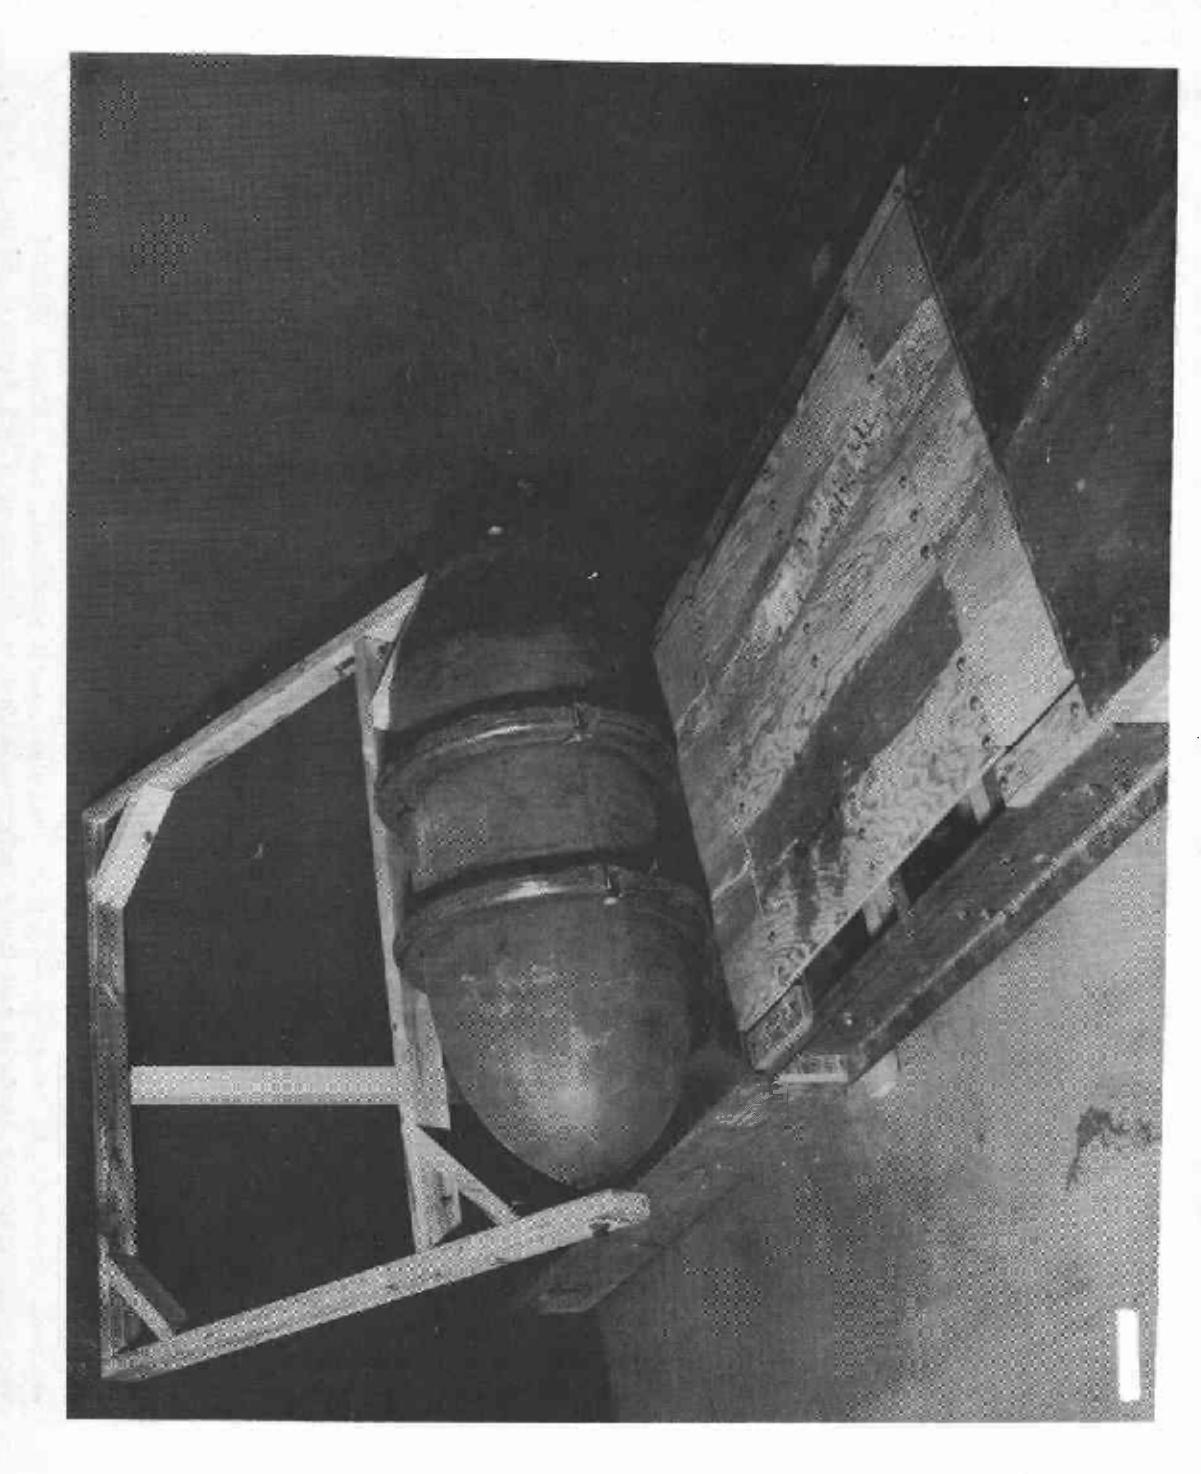
Figure 48.---Equipment used to test the structural and wear resistance of flooring to a rolling load imposed by a 1,000-pound bomb equipped with rings. The bomb is moved across the floor by two men.

The test equipment is shown in figure 48. The results of the tests expressed in terms of number of trips causing structural failure and trips to cause surface deterioration severe enough to contribute to ultimate failure of the floor appear in figure 49.

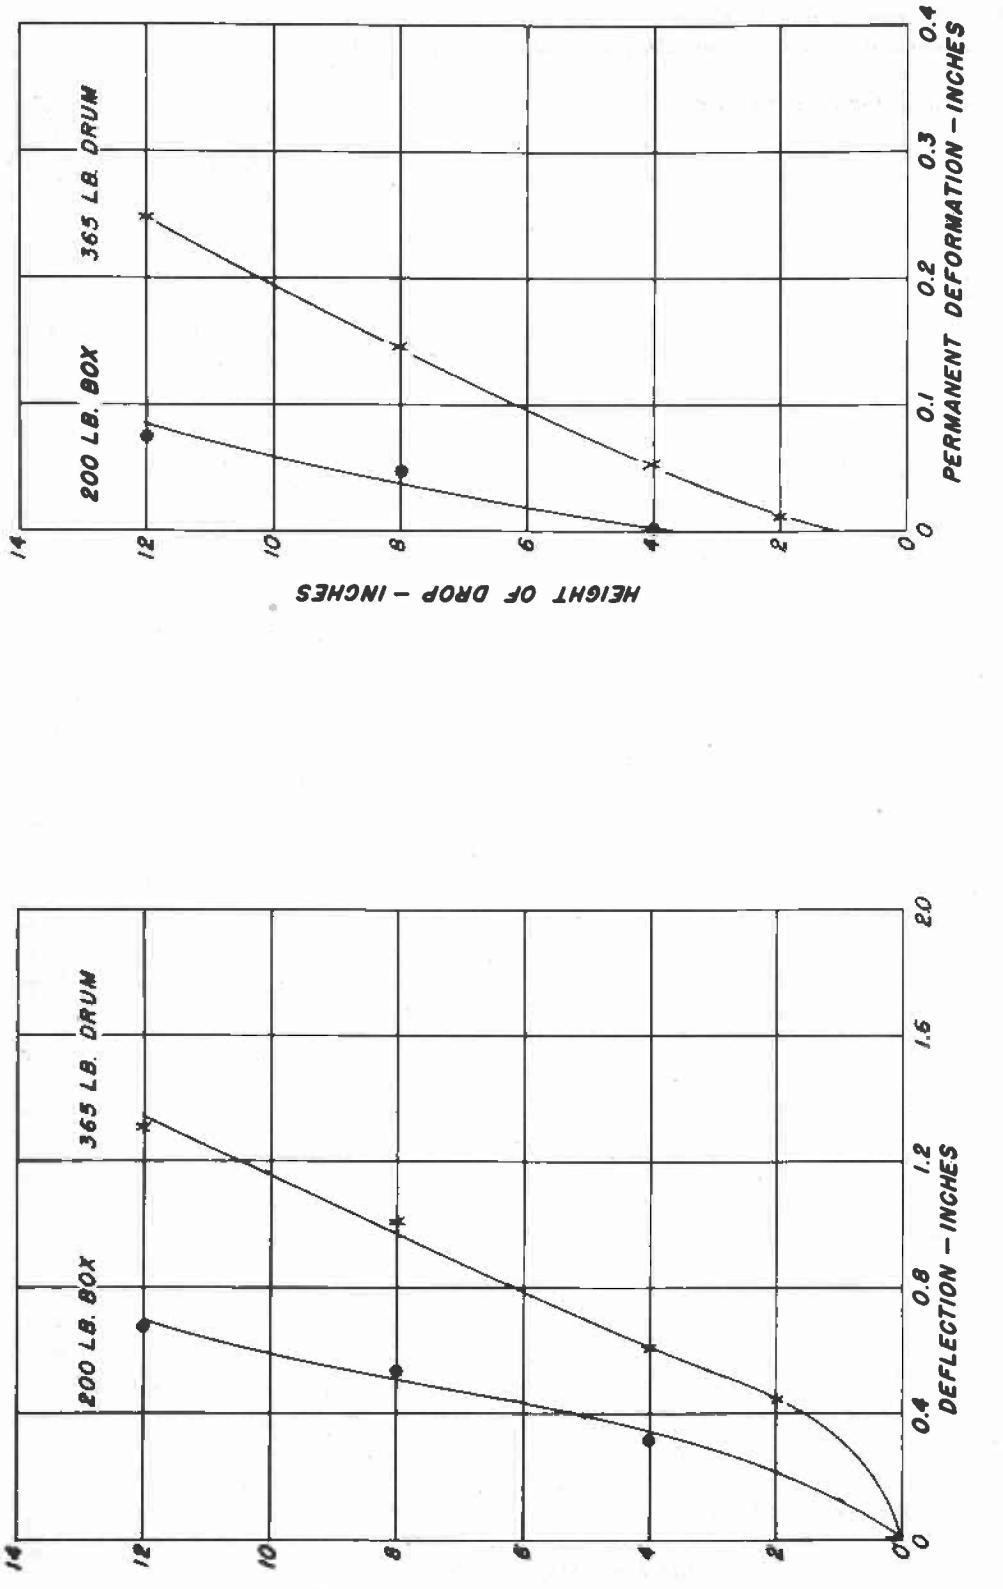
Figure 50 .-- Relation of height of drop of a simulated 200-pound box and 365-pound steel gasoline drum to deflection and permanent deformation in floor K. Z M 61439 F
