Upper Cow Creek

Watershed Assessment and Action Plan

Prepared by Nancy A. Geyer for the
Umpqua Basin Watershed Council

November, 2003

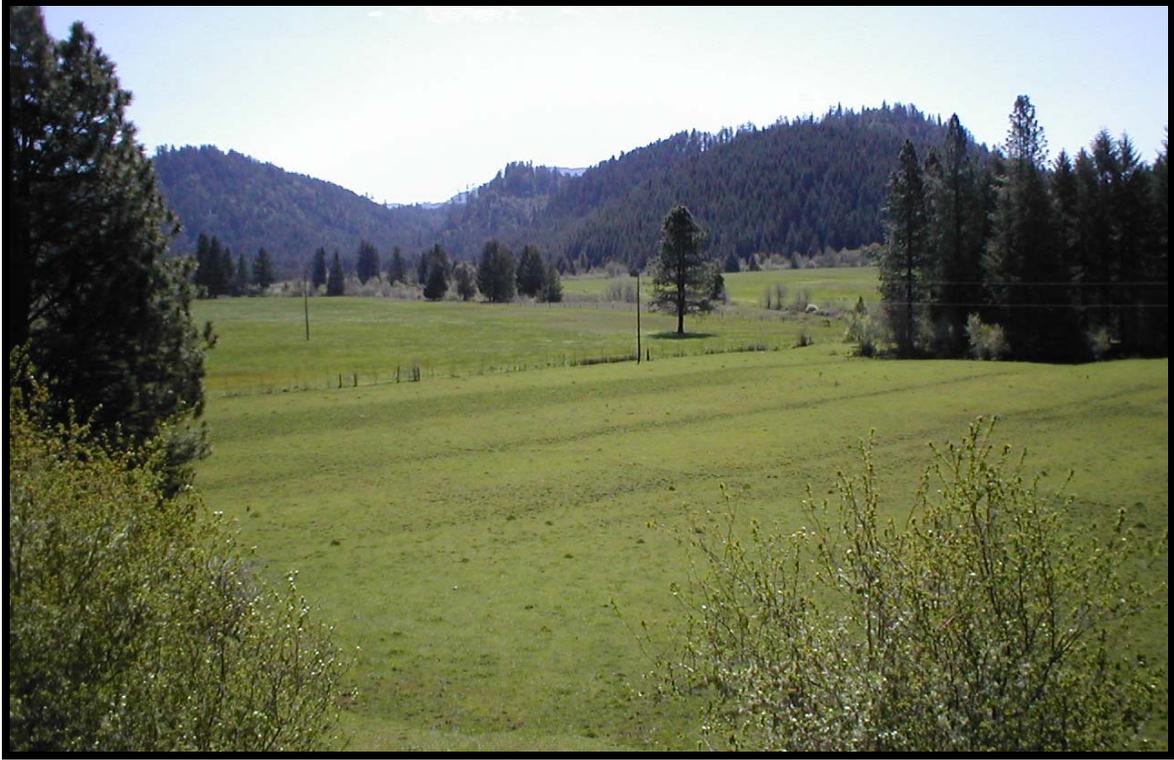
Photo 1-1: Photograph looking east-northeast over The Meadows, a prominent low relief feature in the watershed where Cow Creek opens into a floodplain.⁶

The Upper Cow Creek Watershed exhibits fairly steep topography, with streams dissecting the landscape. Red Mountain, Ike Butte, and Castle Rock are some high points in the landscape. Although the floodplain of Upper Cow Creek is not very large, it does open up at “The Meadows,” where Snow Creek feeds into Cow Creek (see Photo 1-1). Galesville Dam and its reservoir are located at the outlet, or most downstream point, of the Upper Cow Creek Watershed. Though the topography is fairly consistent throughout the Upper Cow Creek Watershed, some changes in slope are evident along contacts between geologic units.

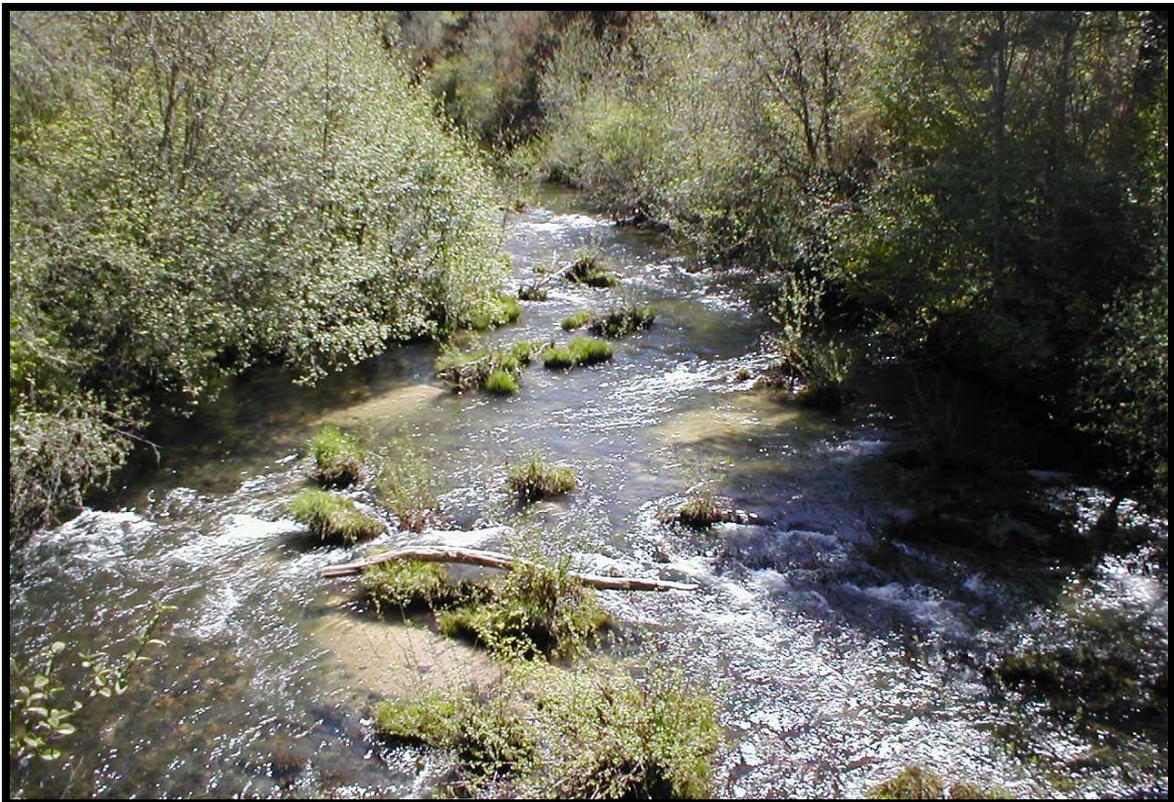
Photo 3-1: Looking east (upstream) at Upper Cow Creek where it is a low gradient, small floodplain channel.²⁶

²⁶ The photograph was taken from Universal Transverse Mercator coordinate 489575/4740961.
