FATIGUE OF SANDWICH CONSTRUCTIONS FOR AIRCRAFT

Aluminum Face and End-Grain

Balsa Core Sandwich Material

No. 1559-B

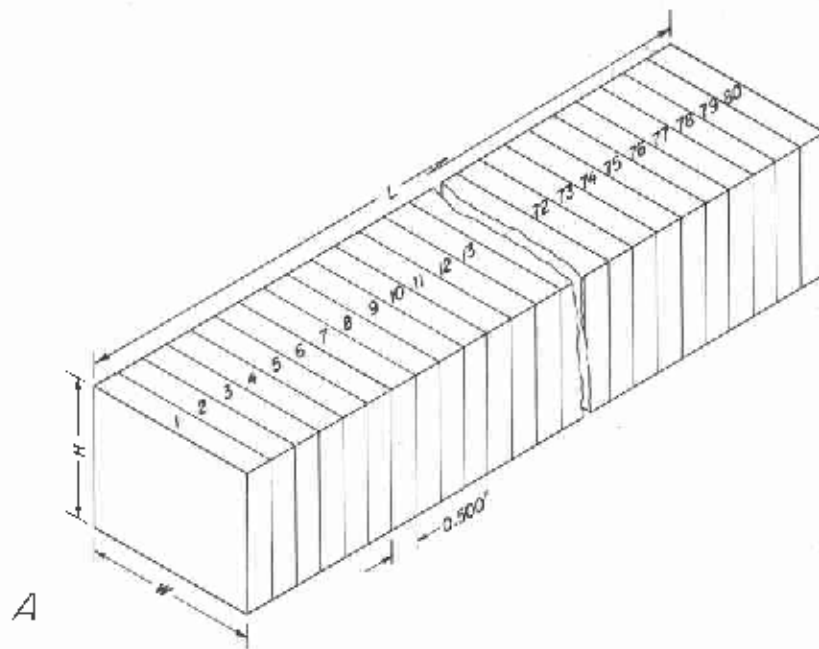
Figure 1.--Method of cutting and distribution of core material in a typical aluminum face and end-grain balsa core sandwich panel to be tested in shear fatigue. A. Method of numbering slabs cut from a balsa block; B. Distribution of slabs in the assembled core; C. Selection and numbering of specimens, 2 by 3.67 inches, cut from an assembled sandwich panel, with "C" designating control specimens.

Figure 1A, shows a typical balsa block accurately jointed and planed to a rectangular shape. The block was then cut into end-grain slabs 0.500 ± 0.003 inch in thickness with a circular saw. Each slab was consecutively numbered as shown and weighed to the nearest tenth gram so that the core density of each specimen could be approximated. The slabs were assembled into a core panel, figure 1B, with the use of a high-frequency edge-gluing machine using a phenolic adhesive. After assembly, the core panel was sanded lightly to remove glue squeeze-out and other minor surface imperfections. (Additional information on the selection and assembly of balsa core material is contained in a previous report.⁵)

The specimens were cut from the assembled sandwich panels (fig. 1C) with a metal-cutting band saw to a width and length of 2 and 5.67 inches, respectively. The sandwich blocks were then glued to 1/2-inch steel shear plates with a high-temperature-setting adhesive, W,⁴ and cured at 150 pounds pressure per square inch at 320° F. for 30 minutes. Some difficulty was experienced in obtaining a good glue bond between the aluminum and steel, and several fatigue

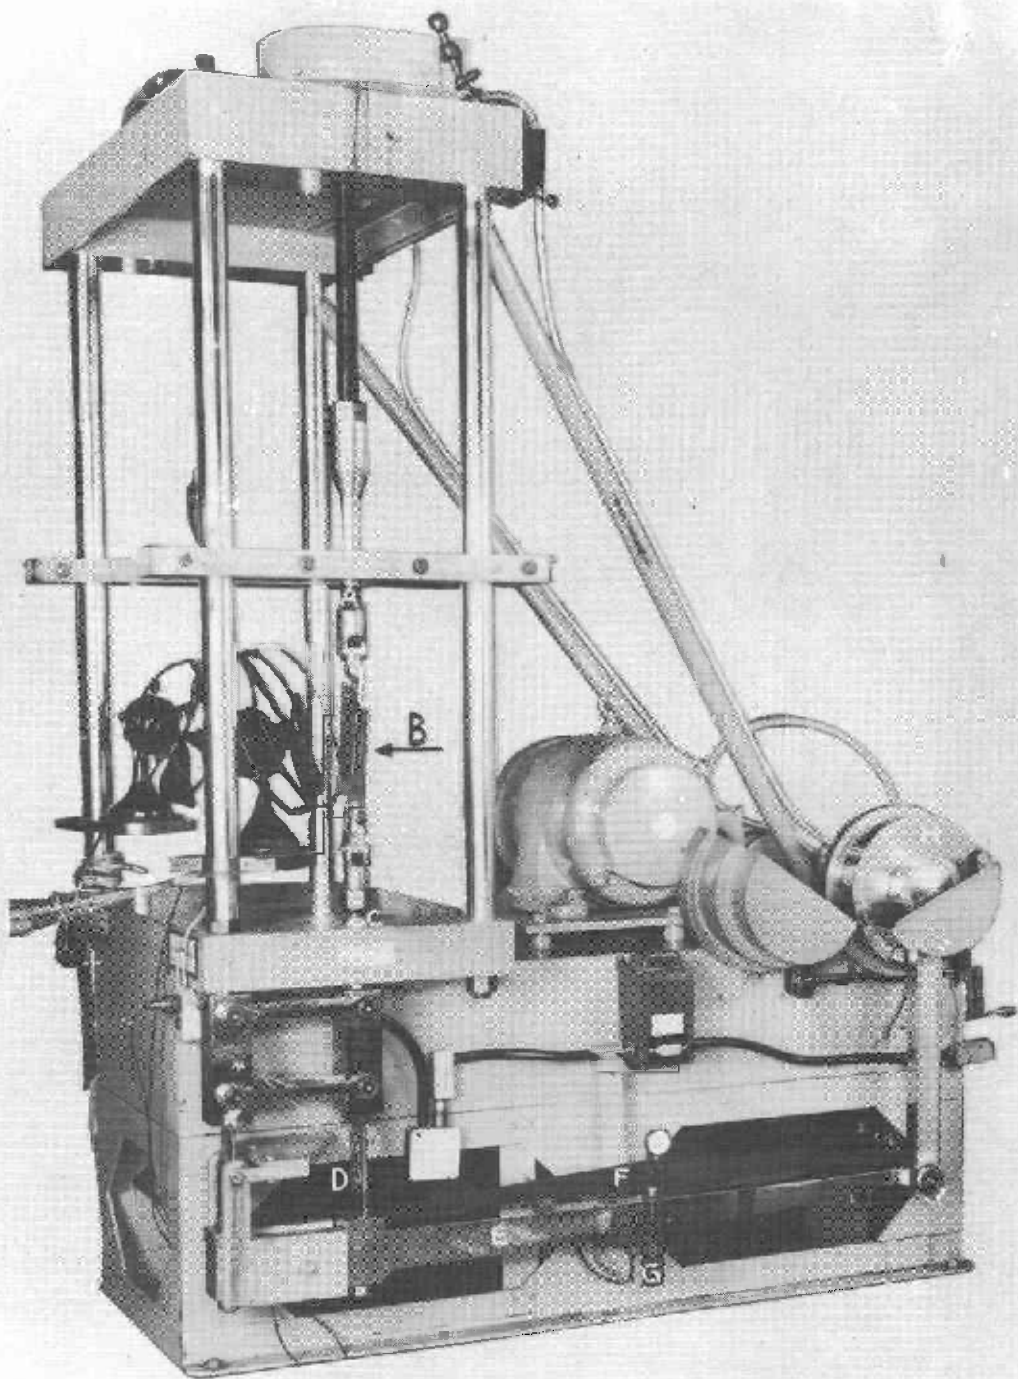
Figure 3.---Direct-stress fatigue machine showing: (A) upper loading screw, (B) specimen, (C) lower loading screw, (D) electric strain gages for determining corrections for dynamic effects, (E) horizontal loading arm, (F) calibrated dial bar for determining static loads, (G) electronic cut-off switch for stopping machine, and (H) adjustable eccentric.

Fatigue specimens (fig. 2) were tested in a direct-stress fatigue machine of either 4,000- or 10,000-pound capacity. The 10,000-pound machine is shown in figure 3, and the smaller machine is fundamentally the same.

The mean load is placed on the specimen by adjusting the upper loading screw (A), and the cyclic variation is obtained by adjusting the eccentric (H). It will be noted that the horizontal loading arm is supported on the end opposite the eccentric, and the deformation applied by the lower loading screw (C) will, therefore, vary with the setting of the eccentric. The magnitude of the static load is measured by the dial on the bar (F), which measures the deflection in the horizontal loading bar. The load is directly proportional to the deflection of this calibrated loading bar.

As would be expected the dynamic load varies from the static load because of inertia effects. The increase of dynamic load over the static load was measured by using the metaelectric strain gages (fig. 3,D) mounted on the lower flexure plate, and a wheatstone bridge and cathode ray oscillograph. The dynamic load was compared with the corresponding static load measured by the dial bar. For any static load, the maximum dynamic load is increased by the same amount as that by which the minimum dynamic load is decreased. This increase or decrease due to the dynamic throw is proportional to the load at any specified machine speed. The static load was corrected and applied so that the dynamic effects would provide the desired load.

The ratio of minimum to maximum load (stress ratio) was 0.1 for all of the fatigue tests. Loads were applied at a rate of 900 cycles per minute, and the maximum repeated load on the specimen was kept nearly constant throughout the test. The loads were checked periodically and adjusted as necessary. When the specimen failed or the load decreased more than about 50 pounds, the machine was stopped by means of an electronic shut-off mechanism (fig. 3,G). The number of repetitions of stress were obtained from cycle counters.

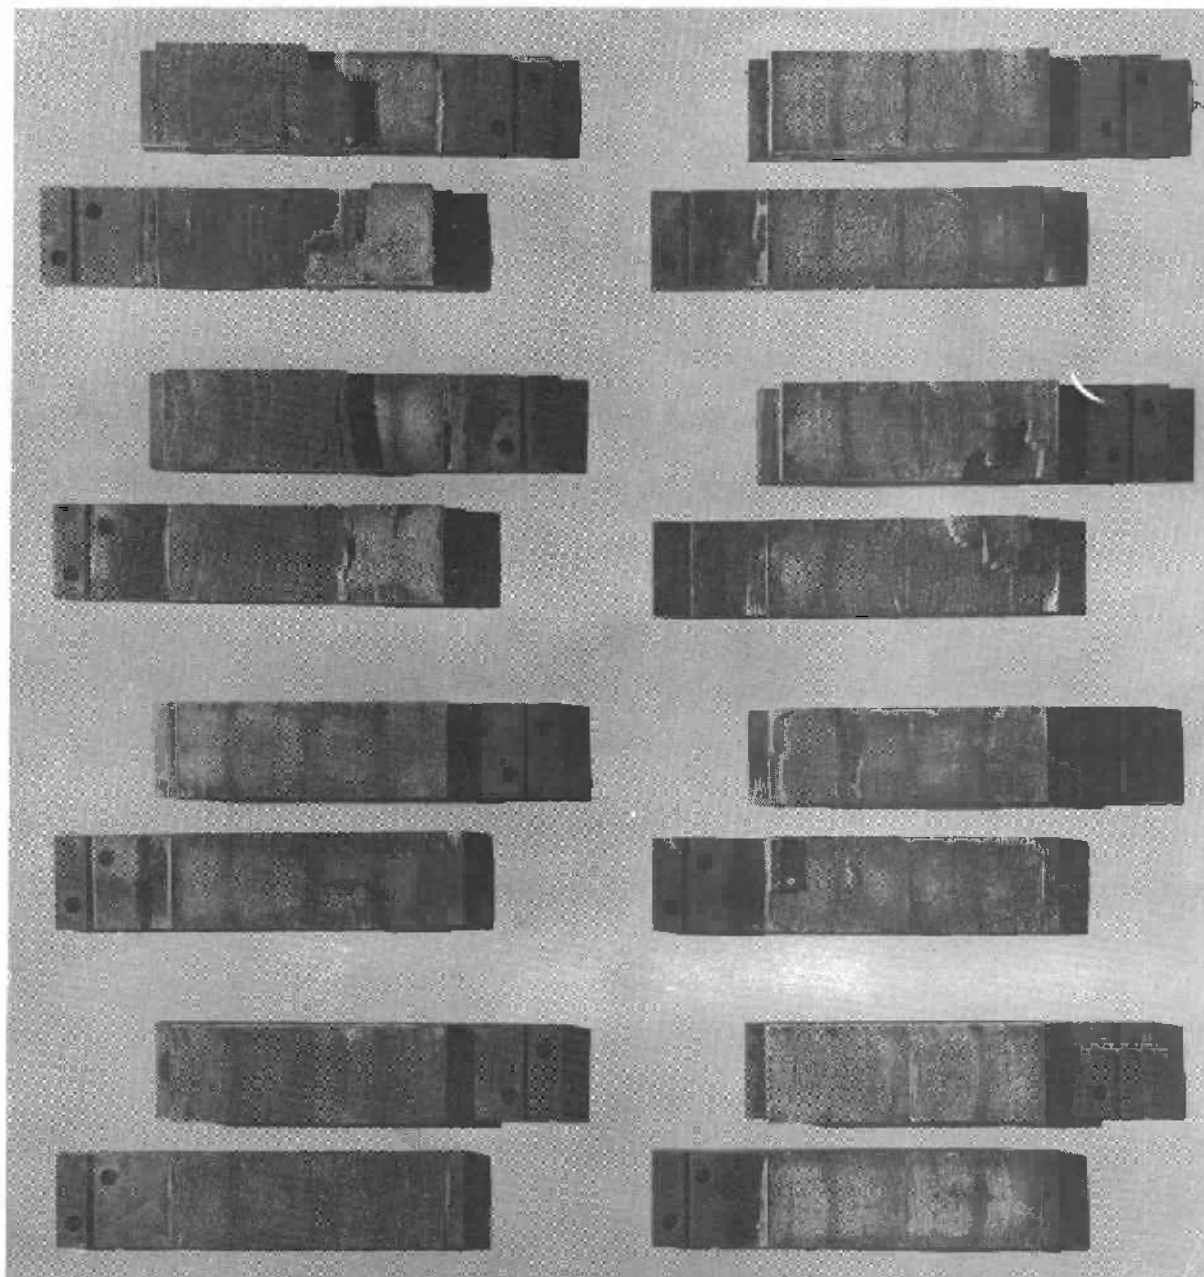
ZM 77043 F

Figure 4.--Typical failures of fatigue shear specimens from aluminum face and end-grain balsa core sandwich panels .

The failures of the fatigue shear specimens are of the type shown in figure 4. In most cases, the failure was a combination of shear failure in the core adjacent to the glue line and partial failure parallel to the grain of the core. A typical failure of this nature is shown in figure 5, where the specimen failed after 42,300 cycles of repeated shear stress at 81.8 percent of control strength. In several instances, there was no evidence of failure parallel to the grain, all failure being shear failure along the glue line.

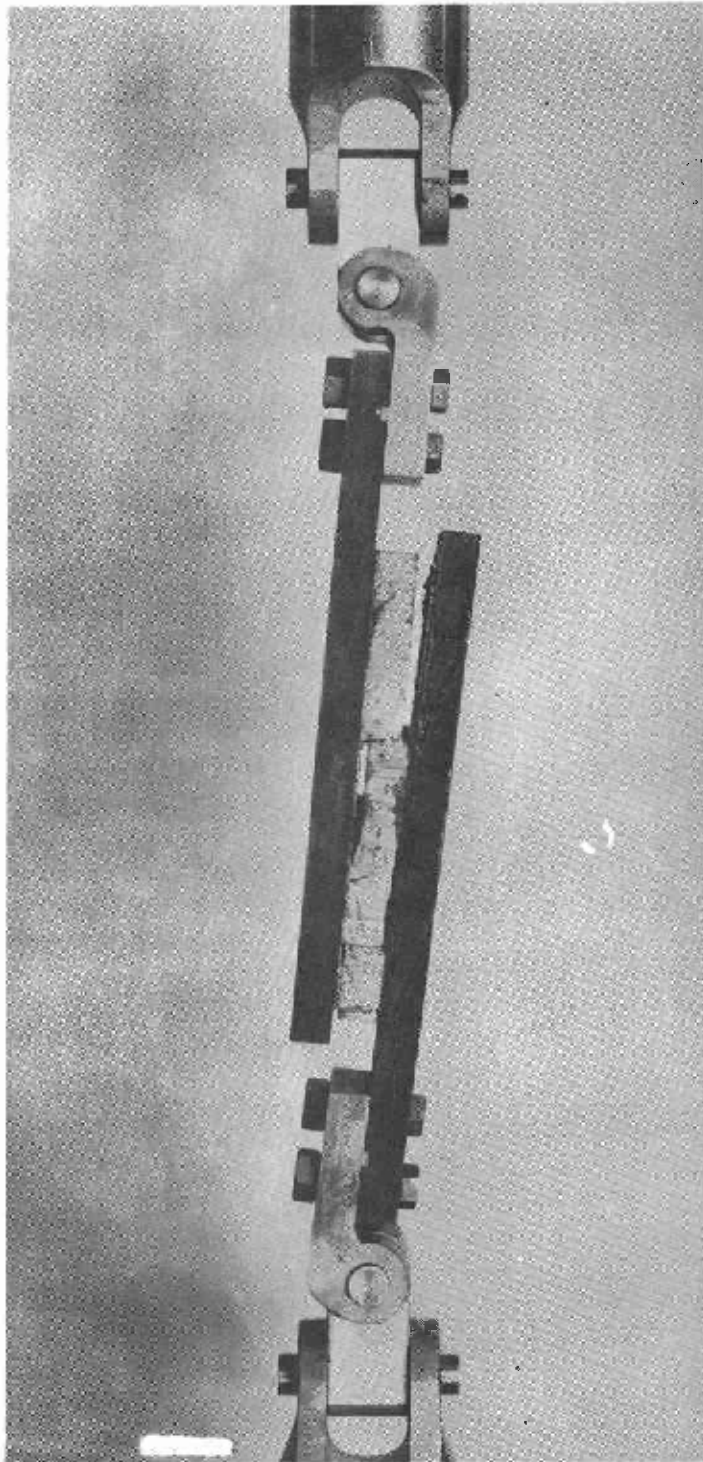
Z M 77044 1

Figure 5.--Typical failure of a fatigue shear sandwich specimen with aluminum faces and end-grain balsa core. Core failure is a combination of shear failure along the glue line and shear failure parallel to the grain.

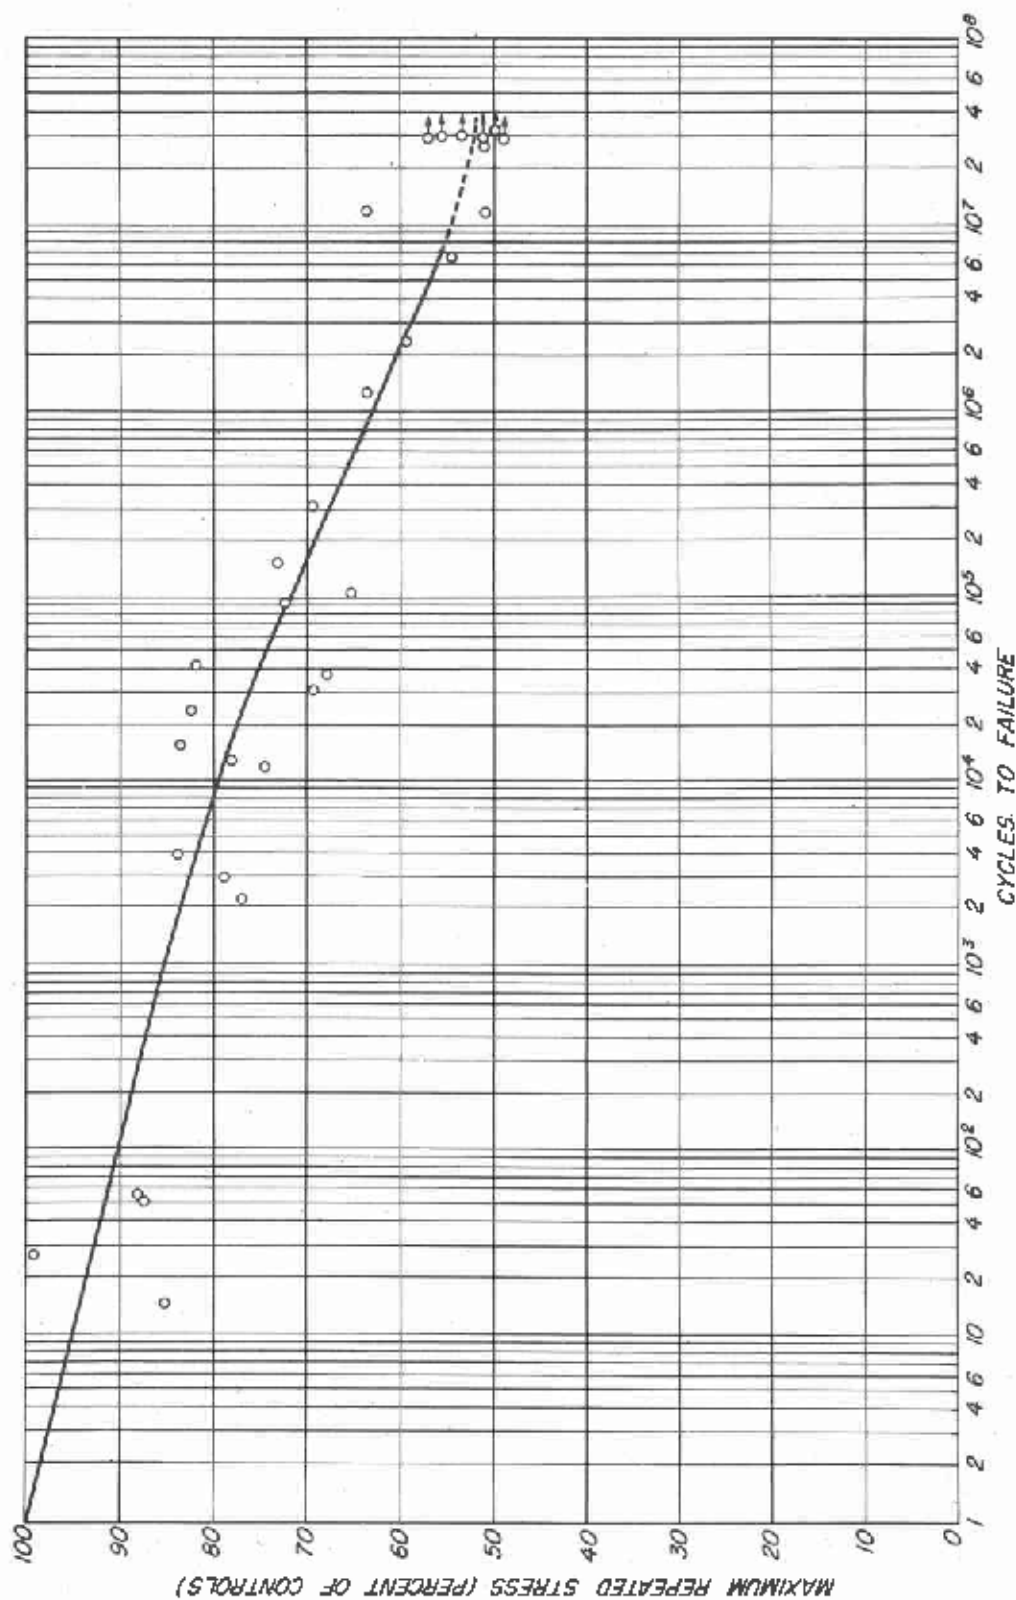
Figure 6.--"S-N": (stress-number of cycles to failure) curve for aluminum face and end-grain balsa core sandwich material in shear. Ratio of minimum to maximum stress (range ratio) was 0.10.

The results of the fatigue tests are plotted in figure 6 and the S-N curve is drawn through the average values. The maximum repeated cyclic stress, expressed as a percentage of the control load, is plotted as the ordinate on rectangular coordinates. The number of cycles to failure is plotted as the abscissa on logarithmic coordinates.

It had been previously agreed to discontinue any specimen that withstood 30 million cycles without failure. Six specimens with maximum stress varying from 48.8 to 56.9 percent of the control strength, withstood over 30 million cycles without failure. Because of the scatter of data, the endurance limit cannot be accurately determined. It does appear, however, that the S-N curve tends to level out beyond 8 million cycles and may be similar to the dotted portion of figure 6.
